16th August 2013

Our Ref: 416.01258.00002

# RE: SUMMARY OF SITE VISIT OBSERVATION AND QALITATIVE STABILITY ASSESSMENT

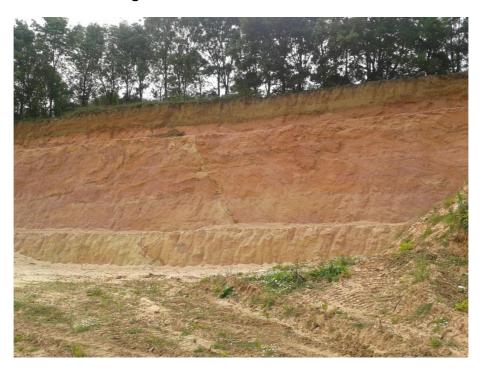
Figure 1 Excavated Sand Face

Of key concern in this site visit is a face in the south west corner of the site. The face has been recently excavated to expose a fresh face of Folkestone Beds.

The face in question is excavated from surface to a maximum depth of approximately 15m below ground level (bgl) (Note, all distances and heights are visually estimated). An initial

upper bench is excavated within topsoil and overburden material observed to comprise brown clayey fine to coarse sand with frequent roots and rootlets.

An approximately 3m wide bench separates the upper overburden material from the main mineral. The main sand face is excavated at a near vertical gradient (approximately 85 degrees) to a maximum height of 10m. A final, approx. 3m wide, bench is located approximately 1.5m above the base of the excavation.

Based on the observations made during the site visit there is no explicit evidence to suggest the cut face is at risk of instability in the short to medium term. Whilst the face is higher than those present elsewhere on the site, the excavation works have been carried out in a manner that reduces the risk of instability having an adverse effect on further activities within the quarry. In addition the excavation has been carried out in general accordance with recommendations within the Quarries Regulations, 1999.

Care should be taken when plant or personnel are operating at the toe of the face and regular inspections of the cut slope should be carried out by the Quarry / Site Manager. Any signs of instability should be addressed as they are identified. Remedial works may include clearing of loose or unstable material from the face or buttressing works, if necessary.

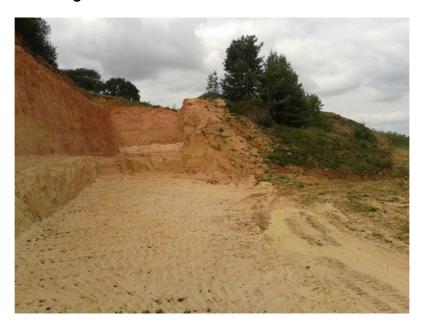
Figure 2 Western Extent of Excavation

At its western edge of the excavation the face has been extended into a deeper wedge of insitu sands, where the inner material has been retained. This appears to have been carried out to allow an area of vegetation to be retained.

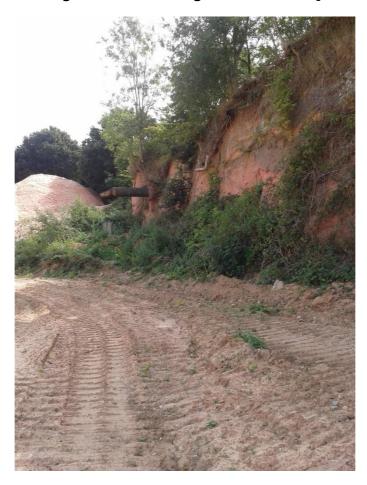
Figure 3 Existing Cut Sand Faces]

The existing cut sand faces appear to be stable at a height of up to 8m. Vegetation at the crest of the face in this is beginning to overhang where overburden material is sloughing from the slope. A similar process is likely to occur at the crest of the new face over time; however, the uppermost bench will prevent this material collapsing into the main void.

The remainder of the existing sand slopes appear have been in-situ for a long period (a number of years) and are not showing any explicit signs of instability.
