# STATEMENT - SUMMARY OF SITE VISIT OBSERVATION AND QALITATIVE STABILITY ASSESSMENT

Ref: 416-01258-00002 11th August 2014

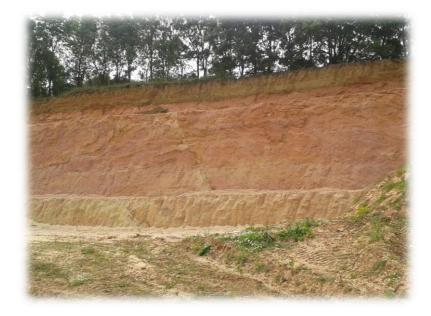
The face in question is excavated from surface to a maximum depth of approximately 15m below ground level (bgl) (Note, all distances and heights are visually estimated). An initial upper bench is excavated within topsoil and overburden material observed to comprise brown clayey fine to coarse sand with frequent roots and rootlets.

An approximately 3m wide bench separates the upper overburden material from the main mineral. The main sand face is excavated at a near vertical gradient (approximately 85 degrees) to a maximum height of 10m. A final, approx. 3m wide, bench is located approximately 1.5m above the base of the excavation.

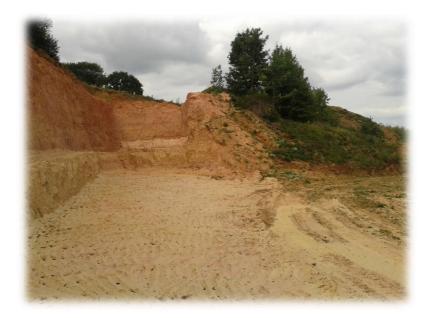
Figure 2 Western Extent of Excavation

At its western edge of the excavation the face has been extended into a deeper wedge of insitu sands, where the inner material has been retained. This appears to have been carried out to allow an area of vegetation to be retained.

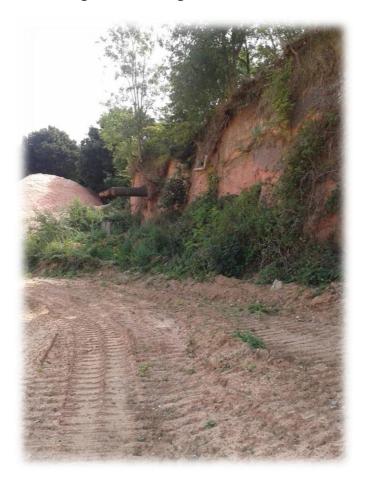
**Figure 3 Existing Cut Sand Faces**

The existing cut sand faces appear to be stable at a height of up to 8m. Vegetation at the crest of the face in this is beginning to overhang where overburden material is sloughing from the slope. A similar process is likely to occur at the crest of the new face over time; however, the uppermost bench will prevent this material collapsing into the main void.

The remainder of the existing sand slopes appear have been in-situ for a long period (a number of years) and are not showing any explicit signs of instability.
