Evergreen Farm
West Hoathly Road
East Grinstead
East Sussex
RH19 4ND

PROPOSED DEVELOPMENT SITE ACCESS

STAGE 1 ROAD SAFETY AUDIT

Report No. EC/2019/10/FP1

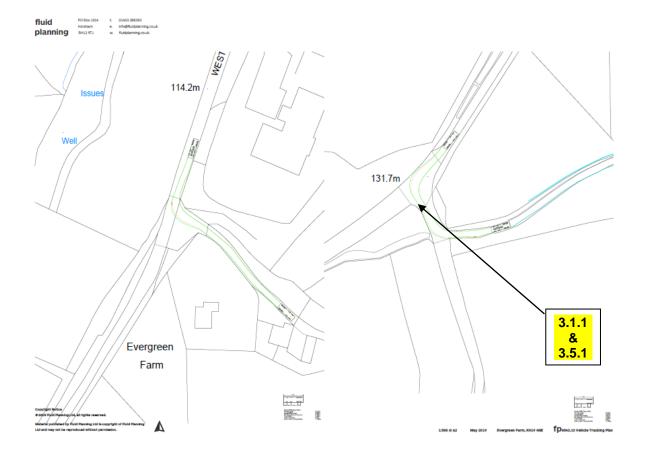
Location of problems identified at this Stage 1 Road Safety Audit

Location: Proposed exit onto West Hoathy Road

Summary: Possible vehicle overrun could result in pedestrian injury.

Detail: Information provided to the Audit Team indicates that HGV vehicles will be turning left

when exiting the development site, however, no vehicle tracking has been provided for these turning movements. The concern is that the movements will be tight and could lead to vehicles overrunning the southwestern kerb line where there is currently a narrow bus stop waiting area at the location. Vehicle overrun would not only put pedestrians waiting at risk of being struck but would cause damage to the kerbing at the location which could cause a further trip hazard. In addition, the overrun would deteriorate the waiting area making it less desirable for pedestrians which could result

in them standing / waiting in the live carriageway causing a secondary risk.

Location: Proposed HGV exit onto Hoathly Road

Summary: Lack of signs could result in side swipe type collisions.

Detail: Although it is proposed to have a one way in and one way out system that ensures

HGV's do not travel along the same stretch of road when entering and leaving the site, there is no signage to ensure that this does not occur. It is proposed that HGV's exiting the site will turn left on West Hoathly Road to ensure that they do not encounter westbound HGV traffic trying to enter the site as the road becomes narrow in parts and, if such instances were to occur, it would result in difficulties for two HGV vehicles to safely pass each other. Such instances could lead to side swipe type

collisions.

Provide adequate swept path and tracking to show that turning movements can be made without vehicle overrun.

Signs should be installed directing HGV traffic to turn left on West Hoathly Road when exiting the development site.
