Appendix D

CCTV SURVEYS

Project Name: 2020_07_20 JACKSON CIVILS LIMITED
Project Number: PJ375561
Project Date: 20/07/2020
Project Standard: MSCC4 Sewers & Drainage GB (SRM4 Scoring)

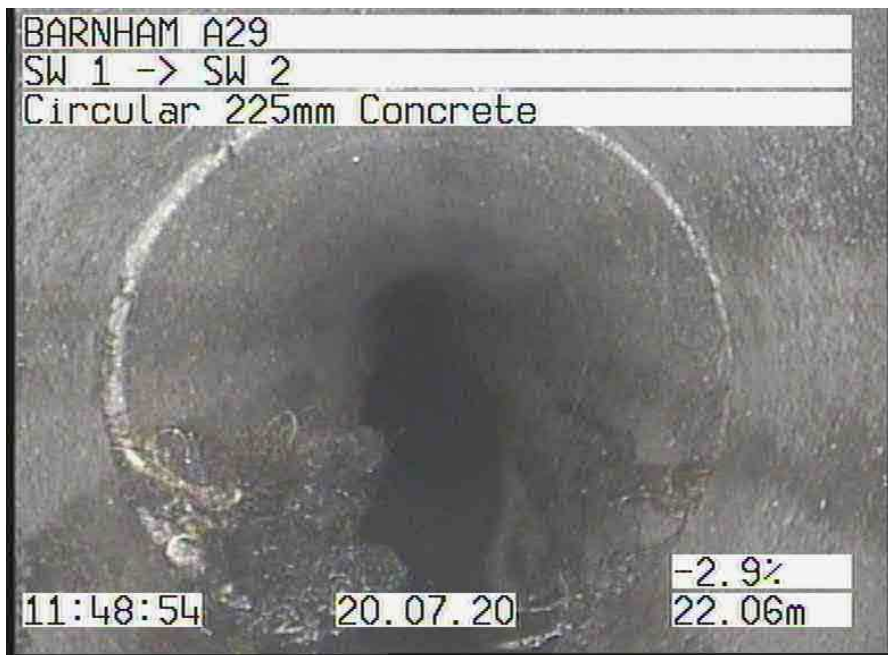
SW 1X_9a1ee07d-49b8-4700-bff9-324346e06c99_20200720_115041_009.jpg, 00:01:47,
 22.06 m

Roots, mass at joint, 10% cross-sectional area loss

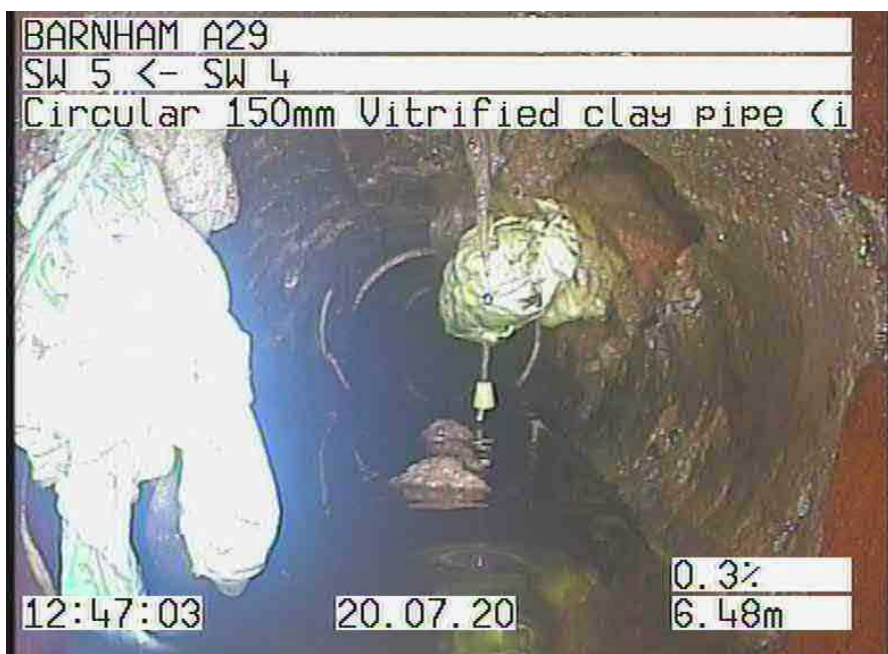
SW 5X_9508c772-46c1-4dc0-9449-e446ea122e05_20200720_124850_300.jpg, 00:00:59, 6.48 m

Fracture, multiple from 12 o'clock to 12 o'clock

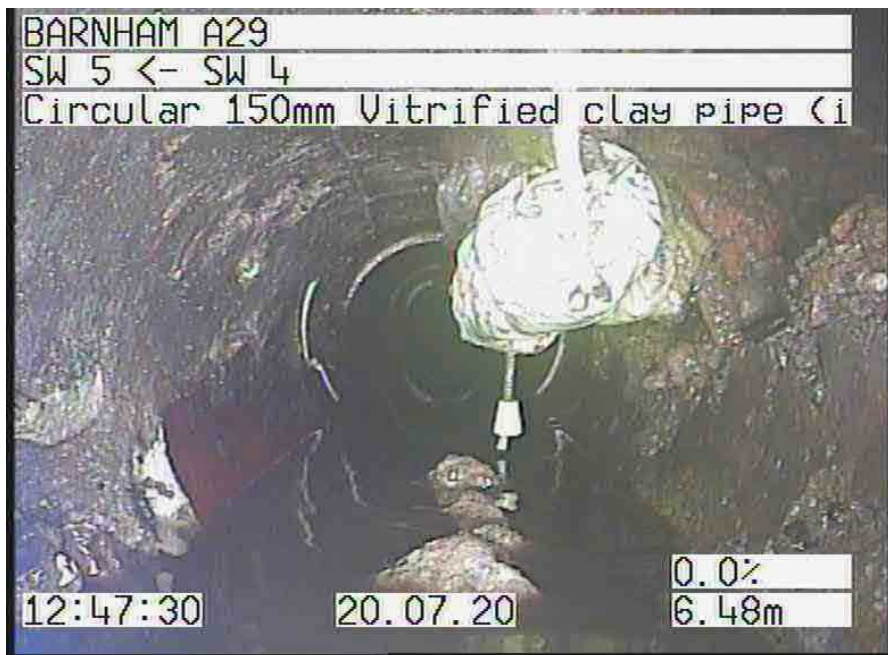
SW 5X_04011062-42b9-46bf-8236-edd0a6c52ff8_20200720_124916_932.jpg, 00:01:08, 6.48 m

Hole in drain or sewer from 1 o'clock to 3 o'clock

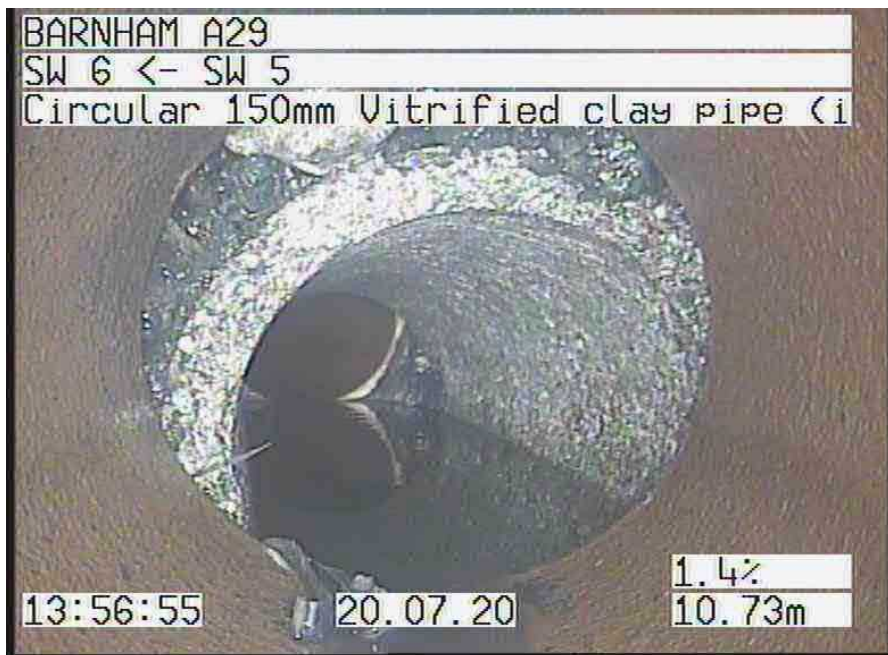
SW 6X_bd285a99-d44c-41d8-b85f-d6ec17a81367_20200720_135842_190.jpg, 00:01:16,
 10.73 m
 Survey abandoned, DUE TO DISPLACED JOINT

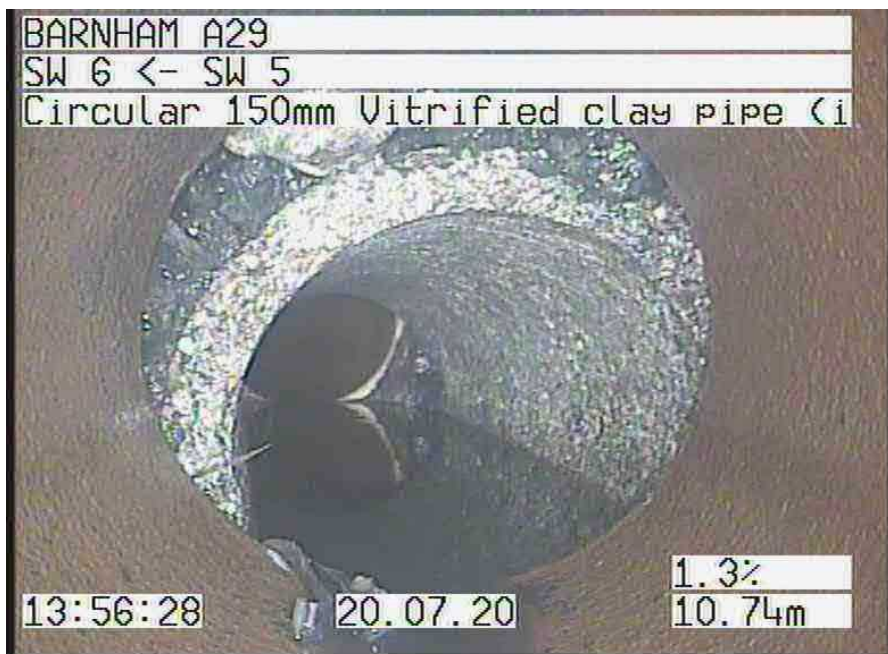
SW 6X_40db77c5-630e-4145-a098-f774cc199496_20200720_135815_263.jpg, 00:01:11,
 10.76 m
 Joint displaced, large

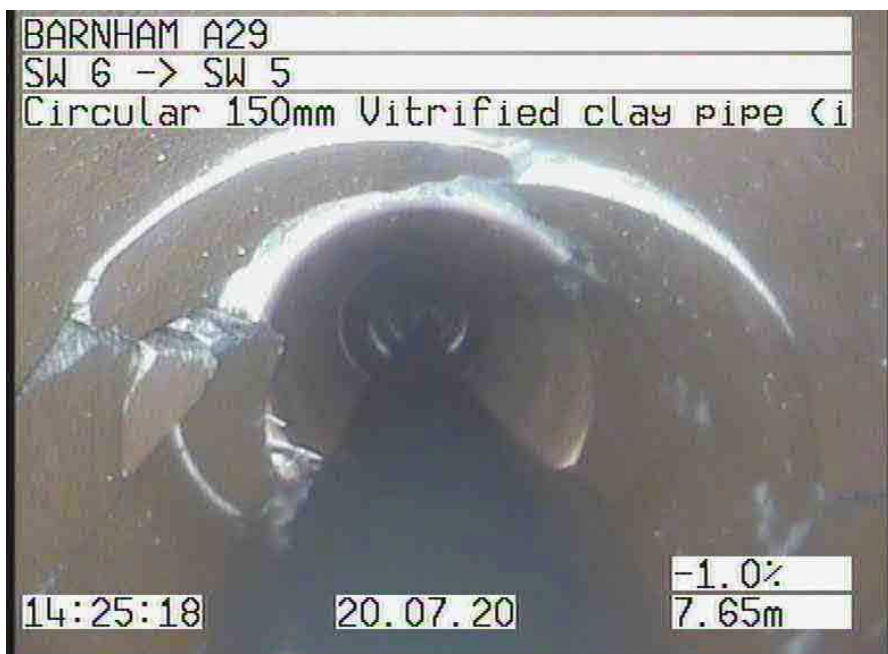
SW 6X_63f9f319-4154-4d30-b2e6-ca79eab7b8b4_20200720_142705_073.jpg, 00:01:29,
7.65 m

Fracture, circumferential from 12 o'clock to 12 o'clock

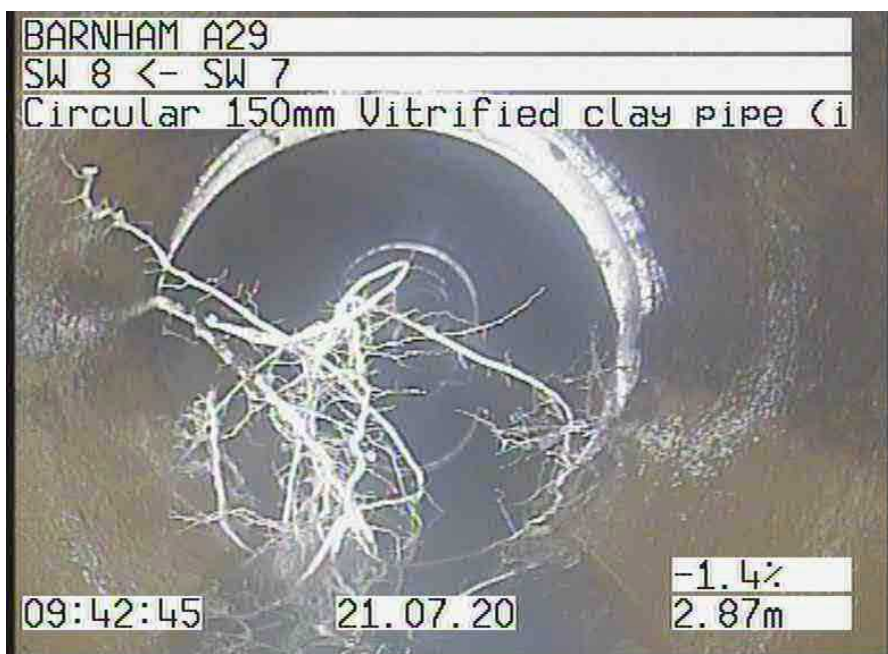
SW 8X_2c402511-4646-4751-b995-ba44b1e1f689_20200721_094434_200.jpg, 00:00:50, 2.87 m
 Roots, tap at joint

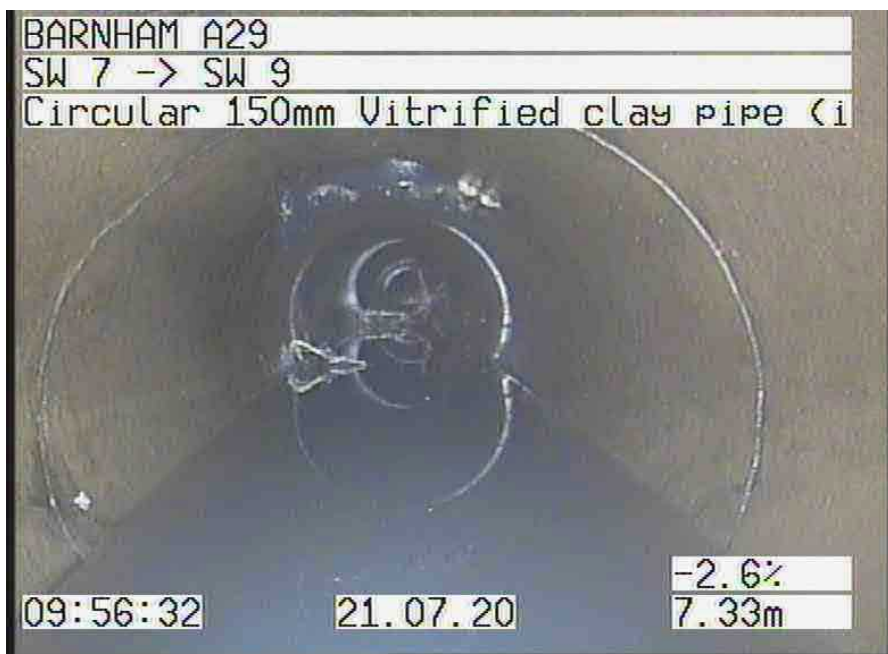
SW 7X_1177ce7f-3eaa-4a5f-8284-e16252b90108_20200721_095821_327.jpg, 00:01:05,
7.33 m

Fracture, circumferential from 8 o'clock to 4 o'clock

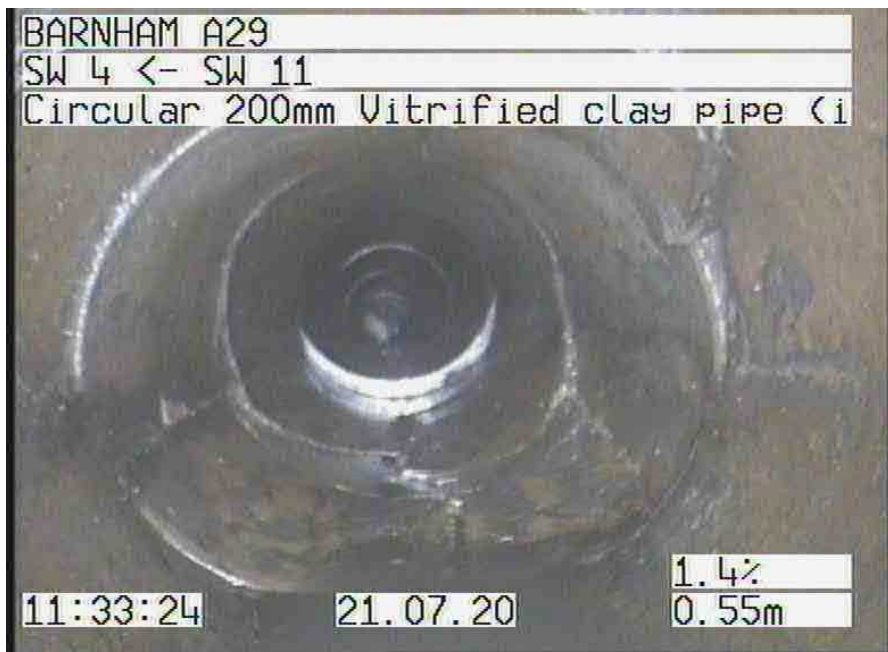
SW 4X_eca14b63-d889-46cd-8c1e-dc9caf6e32db_20200721_113513_950.jpg, 00:00:12,
 0.55 m

Fracture, multiple from 12 o'clock to 12 o'clock

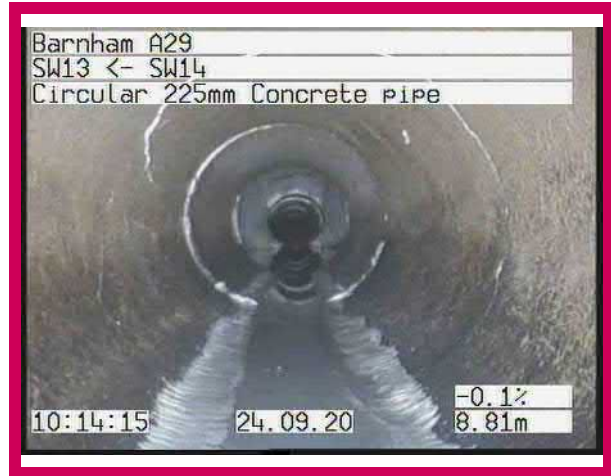
2, 00:00:57, 8.81 m
 Fracture, circumferential from 9 o'clock to 5 o'clock

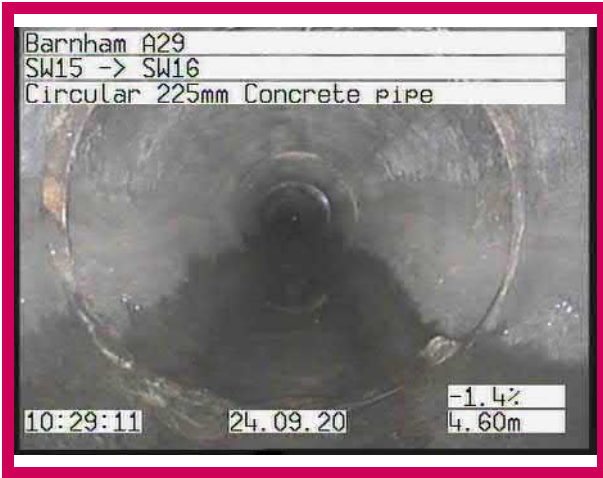
1, 00:00:28, 4.59 m
Fracture, longitudinal at joint at 12 o'clock

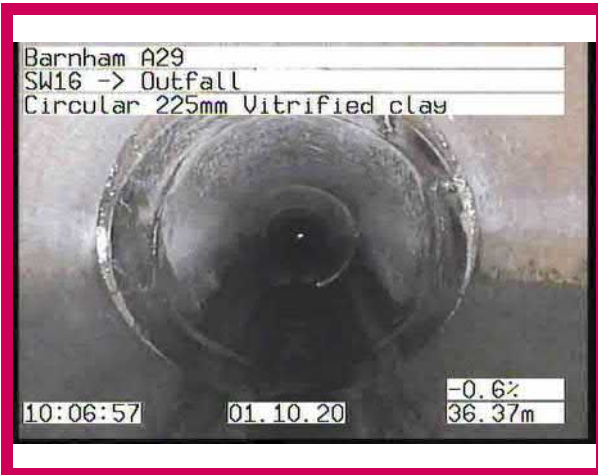
3, 00:03:48, 36.73 m
 Fracture, circumferential at joint from 8 o'clock to 3 o'clock

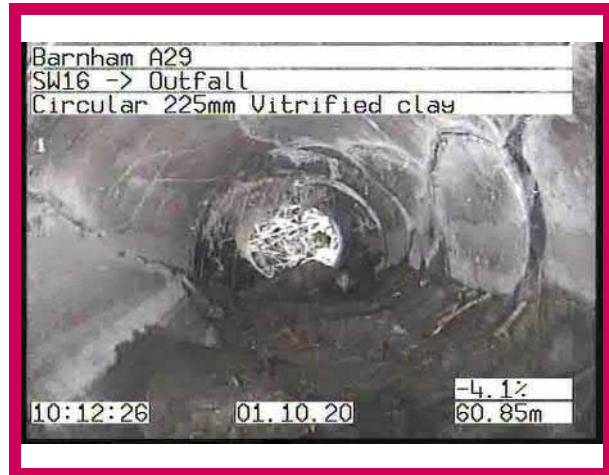
4, 00:08:34, 60.84 m
 Fracture, multiple from 8 o'clock to 4 o'clock

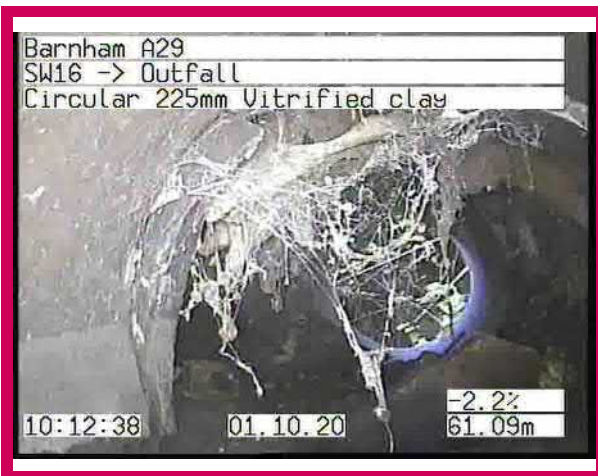
5, 00:08:45, 61.09 m
 Broken pipe from 10 o'clock to 2 o'clock

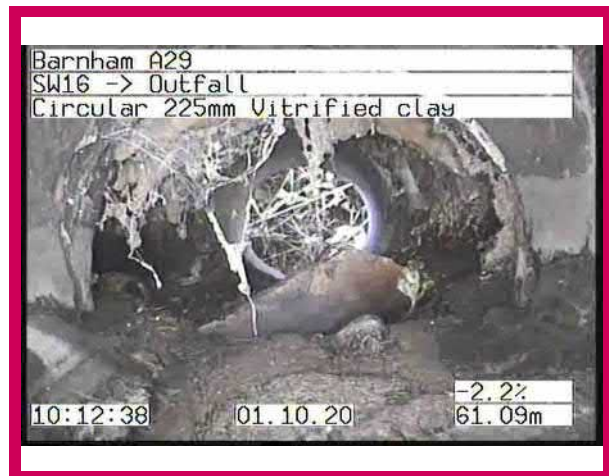
6, 00:08:45, 62.00 m
 Settled deposits, fine, 20% cross-sectional area loss

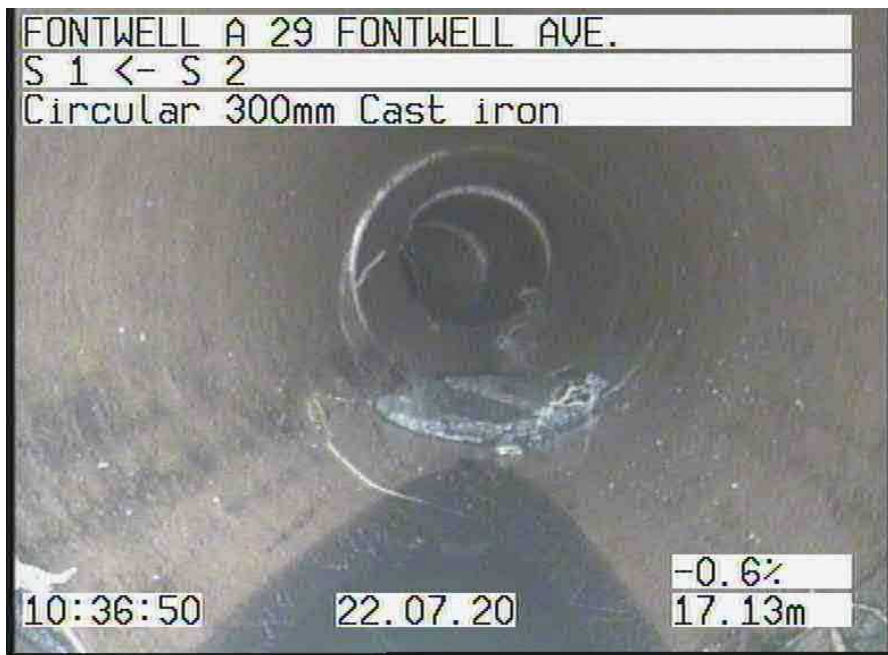
S 1X_5ea0d0dc-ae2d-4172-9971-a51fbc440884_20200722_103841_992.jpg, 00:01:13, 17.13
 m
 Roots, fine at joint

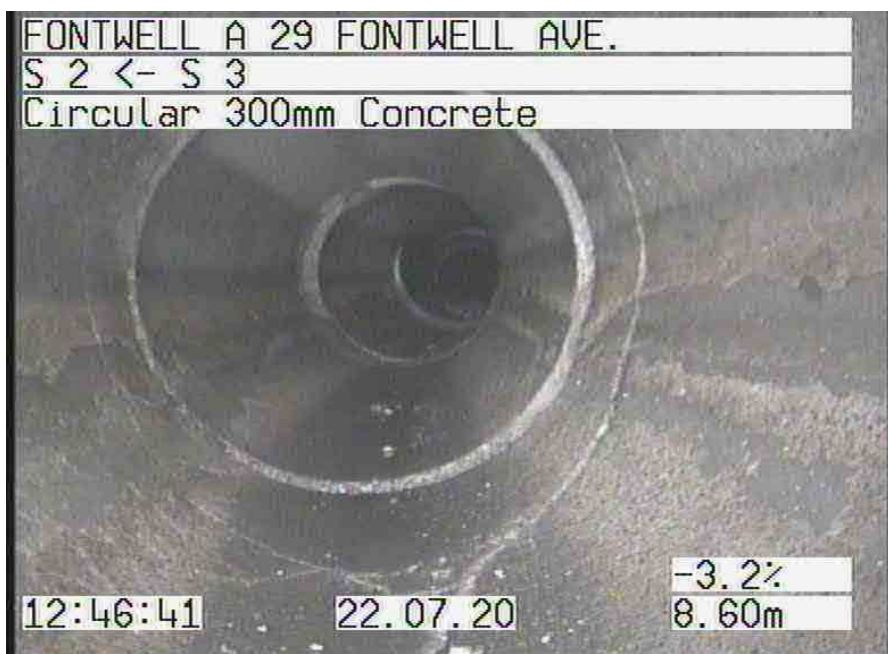
S 2X_f77ccb20-a914-4af1-ab59-3e44fb45e56f_20200722_124833_240.jpg, 00:01:17, 8.60 m
 Fracture, circumferential from 12 o'clock to 12 o'clock

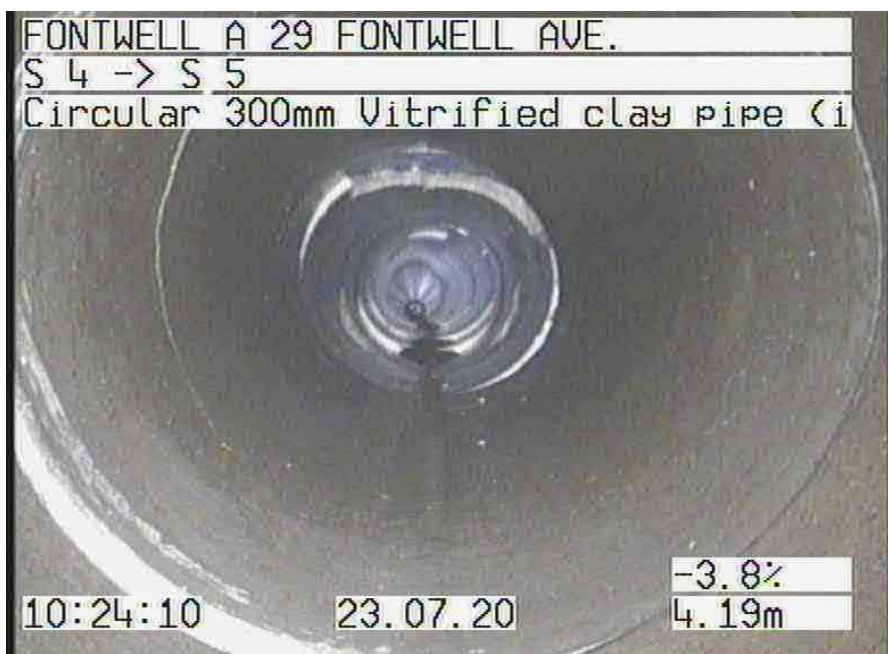
S 4X_e8687c64-3f97-495e-9180-552d6f4f3cce_20200723_102549_074.jpg, 00:00:36, 4.19 m
 Fracture, circumferential from 7 o'clock to 12 o'clock
