ASBESTOS MONITORING LOG

PLINTH Ref : 00502
Establishment Name : Newick House School
Name : D.J Pilbeam
Position : Premises Manager
Date: 17th May 2012

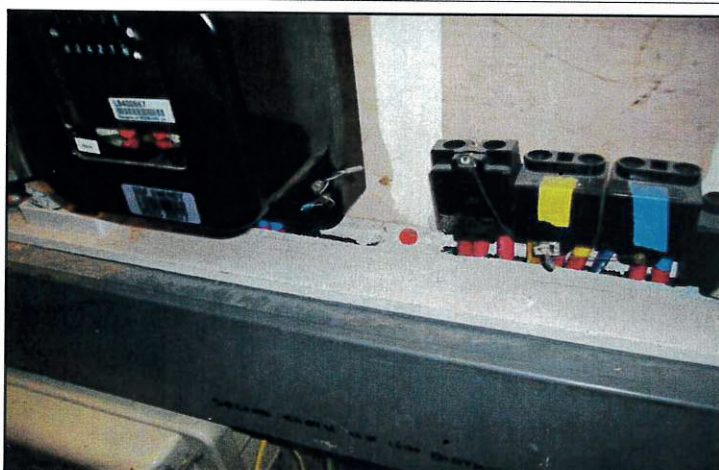
Room No	068	Sample No	A151561/01
Building Name	Newick House School	Identification	Sample/Presumed
Block Ref	A1	Position	Wall
Name	Electrical Cupboard	Use	Shuttering to switchgear

Product Type	AIB	Damage	Medium
Surface Treatment	Unsealed AIB	Asbestos Type	Amphibole asbestos excluding crocidolite

Material Assessment Score		Priority Assessment Score		Total Assessed Risk		
Score	8	Medium Risk	Score	9	Medium Risk	Medium Risk

Action Plan	Label find (if appropriate). Surface treat or encapsulate at earliest practicable opportunity, if not already done so.
--------------------	--

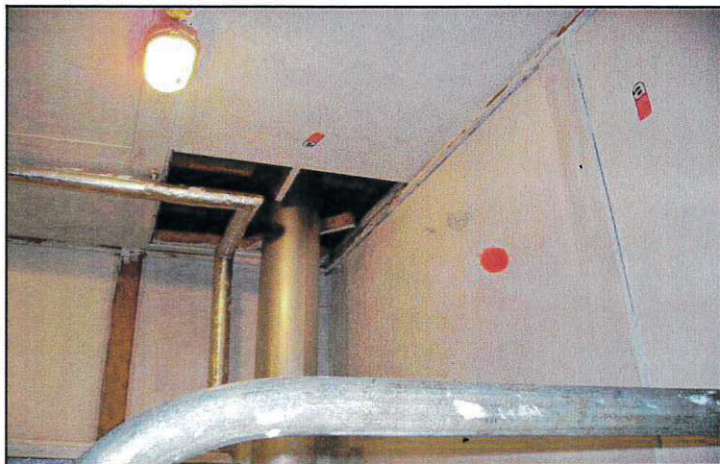
Location			
Room No	076	Sample No	A155385/08
Building Name	Boiler House	Identification	Sample/Presumed
Block Ref	C1	Position	Wall
Name	Boiler House	Use	Board to wall

Material Assessment			
Product Type	AIB	Damage	Low
Surface Treatment	Sealed AIB, etc	Asbestos Type	Amphibole asbestos excluding crocidolite

Management Summary			
Material Assessment Score Score 6 Low Risk		Priority Assessment Score Score 6 Low Risk	
Total Assessed Risk Low Risk			
Action Plan	Label find (if appropriate)		
Comments

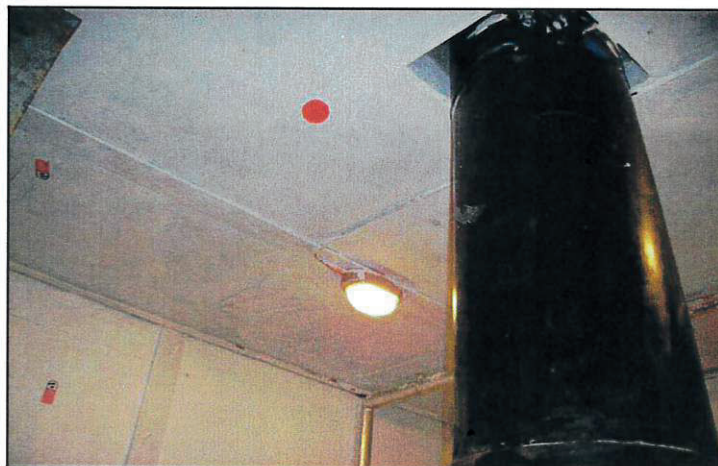
Room No	076	Sample No	A155385/08
Building Name	Boiler House	Identification	Sample/Presumed
Block Ref	C1	Position	Ceiling
Name	Boiler House	Use	Board to ceiling

Product Type	AIB	Damage	Low
Surface Treatment	Sealed AIB, etc	Asbestos Type	Amphibole asbestos excluding crocidolite

Material Assessment Score		Priority Assessment Score		Total Assessed Risk
Score	6	Score	6	Low Risk
Low Risk		Low Risk		Low Risk

Action Plan: Label find (if appropriate)

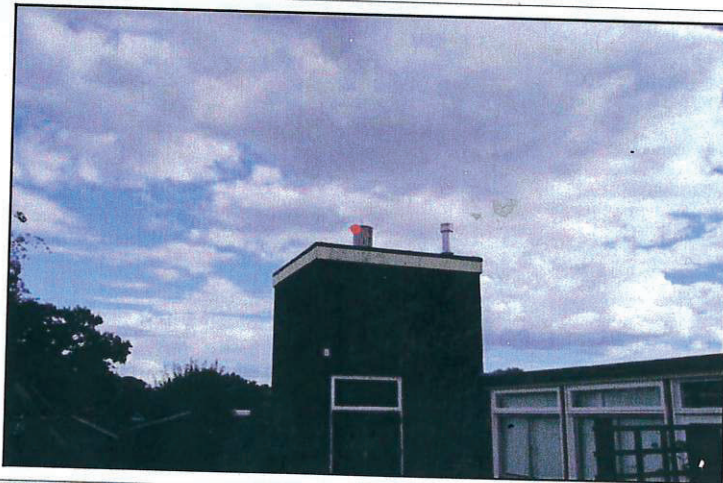
Room No	Block external	Sample No	N/A
Building Name	Boiler House	Identification	Visually Identified
Block Ref	C1	Position	Roof
Name	Boiler House	Use	Cement cowl

Product Type	Asbestos cement	Damage	Low
Surface Treatment	Unsealed Cement	Asbestos Type	Chrysotile

Material Assessment Score	Priority Assessment Score	Total Assessed Risk
Score 4 Very Low Risk	Score 5 Low Risk	Low Risk

Action Plan	Label find (if appropriate)
-------------	-----------------------------
