Road Safety Audit Stage 1 Kirdford Road, Wisborough Green Site Access

Date: 16th July 2013

Reference: RSC/MG/KS/13018/Wisborough Green

Kirdford Road, Wisborough Green - Site Access

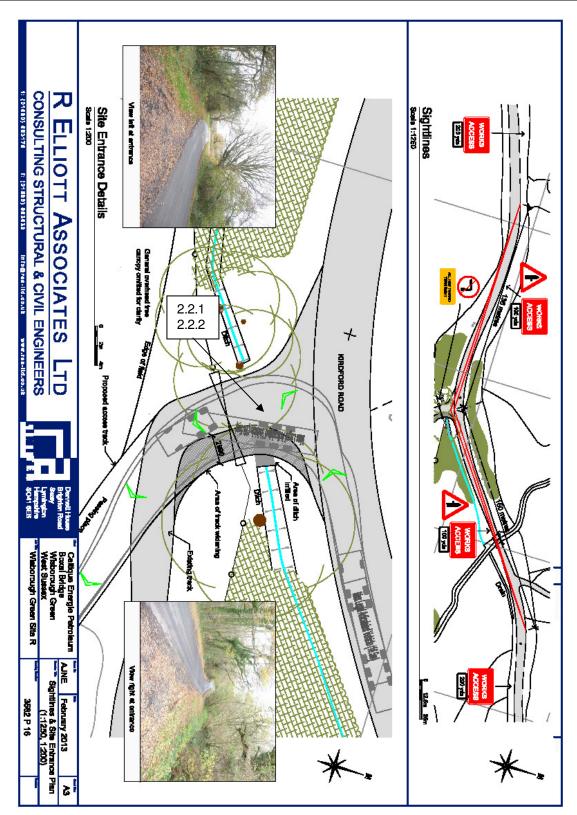
Summary: Conflict between large vehicles on entry and exit

There is some concern that large vehicles may arrive to enter the access at the same time as another is exiting. A large vehicle stopping unexpectedly mid-turn could result in rear end shunt type collisions.

Summary: Detritus on the carriageway

Large vehicles leaving a site can carry mud and other detritus onto the carriageway. This could result in single vehicle loss-of-control type collisions. Riders of two-wheeled vehicles are particularly vulnerable.

It should be ensured that the arrival and departure of large vehicles at the access do not coincide.

The entry area and an appropriate length of the access road should be hard surfaced. It may also be necessary to provide on-site wheel cleaning.
