Proposed Traffic Movements Associated with Exploration Well/s – Tennyson Prospect, Skiff Lane, Wisborough Green, West Sussex

Road Safety Assessment
Proposed Temporary Haul Route
Wisborough Green, West Sussex

Road Safety Audit Stage 1
Kirdford Road, Wisborough Green
Site Access

Kirdford Road, Wisborough Green - Site Access

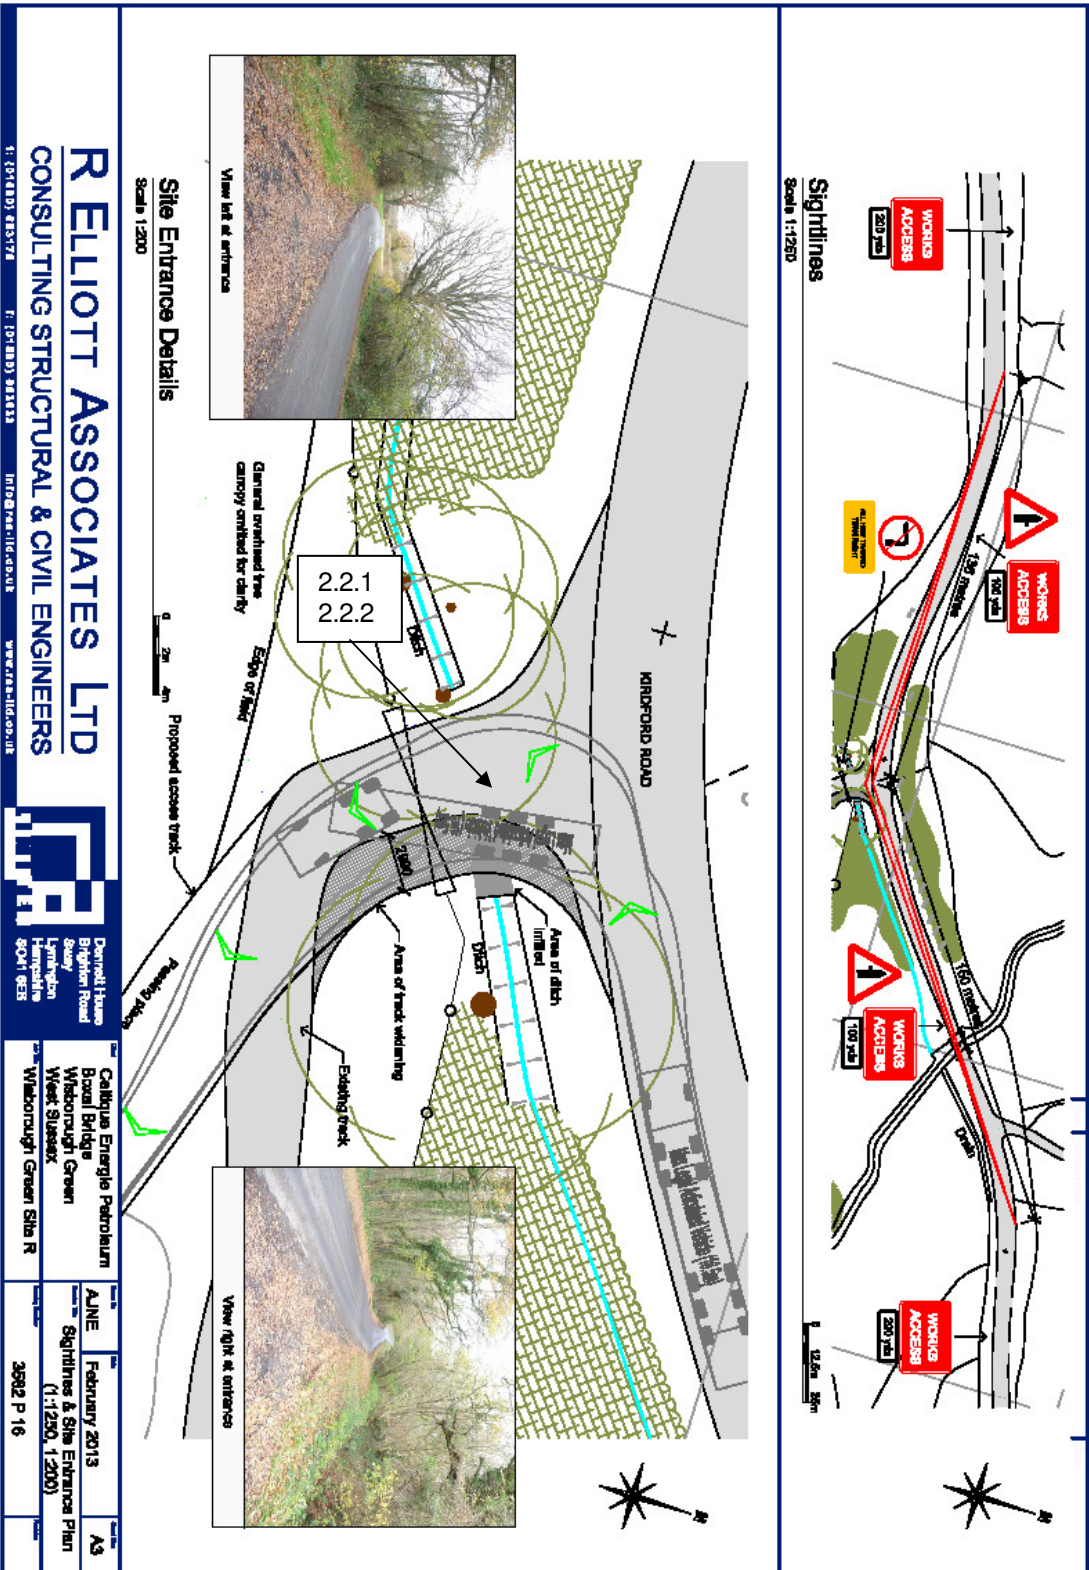
APPENDIX 2
Drawings showing Problem Locations

Summary: Conflict between large vehicles on entry and exit

There is some concern that large vehicles may arrive to enter the access at the same time as another is exiting. A large vehicle stopping unexpectedly mid-turn could result in rear end shunt type collisions.

Summary: Detritus on the carriageway

Large vehicles leaving a site can carry mud and other detritus onto the carriageway. This could result in single vehicle loss-of-control type collisions. Riders of two-wheeled vehicles are particularly vulnerable.

It should be ensured that the arrival and departure of large vehicles at the access do not coincide.

The entry area and an appropriate length of the access road should be hard surfaced. It may also be necessary to provide on-site wheel cleaning.
