**Mannings Heath WTW to Chesworth Lane,
West Sussex**

**Historic Environment Desk-Based Assessment
(Heritage Statement)**

Prepared for Southern Water

**ASE Project No. 220267
ASE Report No. 2022208
WSHER Ref. No. 202223-040**

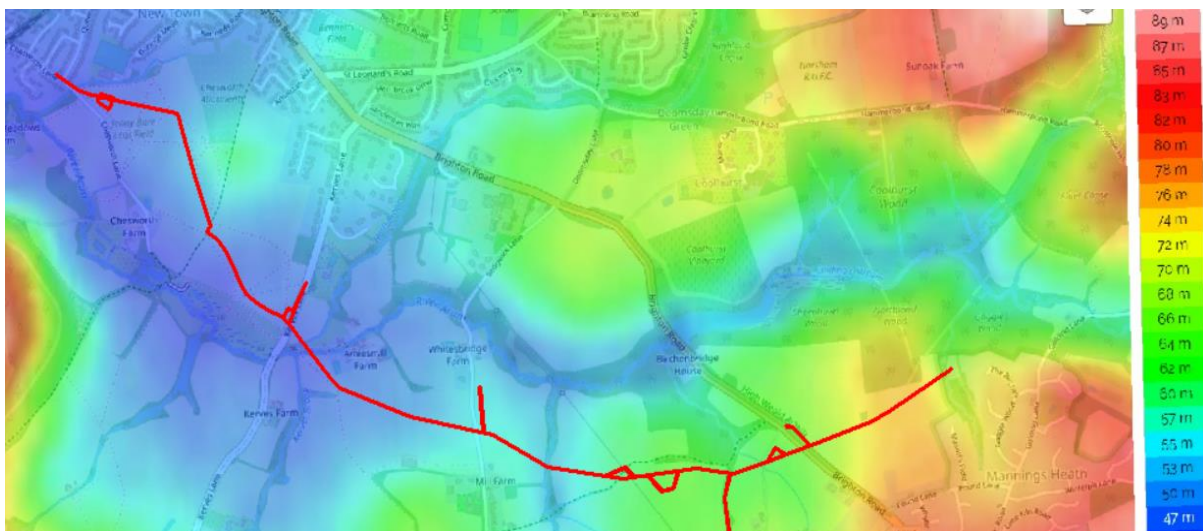
Plate 2.1: Image showing the topography across the Site²

- 2.1.3 The route extends across a mix of fields and existing roads, as well as the watercourses mentioned above. Horsham is situated on the western edge of the High Weald, on a slope falling from c.90m to c.40m aOD (above Ordnance Survey) (Harris 2004, 11). The topography varies across the scheme, but broadly the area lies between 42m aOD in the west at Chesworth Lane and 68m aOD in the east at Gaggle Wood. A localised mound can be seen (green) immediately east of the pipeline in the lower river valley (blue) in the Chesworth Farm area.

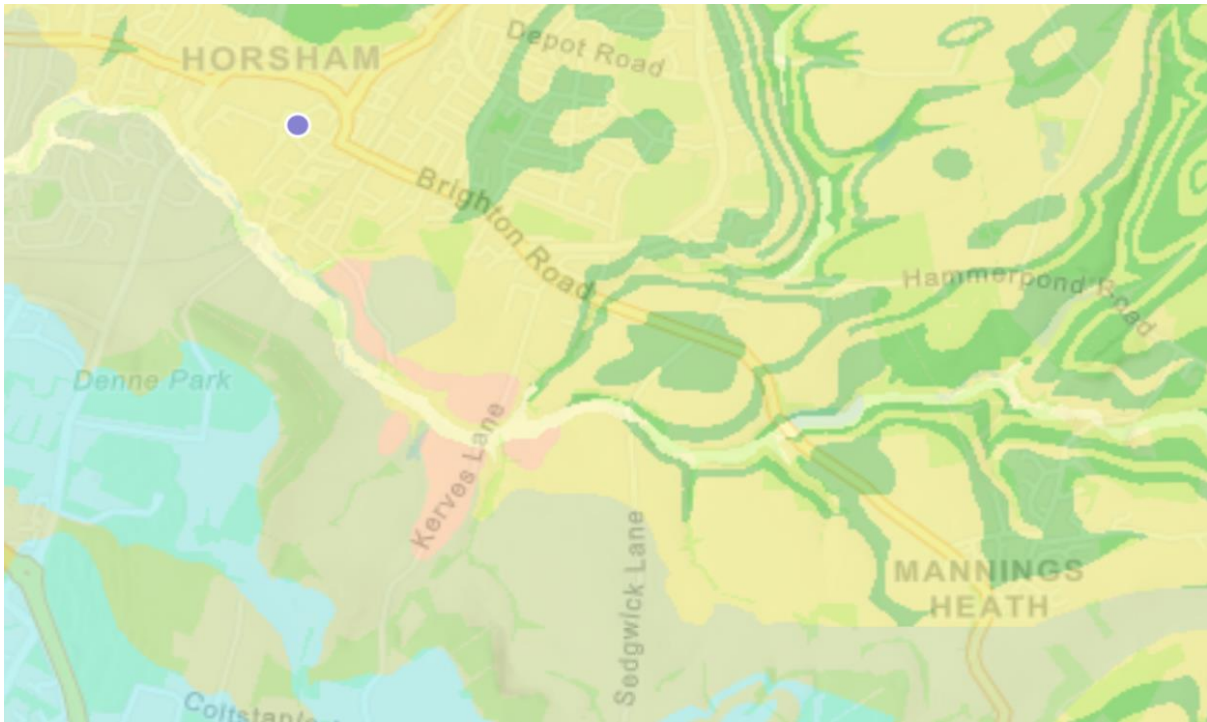
Plate 2.2: View of the bedrock and superficial geology across the wider Study Area and clearly showing the route of the watercourse (pink area indicates Arun Terrace Deposits, 4 Member sand and gravel)

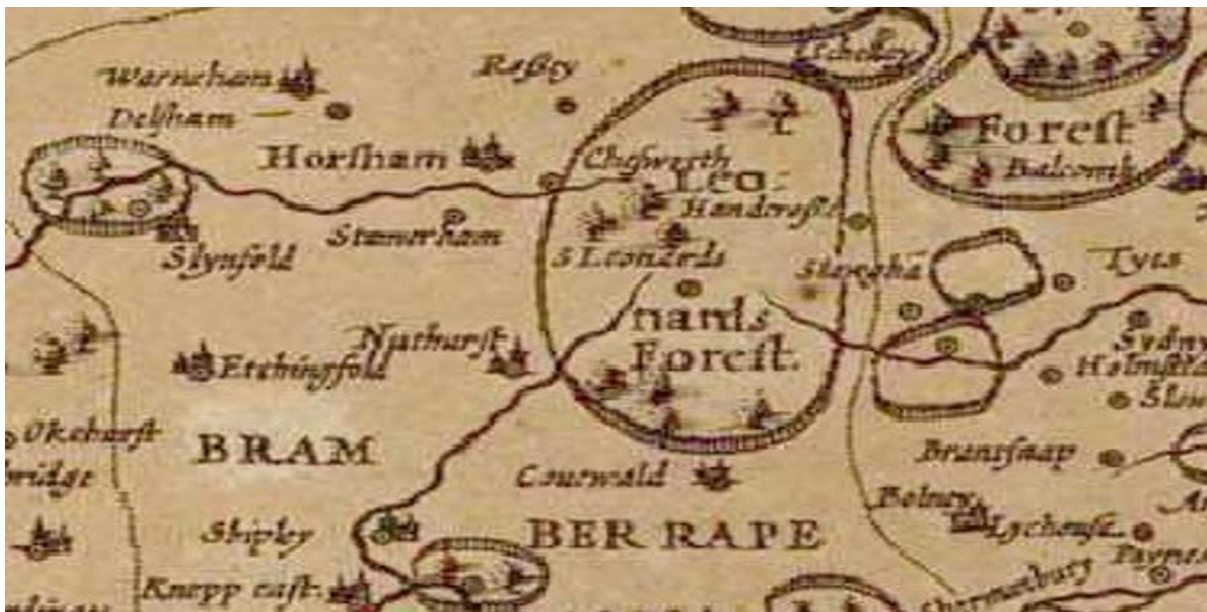
Plate 5.1: Extract from John Speed's 1610 Map of Sussex showing the broader area around the Site

- 5.2 John Speed's 1610 Map of Sussex (Plate 5.1 below) shows that St. Leonard's Forest was a key place in the early 17th century, but there is no record of Mannings Heath at this time. The nearest towns of Horsham and Nuthurst are recorded. By the end of the 17th century, Robert Morden's view of Sussex in 1695 is largely unchanged (Plate 5.2 below).

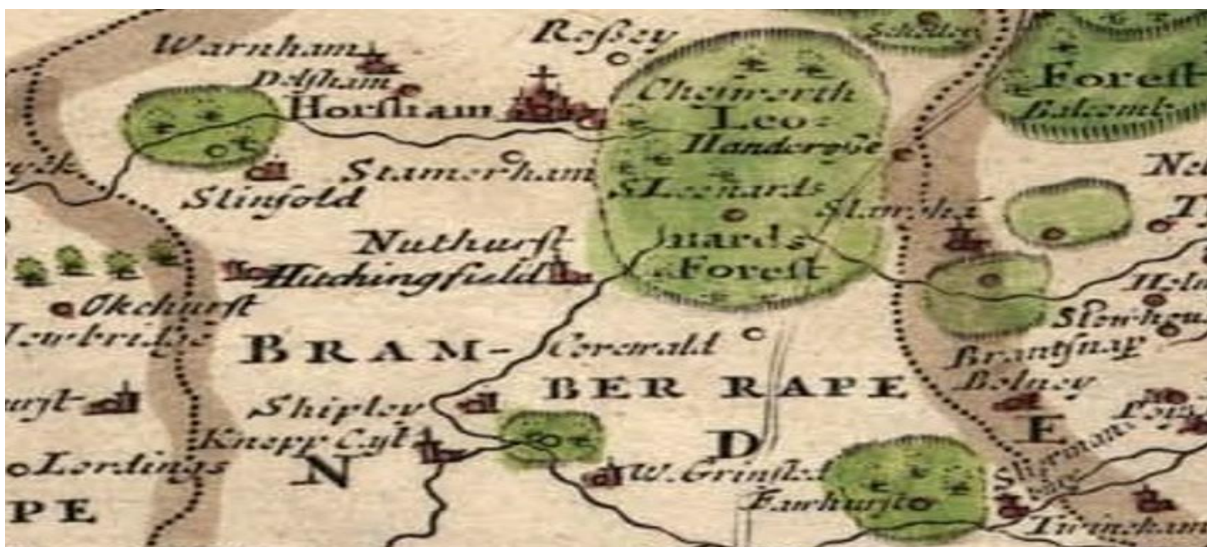
Plate 5.2: Extract from Robert Morden's 1695 Map of Sussex showing the broader area around the Site

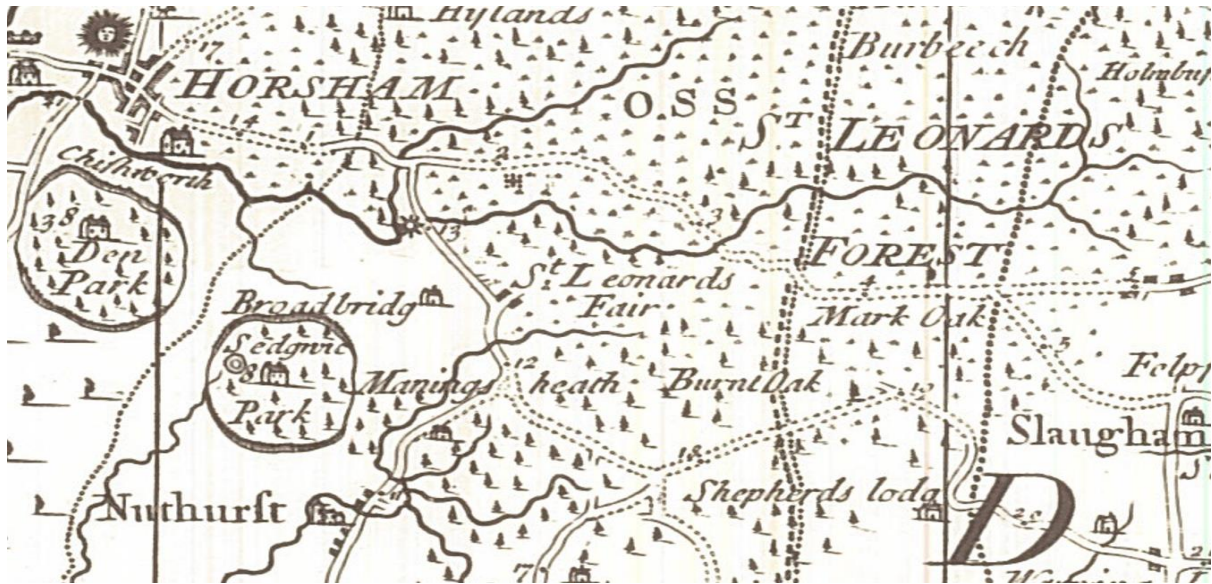
Plate 5.3: Extract from Richard Budgen's 1724 Map of Sussex showing the broader area around the Site

- 5.3 The earliest county map of sufficient detail is the county map drawn by Richard Budgen in 1724 (Plate 5.3 below), which shows the broader context of the Study Area within the wider county. It depicts the area in a stylised fashion with very little detail, although it does label key place-names within the area at the time, including 'Mannings heath', 'St. Leonard's Forest', 'St. Leonard's Fair' and nearby 'Sedgewick Park' and 'Den Park'. The majority of the wider area was part of the heathland/forest at this time.

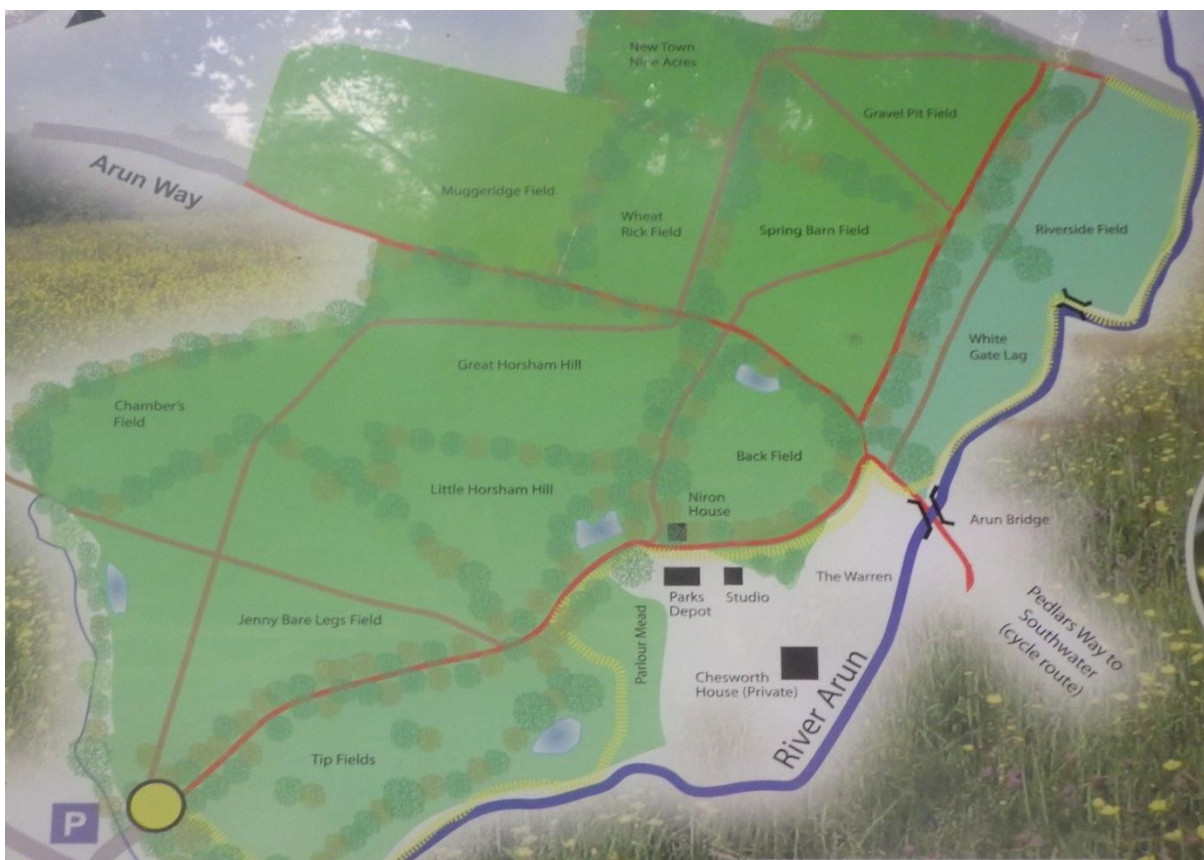
Plate 7.1: Map of Chesworth Farm showing field names for ease of reference within the text

- 7.3 Parts of the route of the proposed pipeline were walked where public footpaths were available, but where access was limited/restricted, the route was viewed from strategic points, such as nearby roads and footpaths. Photographs were taken at various intervals in order to illustrate the proposed route. The photographs used to illustrate the text have been included as plates (Plates 7.1 – 7.23) in this section of the report. Where there was no access to areas, Google Earth satellite images have been used to help with the discussion below. The following text provides a summary of the route from west to east. The walkover survey began at Chesworth Lane where the parking sign is shown in the map of Chesworth Farm below (Plate 7.1). The field names that fall within the Chesworth Farm grounds are also indicated in the map below, which has been included to aid discussion in the text.

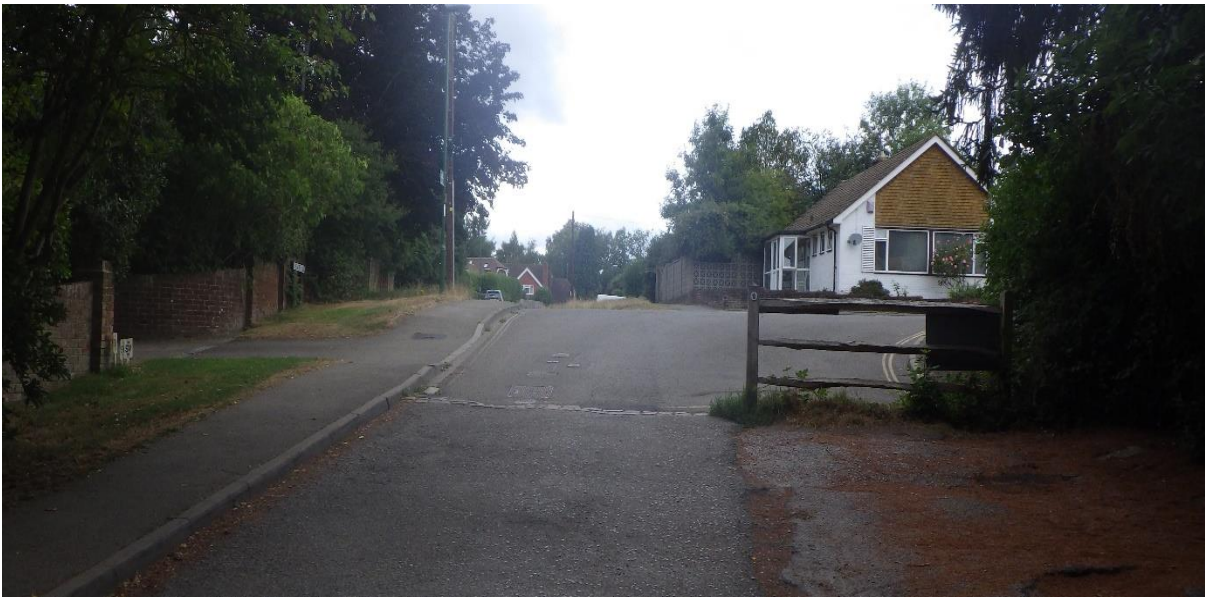
Plate 7.2: View westwards along Chesworth Lane at the western end of the pipeline scheme

- 7.4 The pipeline scheme starts at Chesworth Lane (Plate 7.2), a residential street to the south of Horsham town centre. The lane running roughly east-west, leads to Chesworth

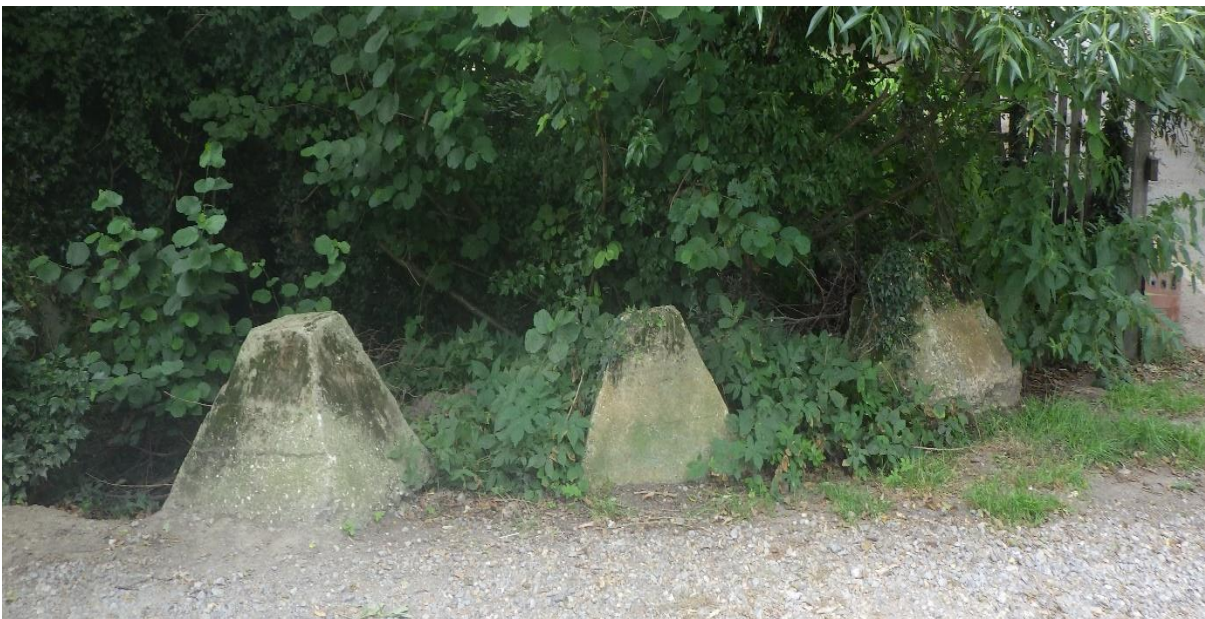
Plate 7.3: Anti-tank blocks (106) located by the stream at the entrance to Chesworth Farm along Chesworth Lane (looking east)

Farm, where the listed house and scheduled medieval moated site are located. WWII anti-tank blocks (106) can be seen at the entrance of Chesworth Farm (Plate 7.3). A washout is proposed here as part of the scheme (Fig.5). The pipeline heads into the first field, Jenny Bare Legs, which was entered by a small pedestrian gate from Chesworth Lane in the south-west corner (Plate 7.4). This field gradually slopes upwards to the east where there is a tall mature tree line boundary. A temporary compound/laydown area is proposed here (Fig. 5). Jenny Bare Legs (as with the others in Chesworth Farm) is covered with long grass and is used as pasture for grazing animals (none at the time of the site visit). The pipeline approximately follows the route of the footpath (Plate 7.5) which leads to a small wooden pedestrian gate leading into the next field, Great Horsham Hill (Plate 7.6).

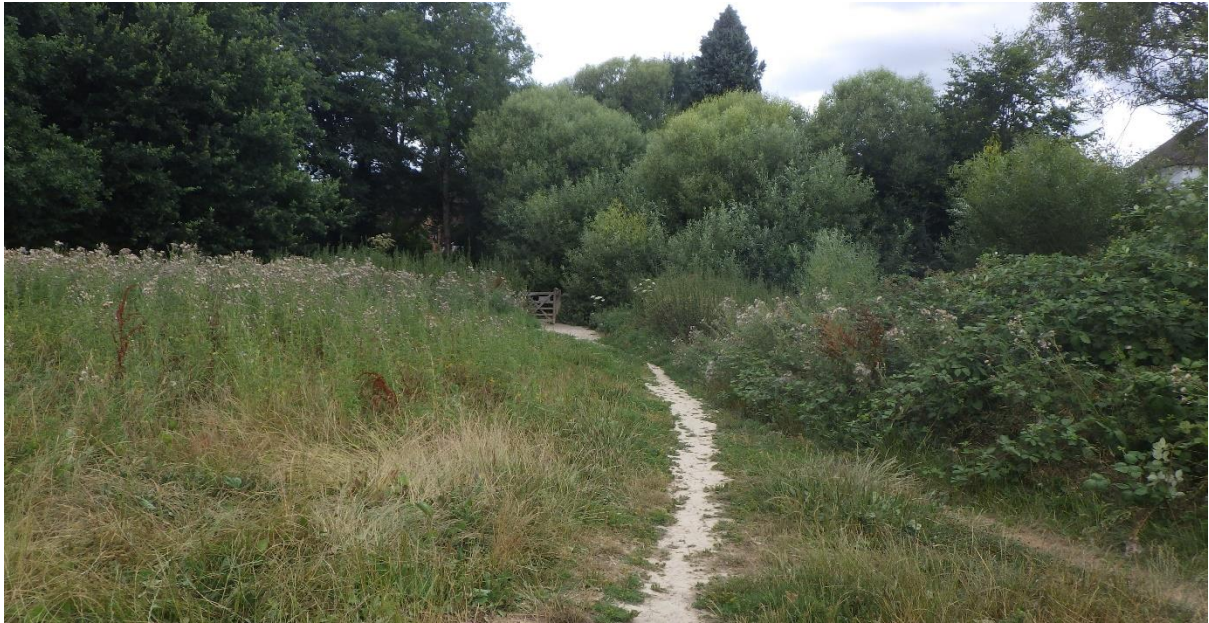
Plate 7.4: Entrance to field in grounds of Chesworth Farm, known as Jenny Bare Legs, from Chesworth Lane (looking west)

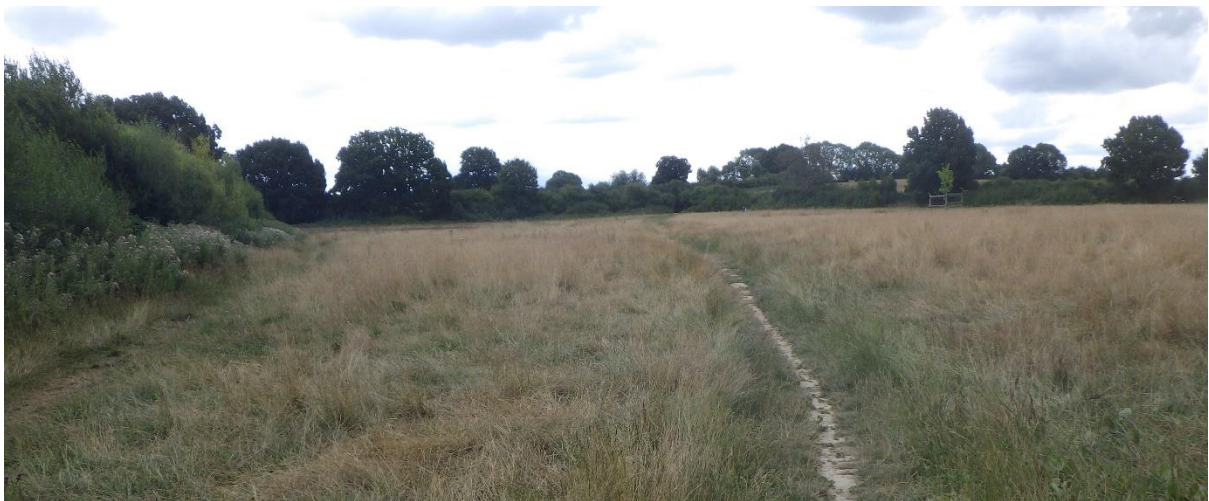
Plate 7.5: View from field within the grounds of Chesworth Farm, known as Jenny Bare Legs (looking east) - pipeline approximately aligned with the footpath

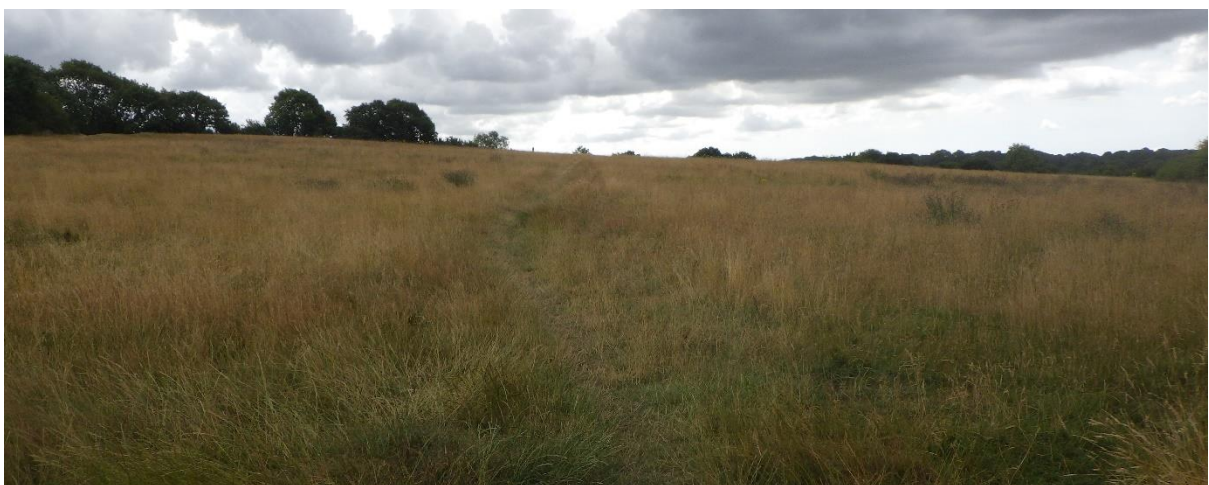
Plate 7.6: View from field within the grounds of Chesworth Farm, known as Great Horsham Hill (looking south-south-east)

- 7.5 As the name suggests, the topography of Great Horsham Hill is like a mound (Plate 7.6), with a noticeable rise from the north-west corner where it is accessed to the middle and east, and then a decline to the south/south-east. From here, there are distant views to Horsham town centre and the Conservation Area (Plate 7.7), which lies approximately 665m to the north-west, but only the tops of buildings and the church spire (2) were visible from the approximate route of the pipeline. Given the distance and in-between development, it is unlikely that there would be a clear view from the conservation area back to the Site. Looking towards the scheduled site and the listed house at Chesworth Farm to the south-west, only a glimpse of the rooftops can be seen amid the dense tree lines and vegetation in between (Plate 7.8). From the scheduled site and listed building no view back to the Site was possible through the dense trees. The peak of Denne Park, beyond the farm and river, sits up high, overlooking the Site with a prominent line of tall trees (Plate 7.8). There is a wide metal field gate in the south-east corner of this field (Plate 7.9) which leads out onto a wide footpath/cycle lane (Arun Way). There is an air valve proposed here (Fig. 5).

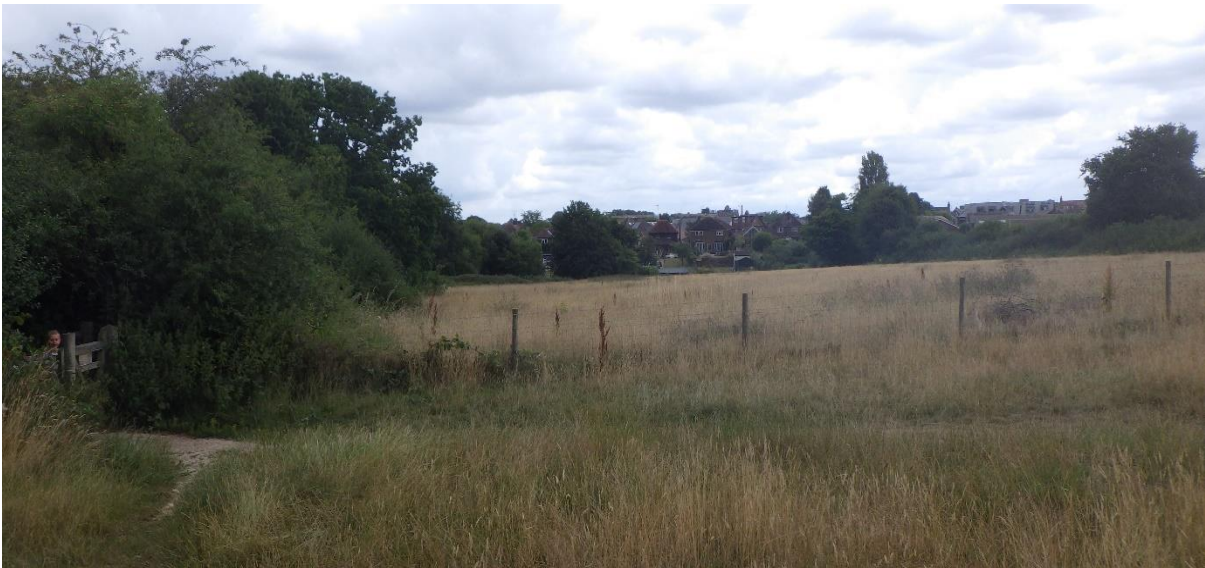
Plate 7.7: View from field within the grounds of Chesworth Farm, known as Great Horsham Hill - looking north-north-west towards Horsham town centre and historic core/conservation area (note that this view is not from the peak of Great Horsham Hill, but from the approximate route of the pipeline)

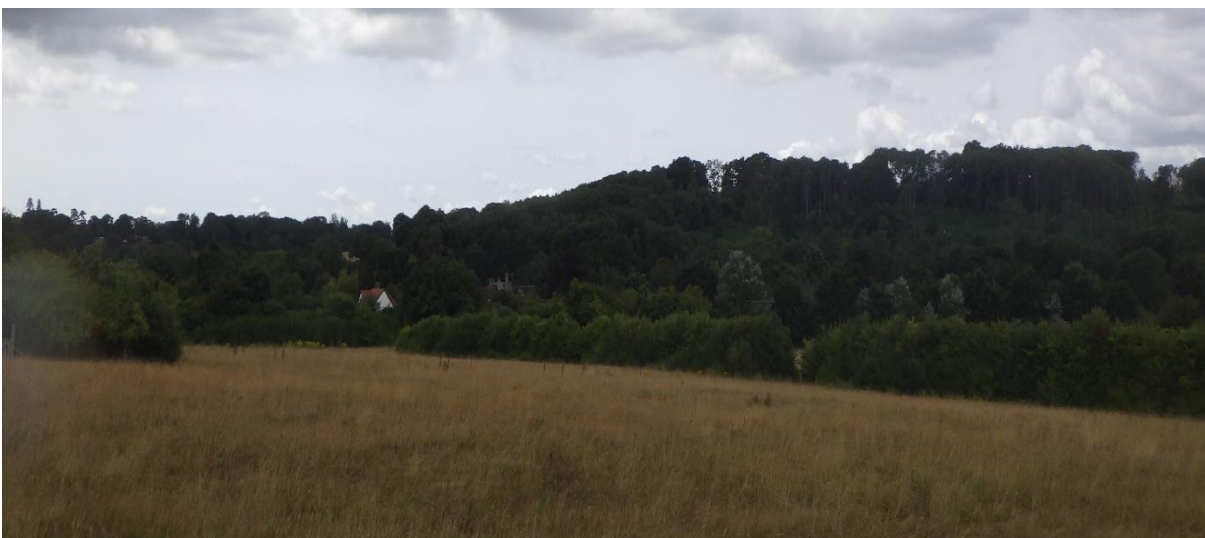
Plate 7.8: View across field within the grounds of Chesworth Farm, known as Great Horsham Hill - looking south-west towards the scheduled moated site and listed house with Denne Park (treeline) in background

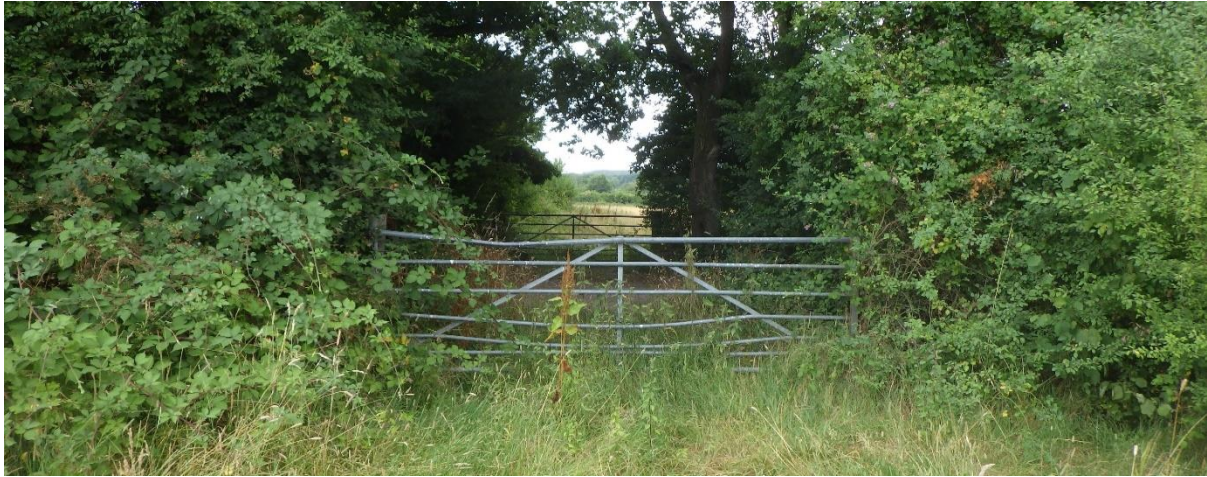
Plate 7.9: Metal field gate in south-east corner of Great Horsham Hill providing access to Arun Way and Spring Barn Field (looking east)

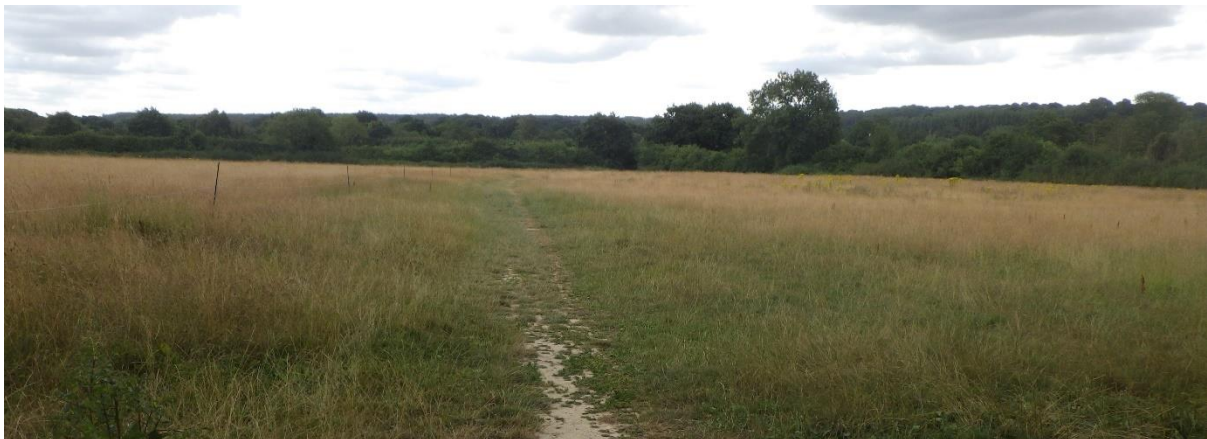
Plate 7.10: View across field within the grounds of Chesworth Farm, known as Spring Barn Field (looking south-east) – pipeline approximately aligned with the footpath

7.6 Across the footpath lies Spring Barn Field (Plate 7.10). The pipeline approximately follows the route of the footpath gradually sloping downwards to Gravel Pit Field in the south-east (7.11) where it runs parallel with the tall hedgerow to the south. A temporary compound/laydown area is proposed during the construction works near to the eastern mature treeline boundary (Kerves Lane beyond), where there is also an access track proposed.

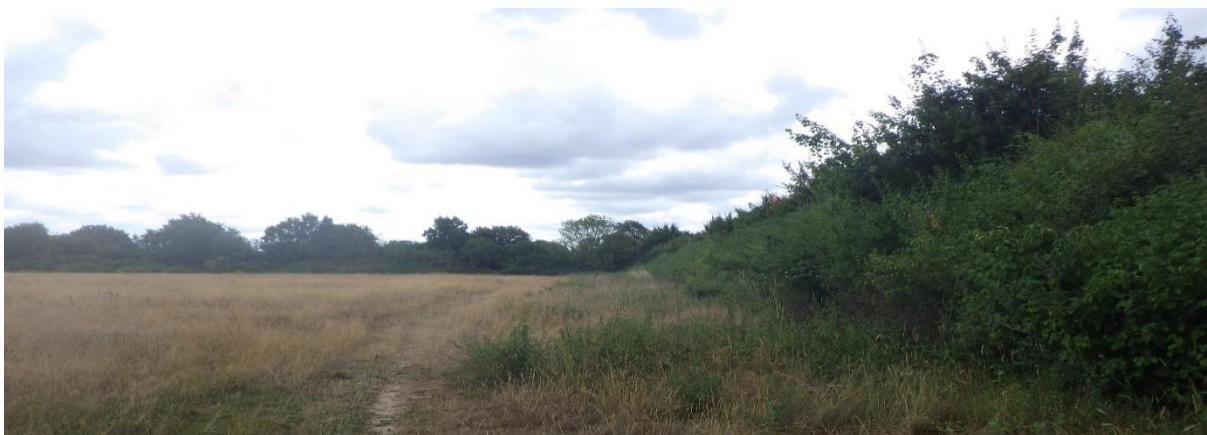
Plate 7.11: View across field within the grounds of Chesworth Farm, known as Gravel Pit Field (looking east-south-east) – laydown/compound area proposed adjacent to mature boundary in distance

Plate 7.11: View across field within the grounds of Chesworth Farm, known as Gravel Pit Field (looking east-south-east) – laydown/compound area proposed adjacent to mature boundary in distance

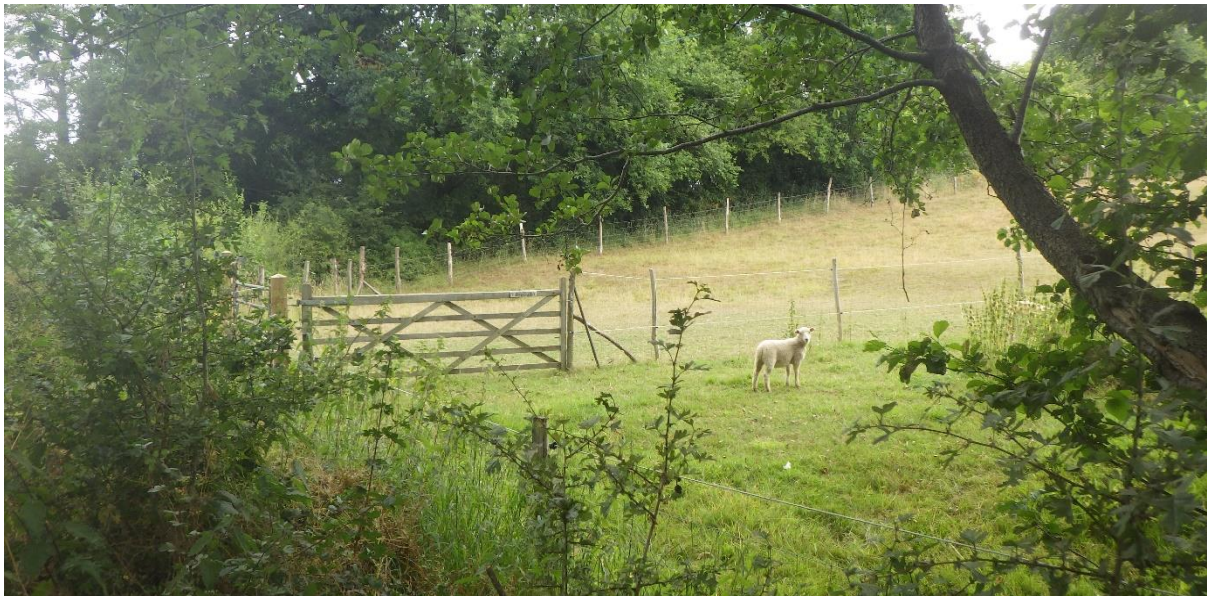
Plate 7.12: View across fields within the grounds of Amiesmill Farm looking north-westwards towards Kerves Lane – directional drilling proposed across the road crossing

- 7.7 Where the proposed pipeline meets Kerves Lane, it crosses the edge of two fields (Plate 7.12), an access lane to Amiesmill Farm and the watercourse (Plate 7.13). There may be some localised Palaeolithic and palaeoenvironmental potential in deeper deposits in this vicinity where the watercourses (River Arun and Hornbrook tributary) converge and gravels are recorded. However, there is a proposed crossing here by directional drilling (Fig. 5) which will reduce the potential for encountering such deposits. A washout is also proposed here (Fig. 5). From here, the pipeline crosses diagonally across a rectangular field to the east of Kerves Lane (Plate 7.14), which is enclosed by tall mature tree boundaries on all edges. The pipeline then heads eastwards in the middle, running south of Amiesmill Farm across horse paddocks across to Sedgewick Lane (Plates 7.15-16). The landscape topography across this middle section of the scheme is fairly flat.

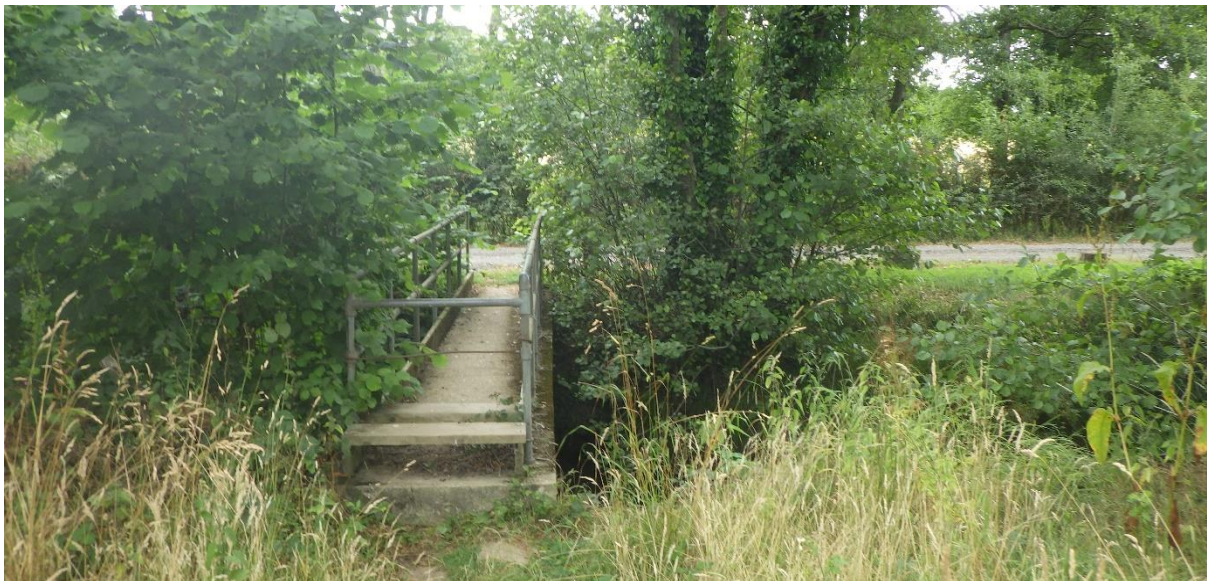
Plate 7.13: View across small footbridge crossing within the grounds of Amiesmill Farm looking north - directional drilling proposed across the stream

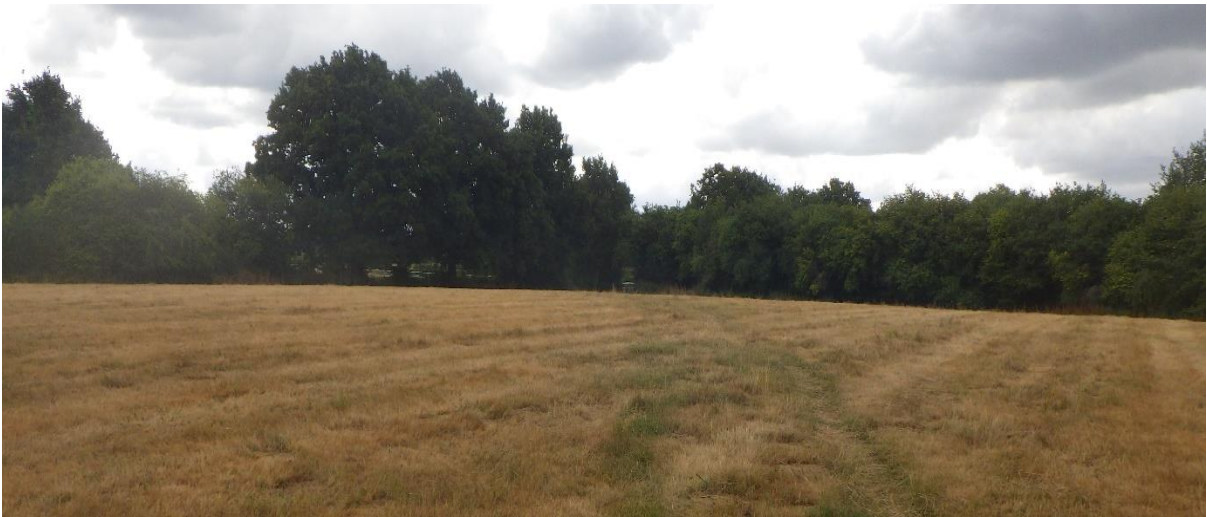
Plate 7.14: View south-eastwards across field to the east of Kerves Lanes

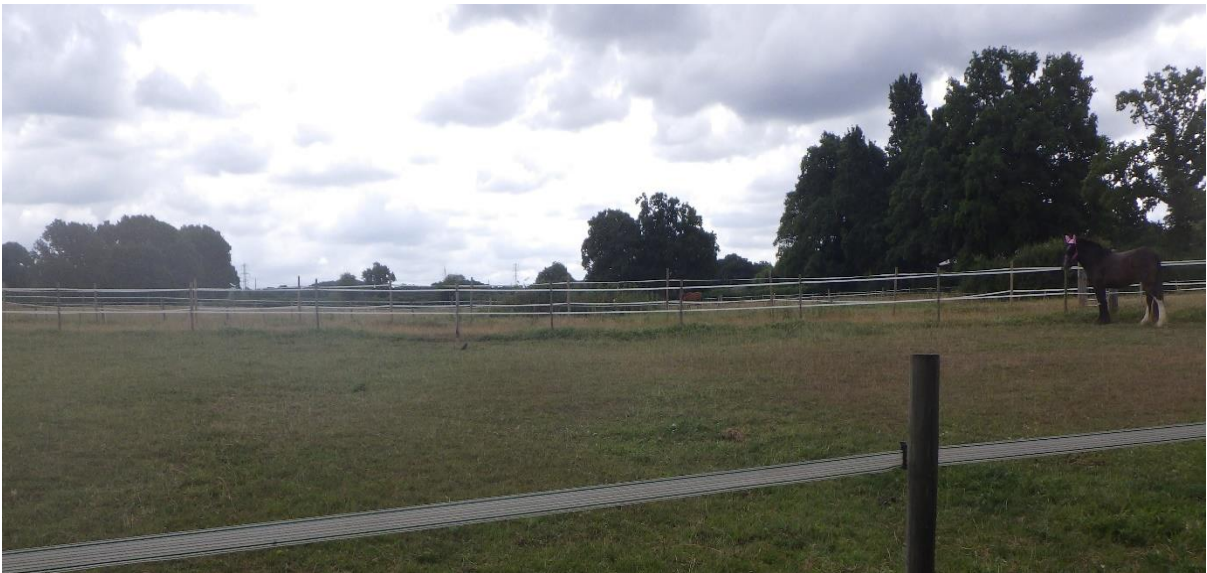
Plate 7.15: View south-eastwards across horse paddock to the south of Amiesmill Farm buildings

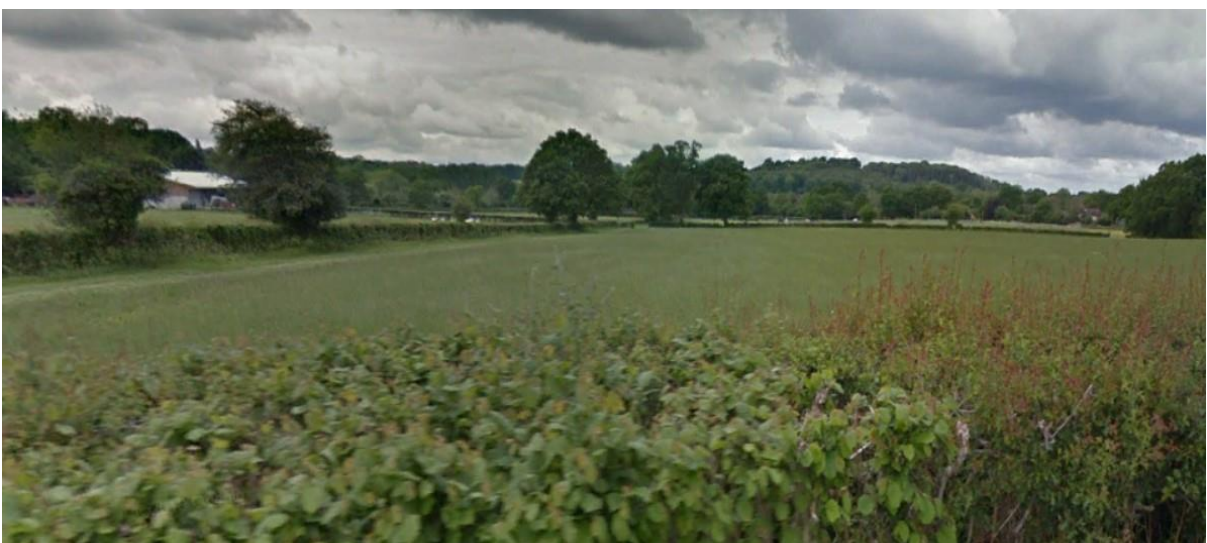
Plate 7.16: View westwards across field to the west of Sedgewick Lane (source: Google Earth Street View as no access or view due to height of hedgerow at time of Site visit)

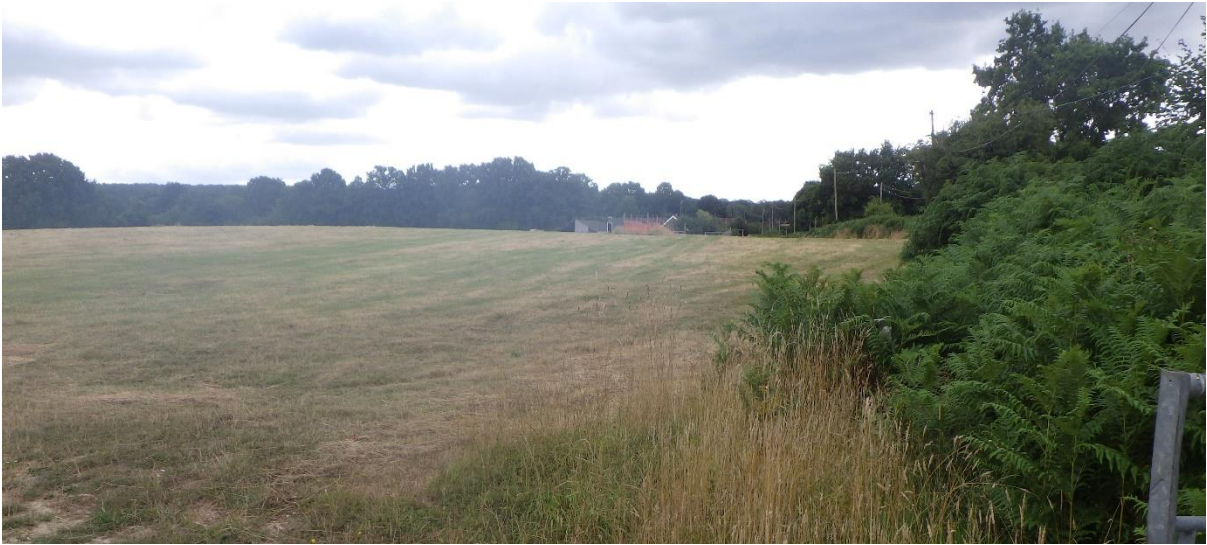
Plate 7.17: View south-eastwards across field to the east of Sedgwick Lane – access route located adjacent to roadside hedge

7.8 At Sedgwick Lane there is a proposed road crossing into another field to the east, where an access track is also proposed (Plate 7.17). The pipeline extends across fields, which were largely inaccessible during the walkover, passing the former Buckleigh Farm/barn to the south and running approximately parallel to the old lane to the north (Buckleigh Lane) to Brighton Road. It was not possible to get direct access to the former Buckleigh farm site at the time of the survey, but a scan of available modern satellite imagery suggests that there are no clear remnants of buildings in this area, although there is an electricity pylon in this area (Plate 7.18). An air valve is proposed in this area (Fig. 5) with directional drilling to the east. Rickfield Farm lies to the south of the pipeline. The pipeline crosses the field which lies immediately west of Brighton Road and just to the south of the access road to Rickfield Farm (Plate 7.19). A washout is proposed here, as it a temporary compound/laydown area (Fig. 5). Directional drilling is proposed for the road crossing to the east of this field across Brighton Road (Fig. 5).

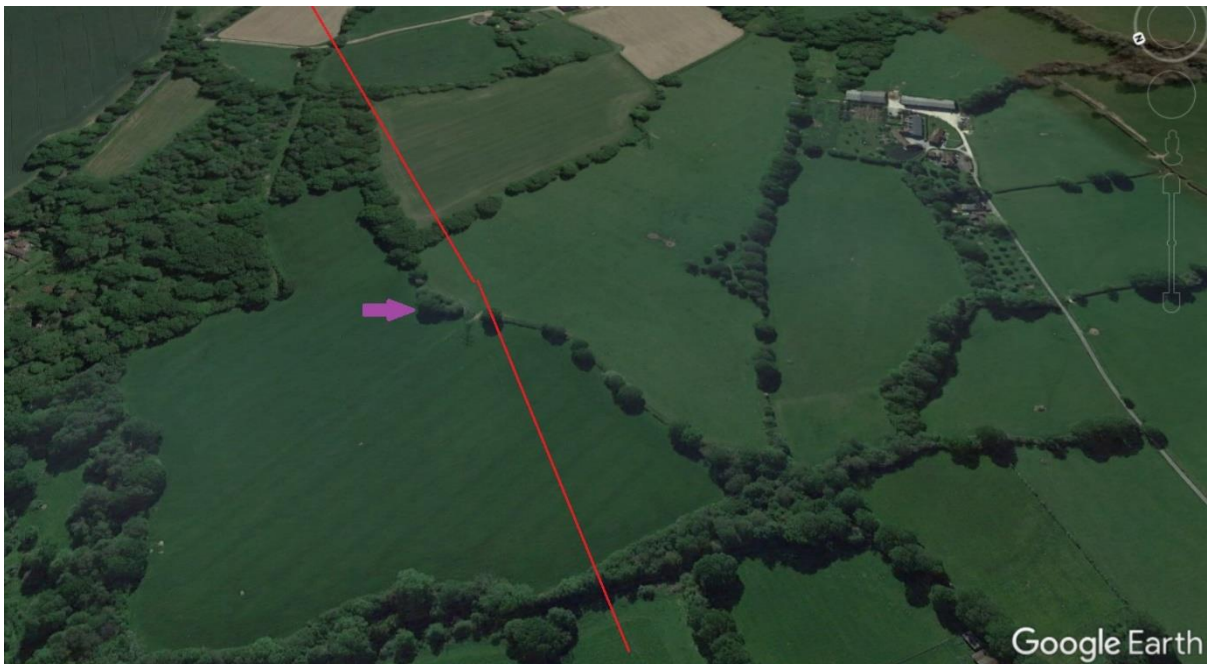
Plate 7.18: Satellite view across fields between Sedgwick Lane and Brighton Road passing the former Buckleigh farm/barn (located with purple arrow) (no access to this area at time of Site visit)

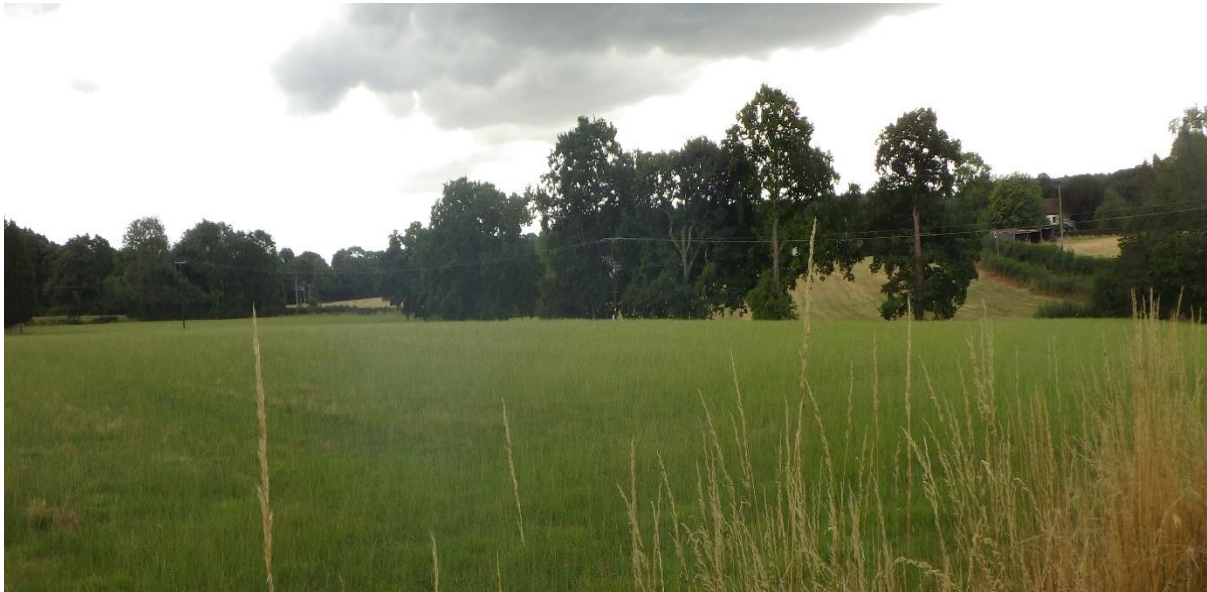
Plate 7.19: View across field to west of Brighton Road and within the grounds of Rickfield Farm – proposed directional drill to cross hedgerow in east (looking south-west)

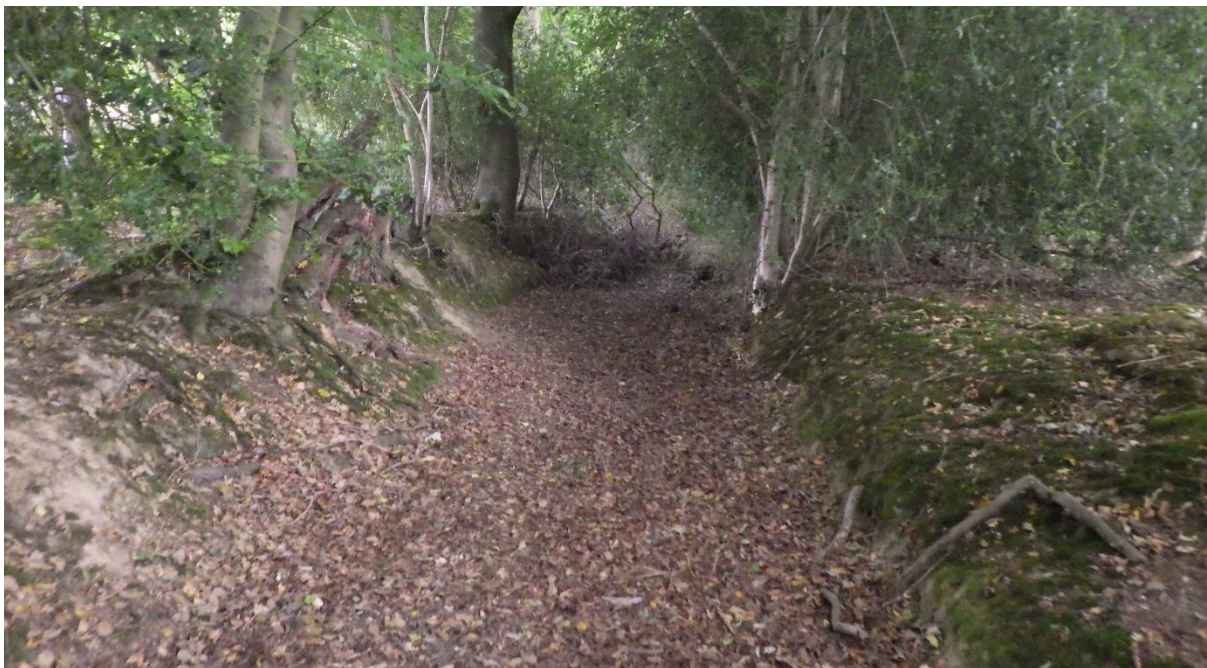
Plate 7.20: View along historic routeway/hollow-way, Buckleigh Lane (looking west)

4.9.7 An historic outfarm (not recorded on the HER), Buckleigh Farm/barn, was observed on the tithing survey in 1841/44 with a lane (Buckleigh Lane) leading to it (Fig. 4). The barn building is recorded on the Horsham (Part 4) tithing survey as a House Homestead occupied by Moses Mason (Fig. 10). The buildings are shown on the 1875-6 OS map (Plate 5.4, Section 5), but have been removed by 1897 (Plate 5.5, Section 5). The lane, now a public footpath (only partially accessible during the walkover survey due to overgrown vegetation and fallen trees), appears to have been a fairly significant historic routeway, with a very wide hollow-way still visible (Plate 7.20 in Section 7 below).

7.9 During the walkover survey, the old Buckleigh Lane was partly accessed (Plate 7.20). Although this lane, now a footpath, lies to the north of the proposed scheme and will not be impacted, it helps to portray the historic landscape around the pipeline. The lane is densely wooded with a wide hollow-way and boundary banks delineating its route. It seems to have once been a fairly significant historic routeway.

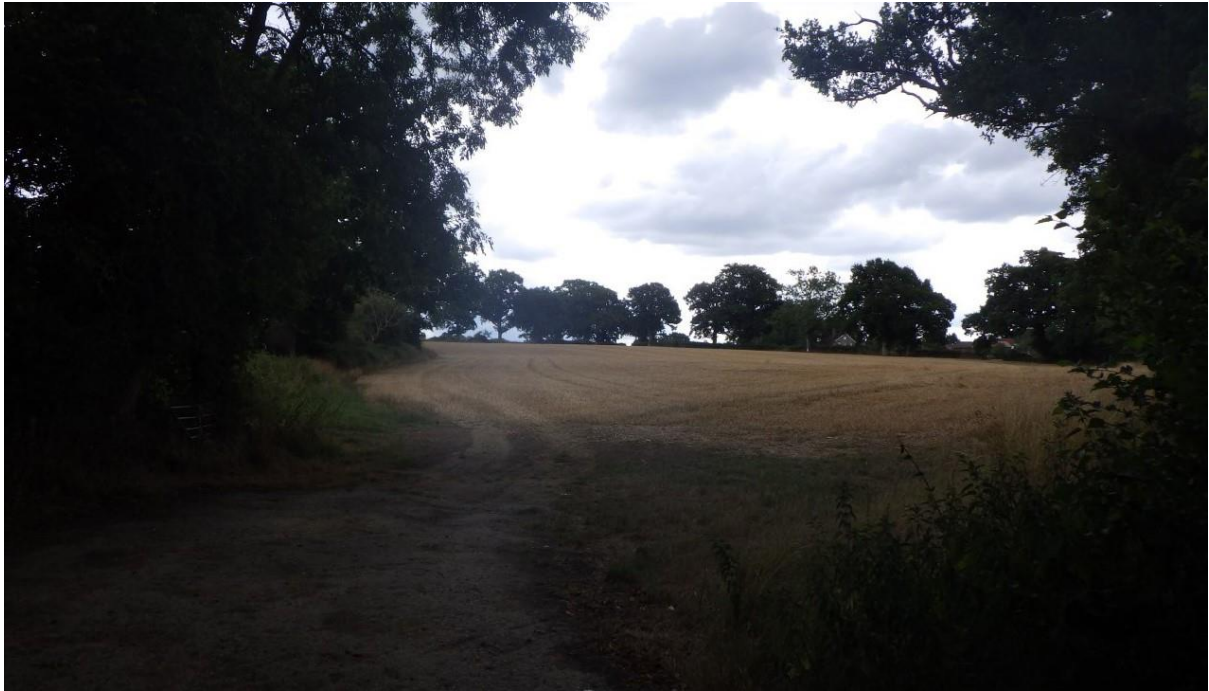
Plate 7.21: View across field to east of Brighton Road (looking south-east) – access route proposed here from Brighton Road – tall, mature roadside treeline boundary located between this field and Brighton Road – directional drilling proposed here to cross road and boundary hedgerows

7.10 Access was limited in the last section of pipeline to the east of Brighton Road and up to the Water Treatments Works in Gaggle Wood (Plate 7.21-23). An access track is proposed from Brighton Road into the first field on the eastern side of Brighton Road (Plates 7.21-22). The pipeline then extends across the fields (Plate 7.22) and a pipe bridge is proposed to cross the stream valley within Gaggle Wood into the WTW, in order to avoid impact on underlying tree roots (Fig. 5).

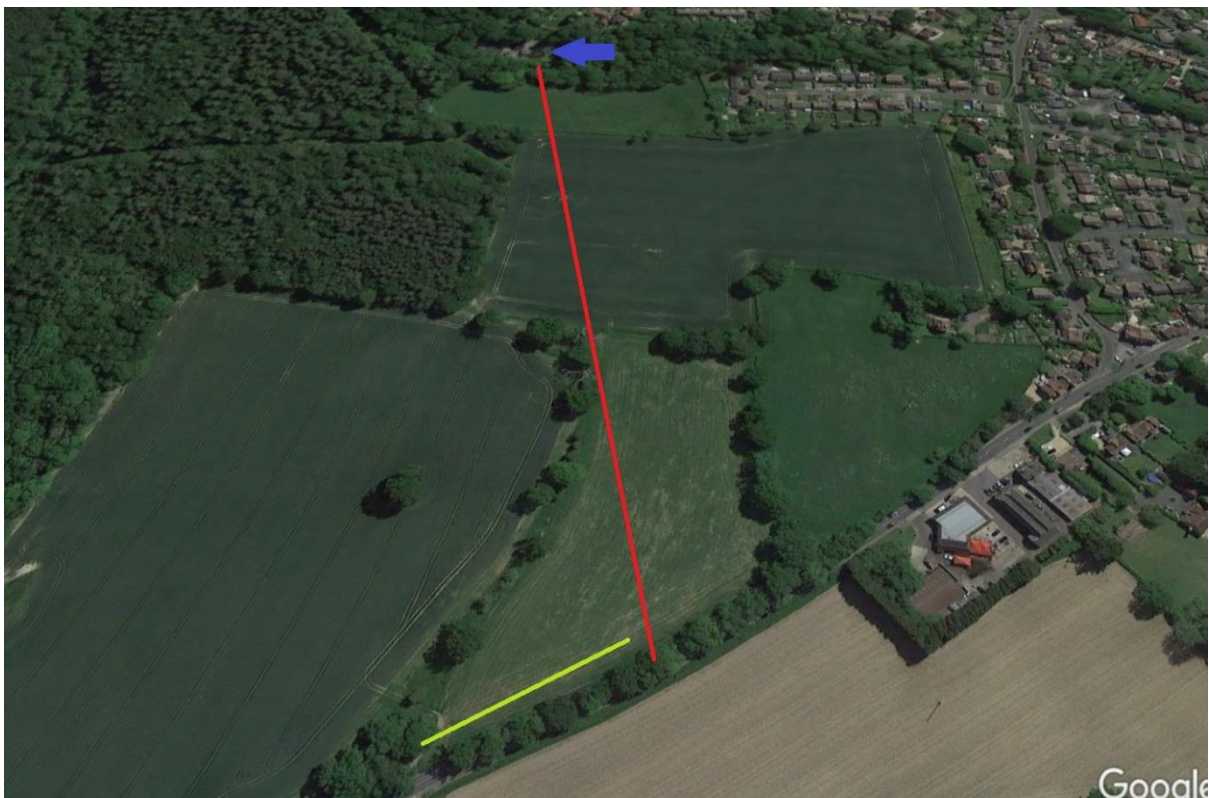
Plate 7.22: Satellite view across fields and woodland to the Mannings Heath Water Treatment Works in the east (blue arrow) – approximate pipeline route shown with red line and access road shown with green line (no access to this area at time of Site visit)
