**Mannings Heath WTW to Chesworth Lane,
West Sussex**

**Historic Environment Desk-Based Assessment
(Heritage Statement)**

Prepared for Southern Water

**ASE Project No. 220267
ASE Report No. 2022208
WSHER Ref. No. 202223-040**

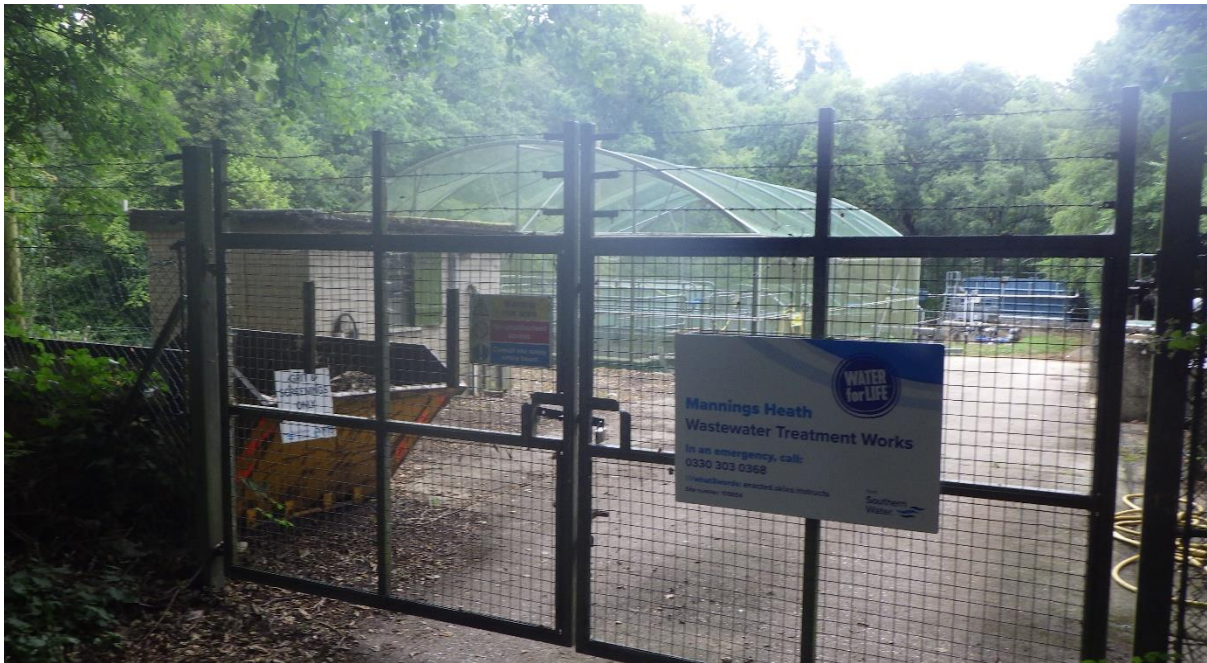
Plate 7.23: Mannings Heath Water Treatment Works at the eastern end of the pipeline scheme (looking north-west)

7.10 Access was limited in the last section of pipeline to the east of Brighton Road and up to the Water Treatments Works in Gaggle Wood (Plate 7.21-23). An access track is proposed from Brighton Road into the first field on the eastern side of Brighton Road (Plates 7.21-22). The pipeline then extends across the fields (Plate 7.22) and a pipe bridge is proposed to cross the stream valley within Gaggle Wood into the WTW, in order to avoid impact on underlying tree roots (Fig. 5).

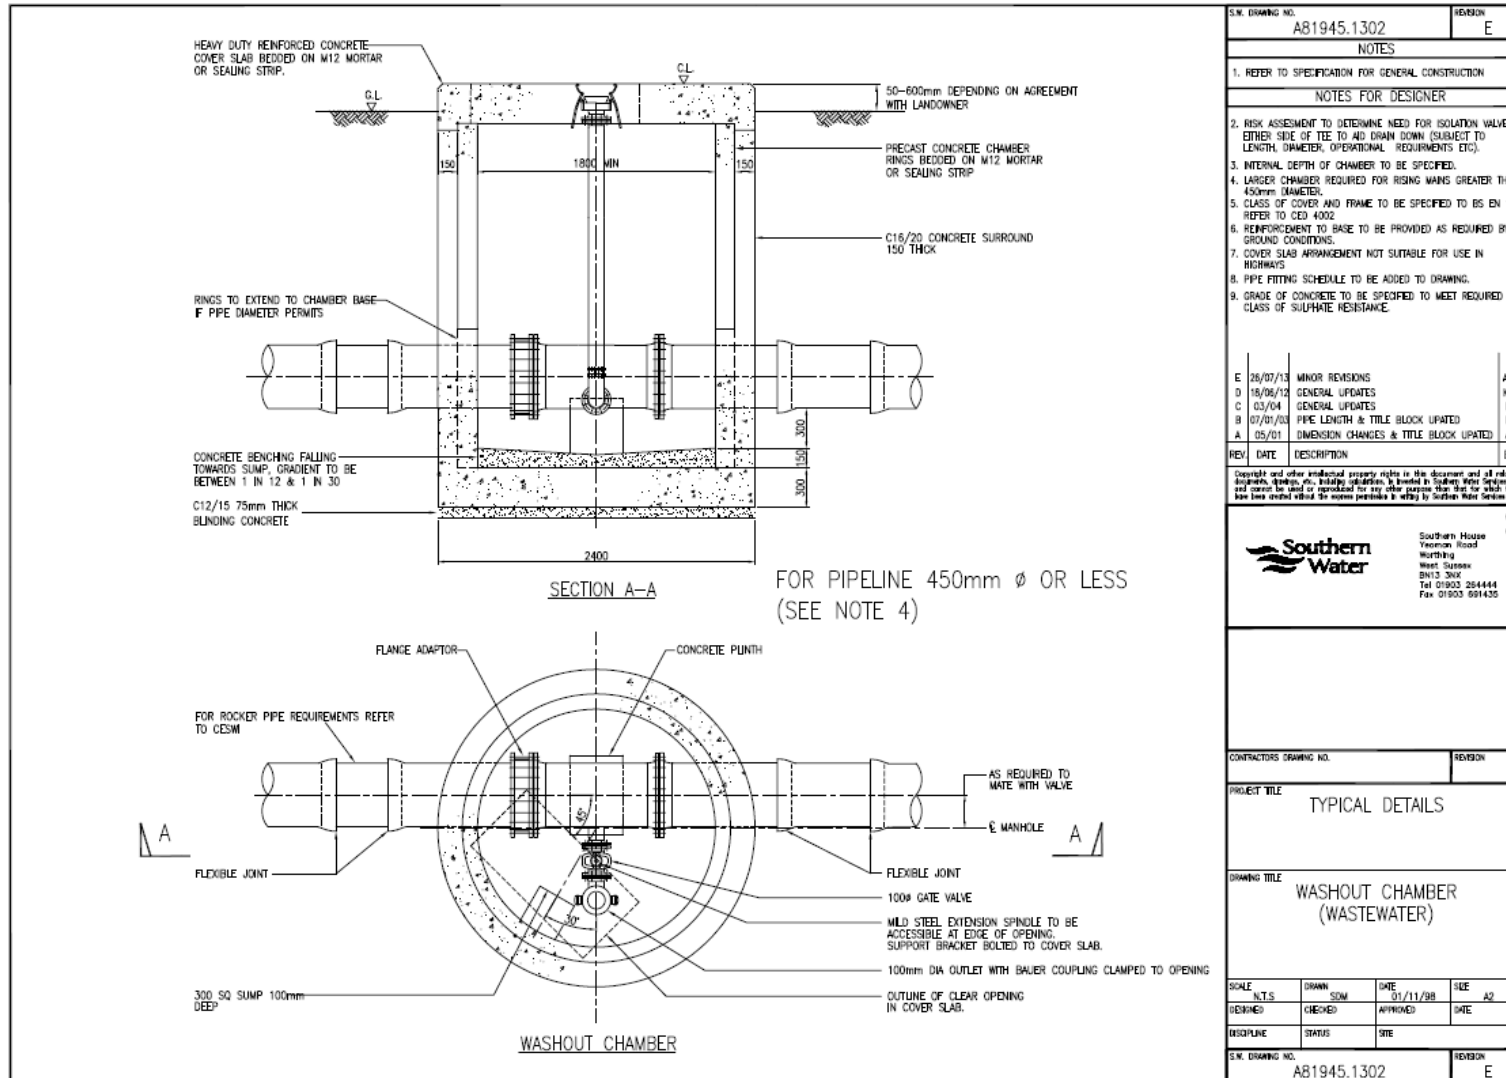
DRAWING TITLE WASHOUT CHAMBER (WASTEWATER)		
SCALE N.T.S.	DRAWN SDM	DATE 01/11/98
DESIGNED	CHECKED	APPROVED
DISCIPLINE	STATUS	DATE
S.W. DRAWING NO. A81945.1302	REVISION E

S.W. DRAWING NO. A81945.1302		REVISION E
NOTES		
1. REFER TO SPECIFICATION FOR GENERAL CONSTRUCTION		
NOTES FOR DESIGNER		
2. RISK ASSESSMENT TO DETERMINE NEED FOR ISOLATION VALVES EITHER SIDE OF TEE TO AID DRAIN DOWN (SUBJECT TO LENGTH, DIAMETER, OPERATIONAL REQUIREMENTS ETC).

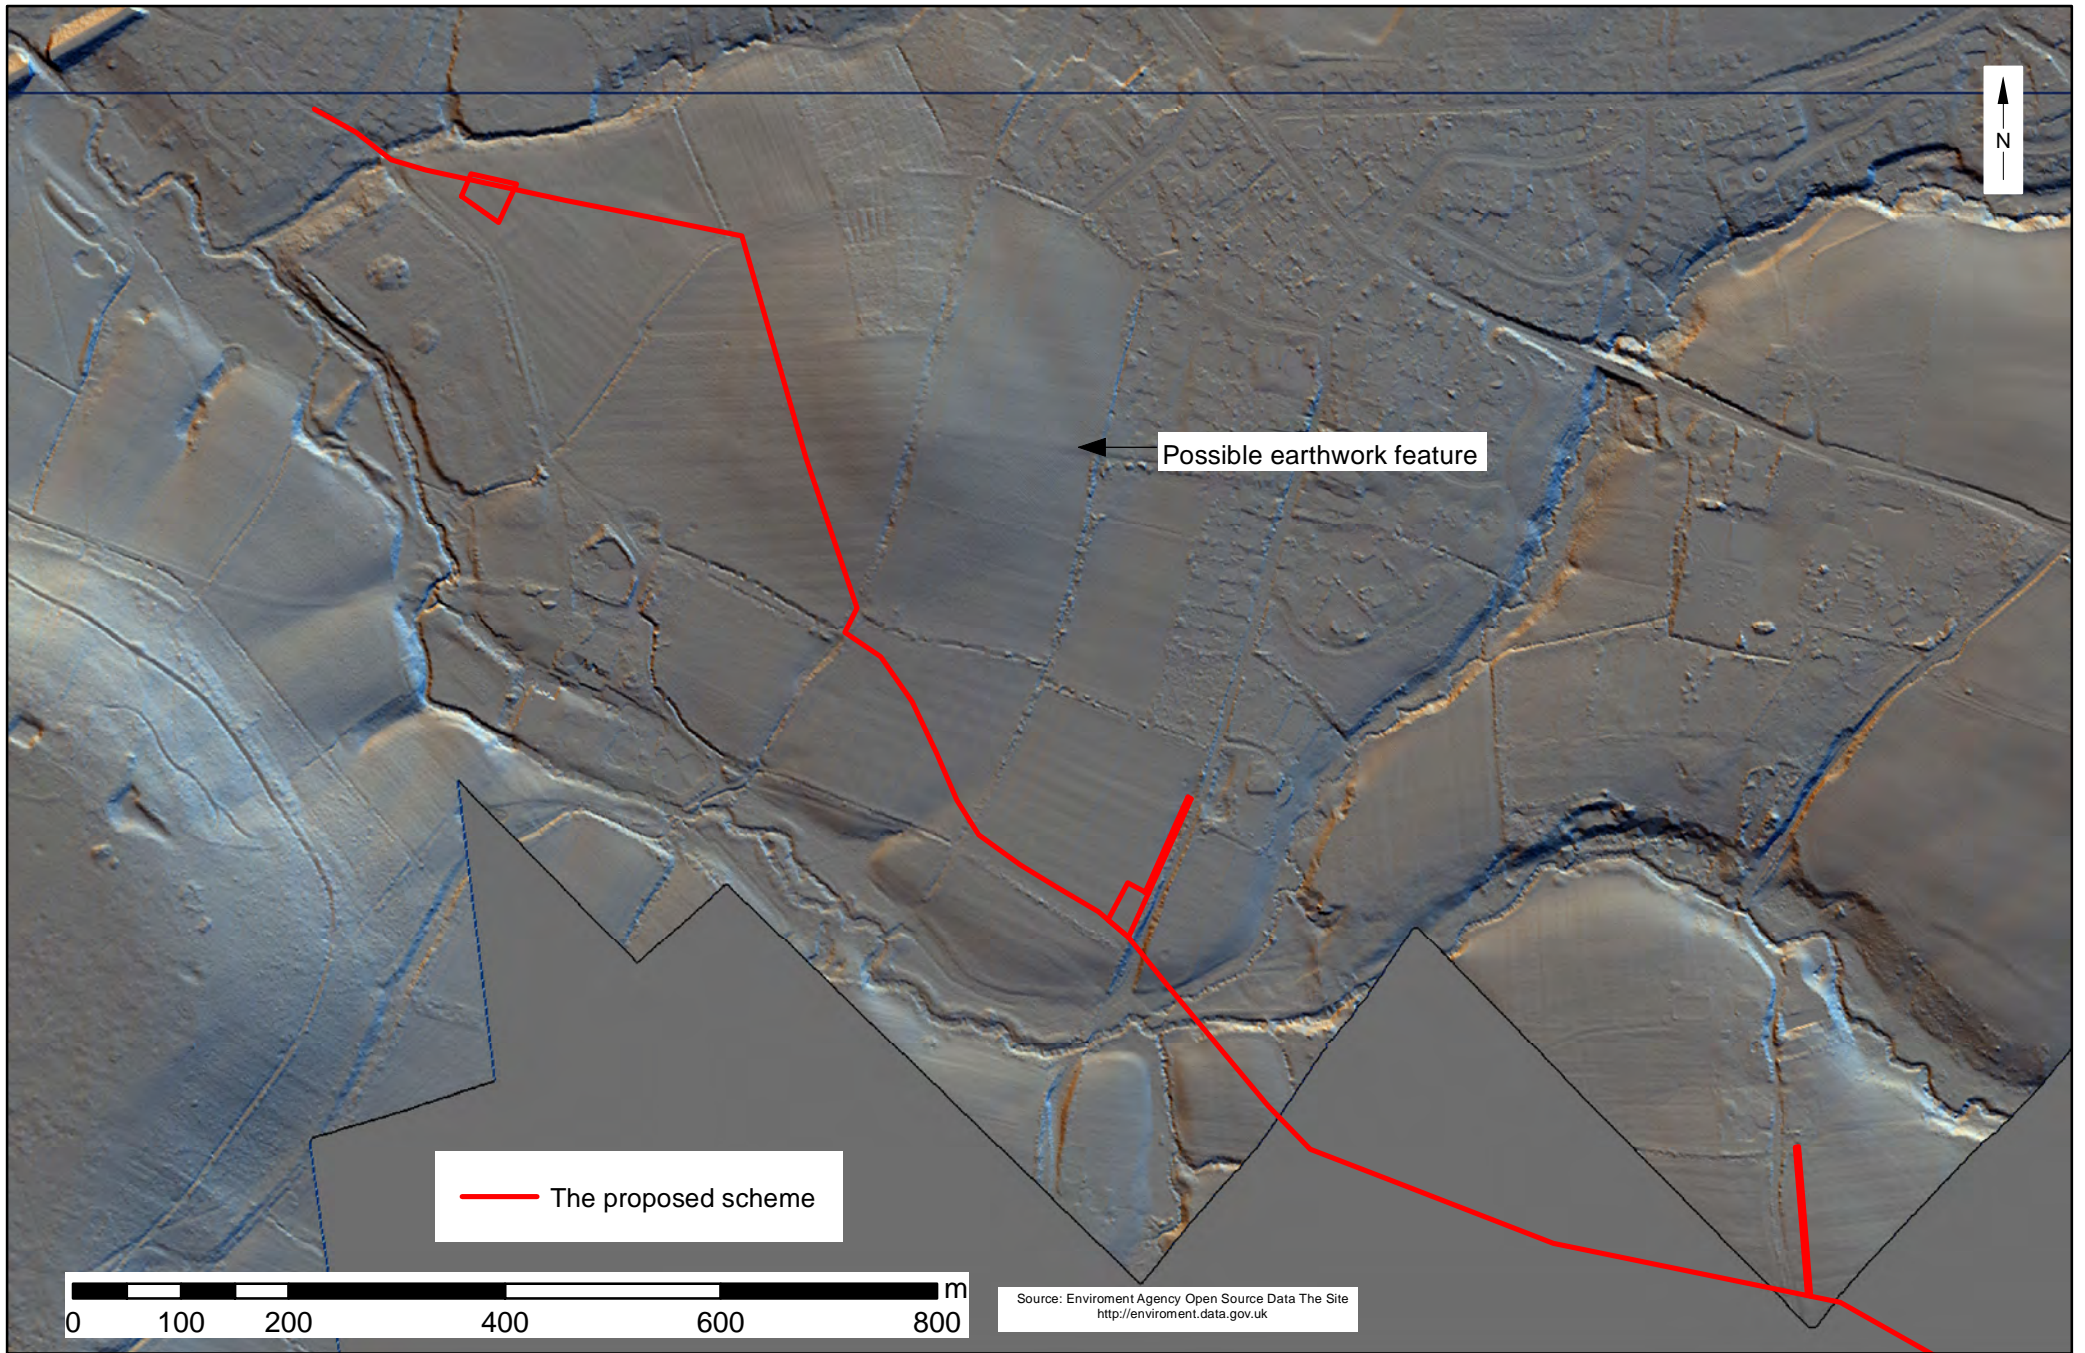
© Archaeology South-East		Mannings Heath WTW to Chesworth Lane, West Sussex	Fig. 15
Project Ref: 220267	July 2022	Lidar imagery (1m DTM Multi D16 H35) showing the	
Report Ref: 2022208	Drawn by: KLGR	area covering the western part of the pipeline

4.10.2 A large sub-rectangular anomaly was seen on LiDAR imagery as part of this assessment in the Great Horsham Hill area to the north-east of Chesworth Farm (within the grounds) (see 6.6 below). It is likely that this has a geological origin, caused by the movement of sandstone and clay (cambering). However, some archaeological origin cannot be ruled out given the regularity of the feature and its prominent position within the river valley, and it has been identified on Figs 4, 15 and 16 as a possible earthwork.
