This Arboricultural Method Statement has been produced following a review of a fixed proposed works layout for the site based on data provided by the client. The methods of work described herein will be a requirement of all relevant contractors associated with the development proposals.

Project <b>Mannings Heath WTW, Birch Grove, Horsham</b>	
Drawing <b>Site Overview</b>	
Client <b>The Clancy Group</b>	
Drawing Number <b>C159801-01-01-RevA</b>	Revision <b>RevA</b>
Scale @ A3 <b>1:500</b>	Date <b>April 2023</b>
Approved By <b>LW</b>	Drawn By <b>VO</b>
  <b>MIDDLEMARCH</b>	
Triumph House, Birmingham Road, Allesley, Coventry CV5 9AZ T:01676 525880 E:admin@middlemarch-environmental.com	
This map is reproduced from the Ordnance Survey material with the permission of Ordnance Survey on behalf of The Controller of Her Majesty's Stationary Office. © Crown copyright. Unauthorised reproduction infringes Crown copyright and may lead to prosecution of civil proceedings. Licence Number: 100040519

Project <b>Mannings Heath WTW, Birch Grove, Horsham</b>	
Drawing <b>Tree Survey Plan</b>	
Client <b>The Clancy Group</b>	
Drawing Number <b>C159801-01-01-RevA</b>	Revision <b>RevA</b>
Scale @ A3 <b>1

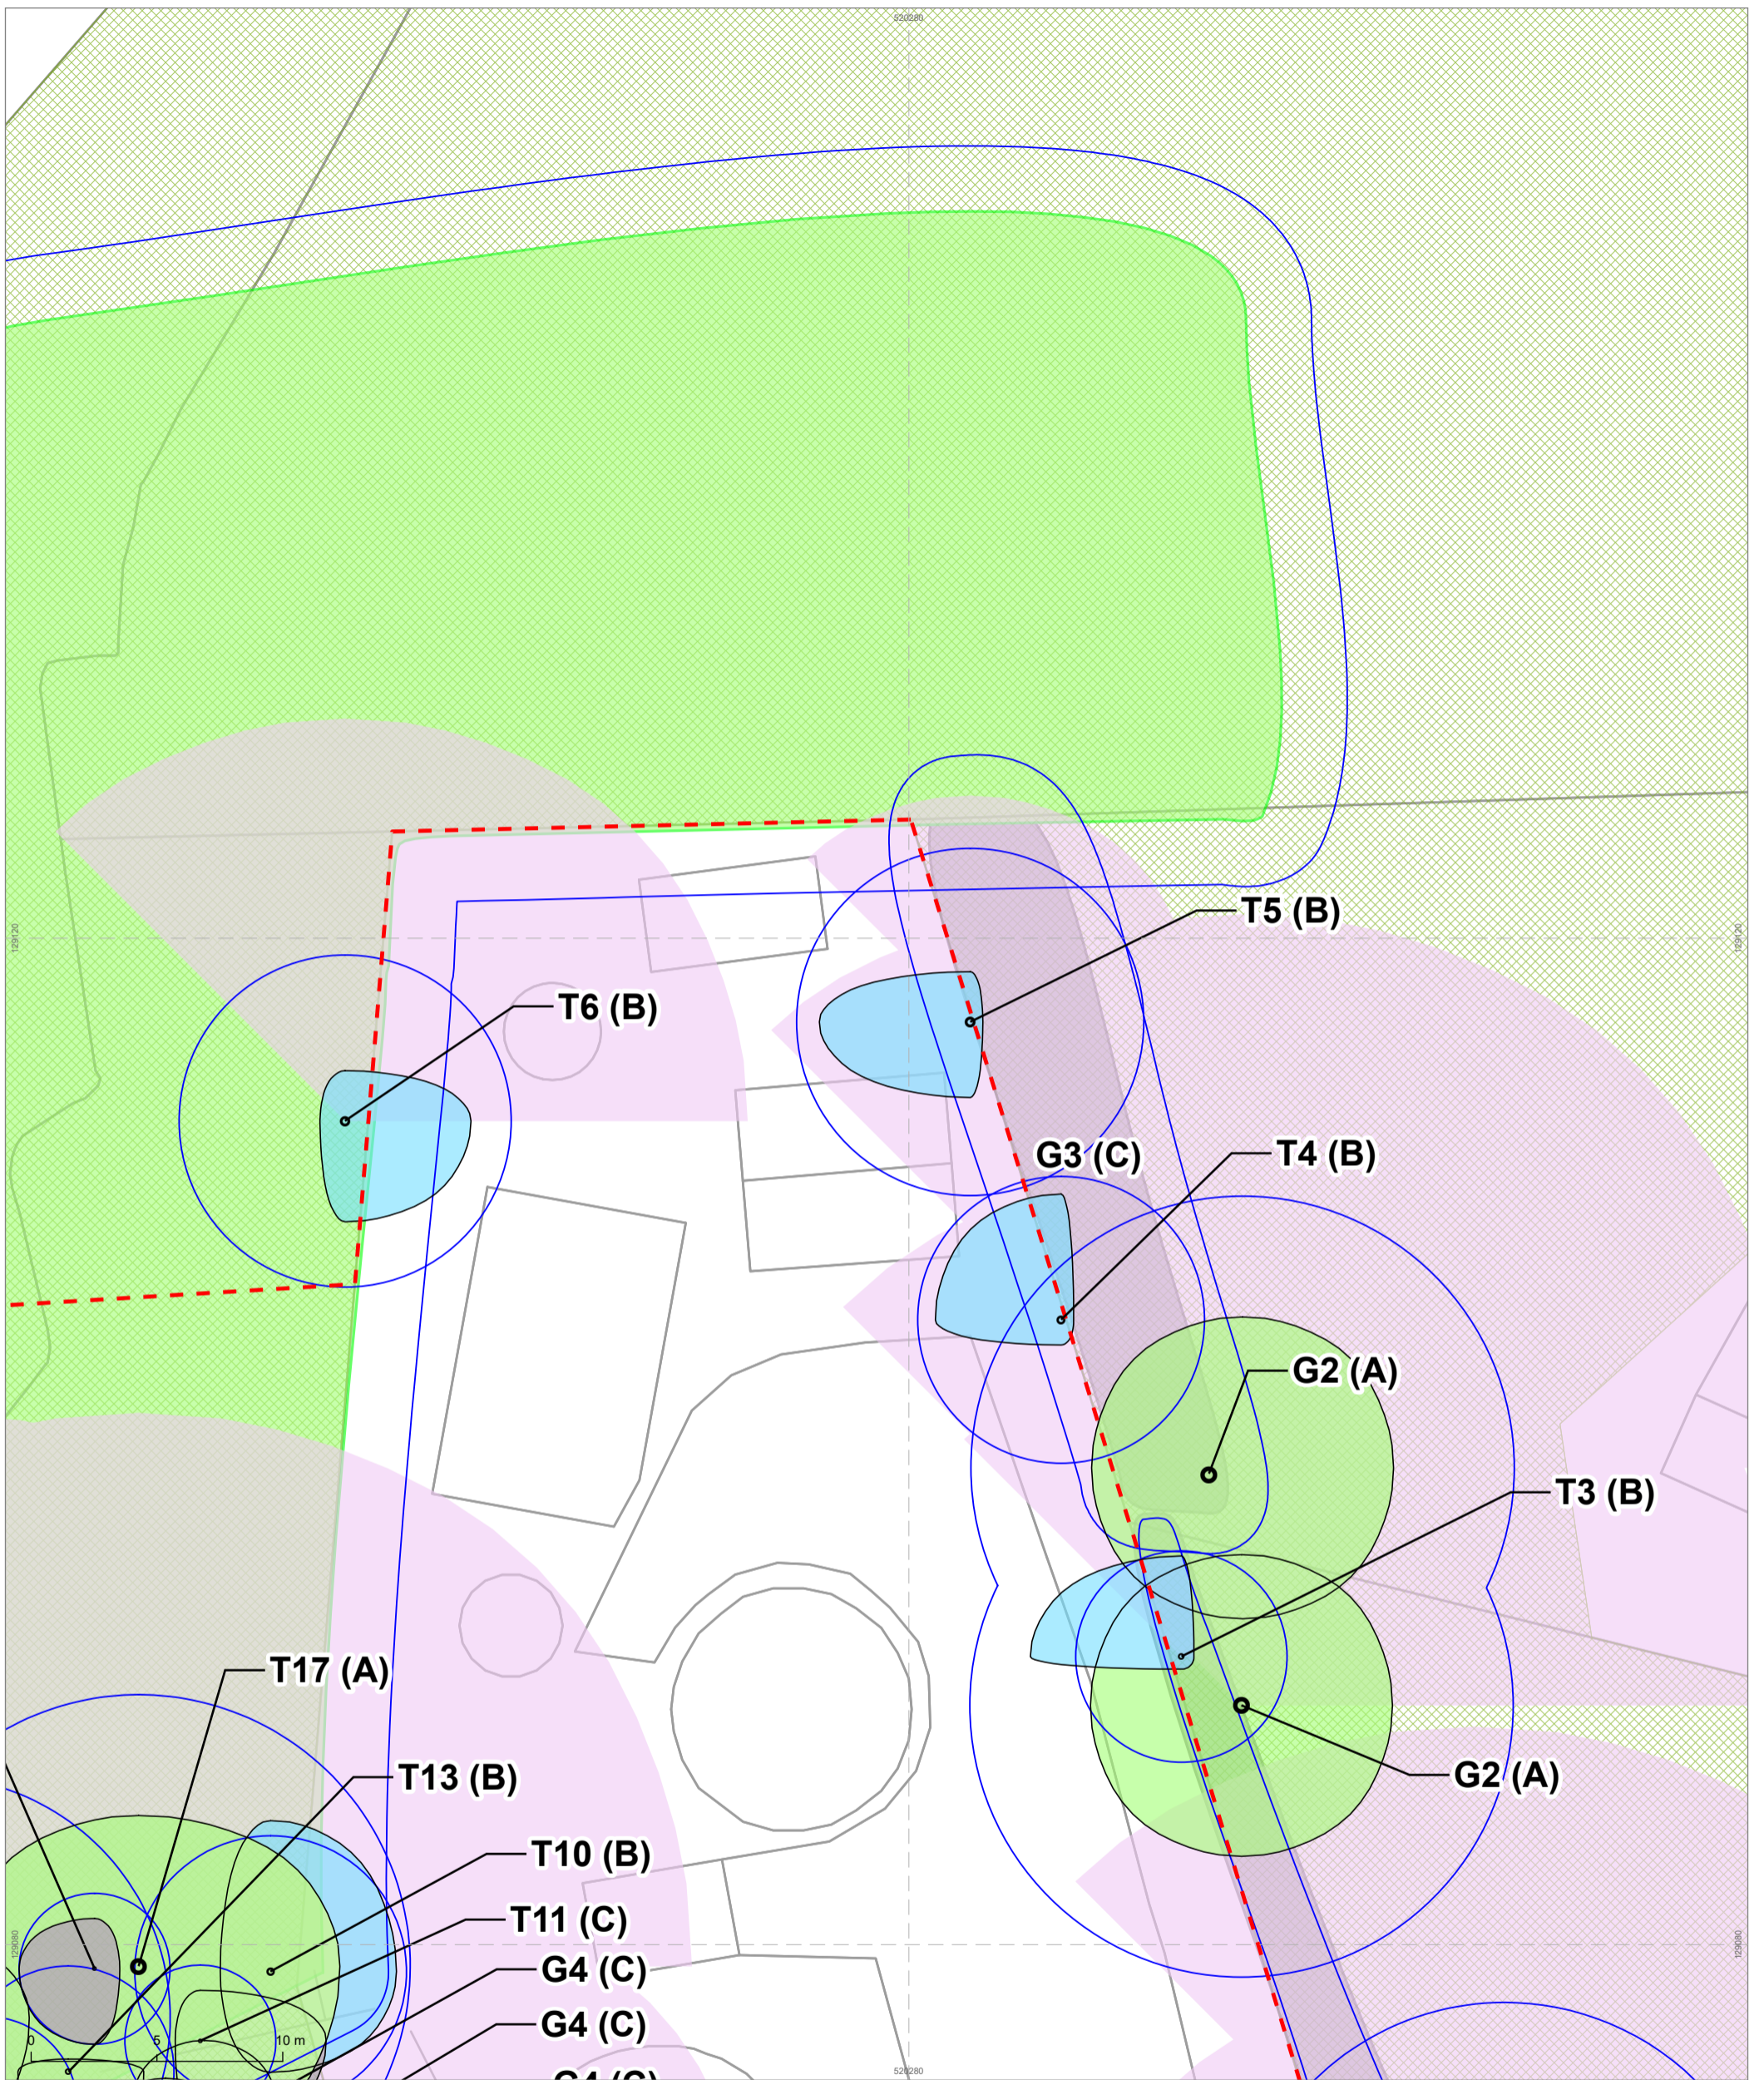
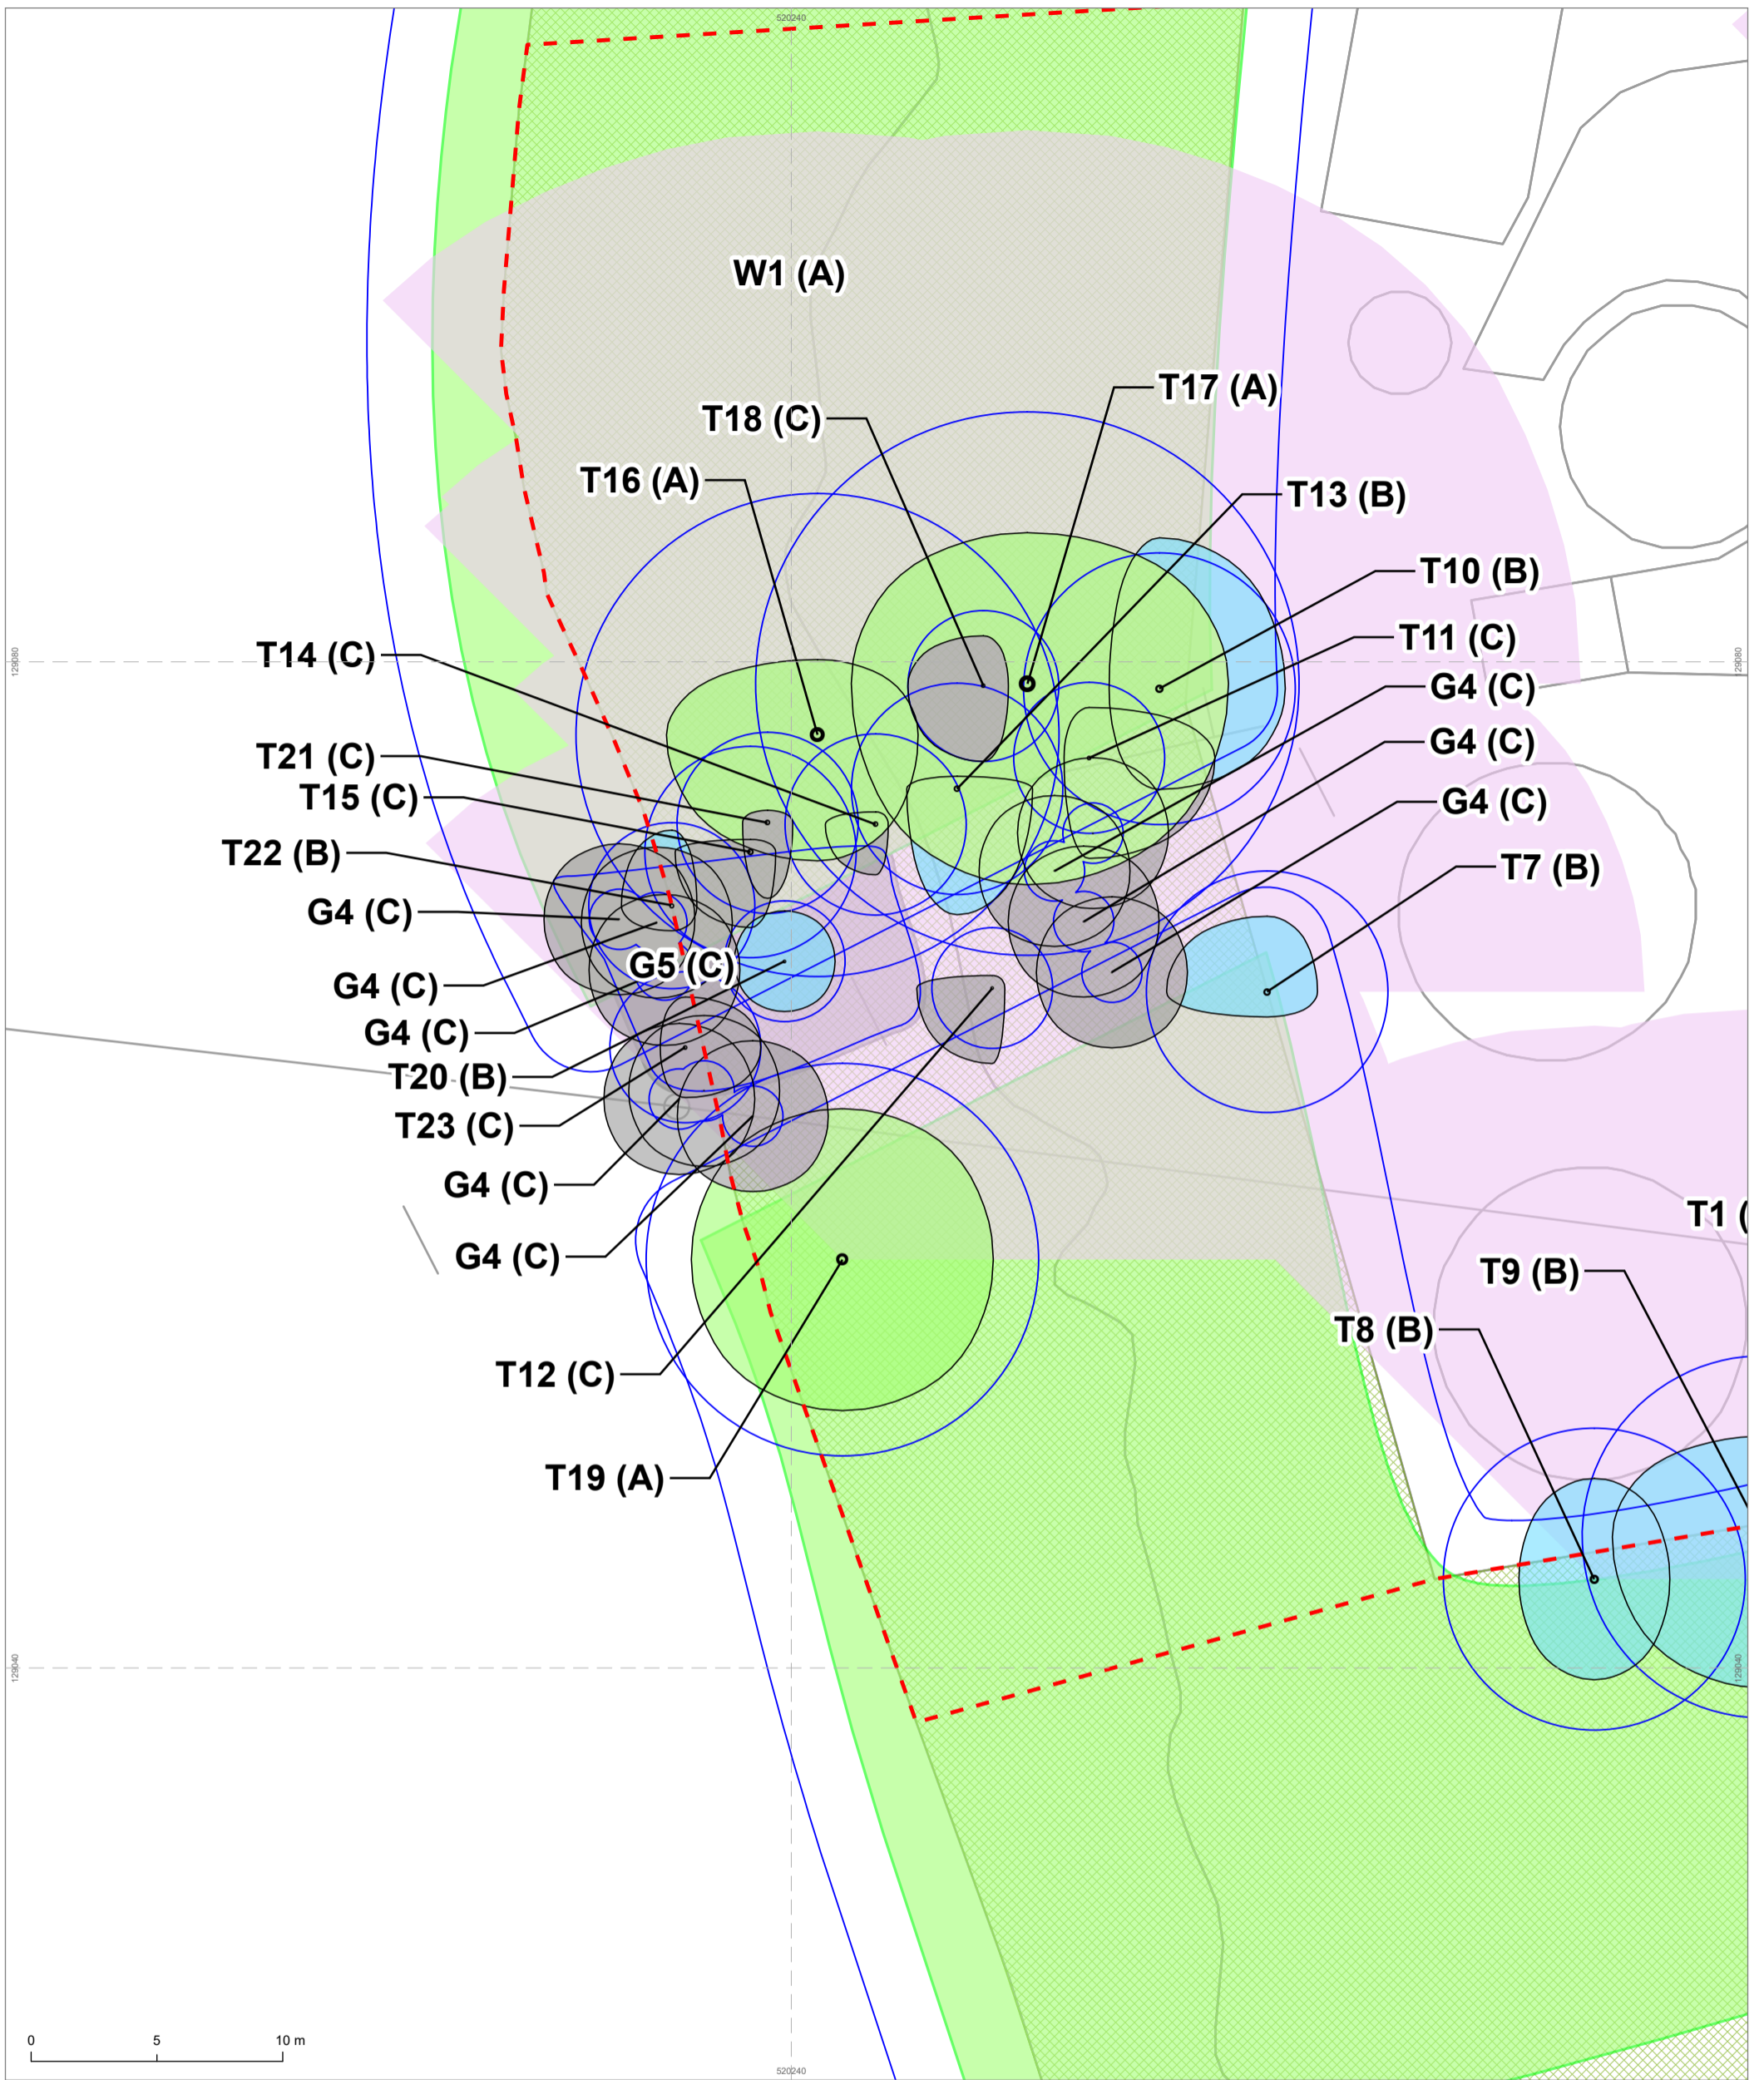
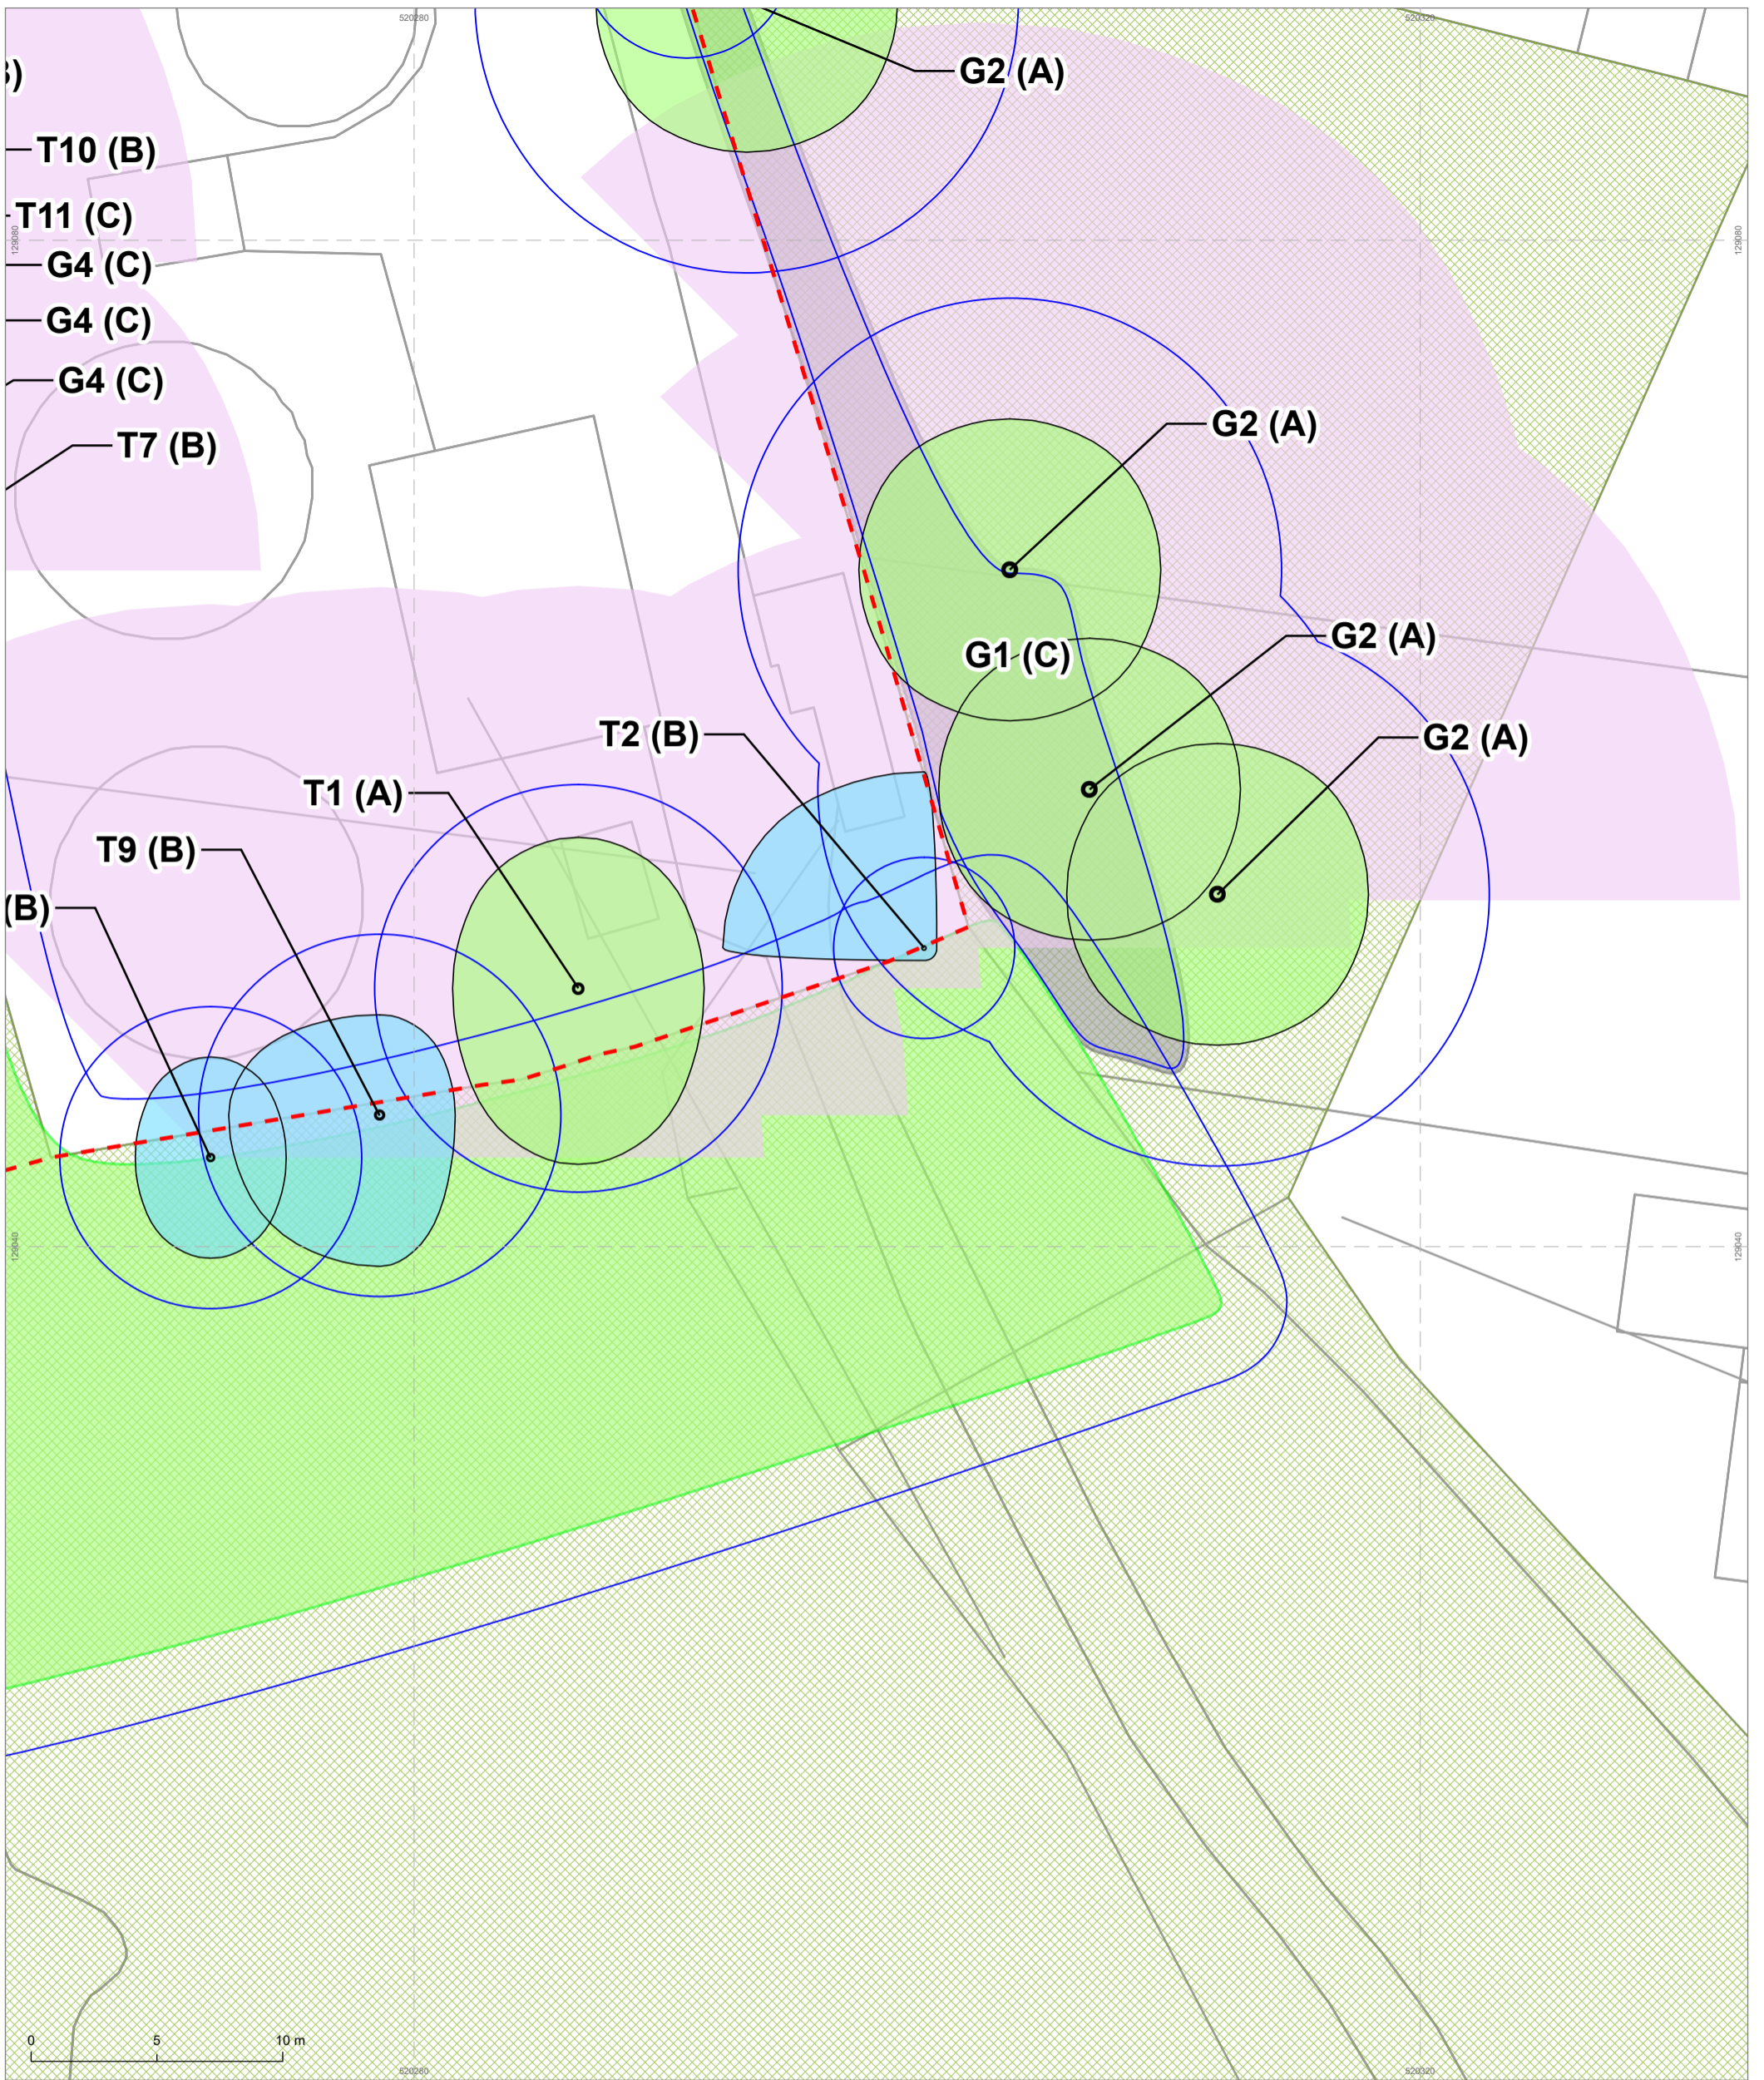
C159801-01-01-RevA

- Stem location and diameter
- Category A tree
- Category B tree
- Category C tree
- Current canopy extent
- Root protection area
- Indicative tree shadow
- Ancient woodland
- Survey extent

**Note:** tree locations are approximate, based on combined field observations and aerial imagery

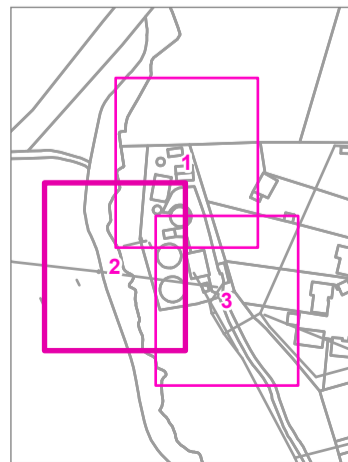
- Stem location and diameter
- Category A tree
- Category B tree
- Category C tree
- Current canopy extent
- Root protection area
- Indicative tree shadow
- Ancient woodland
- Survey extent

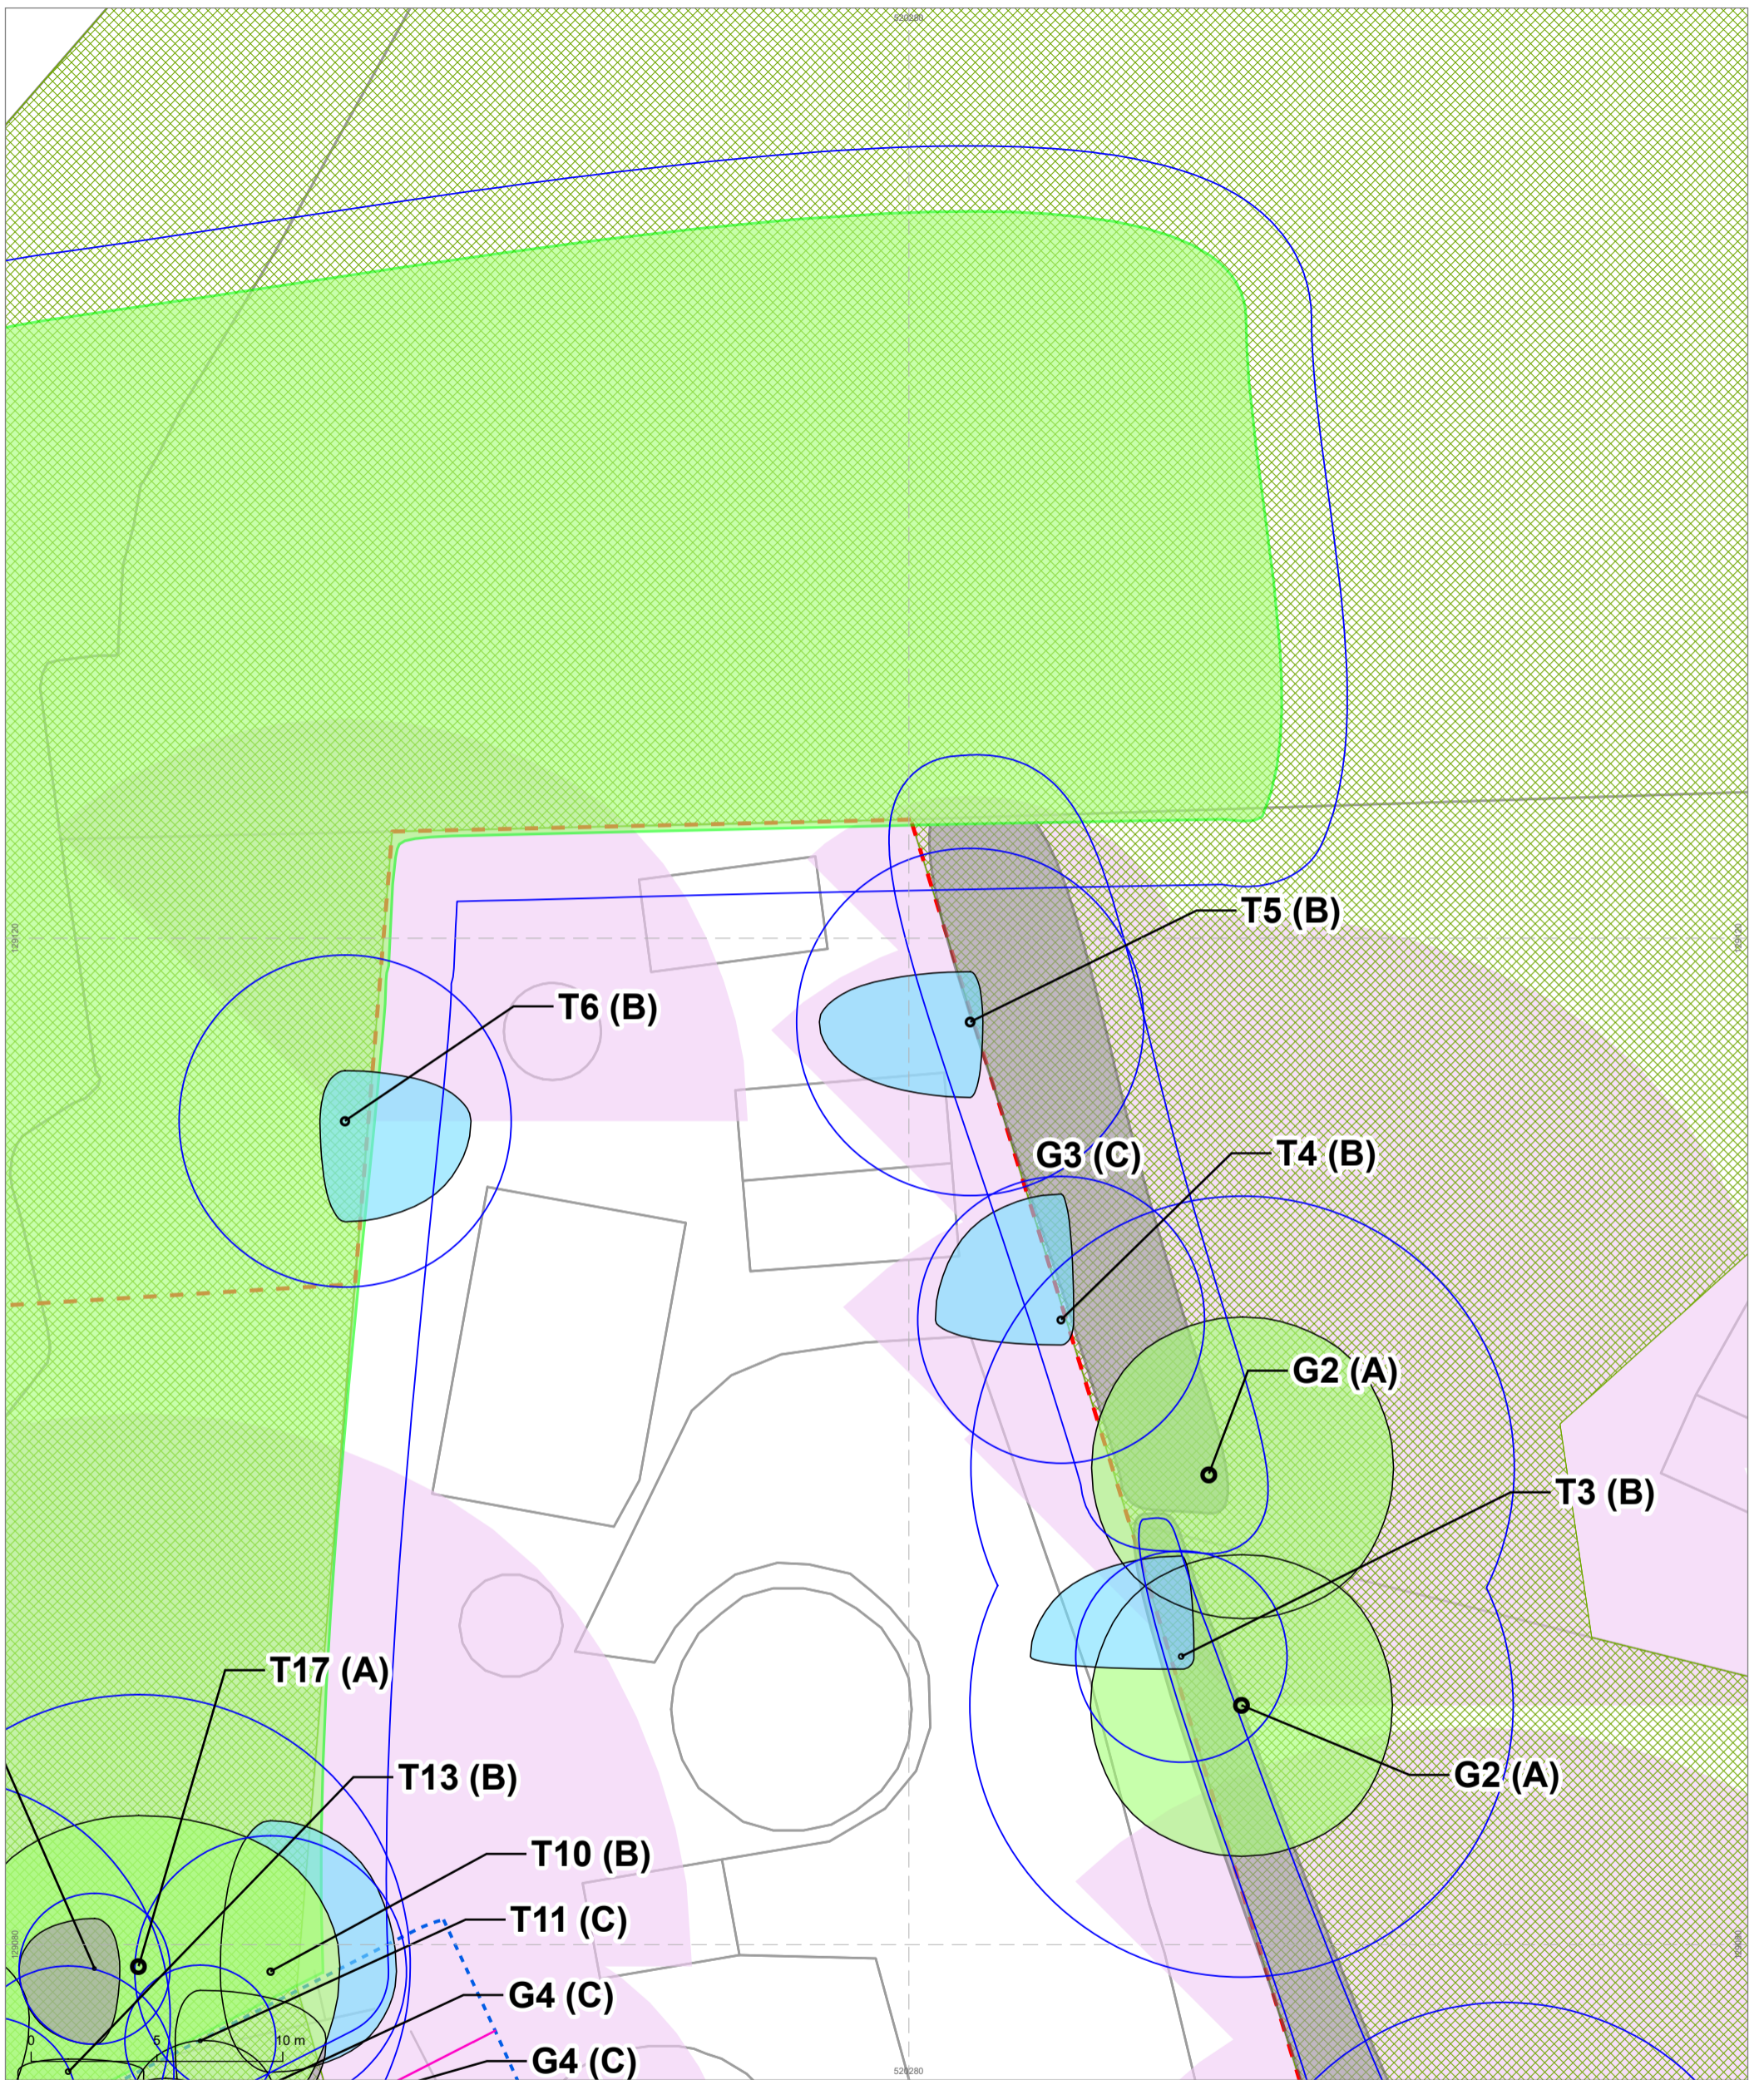
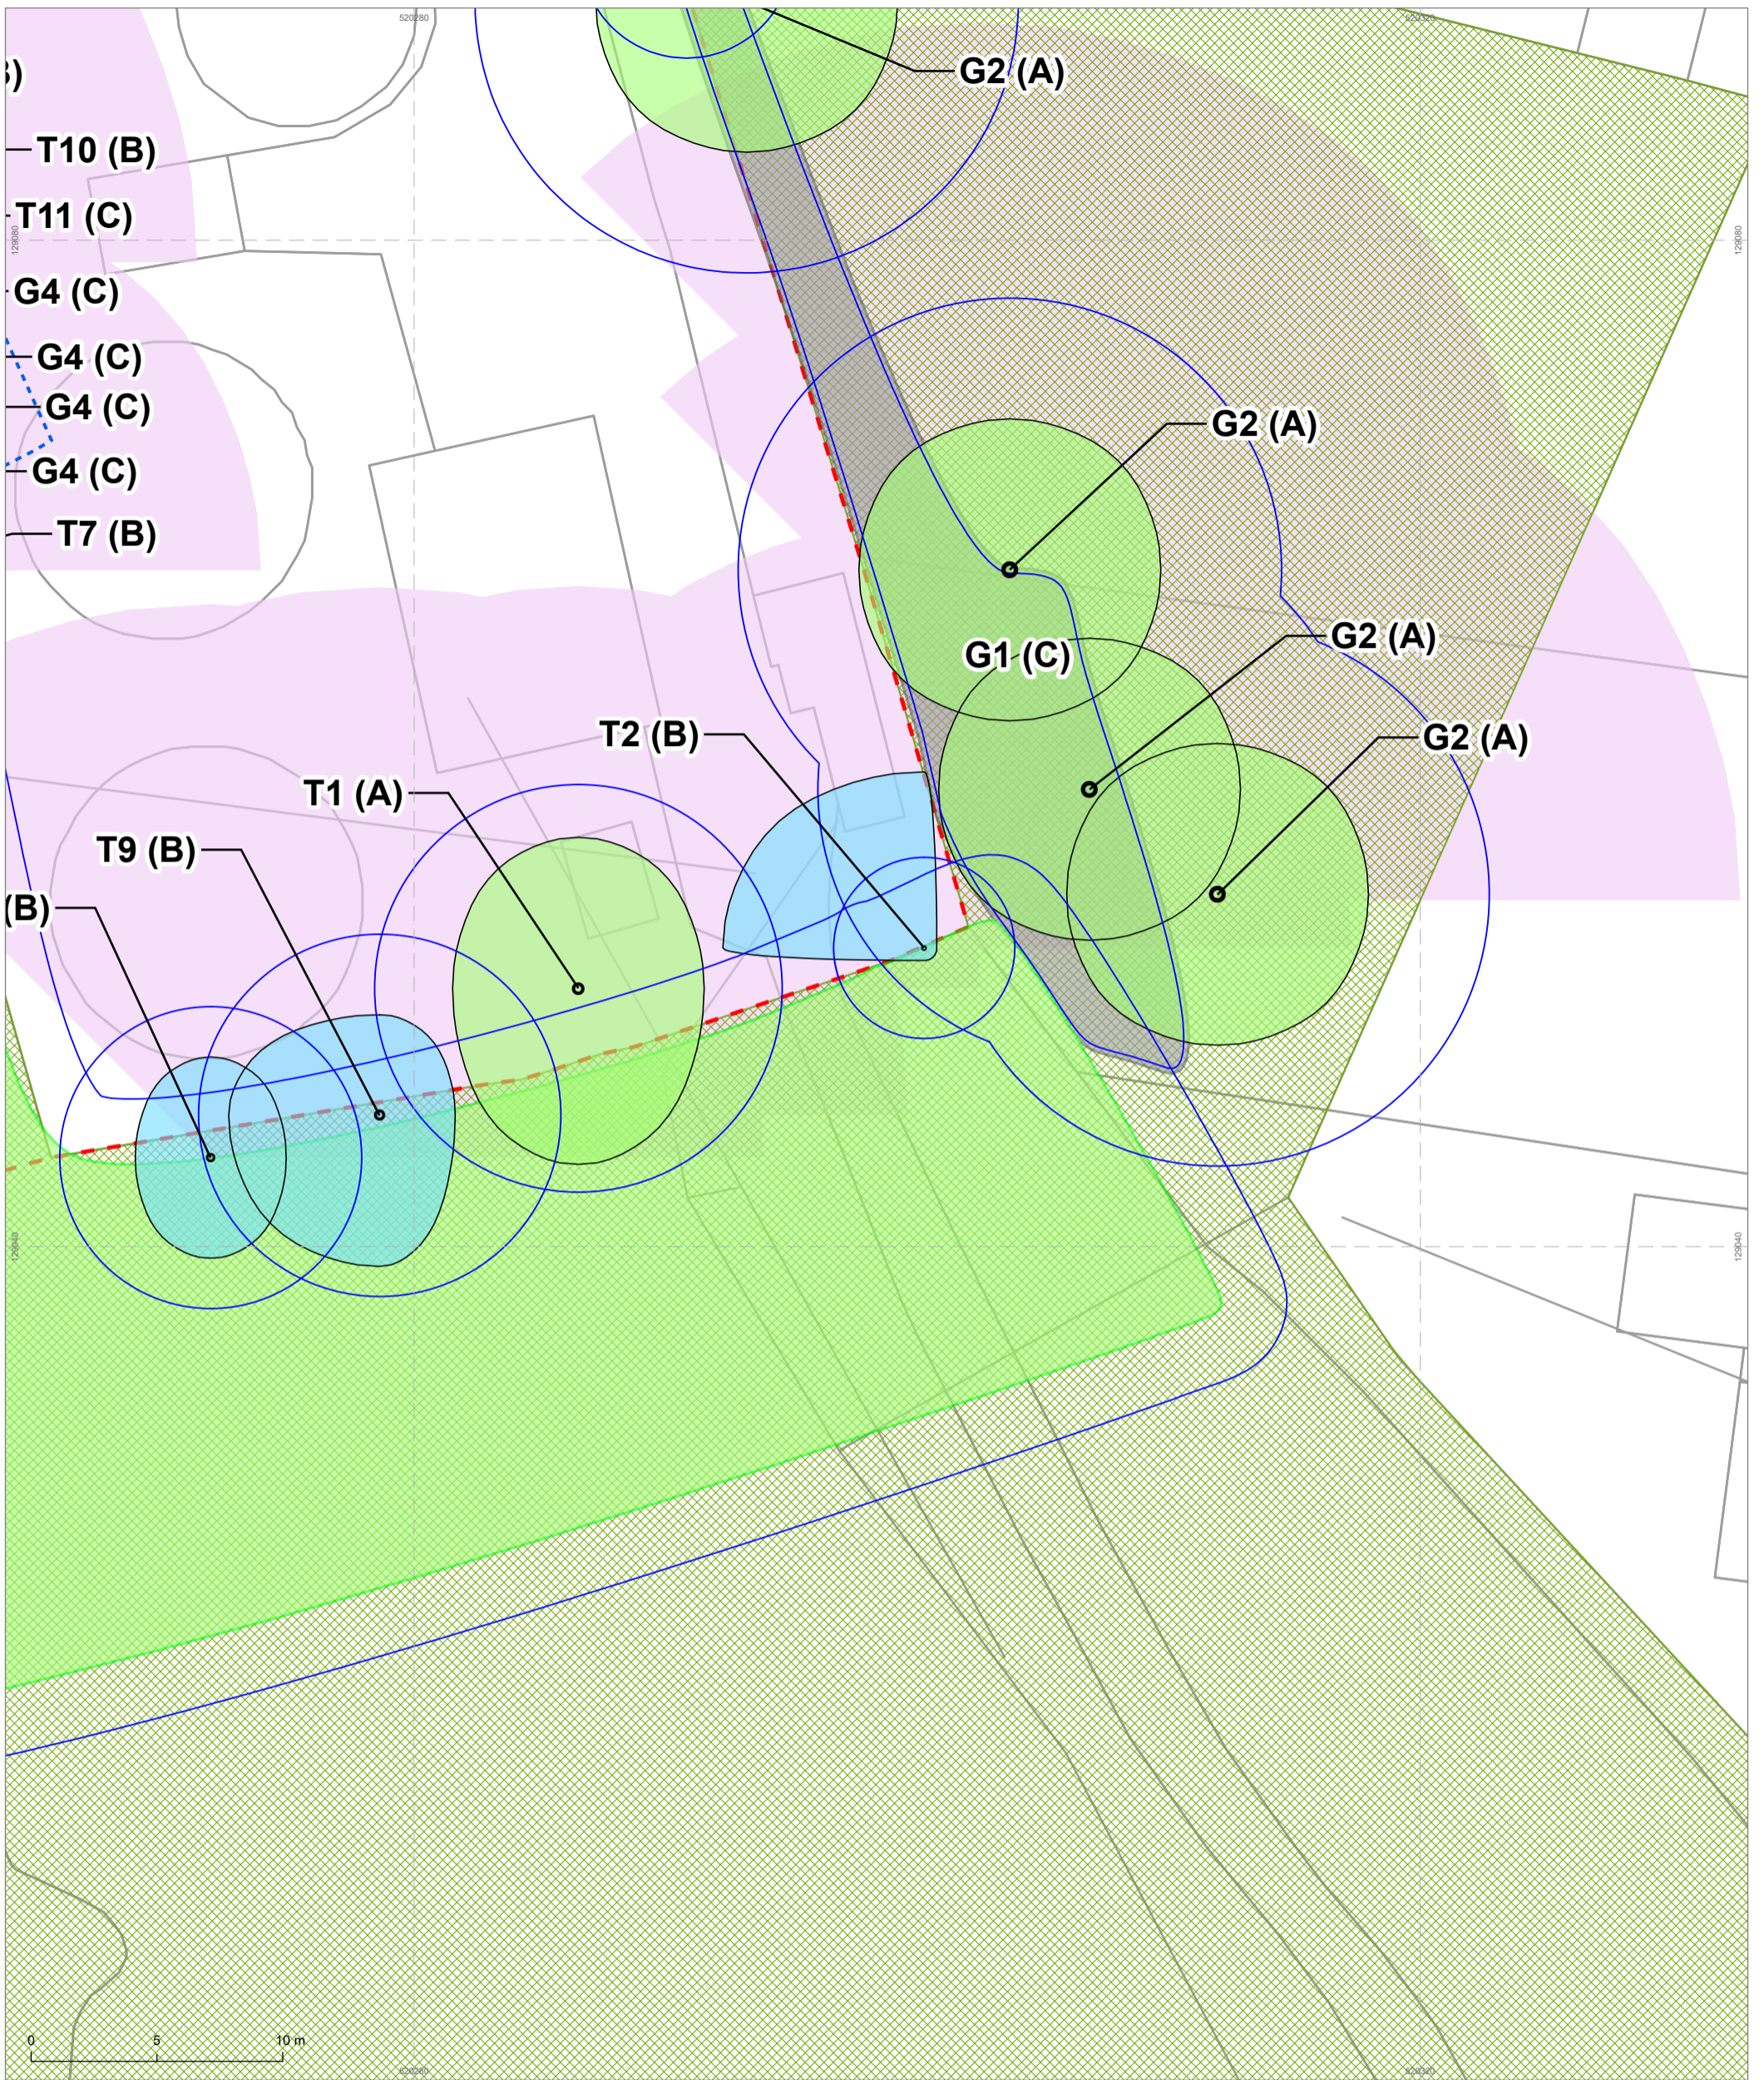
C159801-02-01

- Stem location and diameter
- Category A
- Category B - to be removed
- Category B
- Category C - to be removed
- Category C - to be translocated
- Category C
- Root protection area
- Current canopy - to be removed
- Current canopy - to be retained
- Indicative tree shadow
- Ancient woodland
- 10 m easement
- Proposed pipeline route
- Survey extent
