This Arboricultural Method Statement has been produced following a review of a fixed proposed works layout for the site based on data provided by the client. The methods of work described herein will be a requirement of all relevant contractors associated with the development proposals.

Project <b>Mannings Heath WTW, Birch Grove, Horsham</b>	
Drawing <b>Site Overview</b>	
Client <b>The Clancy Group</b>	
Drawing Number <b>C159801-01-01-RevA</b>	Revision <b>RevA</b>
Scale @ A3 <b>1:500</b>	Date <b>April 2023</b>
Approved By <b>LW</b>	Drawn By <b>VO</b>
  <b>MIDDLEMARCH</b>	
Triumph House, Birmingham Road, Allesley, Coventry CV5 9AZ T:01676 525880 E:admin@middlemarch-environmental.com	
This map is reproduced from the Ordnance Survey material with the permission of Ordnance Survey on behalf of The Controller of Her Majesty's Stationary Office. © Crown copyright. Unauthorised reproduction infringes Crown copyright and may lead to prosecution of civil proceedings. Licence Number: 100040519

Project <b>Mannings Heath WTW, Birch Grove, Horsham</b>	
Drawing <b>Tree Survey Plan</b>	
Client <b>The Clancy Group</b>	
Drawing Number <b>C159801-01-01-RevA</b>	Revision <b>RevA</b>
Scale @ A3 <b>1

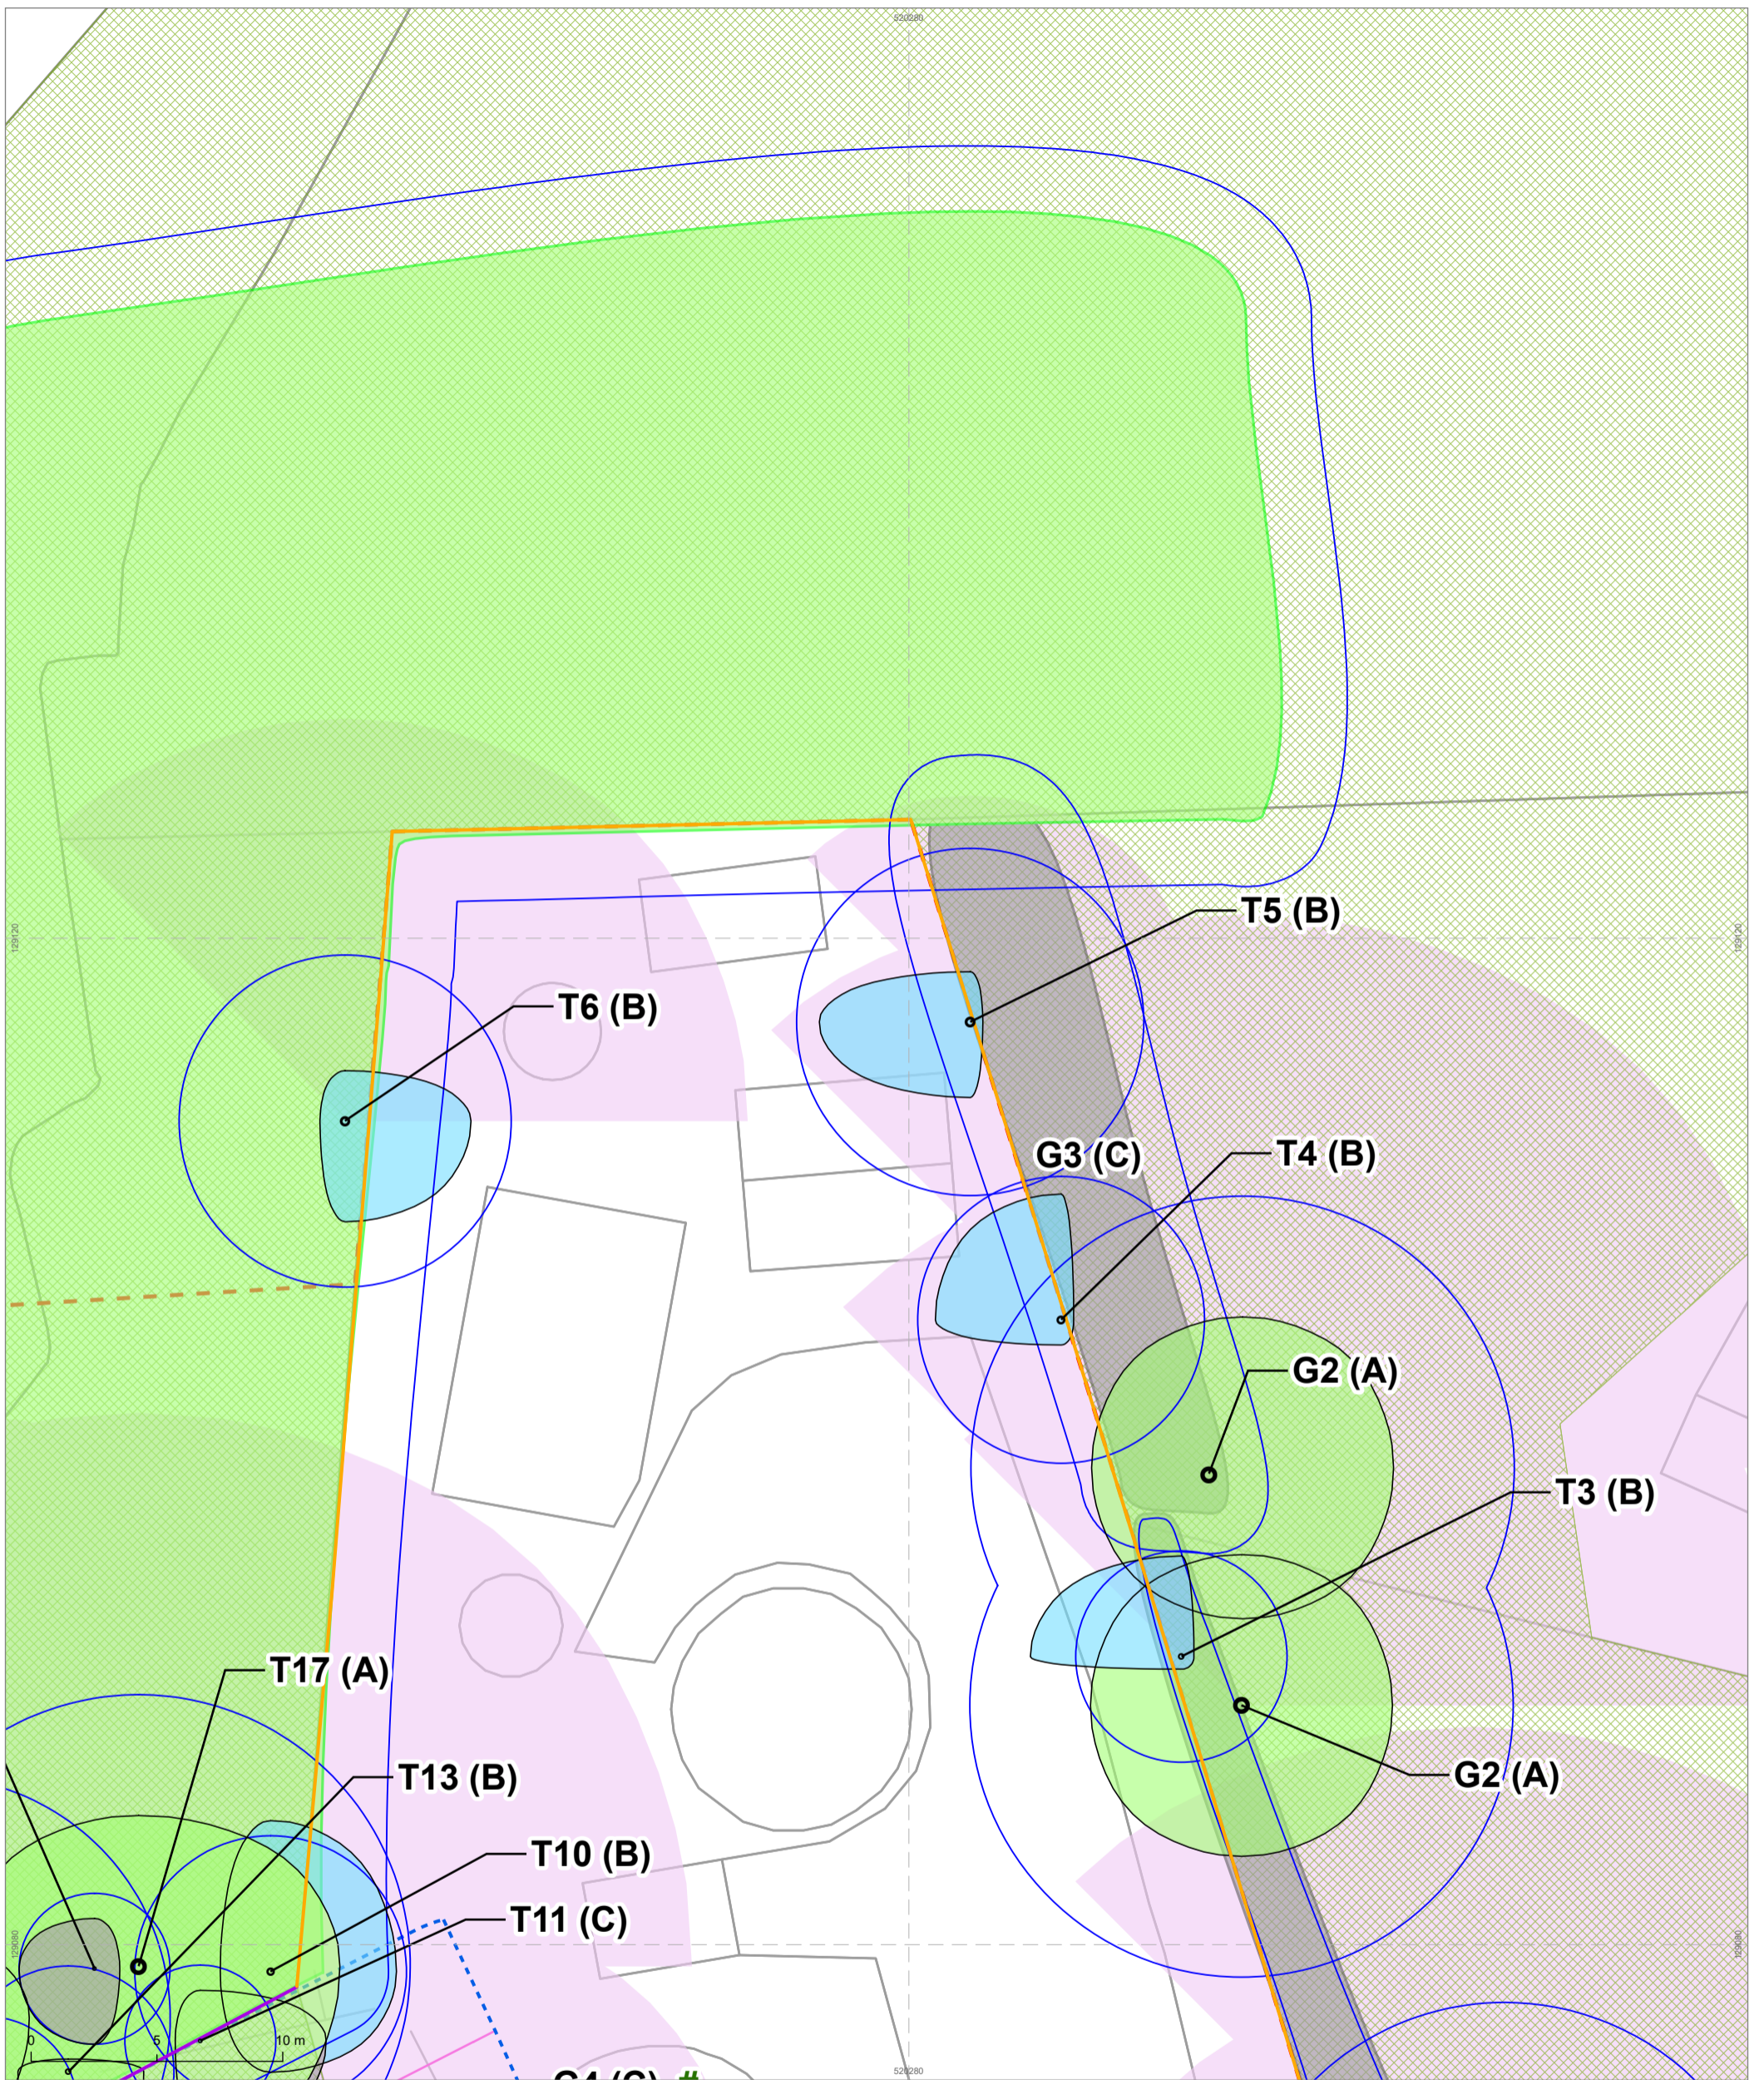
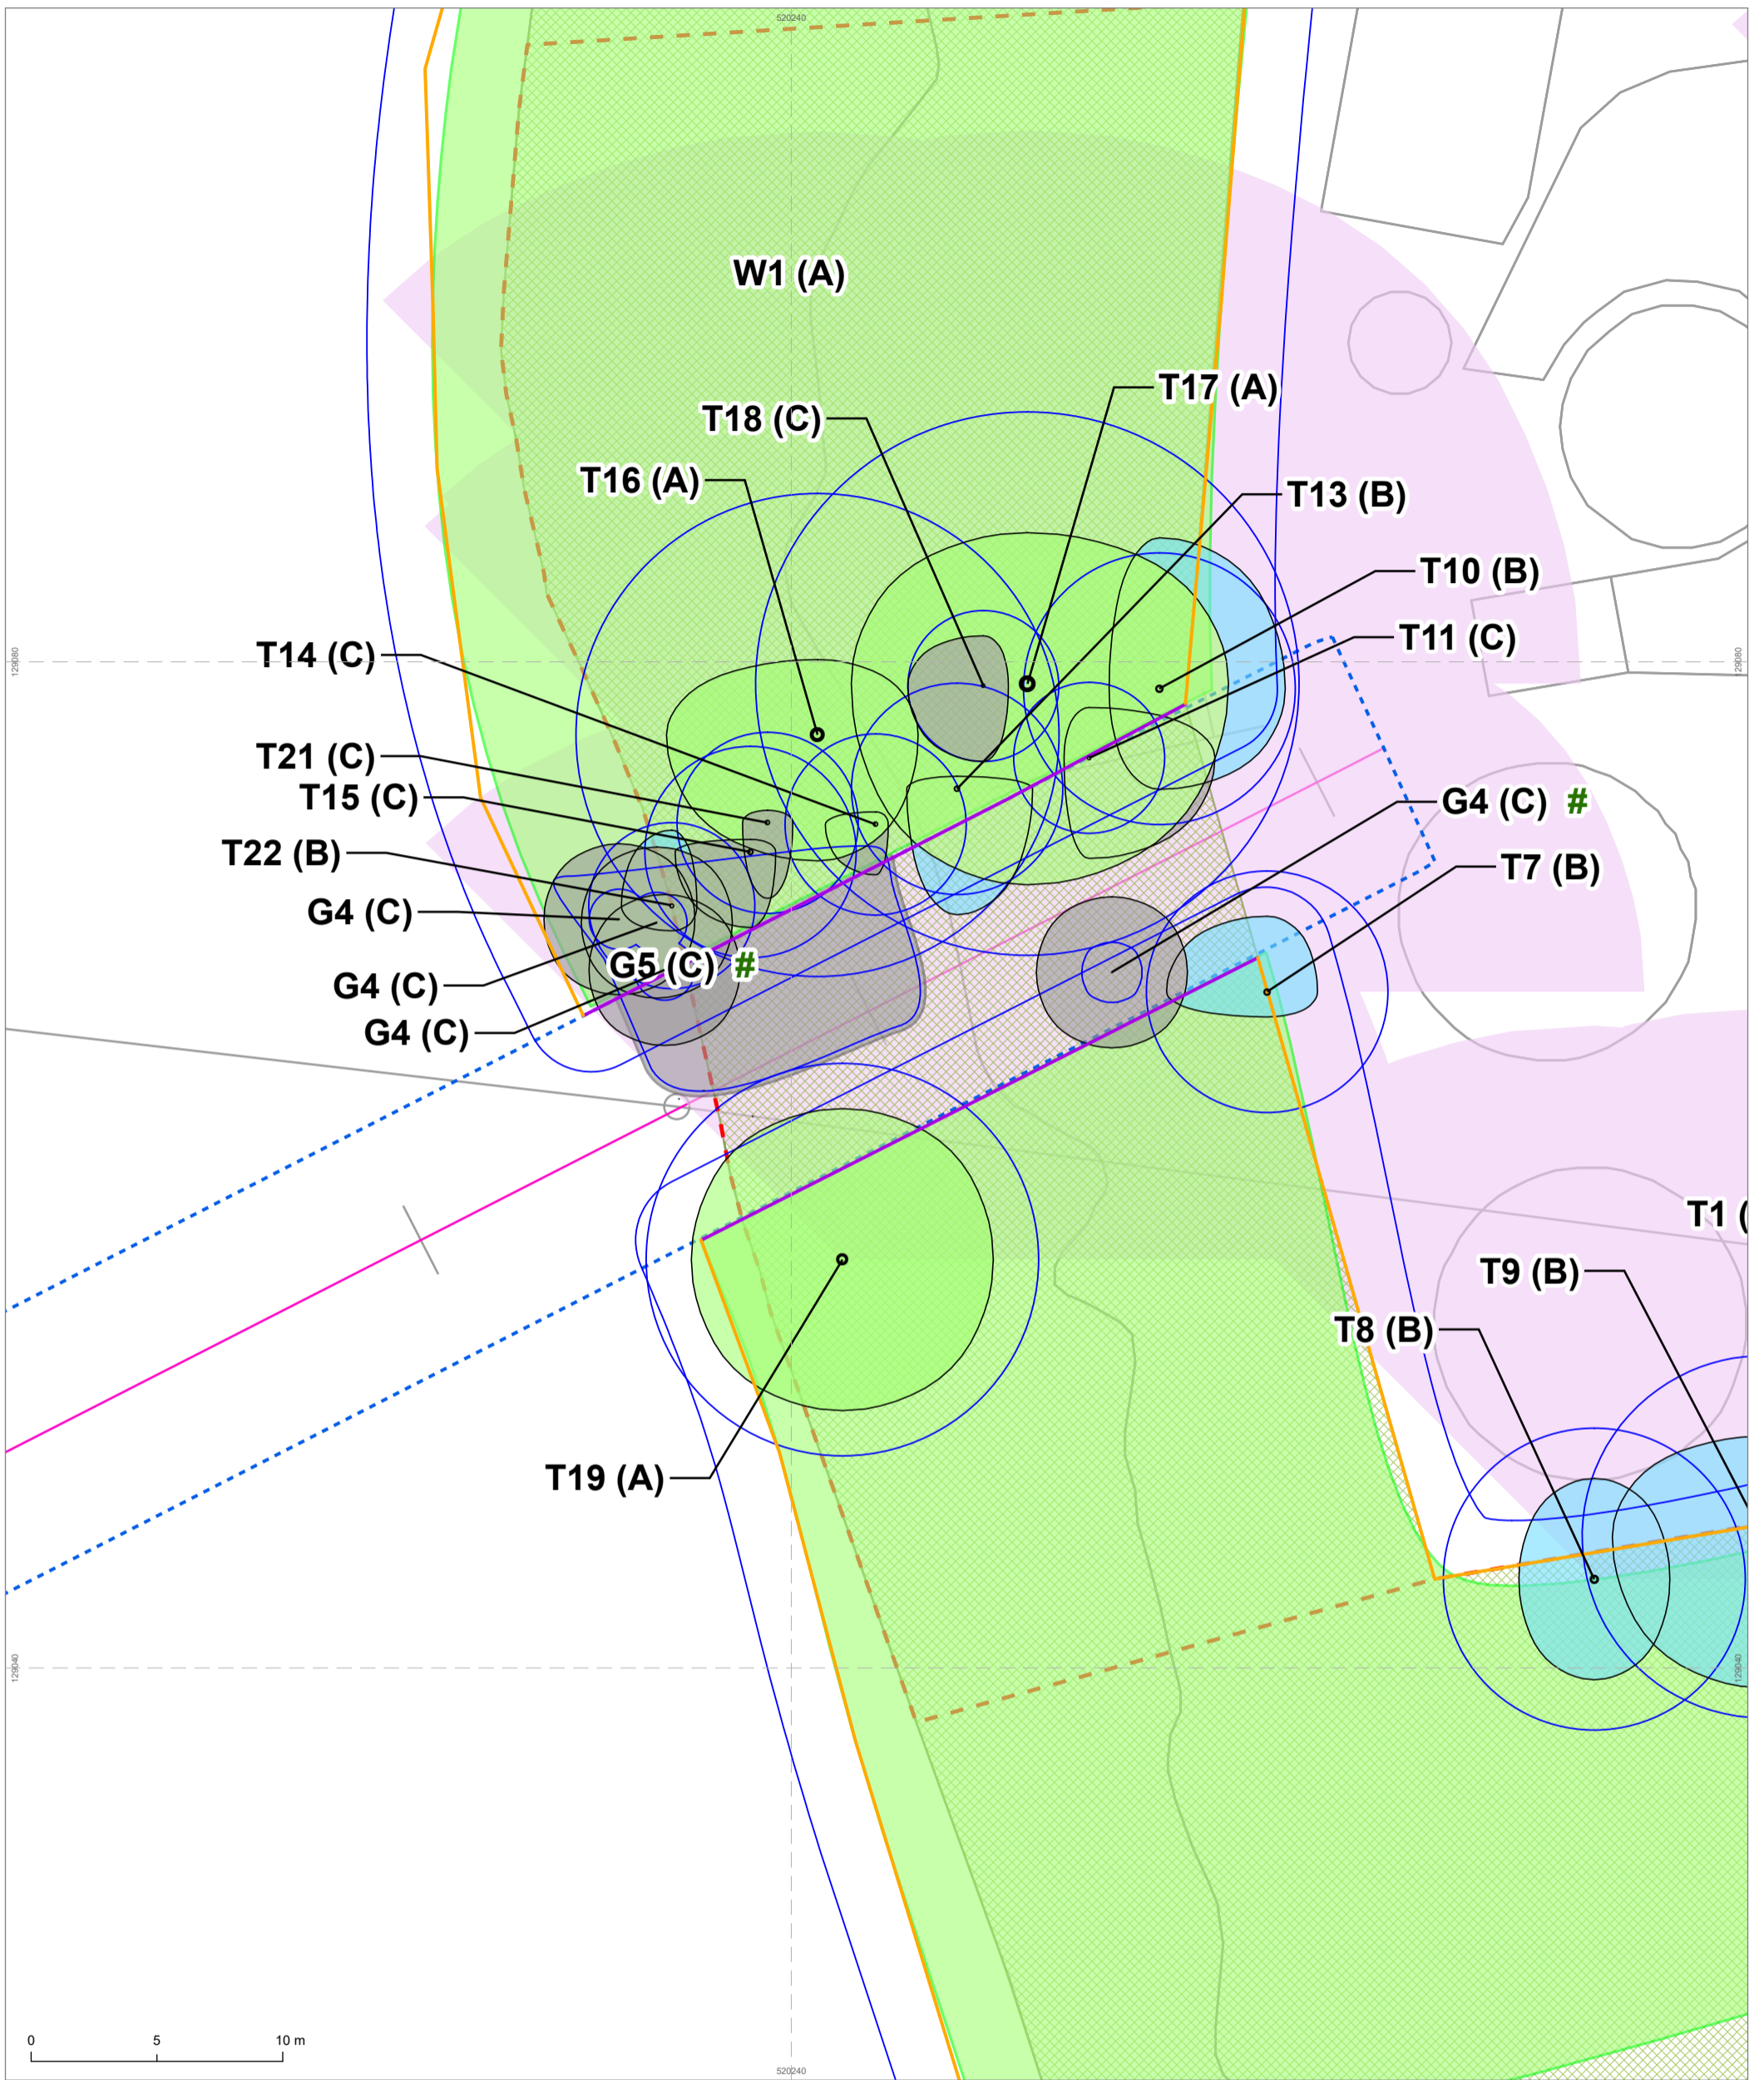
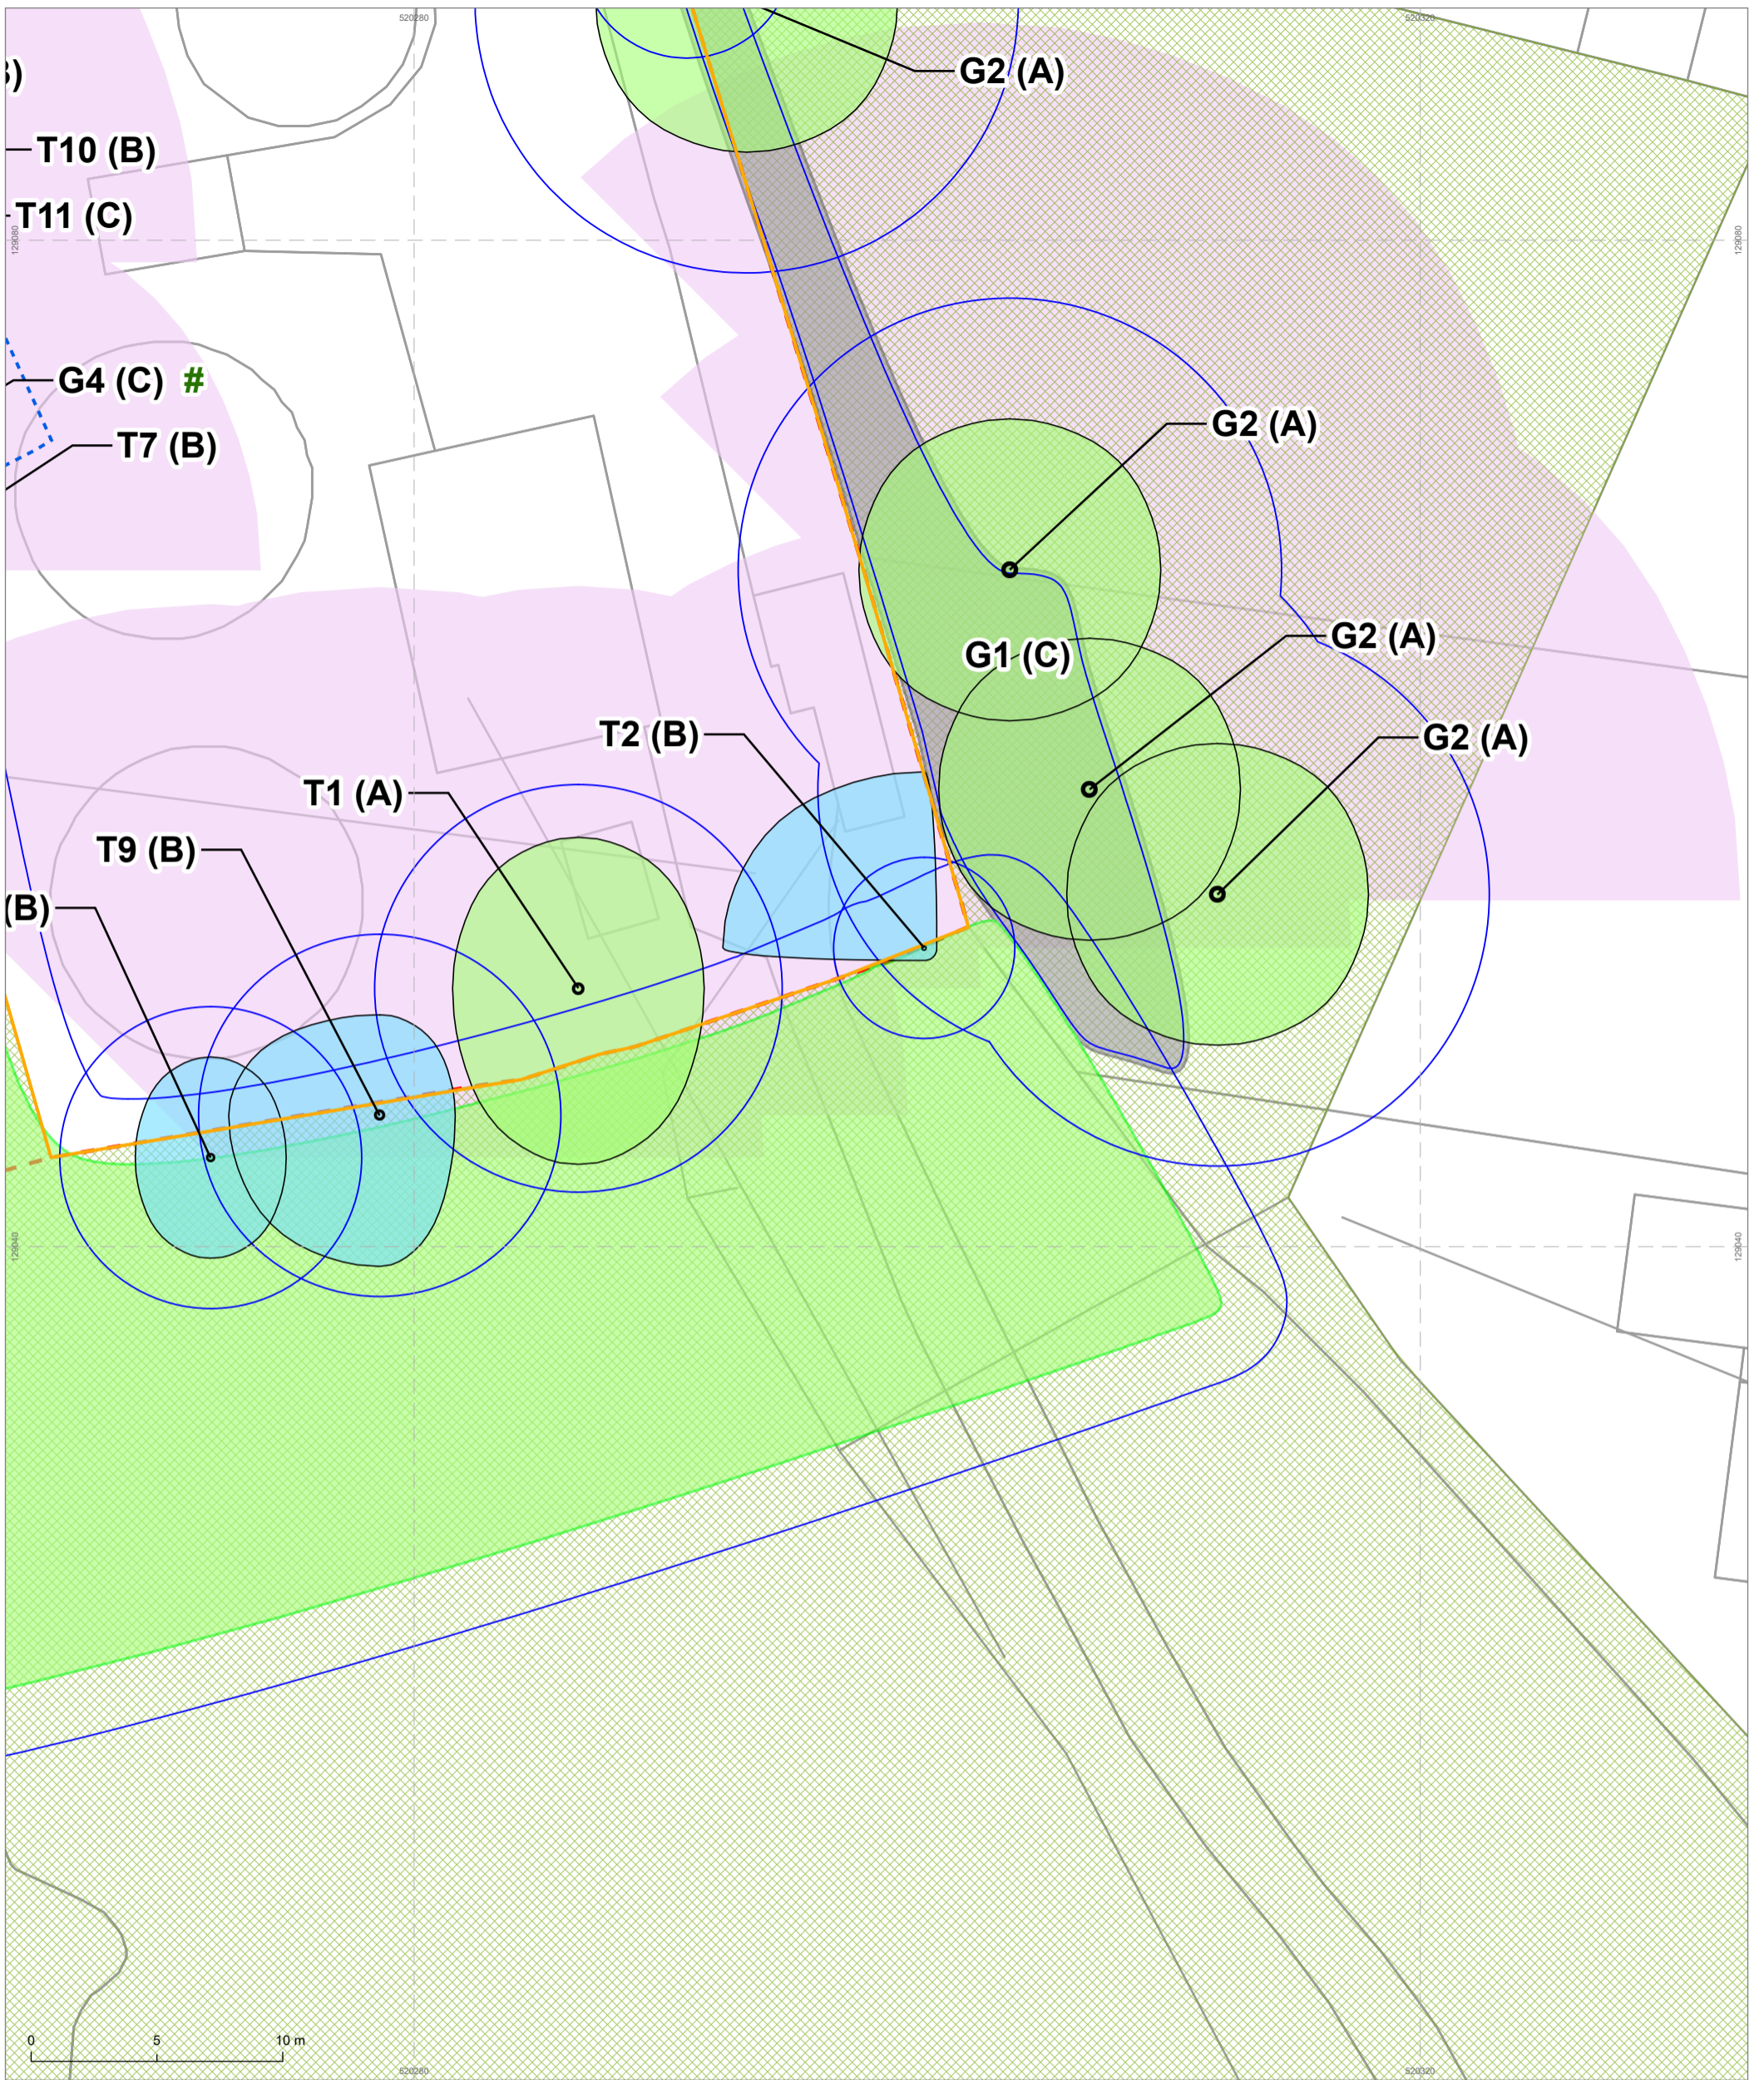
- Barrier tape to be utilised to define Construction Exclusion Zone (CEZ)
- Existing fence to act as tree protection barrier
- Stem location and diameter
- Category A
- Category B
- Category C
- Current canopy - to be retained
- Root Protection Area
- Indicative shadow
- Ancient woodland
- 10 m easement
- Proposed pipeline route
- Survey extent
- Tree coppicing works required

Project Mannings Heath WTW, Birch Grove, Horsham	
Drawing <b>Tree Protection Plan</b>	
Client The Clancy Group	
Drawing Number C159801-03-01	Revision Rev-A
Scale @ A3 1:250	Date October 2023
Approved By LW	Drawn By AW/KB
Triumph House, Birmingham Road, Allesley, Coventry CV5 9AZ T:01676 525880 E:admin@middlemarch-environmental.com	
<small>This map is reproduced from the Ordnance Survey material with the permission of Ordnance Survey on behalf of The Controller of Her Majesty's Stationary Office. © Crown copyright. Unauthorised reproduction infringes Crown copyright and may lead to prosecution or civil proceedings. Licence Number: 100040519</small>

Protective barriers will be positioned where possible to define the Construction Exclusion Zone. It should be noted that due to site specific constraints a combination of existing fencing and the installation of barrier tape will be used to demark and establish the CEZ which will be monitored

by the Project Arboriculturist. Signs will be installed on the barriers to inform site contractors of the importance of the tree protection measures and no works that cause physical damage to retained trees, compaction of the soil or severance of tree roots will occur within any exclusion zone. The extent of the CEZ encompasses the Root Protection Area (RPA) and / or tree canopy where possible.

The construction of the proposed pipe bridge will require foundation construction within the RPAs of trees T17 and T19, both English oak trees located on the ravine edges outside of the proposed easement area. Temporary tree protection fencing will be required during the works in addition to arboricultural supervision and appropriate working methodology in accordance with BS5837.

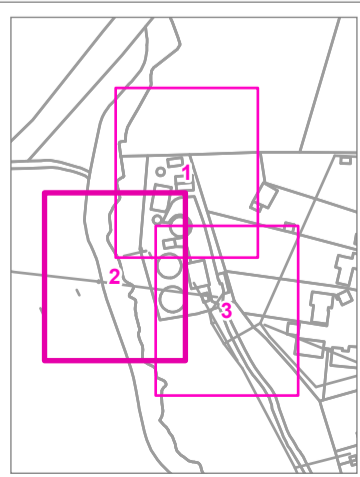
- Barrier tape to be utilised to define Construction Exclusion Zone (CEZ)
- Existing fence to act as tree protection barrier
- Stem location and diameter
- Category A
- Category B
- Category C
- Current canopy - to be retained
- Root Protection Area
- Indicative shadow
- Ancient woodland
- 10 m easement
- Proposed pipeline route
- Survey extent
- # Tree coppicing works required

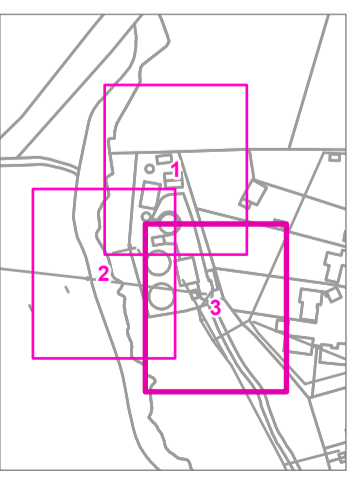
- Barrier tape to be utilised to define Construction Exclusion Zone (CEZ)
- Existing fence to act as tree protection barrier
- Stem location and diameter
- Category A
- Category B
- Category C
- Current canopy - to be retained
- Root Protection Area
- Indicative shadow
- Ancient woodland
- 10 m easement
- Proposed pipeline route
- Survey extent
- # Tree coppicing works required

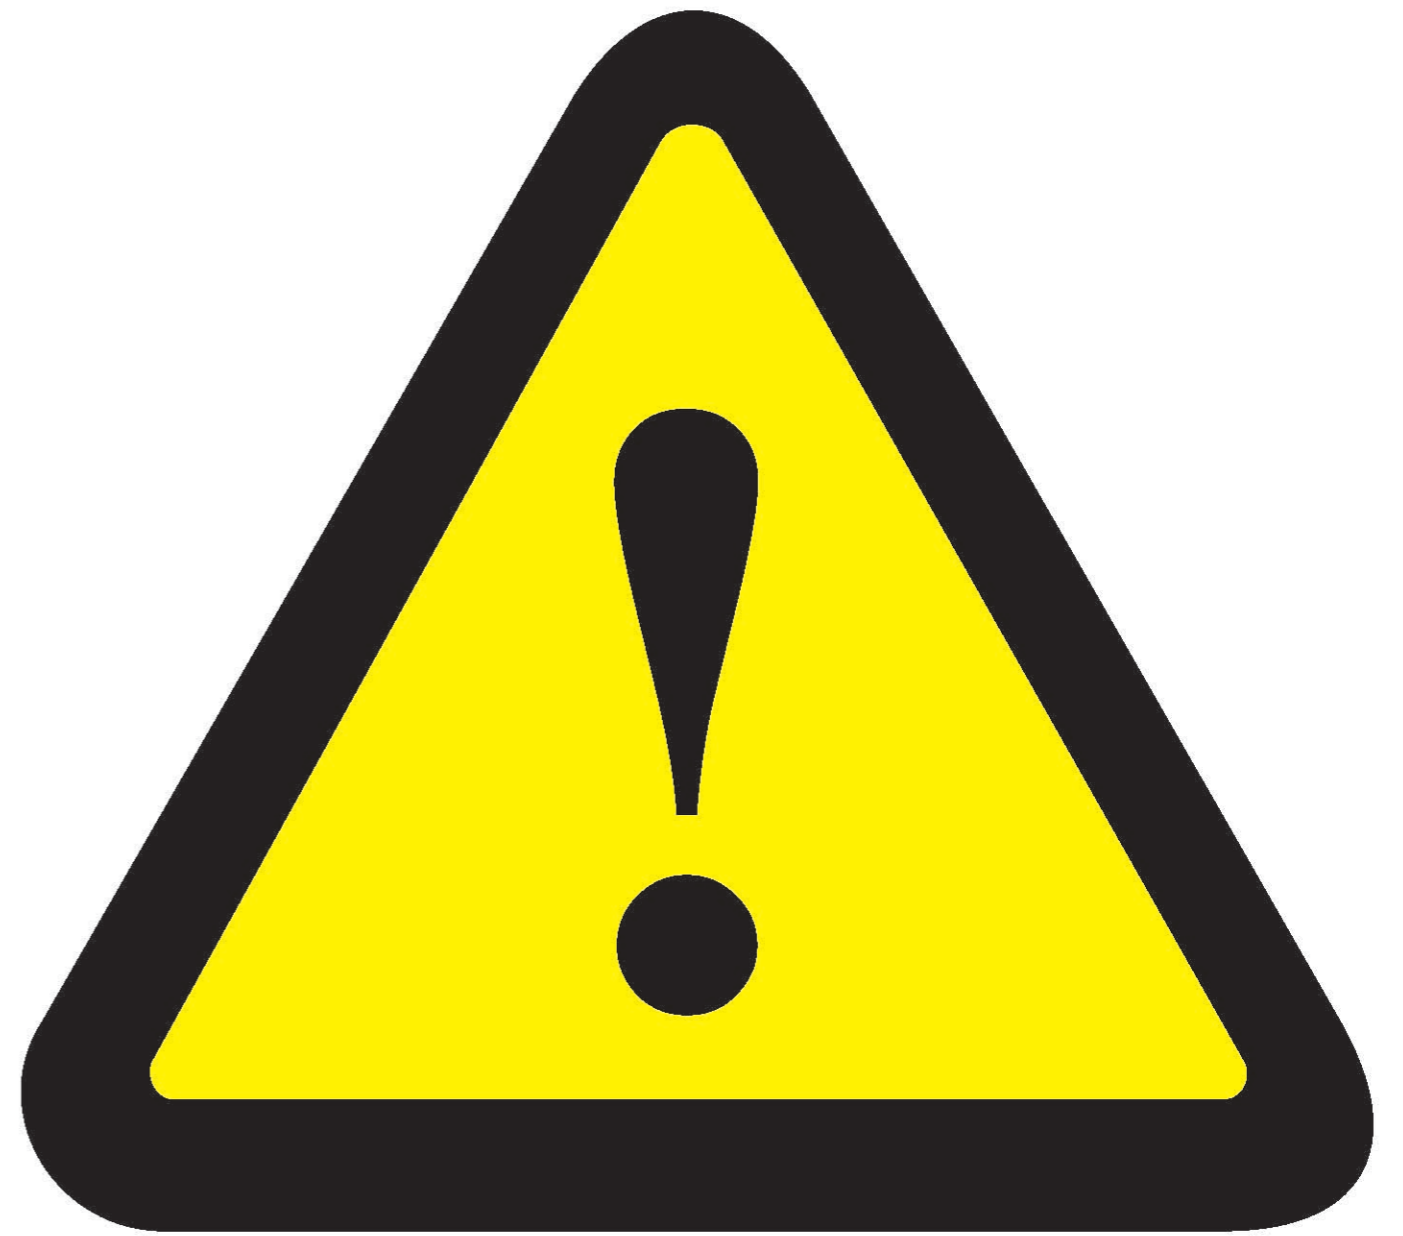
**PROTECTIVE FENCING. THIS FENCING MUST BE MAINTAINED IN ACCORDANCE WITH THE APPROVED PLANS AND DRAWINGS FOR THIS DEVELOPMENT.**

**TREE PROTECTION AREA  
KEEP OUT !**

**(TOWN & COUNTRY PLANNING ACT 1990)  
TREES ENCLOSED BY THIS FENCE ARE PROTECTED BY PLANNING CONDITIONS AND/OR ARE THE SUBJECTS OF A TREE PRESERVATION ORDER.  
CONTRAVENTION OF A TREE PRESERVATION ORDER MAY LEAD TO CRIMINAL PROSECUTION**
