ROCK COMMON QUARRY
The Hollow, Washington RH20 3DA

PLANNING AND ENVIRONMENTAL STATEMENT
VOLUME 2
PART 1

ENVIRONMENTAL REPORTS AND IMPACT ASSESSMENTS

Landscape and Visual Impact Assessment

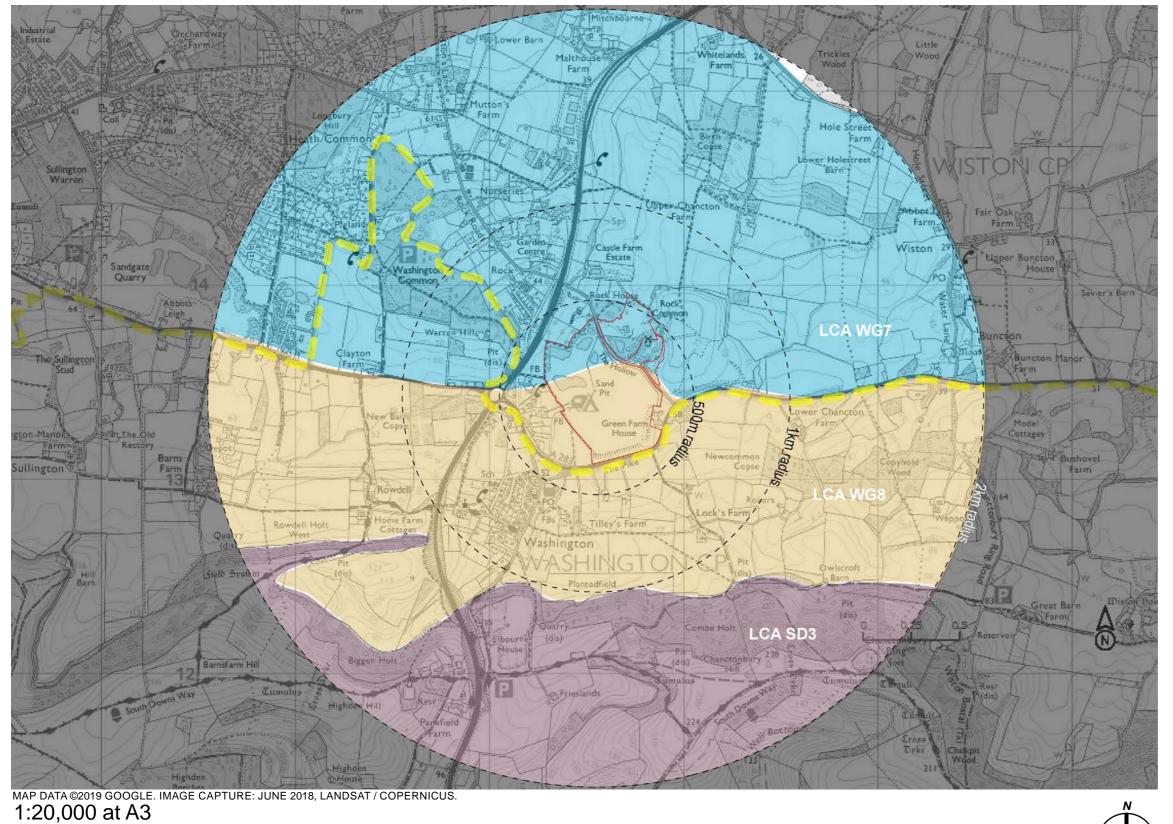
Figure 5.1. West Sussex Landscape

Legend Site Boundary. South Downs National Park, (south of the dashed yellow line). Landscape Character Assessment of West Sussex (2003): Storrington Woods and Heaths, (LCA WG7). Central Scarp Footslopes, (LCA WG8). Central Downs, (LCA SD3).

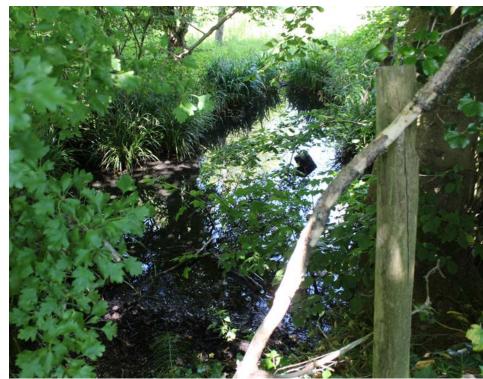
Photograph A. Wetted, upper channel of the Honeybridge Stream, viewed south from Public Footpath No. 2089, (Location shown on **Figure 6.1**).

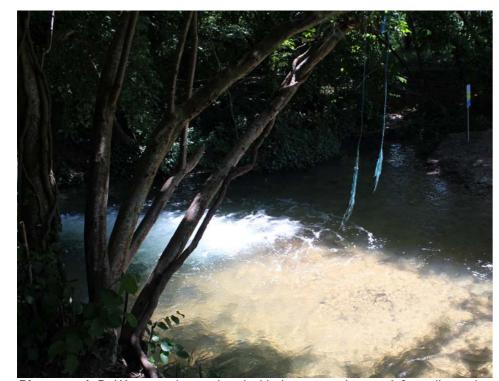
Photograph D. Water pool associated with the pumped water, informally made into a recreational play space by users of the Washington Caravan & Camping Park.

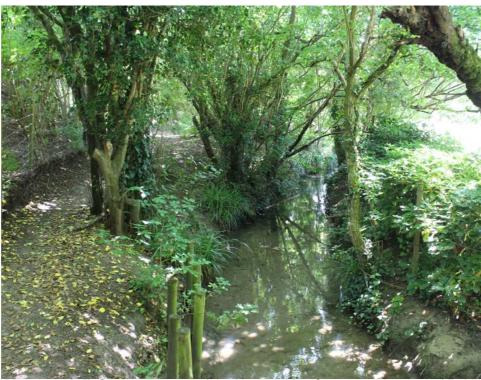
Photograph E. Sunken channel of the Honeybridge Stream, to the west of Public Footpath No. 2700, east of the Washington Caravan & Camping Park.

- 6.17 The stream continues within a sunken channel along the eastern edge of the campground, west of Public Footpath No. 2701, (see **Photograph E**) along the western edge of the Site.

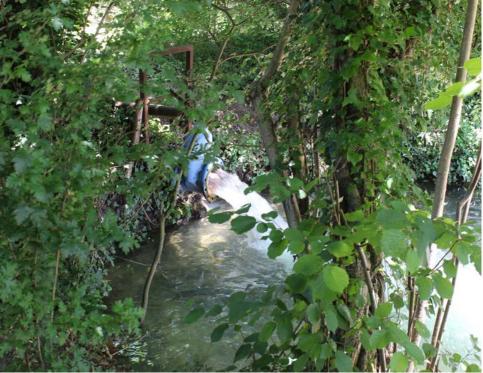
Photograph C. Sunken channel of the Honeybridge Stream, to the west of Public Footpath No. 2700, contributed to by the pumped water discharged from that accumulated within the Rock Common Quarry bottom.

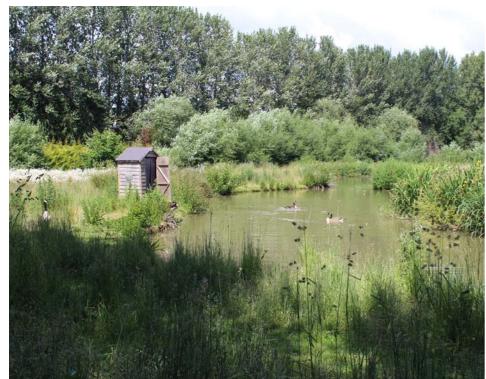
Photograph G. Private wetland area with ducks to the north of Sandhill Farmhouse from Public Footpath No. 2700, surrounded by grey poplar trees.

- 6.18 North of the short waterfall over the sill upstream of a footbridge crossing of the Honeybridge Stream, (for Public Footpath No. 2700), (see **Photograph F**) the water from the stream accumulates within a private wetland area to the north of Sandhill Farmhouse, (see **Photograph G**).

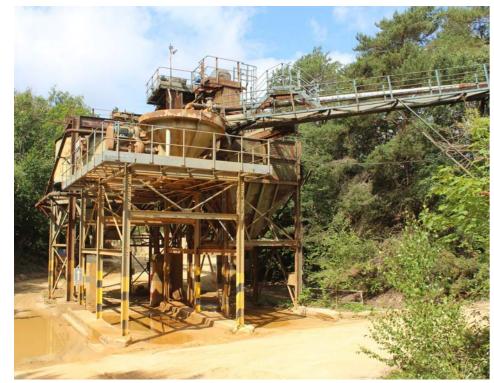
Photograph C7. Westerly view of sand processing machinery.

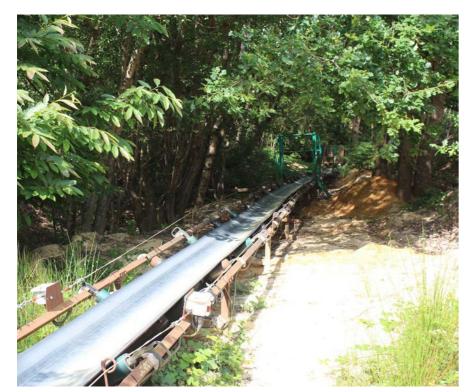
Photograph C10. Conveyor, east of the tunnel under The Hollow.

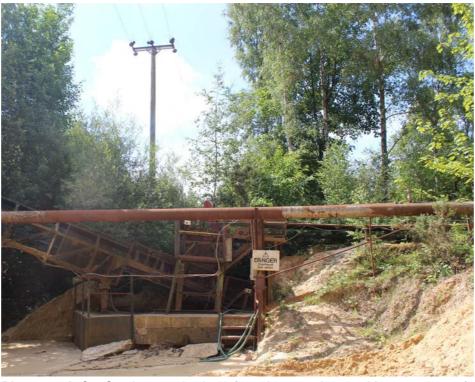
Photograph C8. South westerly view of sand processing machinery, to west of the conveyor.

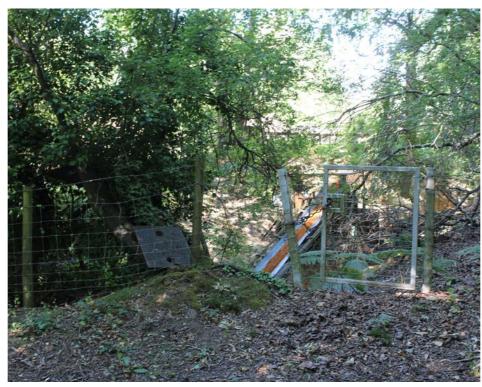
Photograph C11. Easterly view of the conveyor, glimpsed from the edge of The Hollow.

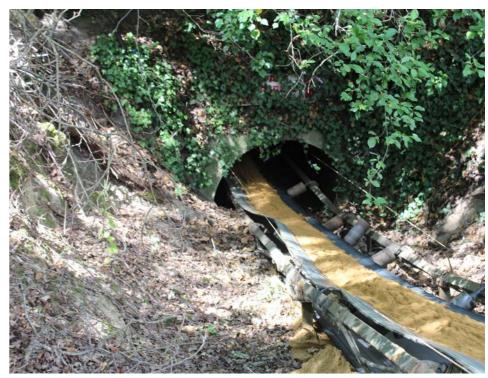
Photograph C9. Point at which the conveyor runs within a tunnel under The Hollow

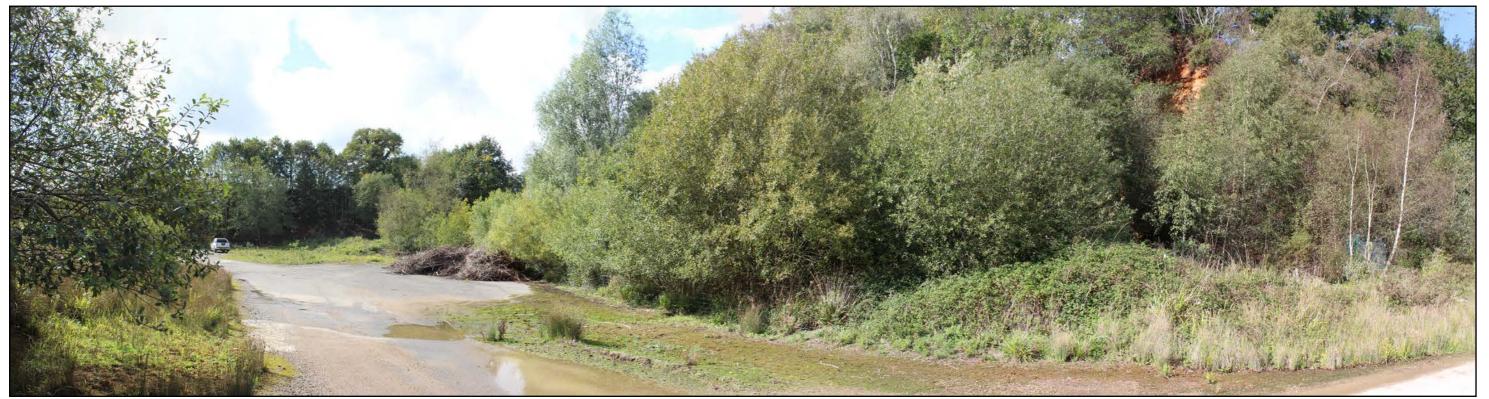
Photograph C19a - South westerly view towards a ponded area, (see Photo C21) inset within the wooded cutting to the west of The Valley. Exposed rock face is apparent to the cliffed western edge of The Valley.

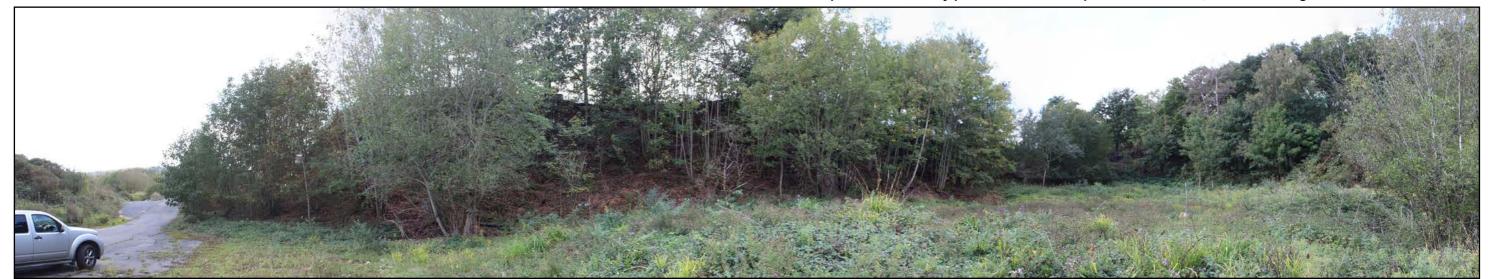
Photograph C21b - South westerly view of an excavated area to the south west of the Site, which is fringed with trees and includes an elevated concrete platform.

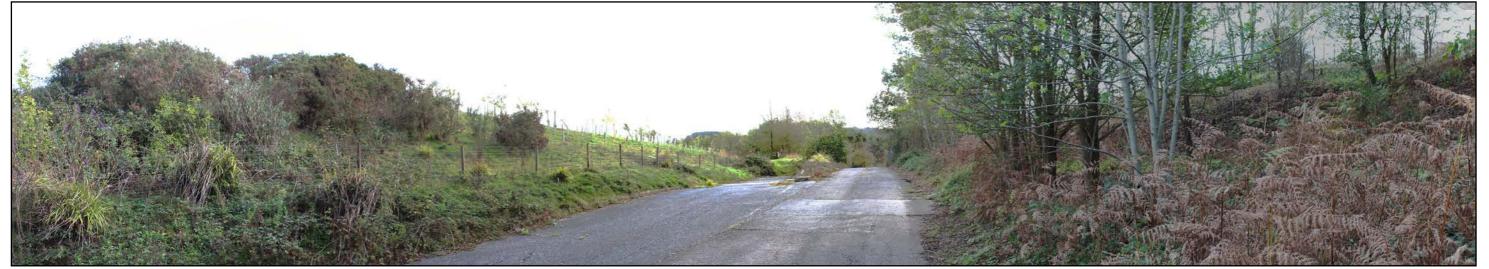
Photograph C22 - South easterly view towards the access rising out to the south of The Valley, where a siding can be seen to left of view.

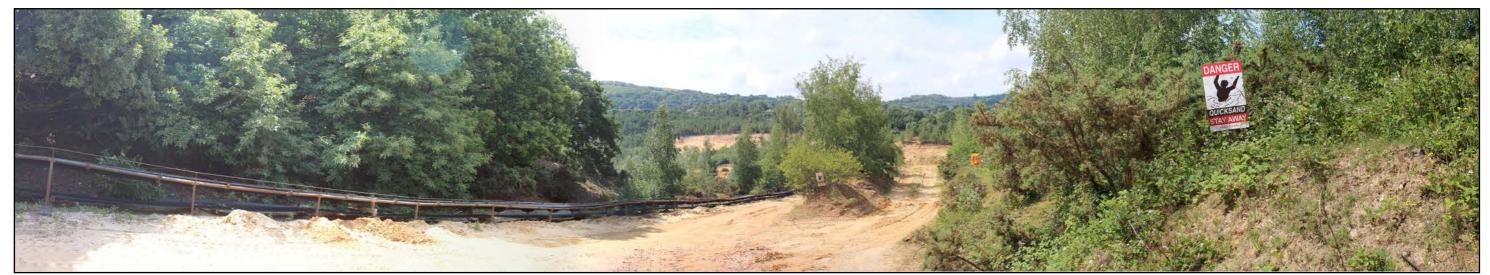
Photograph D1 - South westerly view along the conveyor towards the distant sculptural ridge of the South Downs escarpment about Chanctonbury Hill.

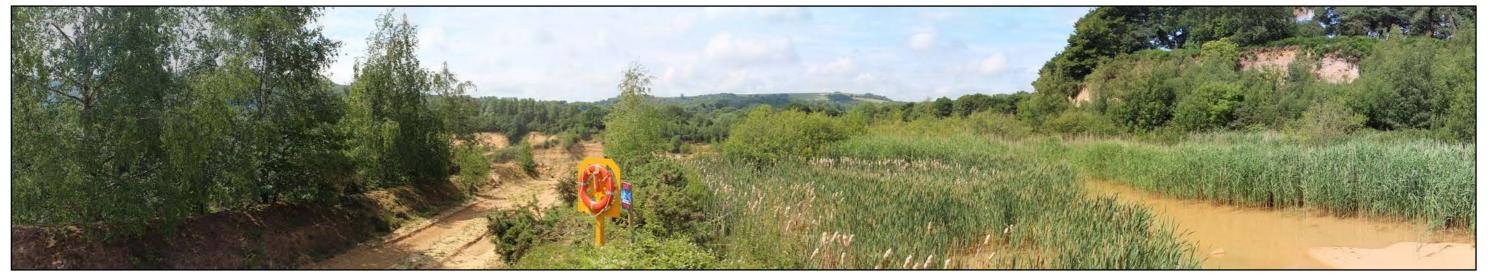
Photograph D2 - South westerly view along a western aligned track, which terminates further to the west adjacent to a perched pond with reedbed, beyond which Barnsfarm Hill can be seen.

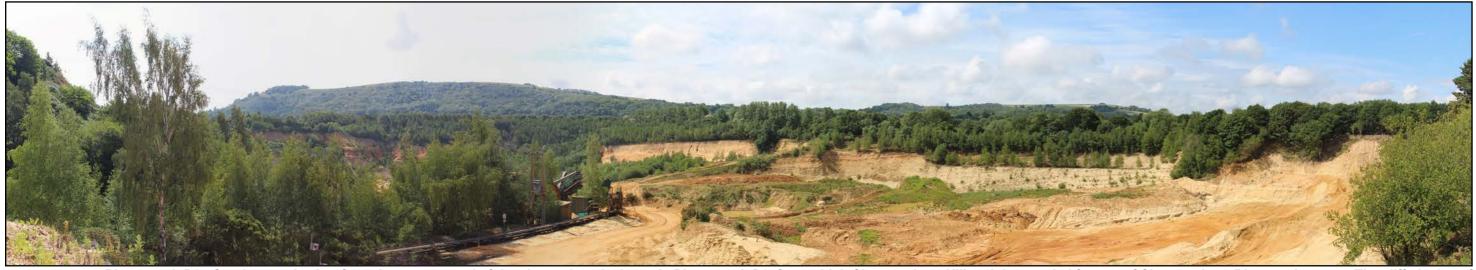
Photograph D3 - South easterly view from the western end of the elevated track shown in Photograph D2, from which Chanctonbury Hill and the wooded feature of Chanctonbury Ring can be seen. The cliffed edge of the quarry.

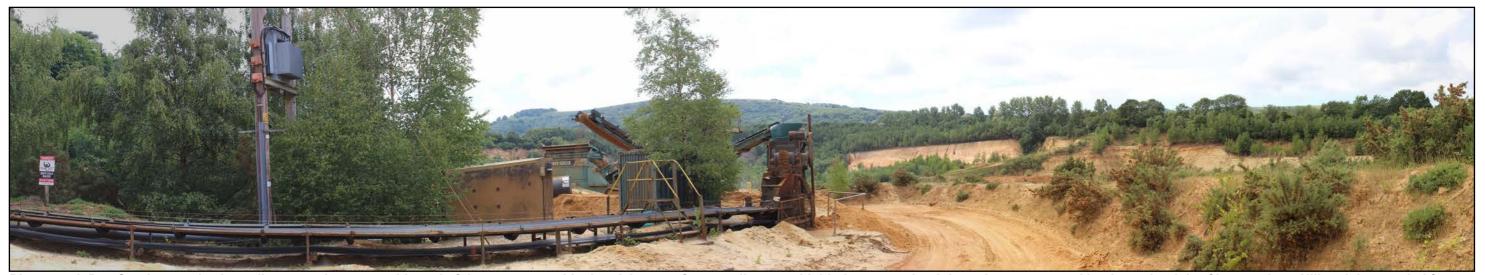
Photograph D4 - South easterly view adjacent to the quarry side end of the conveyor, with electricity transformer adjacent, with birch trees to the right and gorse on sand banks to the right. Chanctonbury Hill and the wooded feature of Chanctonbury Ring can be seen. The cliffed edge of the quarry can be seen to the west of the quarry.

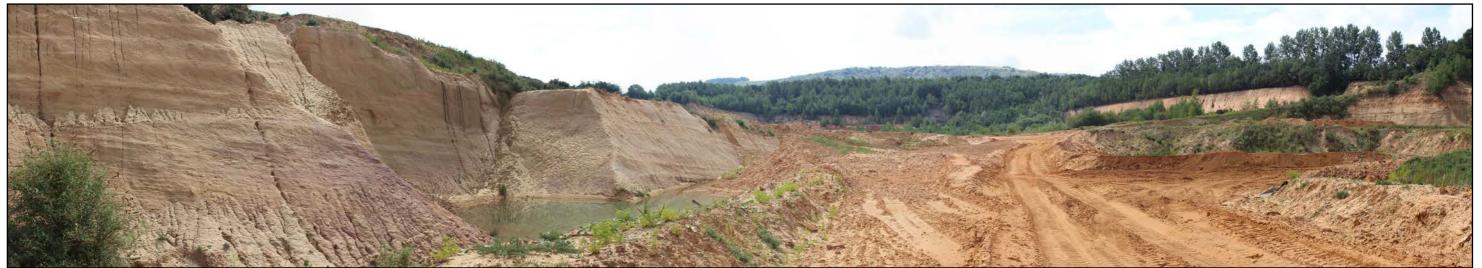
Photograph D6 - Southerly view from within sunken landform to the north west of the Site, with poplar tree line atop the western cliff face.

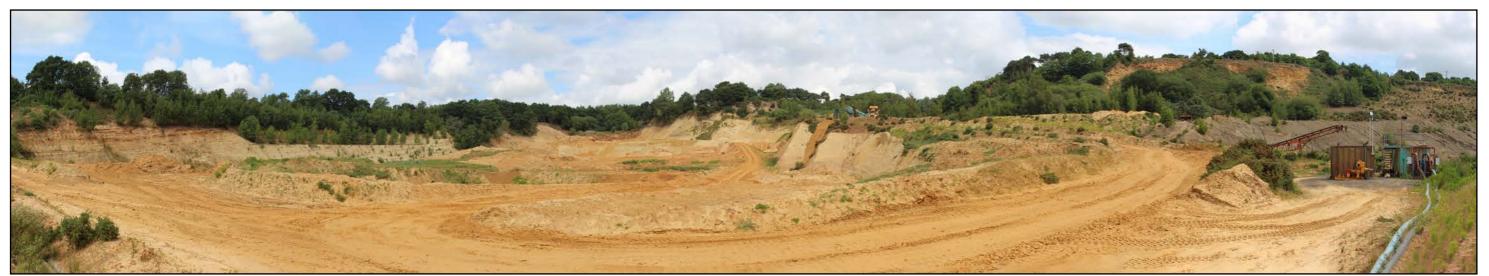
Photograph D7 - North westerly view towards the north western end of the quarry, with elevated remnant landform to the right of view, (which would have continued across the centre of view originally).

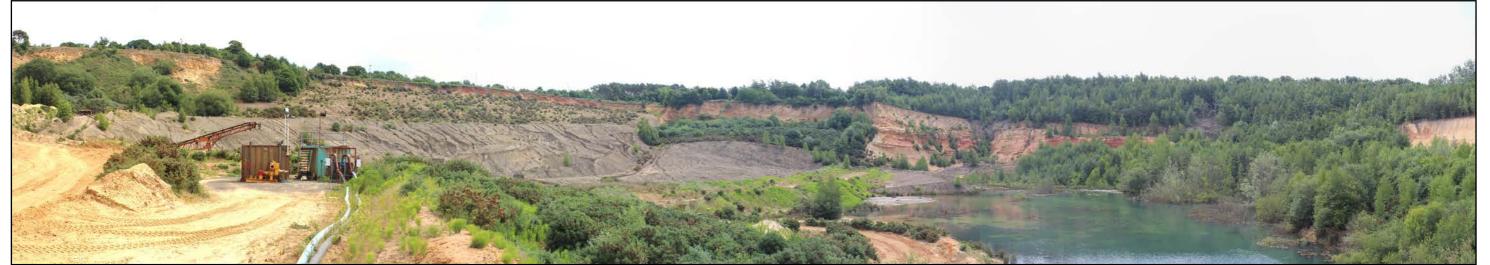
Photograph D8 - South easterly view into the lake about the 10m aOD level, within the southern part of the Site, south of which 40m high exposures extend towards a coniferous woodland fringe about the southern edge of the Site.

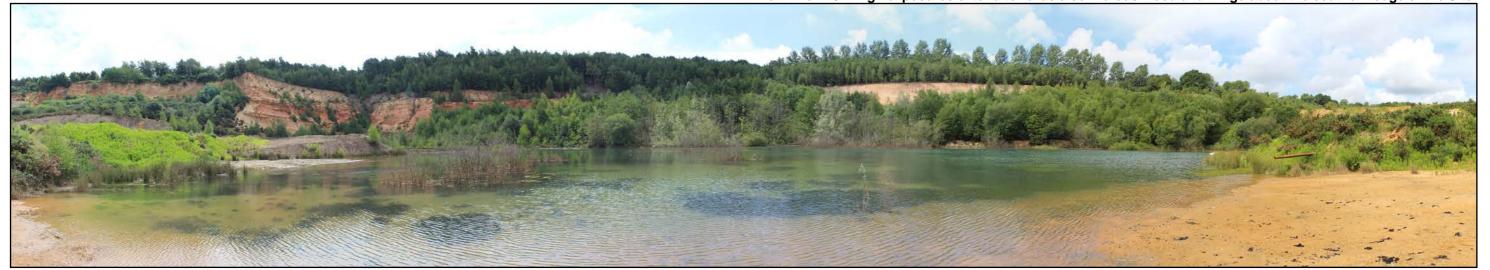
Photograph D9 - Southerly view from a sandy margin adjacent to the lake about the 10m aOD level, within the southern part of the Site, south of which 40m high exposures extend towards a coniferous woodland fringe about the southern edge of the Site.

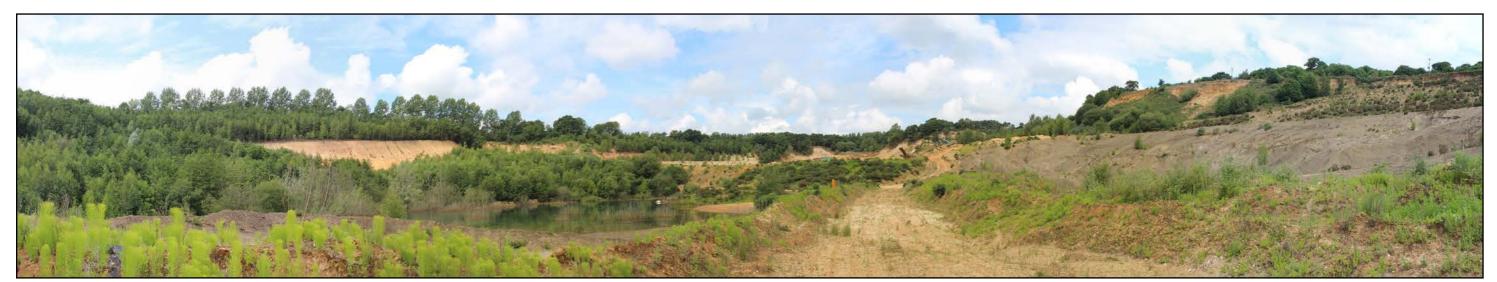
Photograph D10 - North westerly view from the south western end of the quarry site. The poplar tree line can be viewed to left above the quarry edge, whilst the elevated remnant landform to the right of view, (which would have continued across the centre of view originally).can be seen, forming the high point.

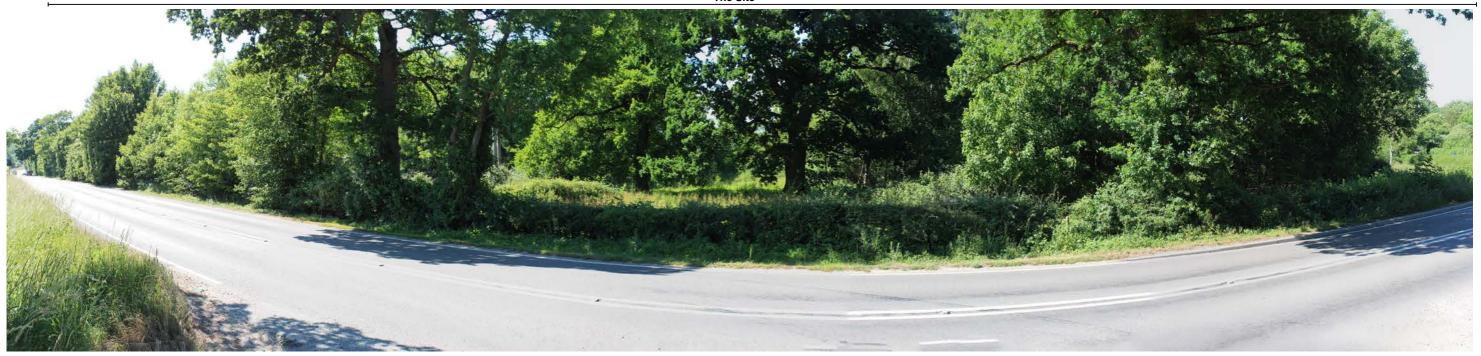
Weather: Clear weather conditions Lighting Conditions: Good visibility Approximate Ground Level: 55 metres aOD Ordnance Survey Grid Coordinates: TQ 12833 13144 **Viewpoint No. 01**: North westerly representative view from the northern end of Public Bridleway No. 2703, adjacent to The Pike, (A283).

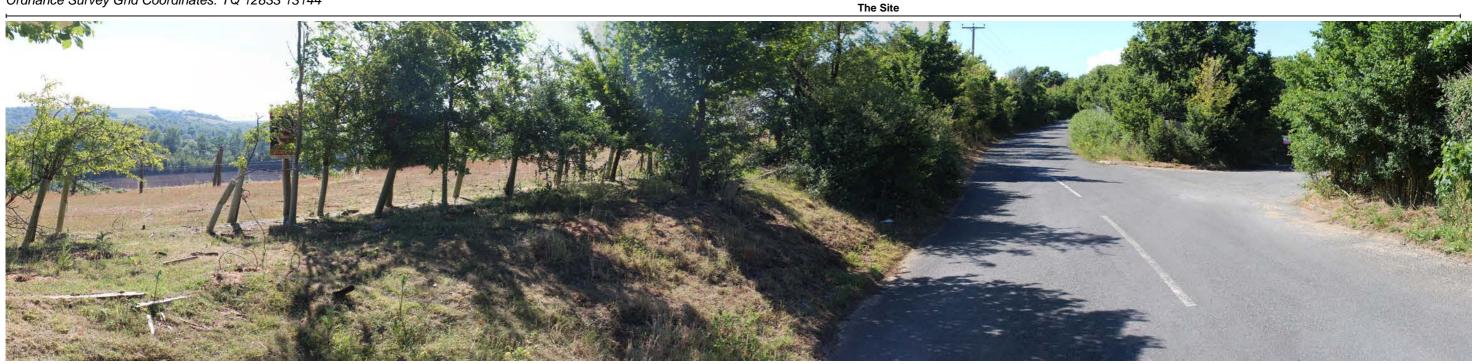
Approximate Ground Level: 65 metres aOD Ordnance Survey Grid Coordinates: TQ 12880 13455 **Viewpoint No. 02**: North westerly illustrative view from The Hollow adjacent to the entrance to the former municipal landfills known as Windmill, the Rock and the Rough.

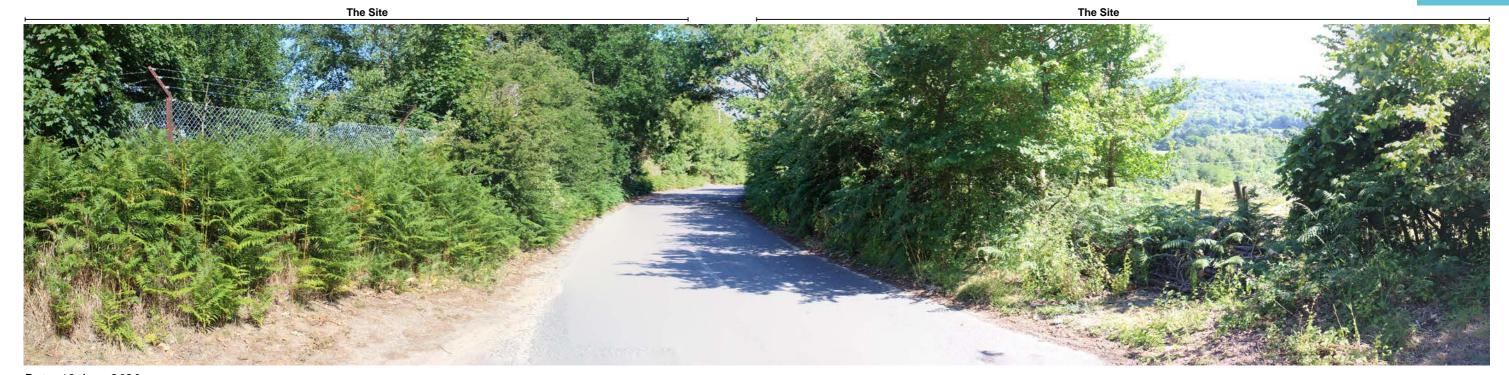
Weather: Clear weather conditions Lighting Conditions: Good visibility Approximate Ground Level: 70 metres aOD Ordnance Survey Grid Coordinates: TQ 12754 13587 **Viewpoint No. 03**: South easterly illustrative view from The Hollow adjacent to the southern end of the track / driveway to (Grade II Listed) Rock Windmill.

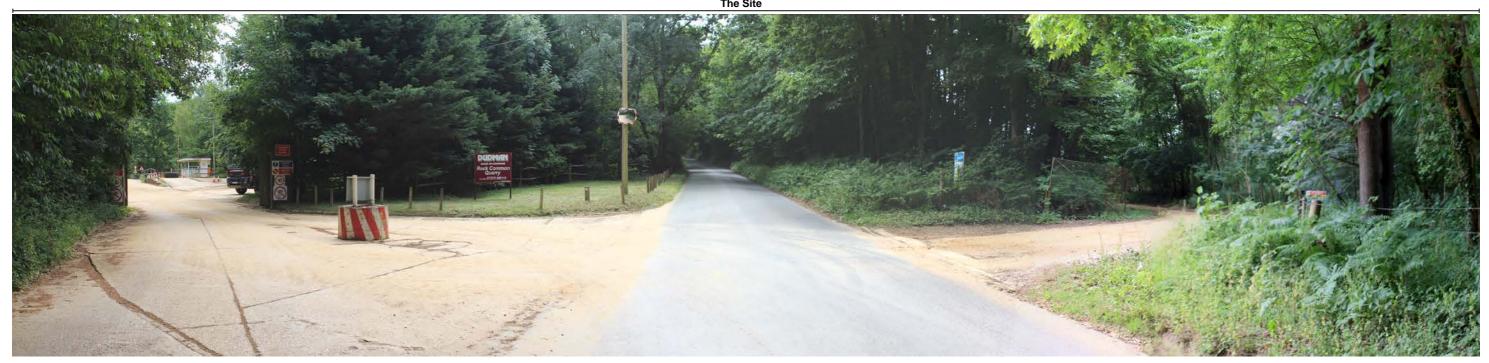
Weather: Clear weather conditions Lighting Conditions: Good visibility Approximate Ground Level: 55 metres aOD Ordnance Survey Grid Coordinates: TQ 12546 13819 **Viewpoint No. 05**: South easterly illustrative view from The Hollow adjacent to the access to the northern Site area (to left) and quarry (to right).

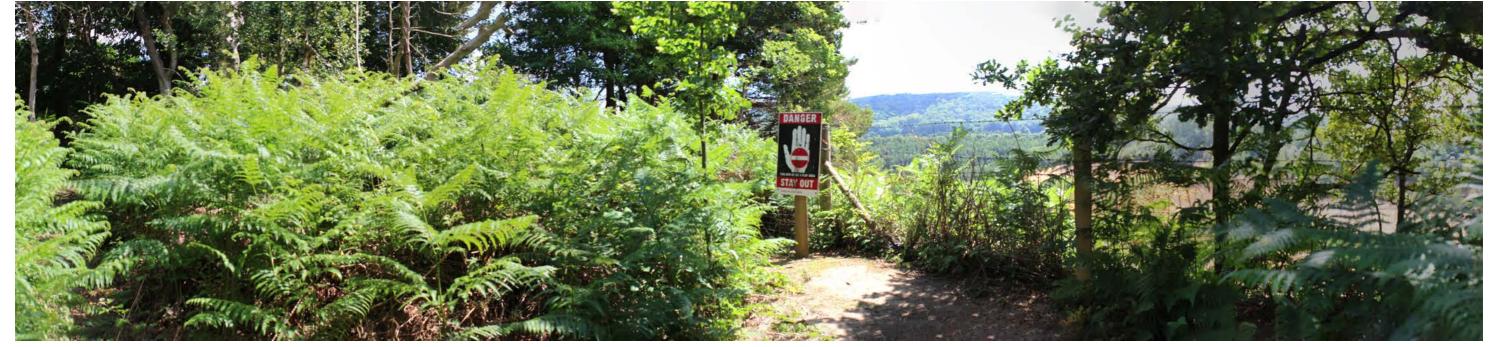
Approximate Ground Level: 55 metres aOD Ordnance Survey Grid Coordinates: TQ 12396 13681 **Viewpoint No. 12**: South easterly illustrative view from a break in vegetation along Public Footpath No. 2701. The landform of the chalk escarpment can be seen over the Site, about Chanctonbury Hill.

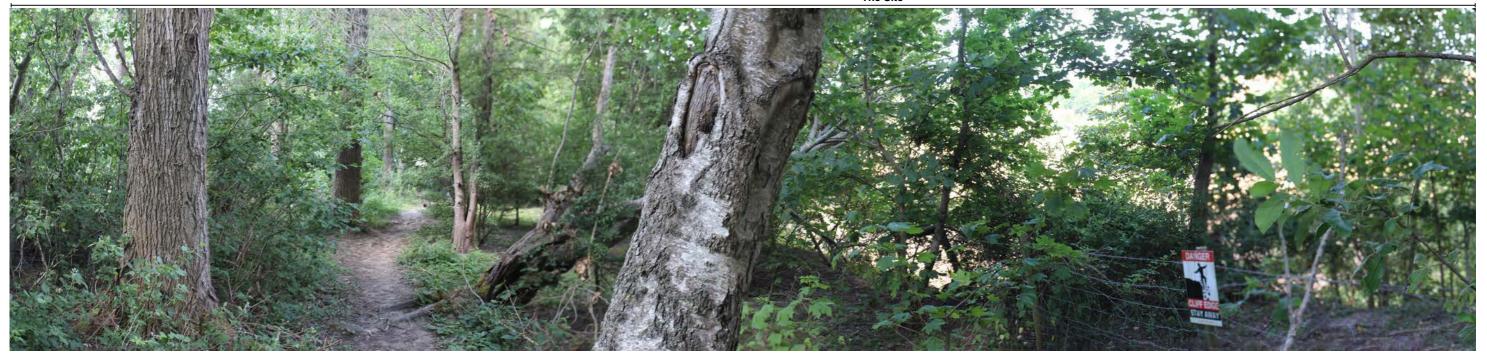
Approximate Ground Level: 50 metres aOD Ordnance Survey Grid Coordinates: TQ 12403 13317 **Viewpoint No. 16**: North easterly illustrative view from Public Footpath No. 2701 adjacent to the thin strip of vegetation along the clifftop of the quarry.

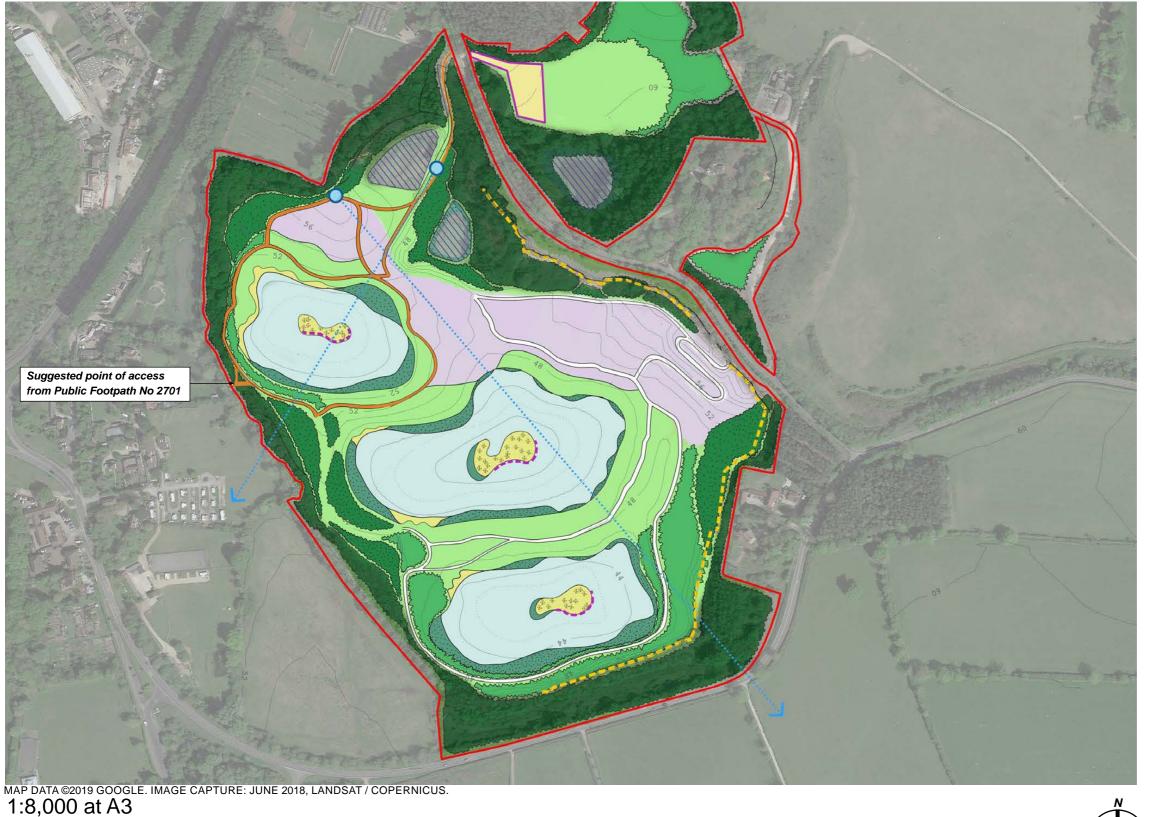
Legend Development Site Location. **Existing Broadleaved** Woodland - To be retained and enhanced. **Broadleaved Acid Woodland -**To be planted out. Native scrub planting - Self Lowland Heathland species to be targeted for establishment, further to trials early in phased Acid grassland establishment targeted with areas of bare ground left for natural succession to take place. Existing Standing water. Proposed Standing water. Marginal planting to areas of Gravel Islands created above standing water level to provide habitat for ground nesting Sand/Gravel 'Beach' areas to allow interaction with the waterside by visitors. Shallow vertical faces to be created using gabions or similar filled with rock and reclaimed material to provide additional sand Martin habitat. Soft Cliff faces to be retained as habitat to solitary bees. Any enhancement planting within the proximity should avoid these faces as well as sand Martin nesting sites found to the east. Footpaths for informal public Private use access for maintenance and habitat Retained hardstanding/site maintenance area Viewpoints from high ground across the Site to surrounding chalk escarpment landform including the wooded Figure 4.1. Landscape Masterplan

- 4.1 The Landscape Framework is structured through reference to the Design Principles identified within **Section 3.0** and informed by recommendations provided by The Ecology Co-op. These recommendations have been applied iteratively in the development of the final Site layout and presented within the Illustrative Landscape Masterplan produced by LLD.

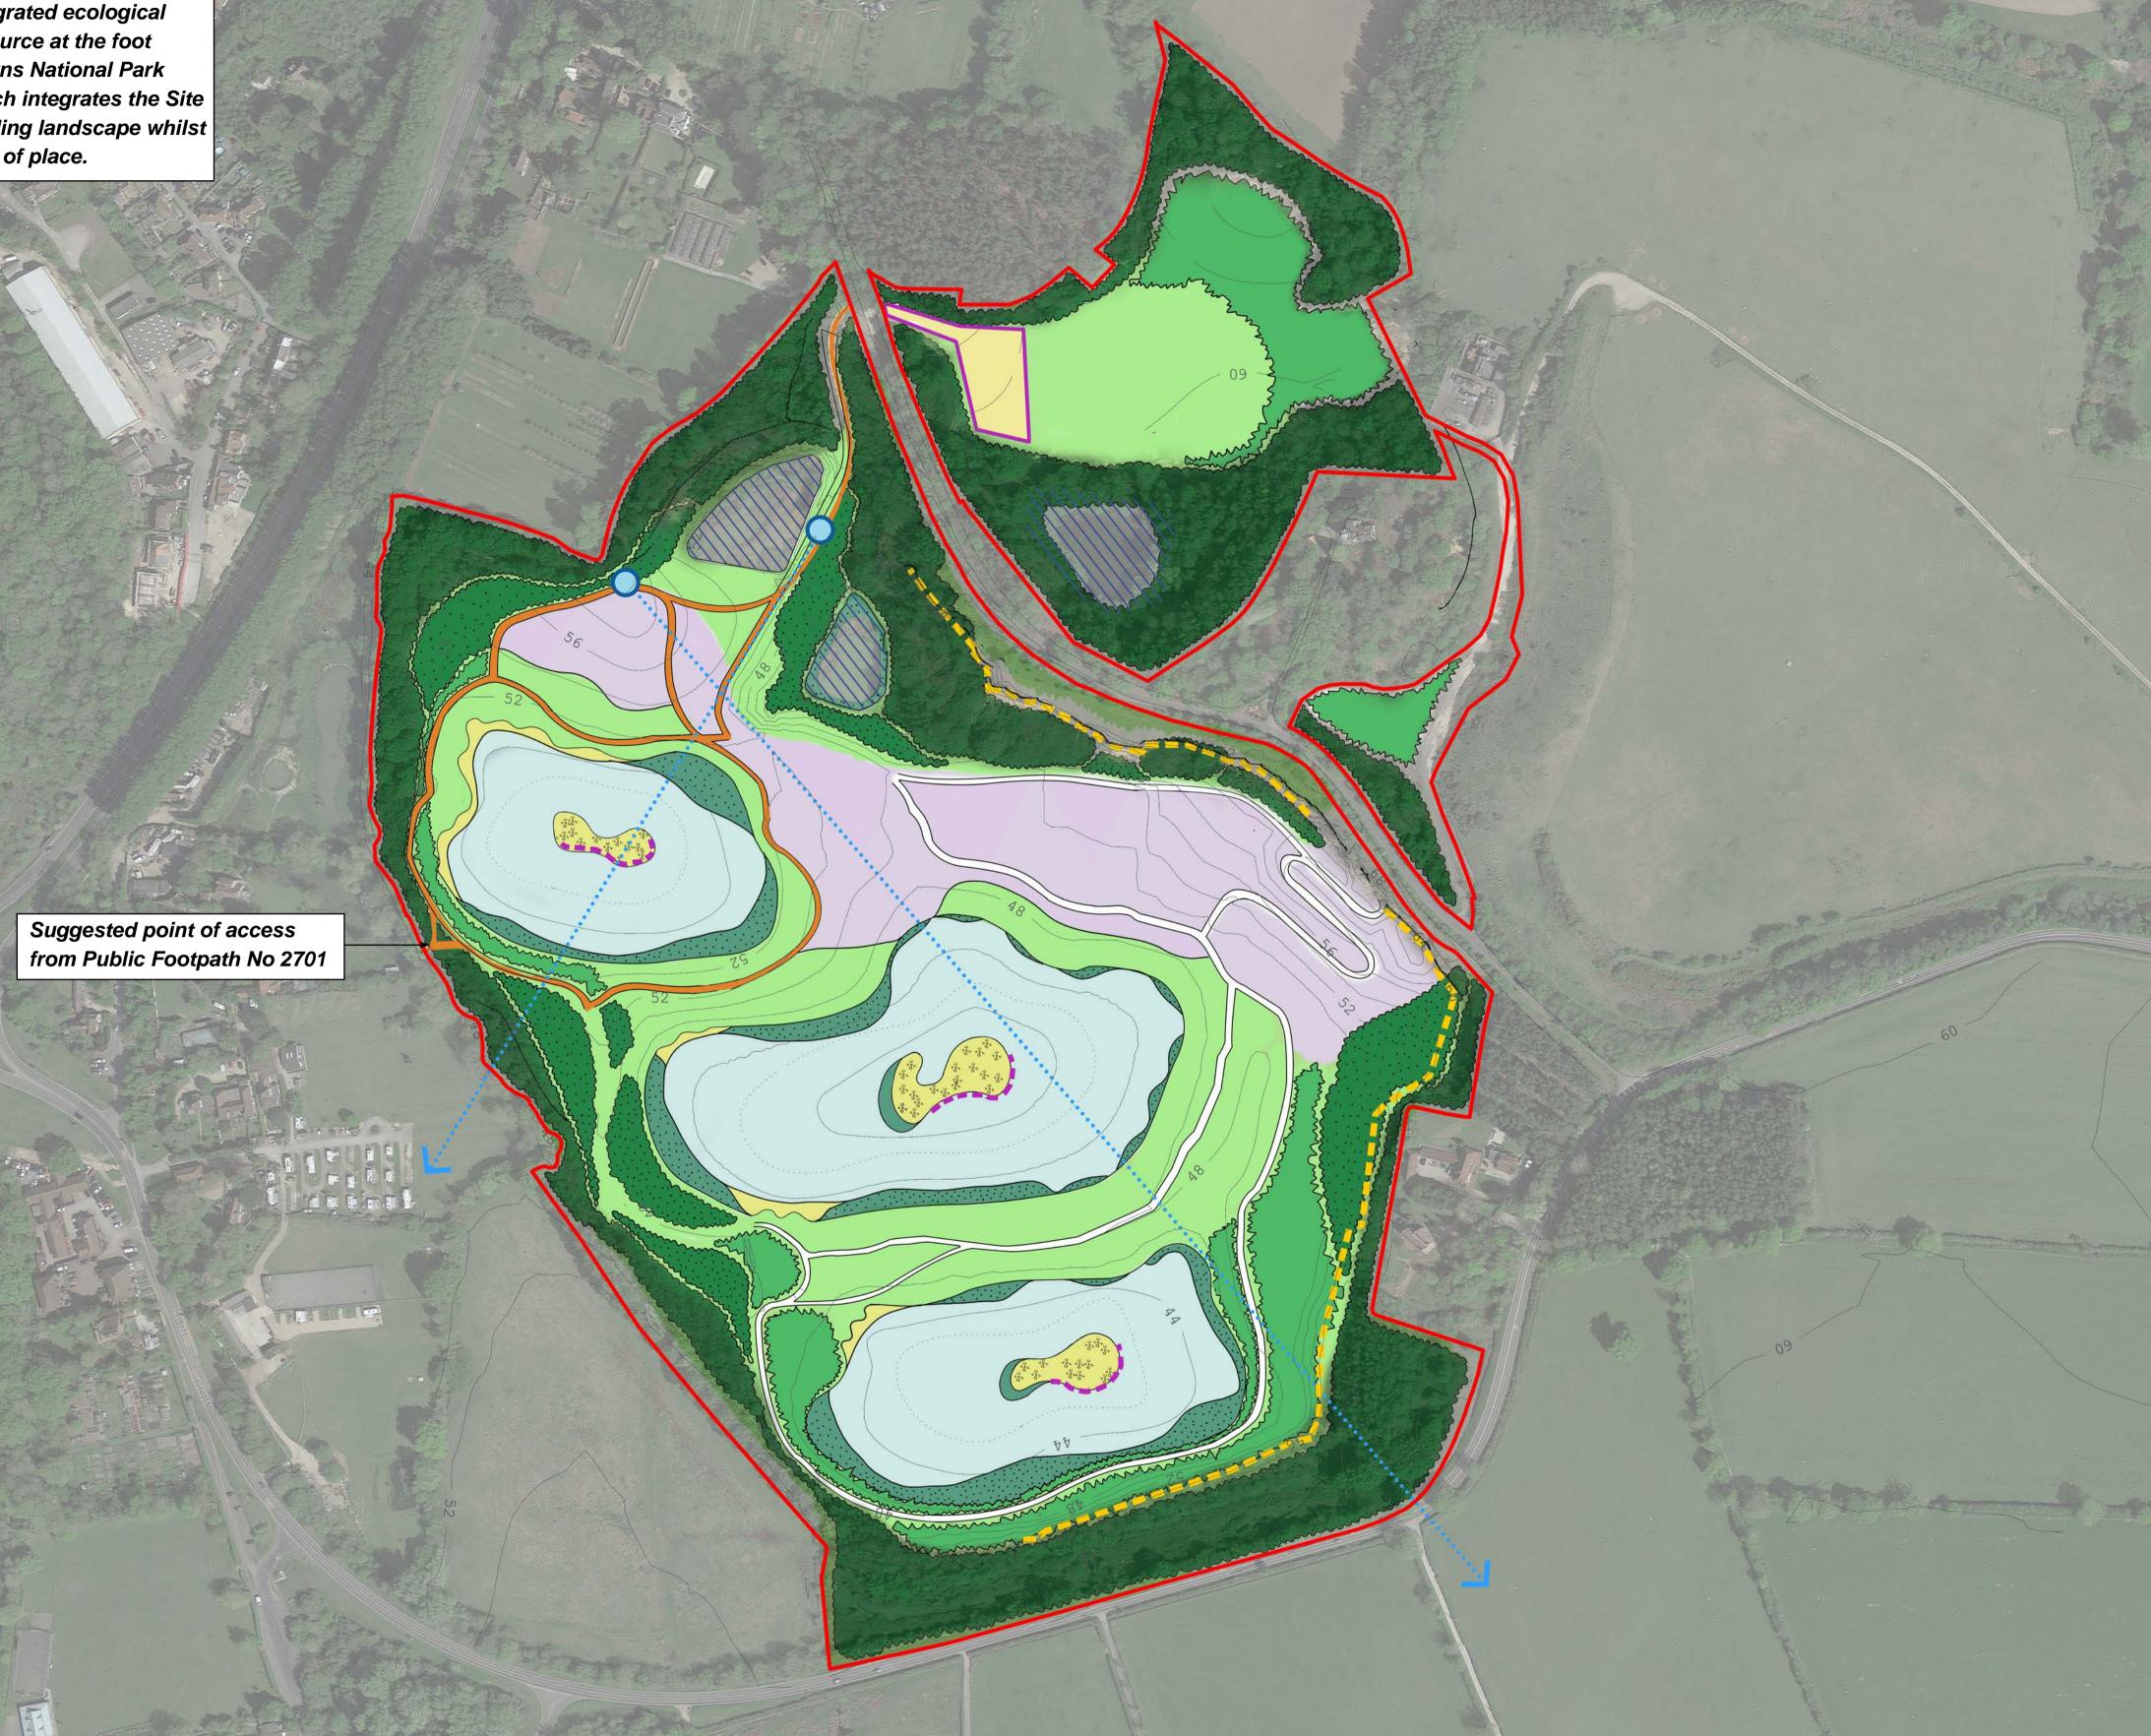
Landscape Masterplan Strategy (Illustrative) Rock Common Quarry, The Hollow, Washington

To create an integrated ecological and amenity resource at the foot of the South Downs National Park escarpment, which integrates the Site into the surrounding landscape whilst enhancing sense of place.

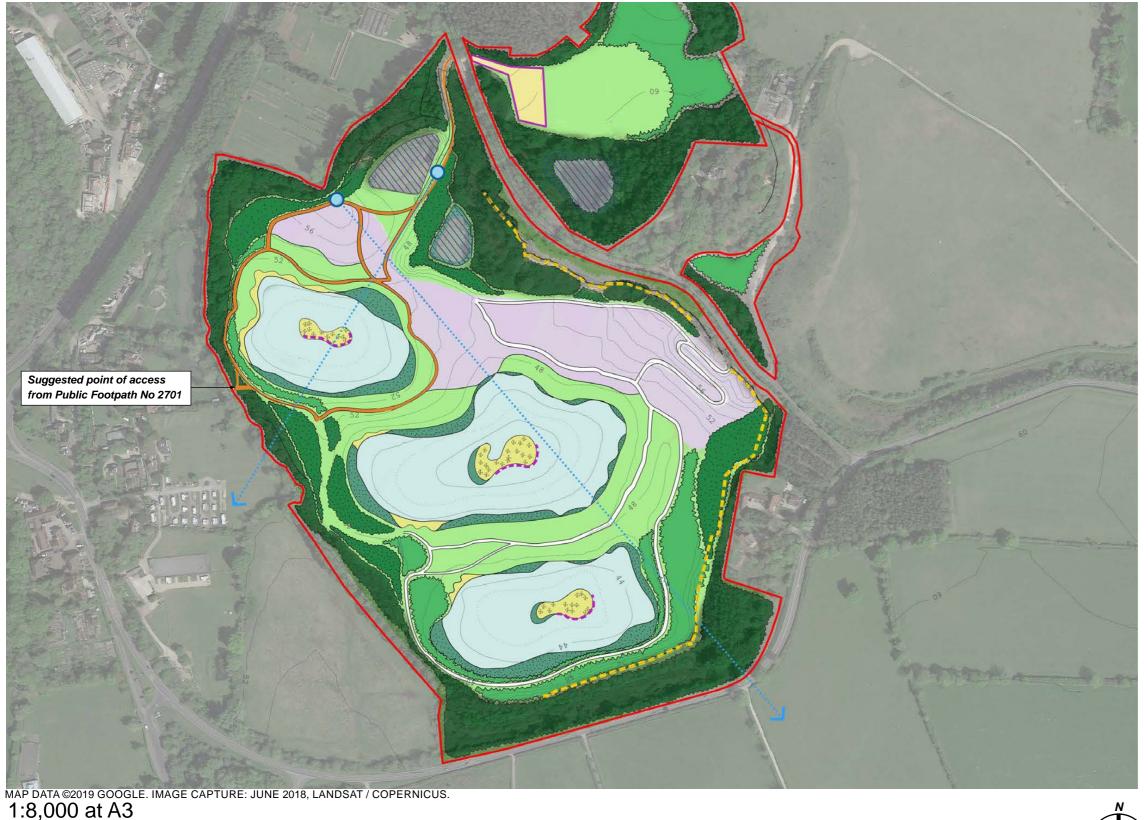
Legend Development Site Location. **Existing Broadleaved** Woodland - To be retained and enhanced. **Broadleaved Acid Woodland -**To be planted out. Native scrub planting - Self Lowland Heathland species to be targeted for establishment, further to trials early in phased Acid grassland establishment targeted with areas of bare ground left for natural succession to take place. Existing Standing water. Proposed Standing water. Marginal planting to areas of Gravel Islands created above standing water level to provide habitat for ground nesting Sand/Gravel 'Beach' areas to allow interaction with the waterside by visitors. Shallow vertical faces to be created using gabions or similar filled with rock and reclaimed material to provide additional sand Martin habitat. Soft Cliff faces to be retained as habitat to solitary bees. Any enhancement planting within the proximity should avoid these faces as well as sand Martin nesting sites found to the east. Footpaths for informal public Private use access for maintenance and habitat Retained hardstanding/site maintenance area Viewpoints from high ground across the Site to surrounding chalk escarpment landform including the wooded Figure 3.1. Landscape Masterplan, (Illustrative).

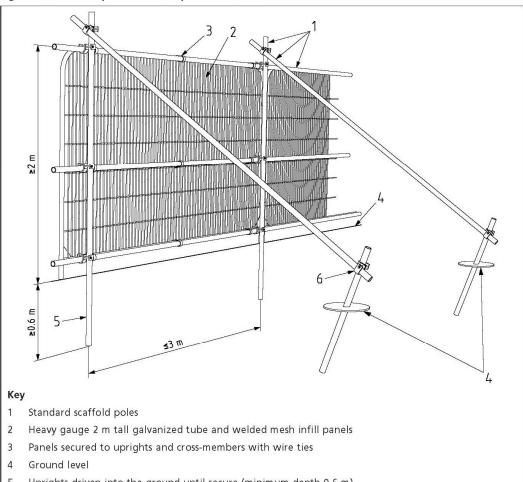
Figure 2 Default specification for protective barrier

- 3.5 The installed protective barrier shall be 2.0 metres minimum height 'Heras' Welded Wire Mesh Fencing secured to a scaffolding framework, set into the existing ground, and positioned to the outside edge of the existing Tree Root Protection Area. Where existing ground conditions do not allow for the above method, the Welded Wire Mesh Fencing Panels may be mounted on concrete or rubber feet, supported on the inner side with stabilizer struts fixed on a block tray or secured with ground pins; and positioned as specified. The barrier should be strained, and fixed to fences, walls, knee rails where possible to provide a complete protected area (refer to Figure 2 and Figure 3 below; © British Standards Institute 2012). All tree protection to be in accordance with BS 5837: 2012; 'Trees in Relation to Design, Demolition and Construction Recommendations' set out as specified within drawings LLD1955-ARB-DWG-002 Tree Retention and Protection Plan.

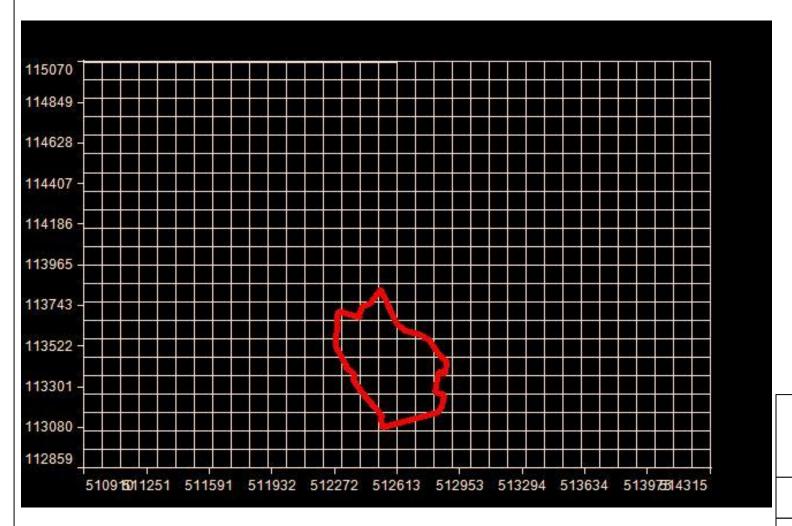
Figure 10 Model Grid

The groundwater model covers an area of 750 Hectares and is shown in Figure 10. The grid, known as the model domain, is made up of 56 100x100m squares.
