**ROCK COMMON QUARRY**  
The Hollow, Washington RH20 3DA

**PLANNING AND ENVIRONMENTAL STATEMENT  
VOLUME 2  
PART 2**

**ENVIRONMENTAL REPORTS AND IMPACT ASSESSMENTS**

## Ecological Impact Assessment

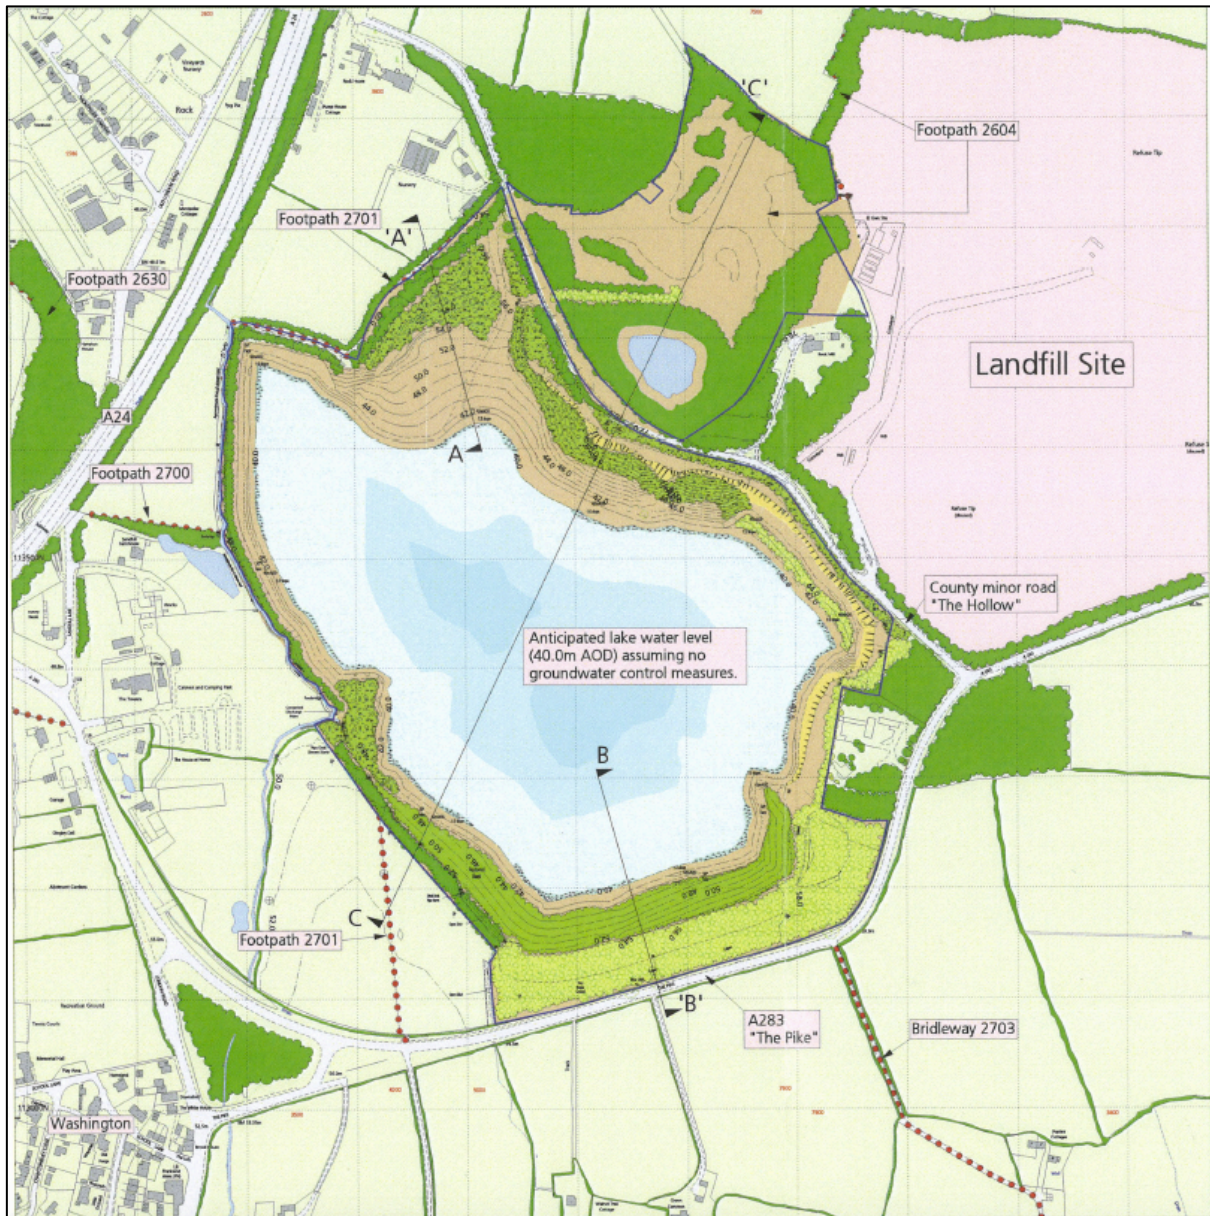
**Figure 2.** Layout of the Approved Restoration Scheme. Image reproduced from Concept Restoration Plan, Tarmac Ltd Dated January 2004.

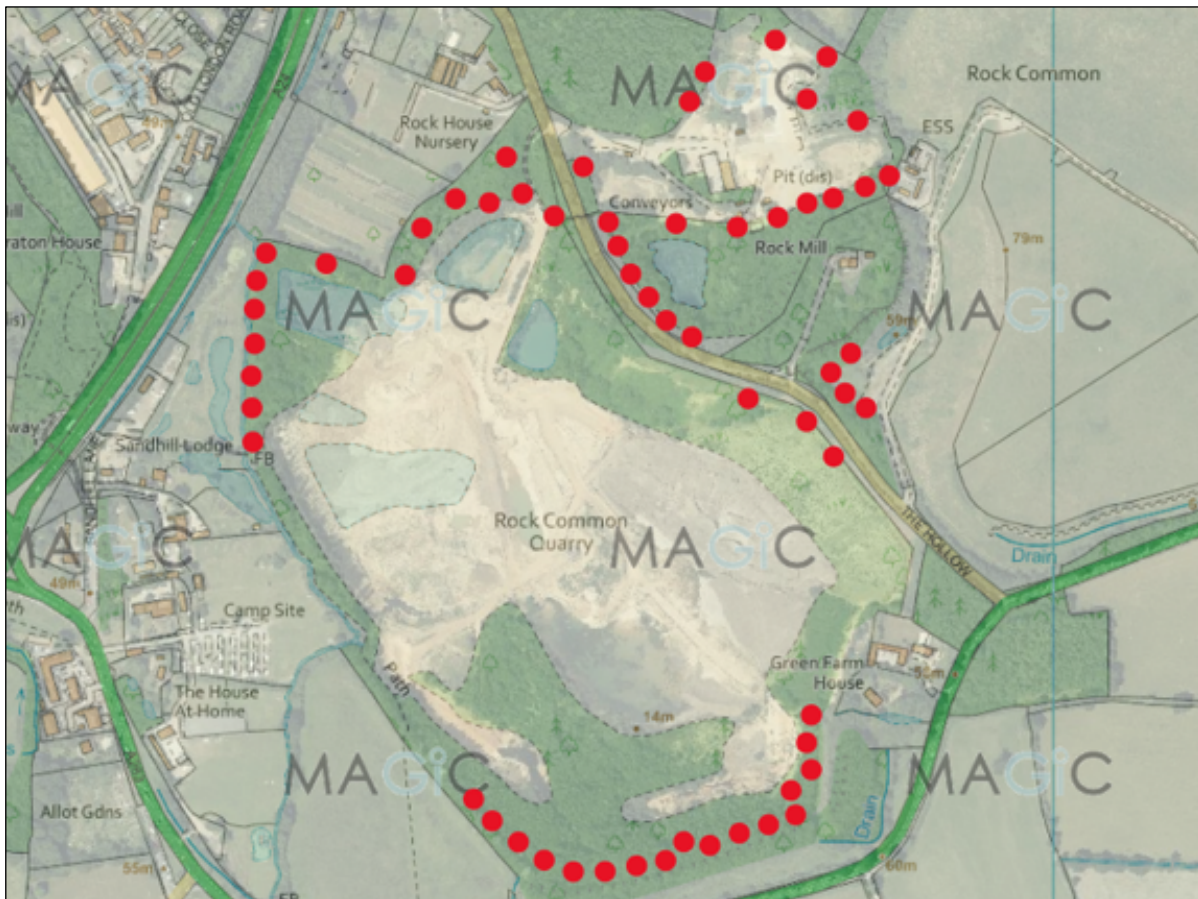
**Figure 8.** Dormouse nest tube locations (identified as red dots) across suitable habitat at Rock Common Quarry. Image produced courtesy of Magic maps (<http://www.magic.gov.uk/>), contains public sector information licensed under the Open Government Licence v3.0).

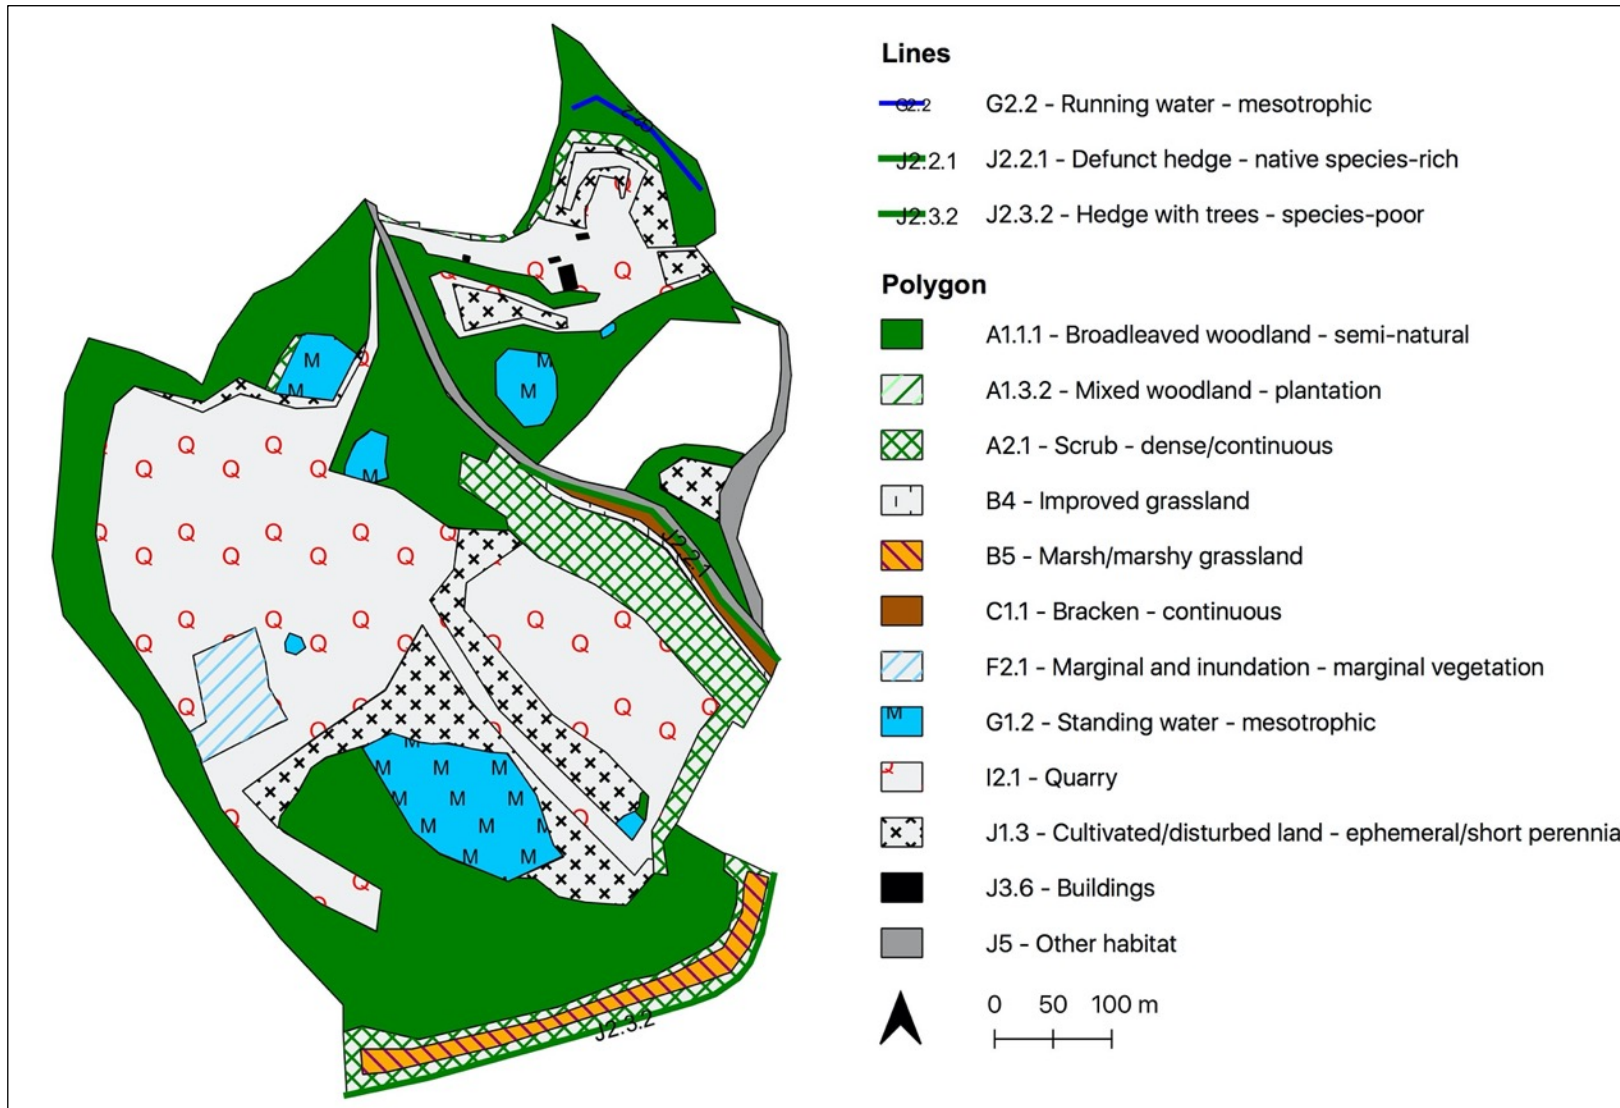
Figure 12. Phase 1 map of Rock Common Quarry as at March-April 2020. Image prepared by The Ecology Co-op.

The Phase 1 Habitat Map for the site and key to the standard mapping symbols used is presented in Figure 12. Table 3 provides a detailed description of each habitat type listed on the site. Photographs of important areas of habitat are presented below.

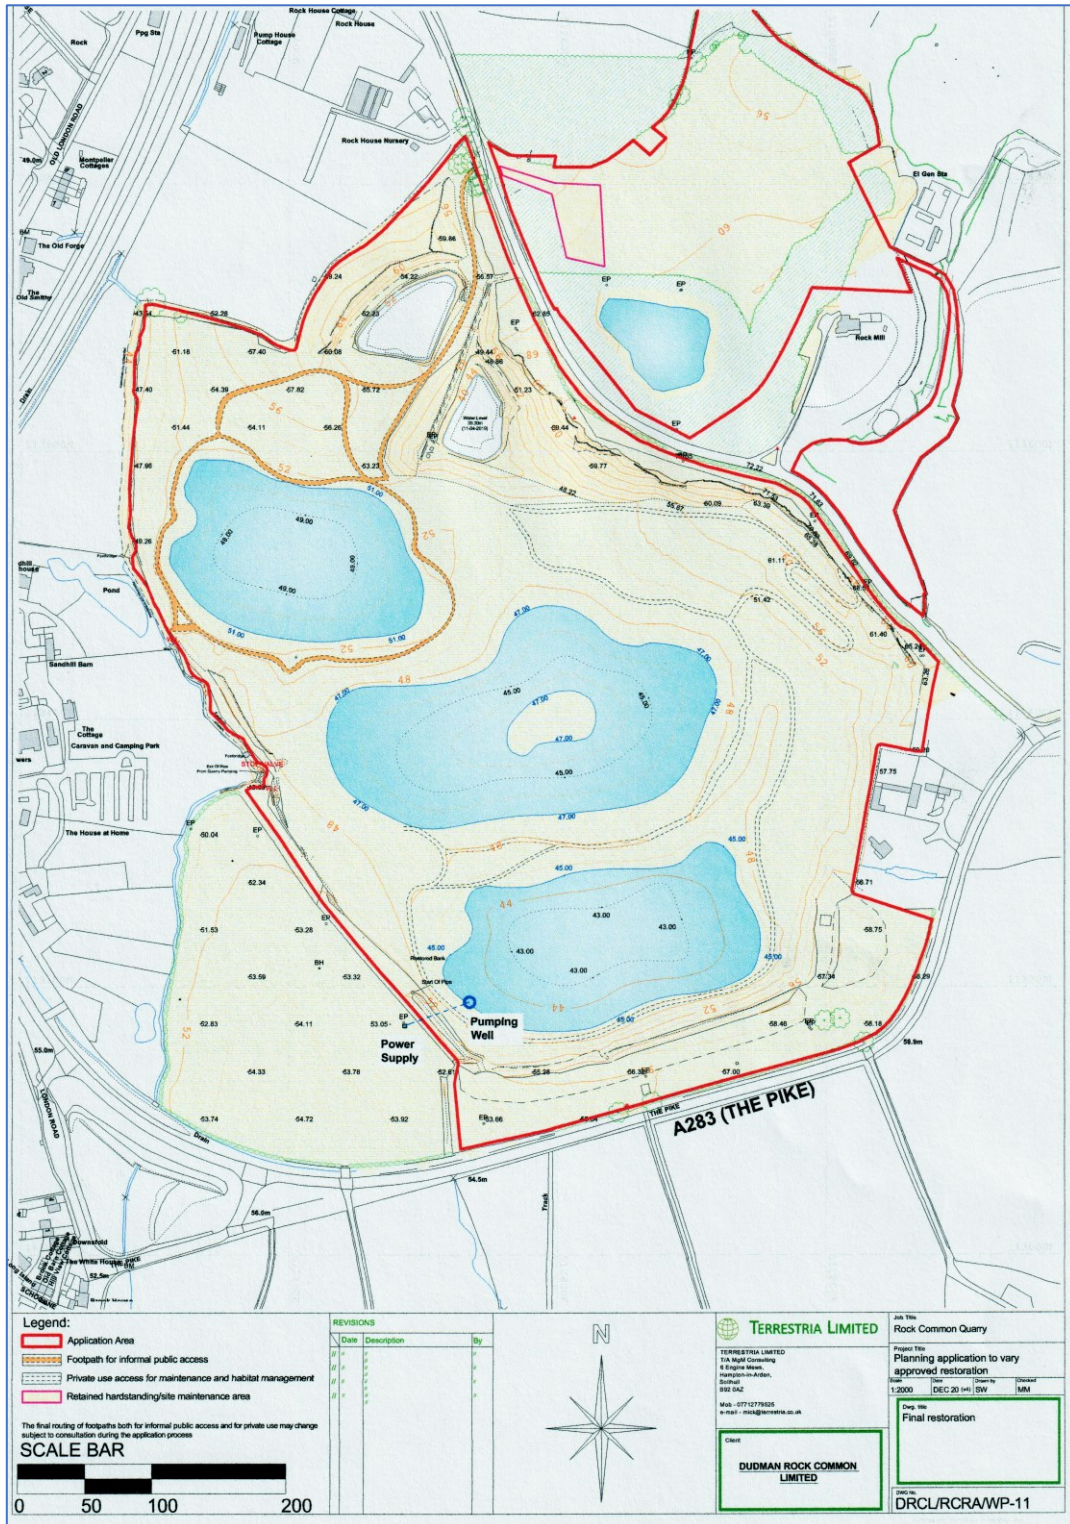
**Figure 4:** Plan showing the proposed final restoration layout of the assessment sites within the planning application boundaries (marked in red) at an original scale of 1:2,000.
