Staplefield Wetland Creation

Arboricultural Report

March 2024

Document reference: 639529-MM-N-RPT-0021

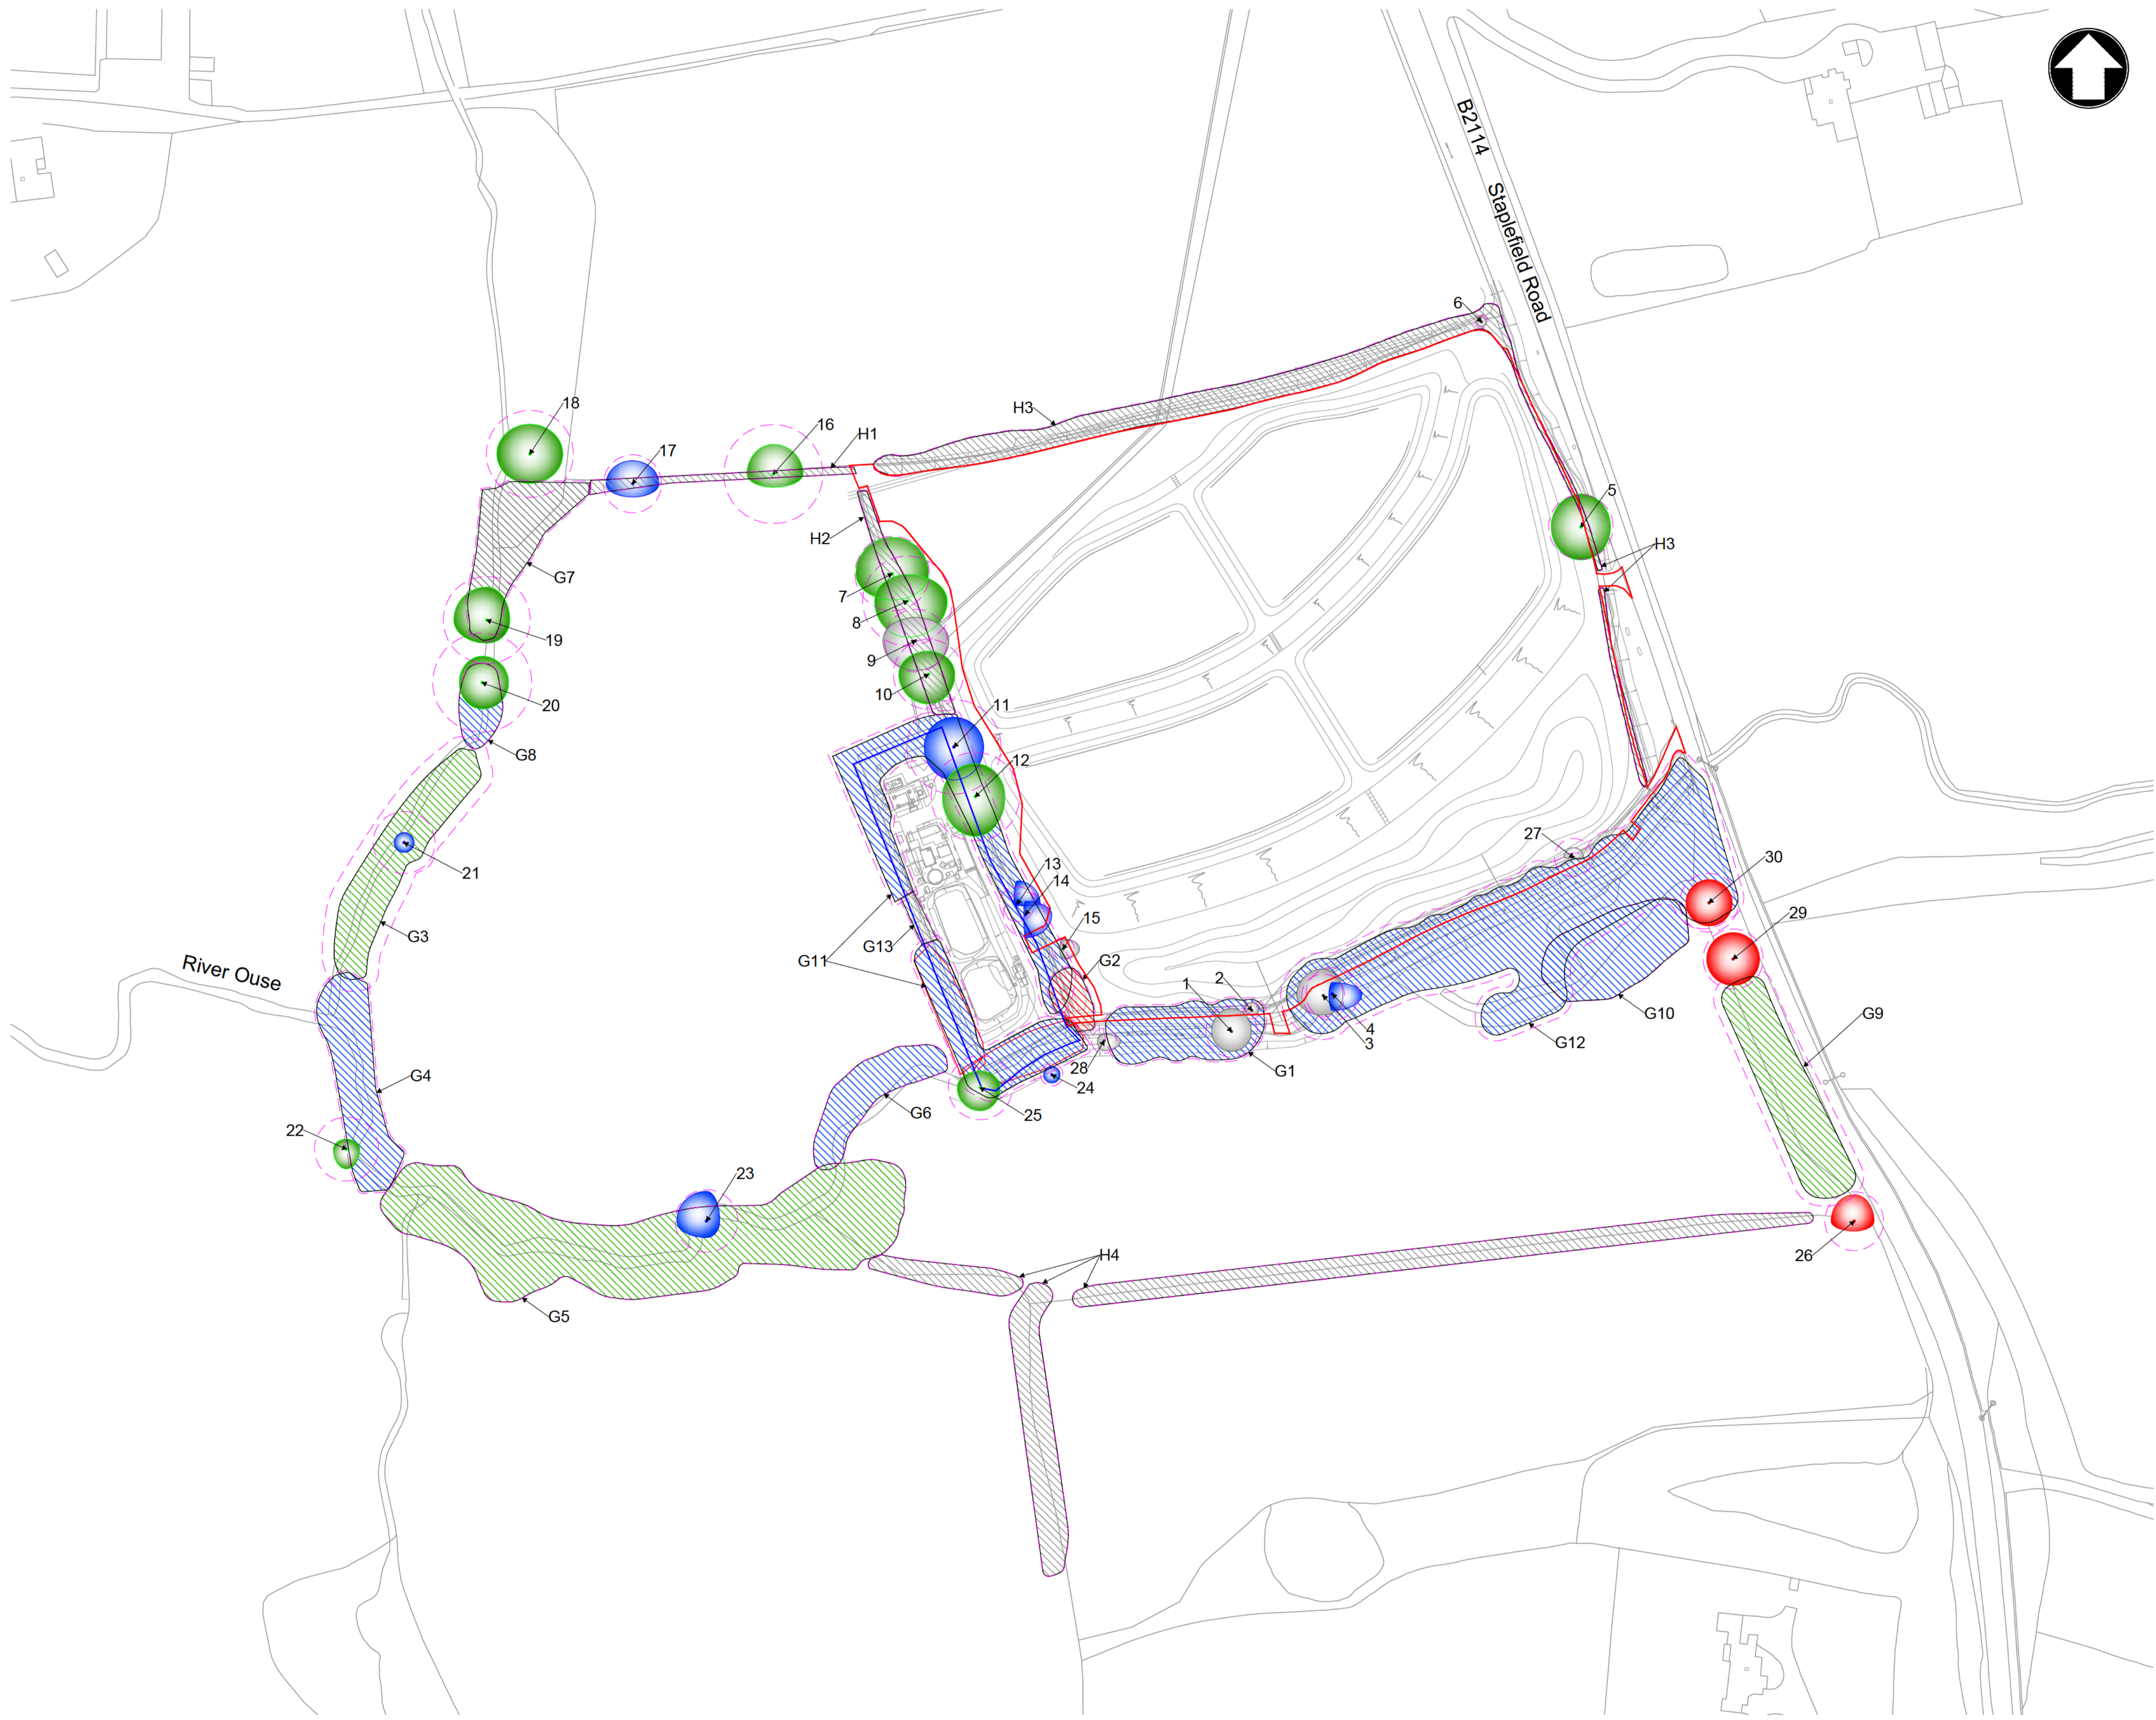
Title **Staplefield Wetland Creation Tree Constraints Plan**

- Key to symbols**
- 2/G2/H1 Tree/Tree Group/Hedge Reference
- Approximate extent of canopy
 - Tree Root Protection Area (RPA)
- Individual Trees**
- No Category
 - Category A Trees
 - Category B Trees
 - Category C Trees
 - Category U Trees recommended for removal for reasons of sound arboricultural management
- Tree Groups**
- ▨ Category A Trees
 - ▨ Category B Trees
 - ▨ Category C Trees
- Ownership Boundary
- ICW Site Boundary (3.135ha)

- A.1 Tree Constraints Plan (639529-MM-N-DWG-0001)
- A.2 Tree Protection Plan (639529-MM-N-DWG-0002)
- A.3 Proposed Site Layout (752214-MWX-ZZ-00-DR-C-00100)

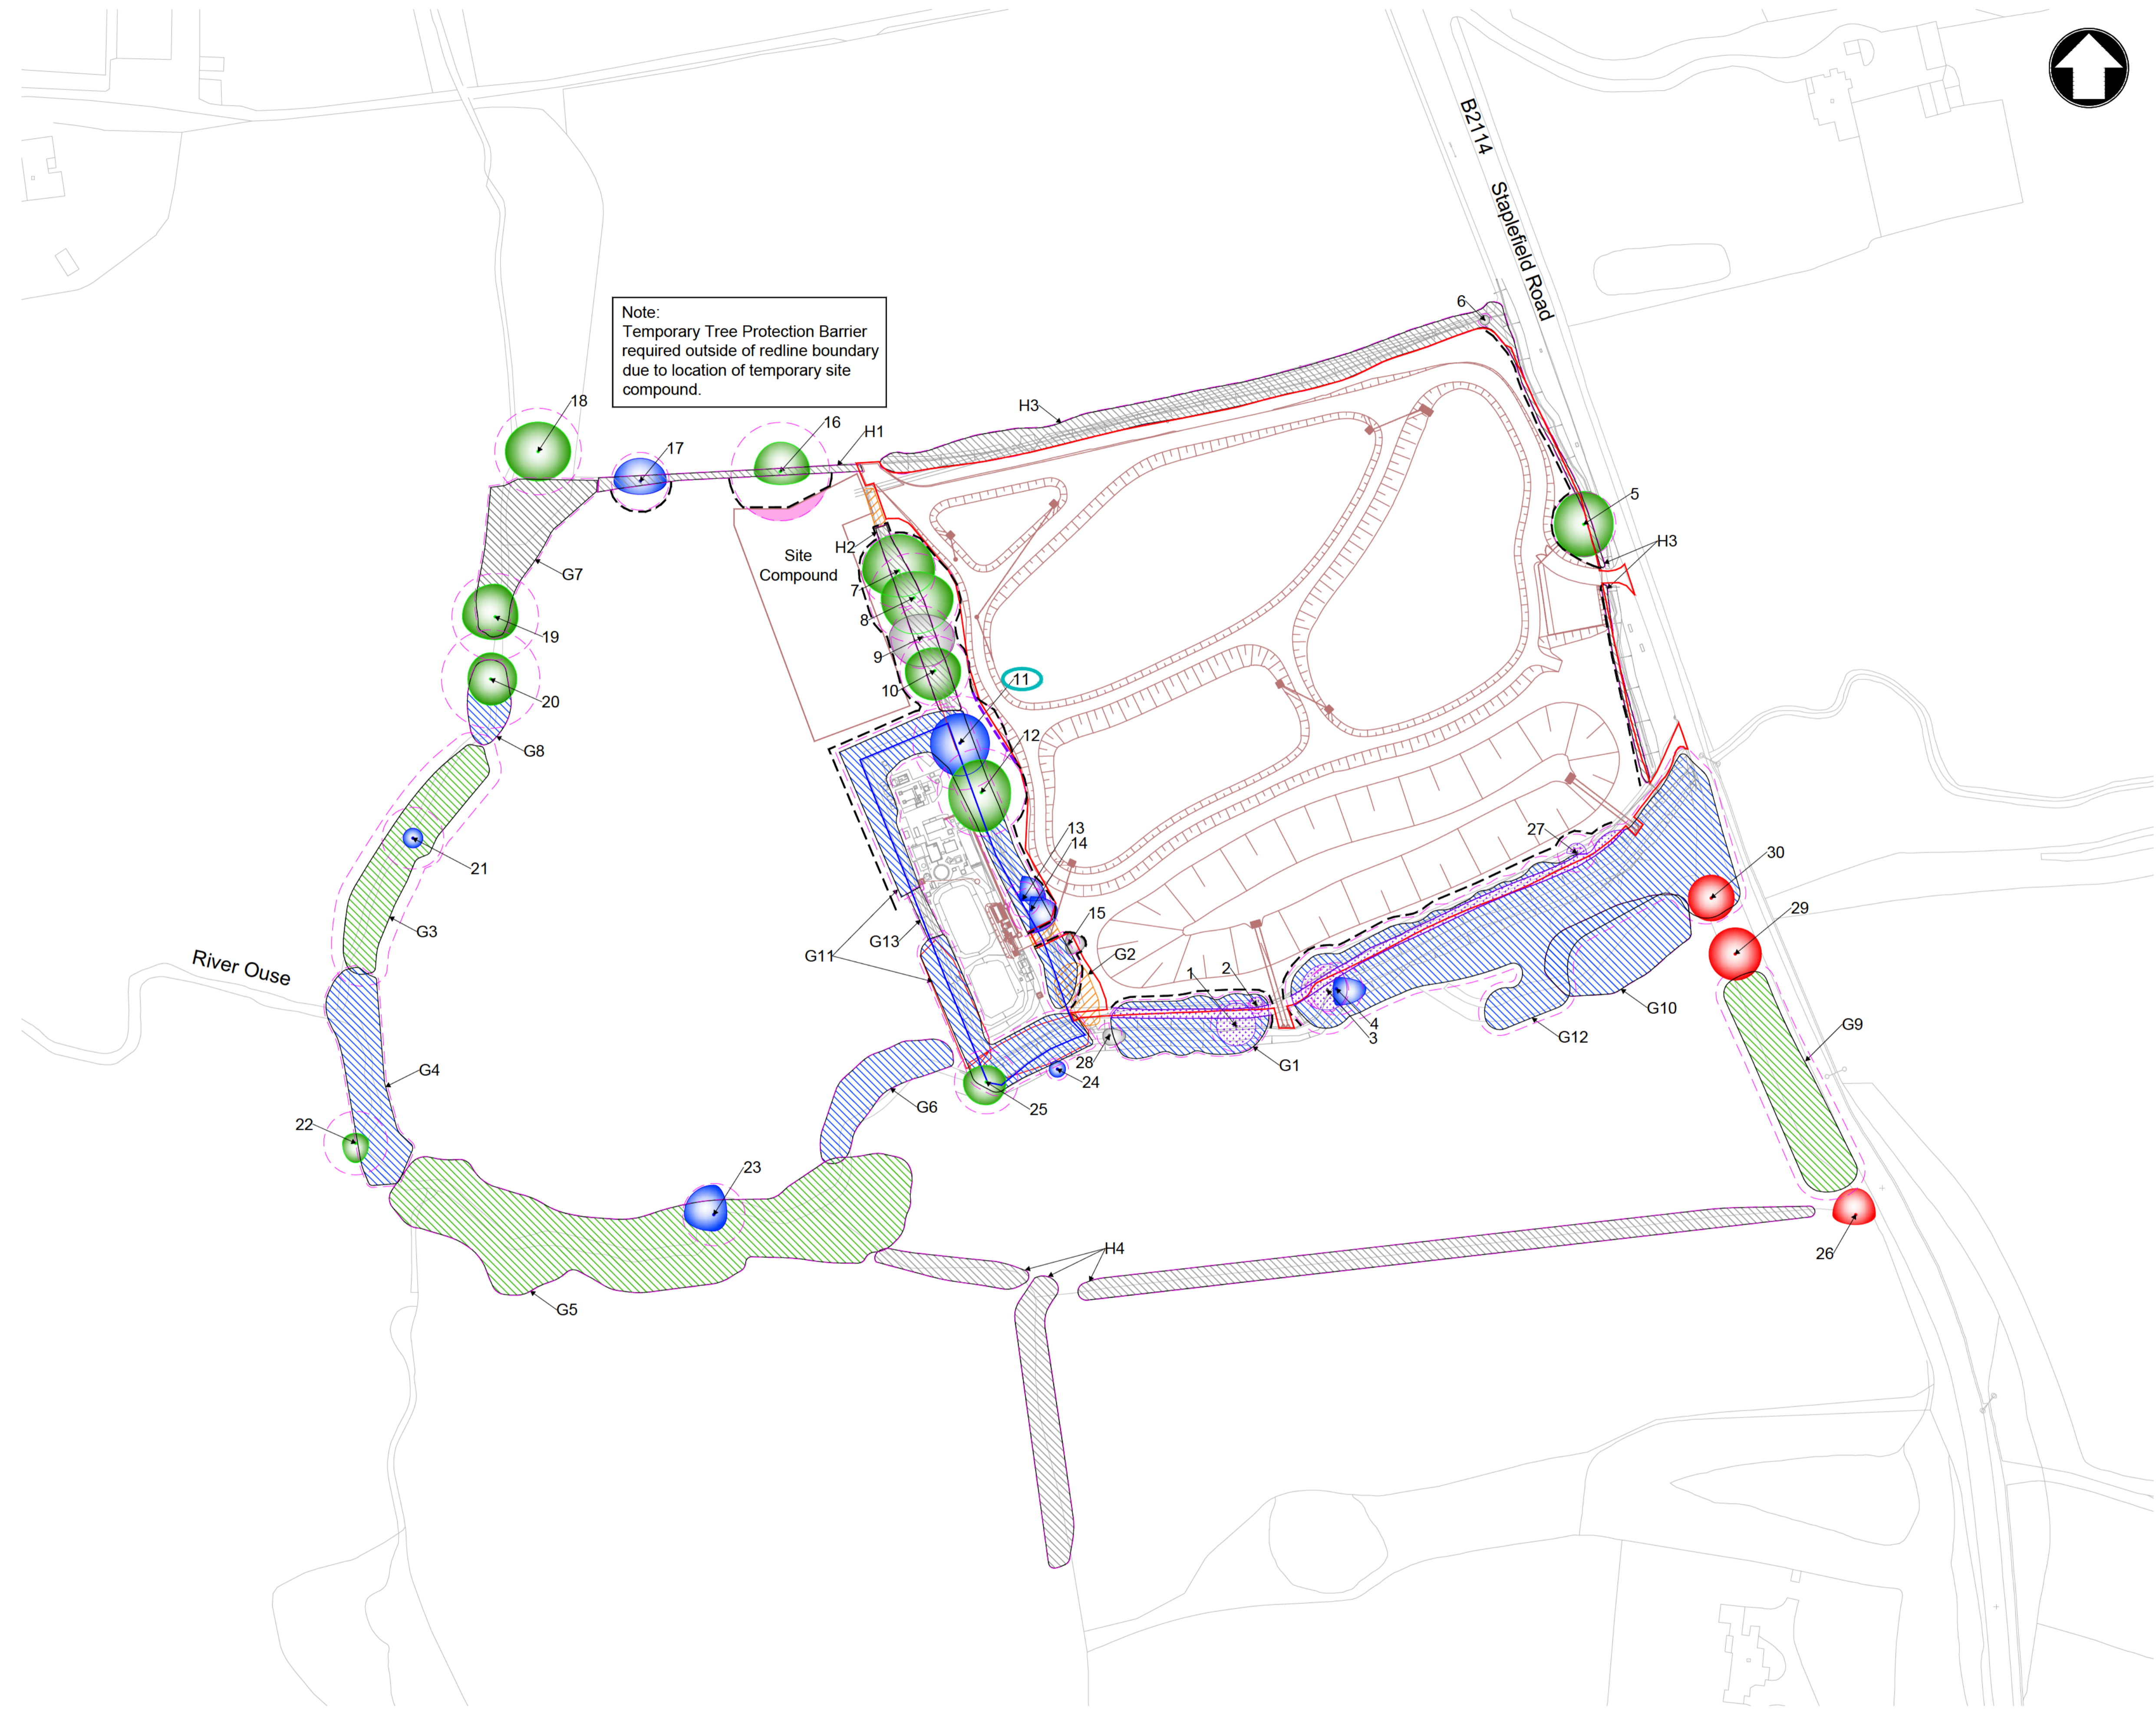
Note:
Temporary Tree Protection Barrier
required outside of redline boundary
due to location of temporary site
compound.

- No Category
- Category A Trees
- Category B Trees
- Category C Trees
- Category U Trees recommended for removal for reasons of sound arboricultural management

The construction of this Scheme must be undertaken in accordance with the following recommendations (Table 3.1) and the Tree Protection Plan (Appendix A.2) to enable integration between with the Scheme and the existing tree constraints on the Site. Definitions for the retention category are given in Table 1.2 and Appendix C.
