Our Ref: 890323-R1(01)-FRA

26th June 2020

**RE: QUALITATIVE HYDROLOGY AND FLOOD RISK ASSESSMENT
LOWER STUMBLE EXPLORATION SITE, BALCOMBE, HAYWARDS HEATH**

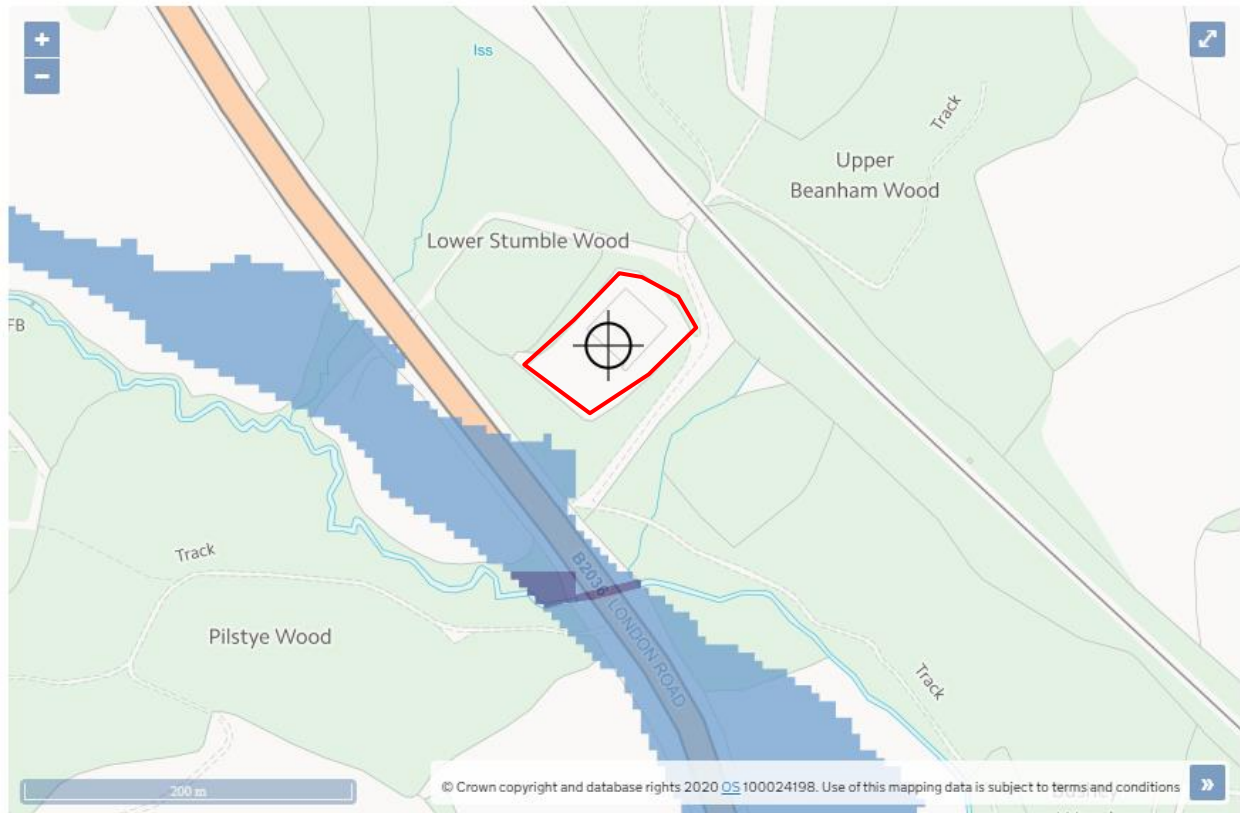
Figure 2b: Flood risk from rivers or the sea

Extent of flooding from rivers or the sea

● High ● Medium ● Low ● Very low ⊕ Location you selected

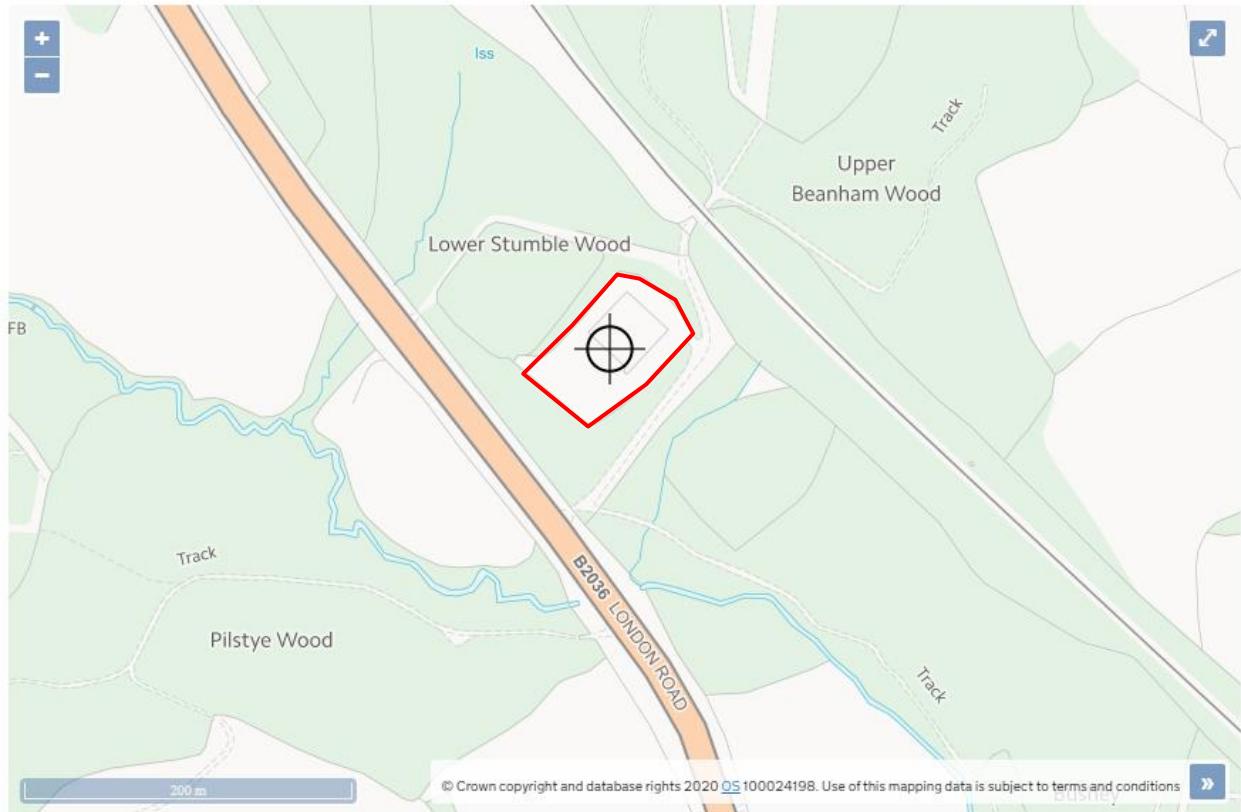
Figure 4: Risk of flooding from reservoirs

The EA's online reservoir flood risk map (**Figure 4**) provides a worst-case scenario of the maximum extent of flooding that would occur in the event that a reservoir were to fail and release the water it holds. The map indicates that the site is located outside a reservoir breach zone.

Extent of flooding from reservoirs

● Maximum extent of flooding ⊕ Location you selected

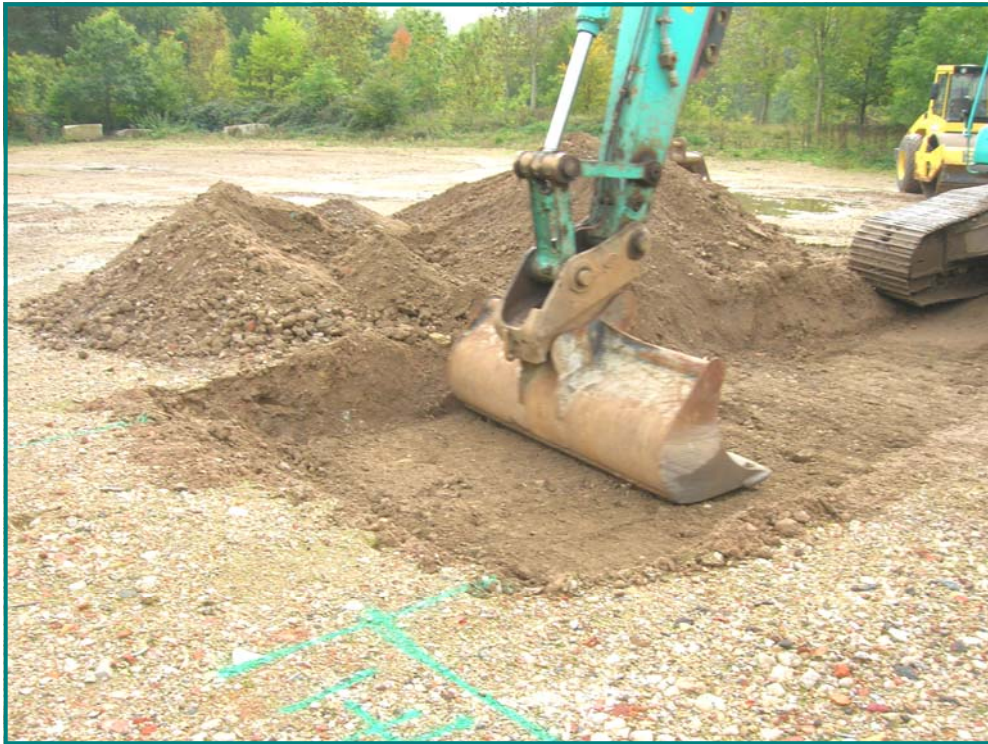
**Photograph Location 7 — Trial fill trench
4th October 2010**

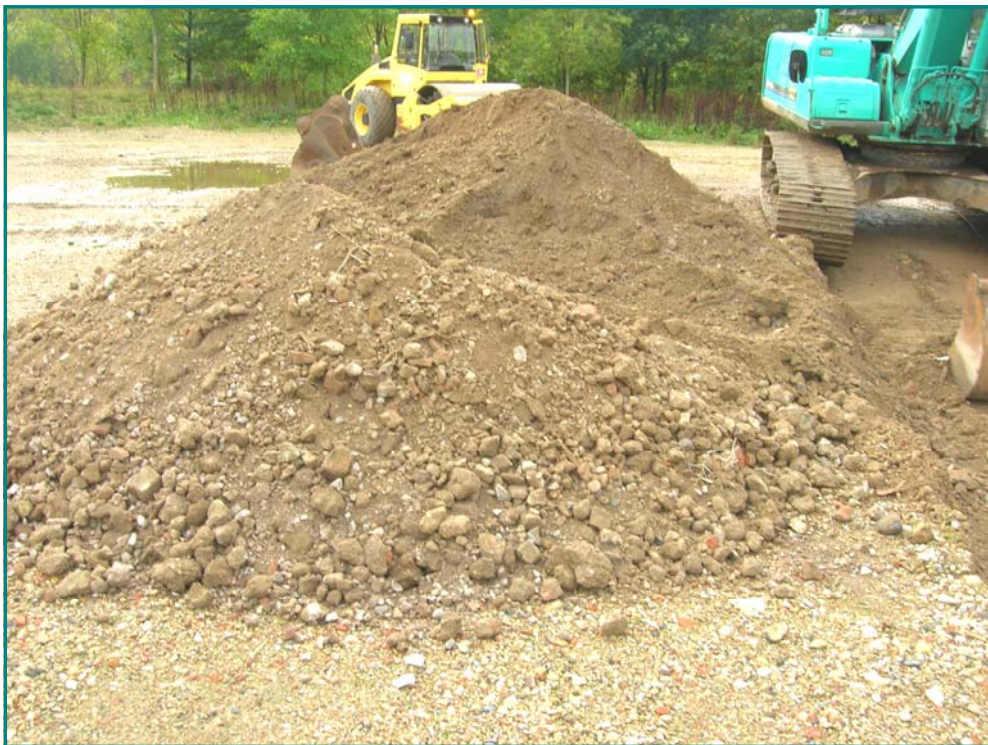
**Photograph Location 8 — Crushed fill
4th October 2010**

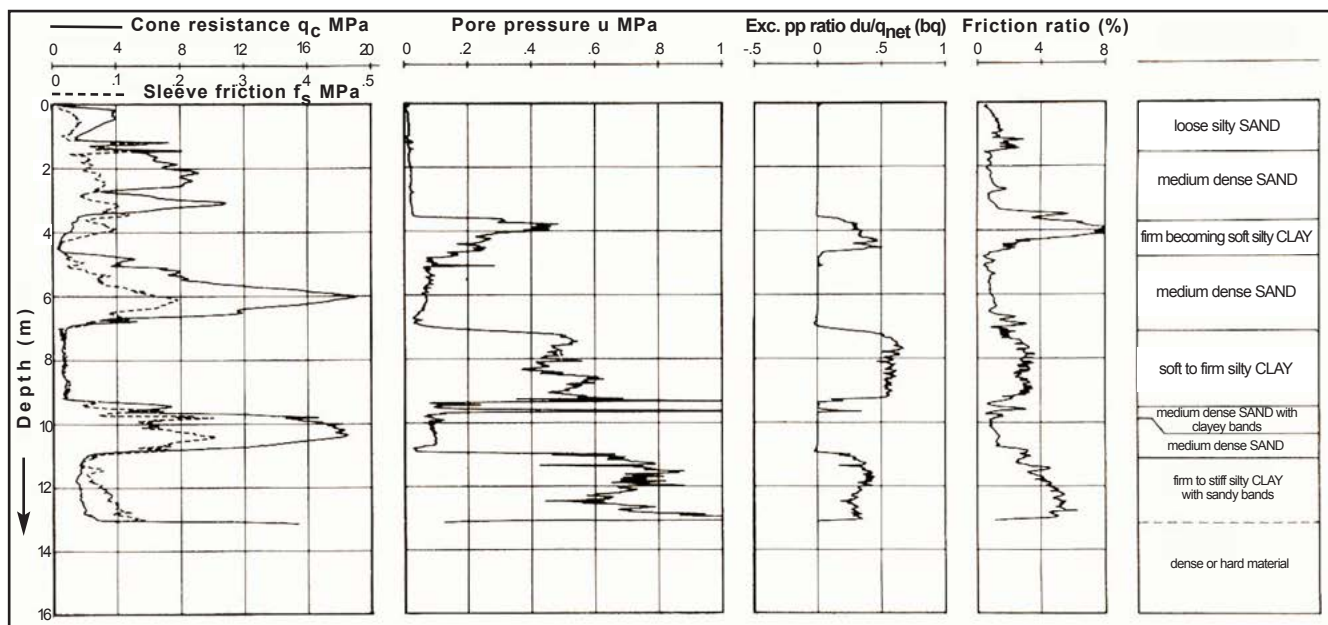
Figure 1 - Typical Cone Test Graph with Estimated Soil Type

On each of the attached cone test graphs presented in Appendix B, the estimated soil type has been plotted alongside. The descriptions are based on the data obtained from the cone end resistance and friction ratio data, together with experience gained in similar soils elsewhere. It should be noted that the descriptions can be enhanced if there is borehole information from the site. Opinions and interpretations expressed herein are outside the scope of UKAS accreditation.

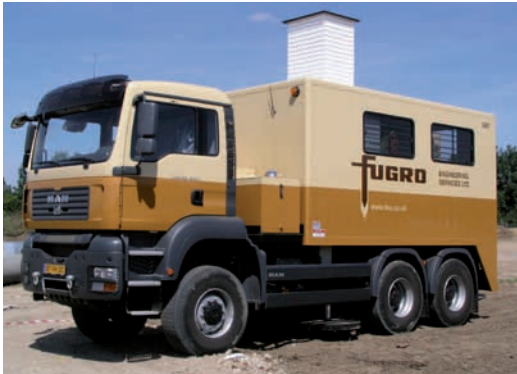
Heavy Truck Mounted Penetrometer

The Fugro Static Cone Penetration Test System provides a quick, efficient and reliable method of soil exploration. The penetrometers are mounted on rugged, six wheel drive, all terrain trucks which provide a reaction force of 20 tonnes from their own weight. In suitable conditions the reaction force available can be increased to 23 tonnes by using supplementary ballast.
