# Desk Top Study

# Evergreen Farm

Prepared by Ged Duckworth Limited

May 2018

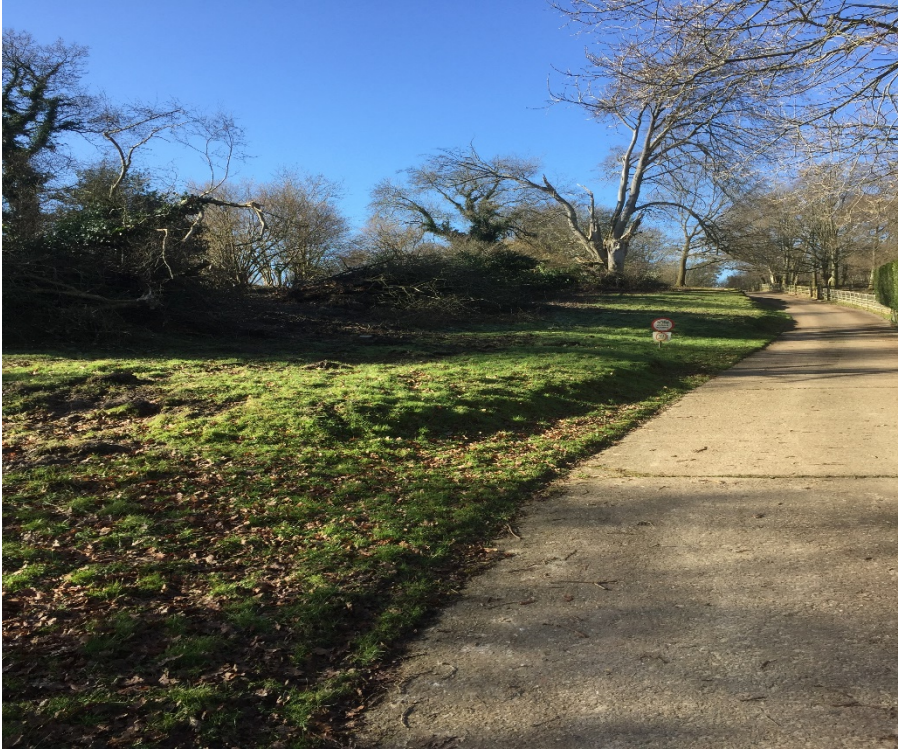
1. View from the site towards the site entrance. Waste observed in the grassed areas

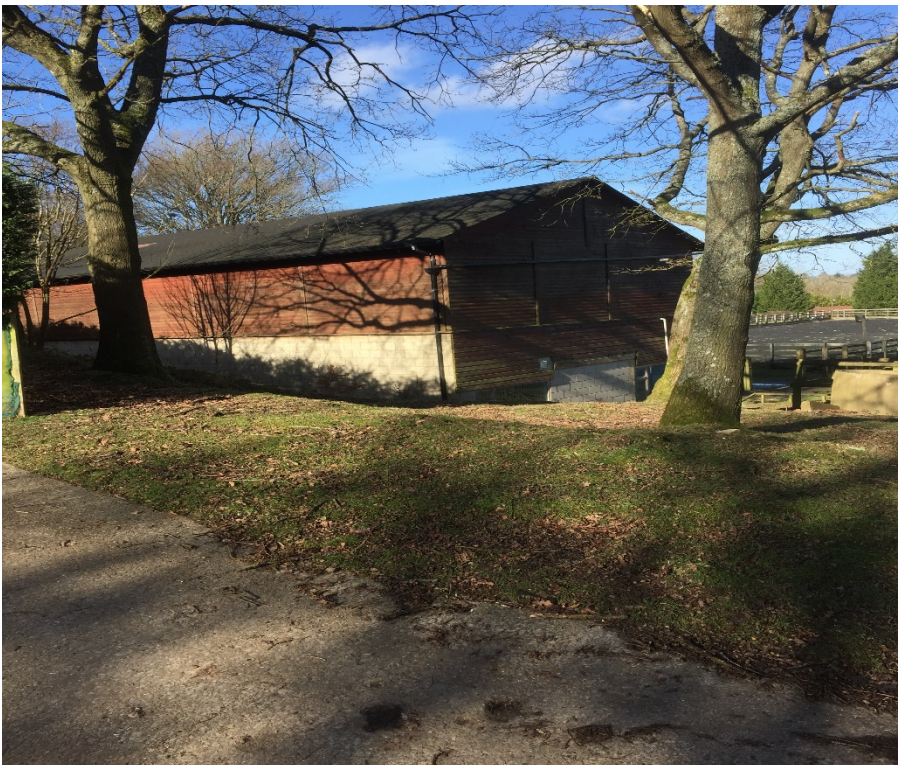
9.2 Of important note is that the onsite building and barn were built during the time that the landfill was operational. The larger barn (former workshop) was built into waste as evidenced by exposed waste in the adjacent embankment.

2. On site building. Waste observed in the embankment.

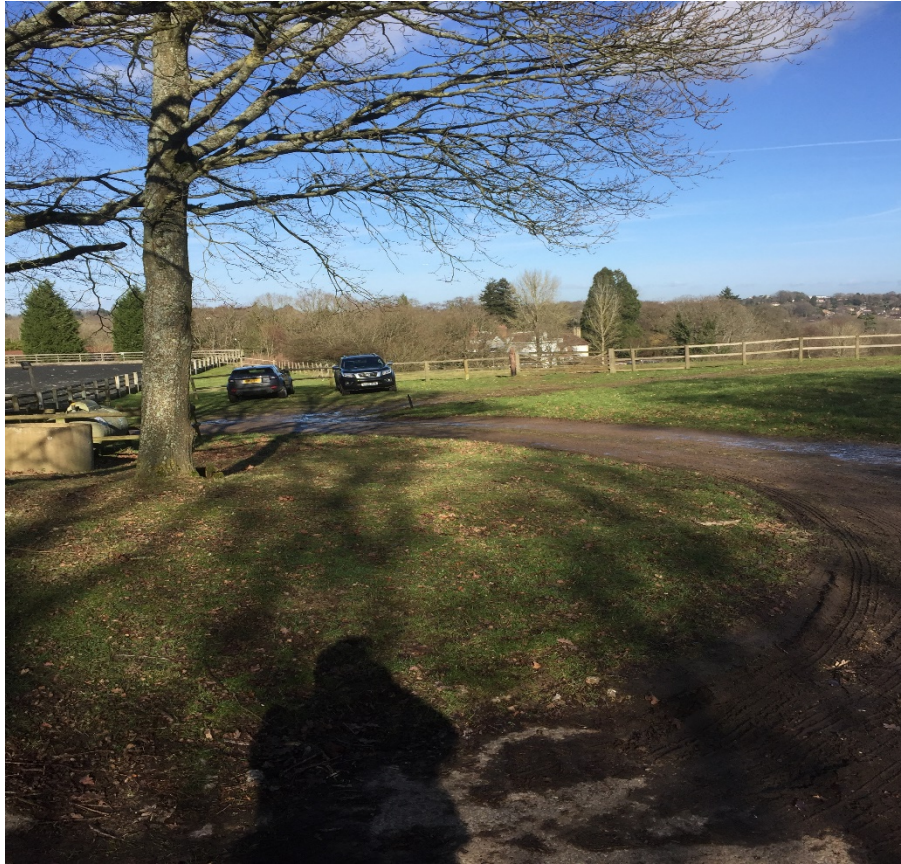
3. View from end of site access across the valley feature. Site falls away steeply after the wooden fence. (Horse training area to the left)

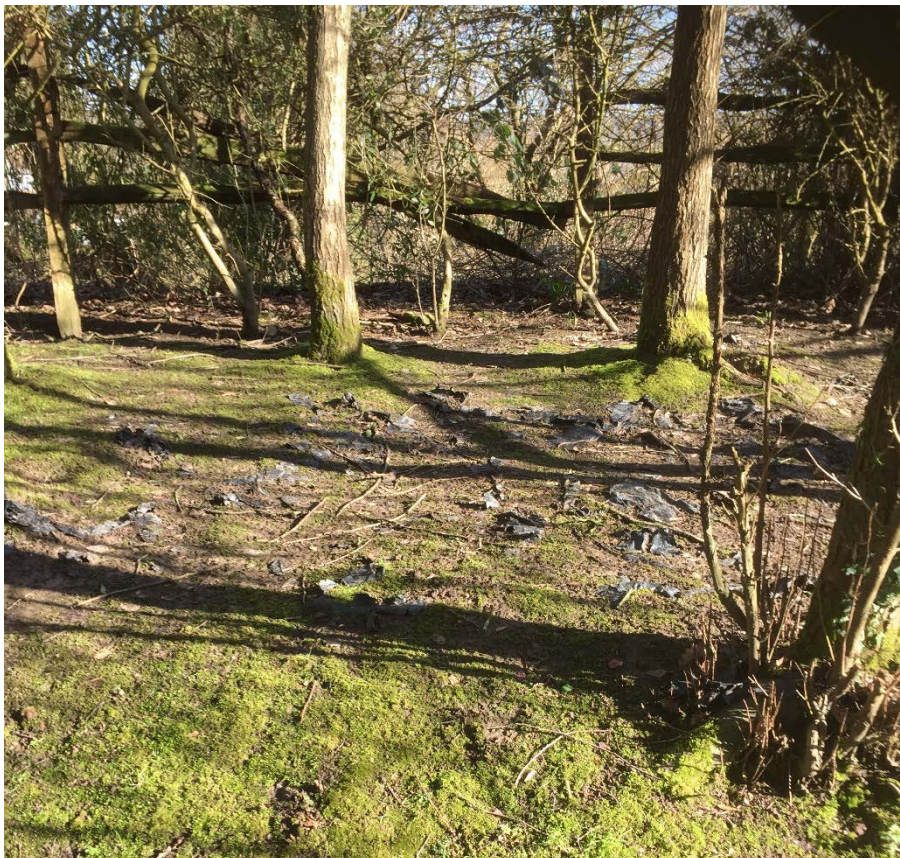
6. Exposed waste in wooded area
