GROUND INVESTIGATION REPORT

**FORMER STANDEN LANDFILL,
EVERGREEN FARM, WEST HOATHLY ROAD,
EAST GRINSTEAD, WEST SUSSEX,
RH19 4NE**

TJS SERVICES LIMITED

Report:	GROUND INVESTIGATION REPORT
Site:	FORMER STANDEN LANDFILL, EVERGREEN FARM, WEST HOATHLY ROAD, EAST GRINSTEAD, WEST SUSSEX, RH19 4NE
Client:	TJS SERVICES LIMITED
Date:	SEPTEMBER 2018
Reference:	GE17326/GIR/SEPT18
Version:	1.1
Prepared by:

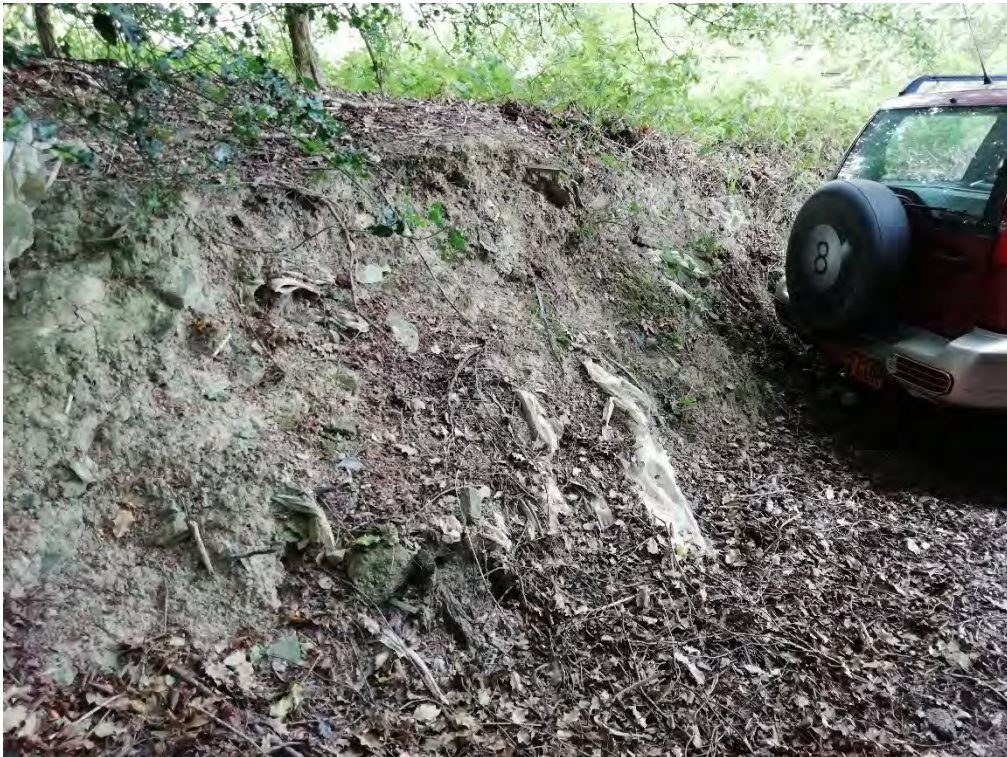
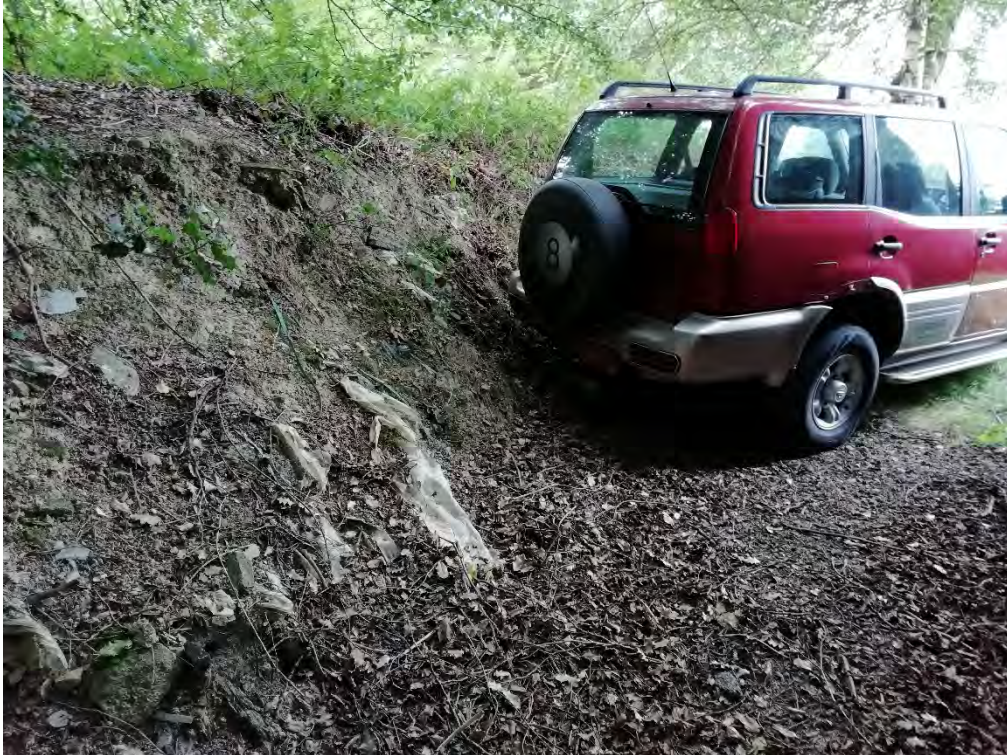
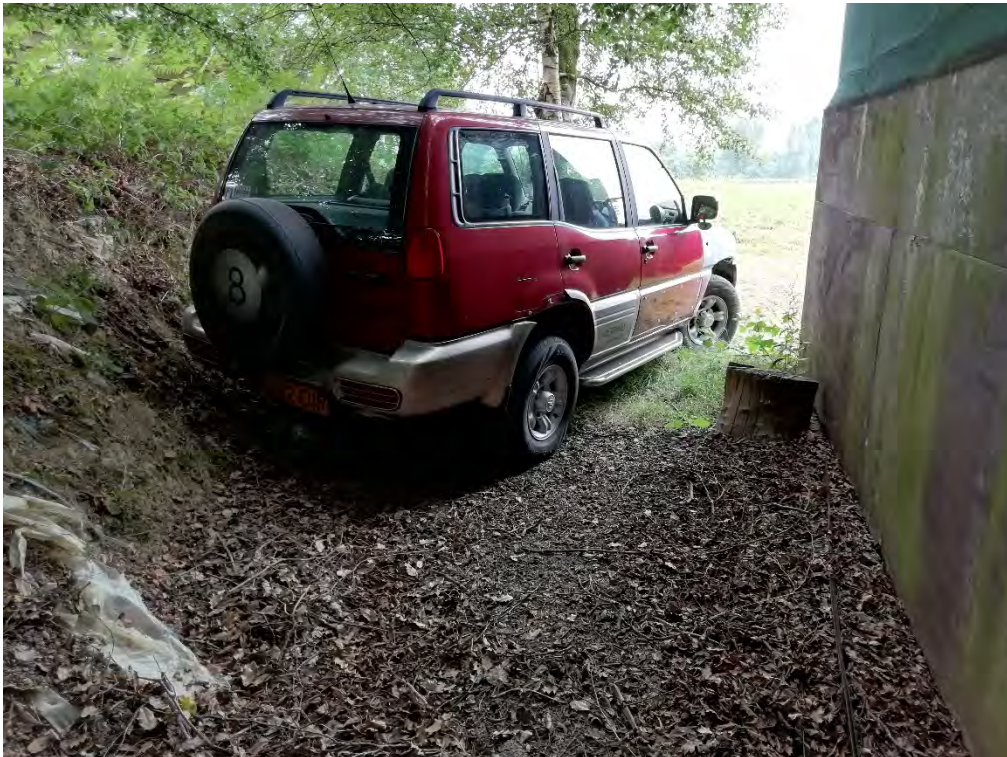
Plate 36 – Embankment next to wood store

Plate 37 – Embankment next to wood store

Plate 38– Embankment next to wood store

was operational and that the larger barn present on the site was potentially constructed into the waste mass on site (as reportedly evidenced by exposed waste in the adjacent embankment). There was also reported to be a potential risk to the adjacent woodland from potential ground gases, noted from trees along areas of the site boundary demonstrating some distress and dying back.
