Geotechnical Design Report for Landfill Cap

Evergreen Farm

February 2019

Reference	EPG/AMV/EGF/2019/GDR/V3	Version	3.0	Issue Date	February 2019
------------------	-------------------------	----------------	-----	-------------------	---------------

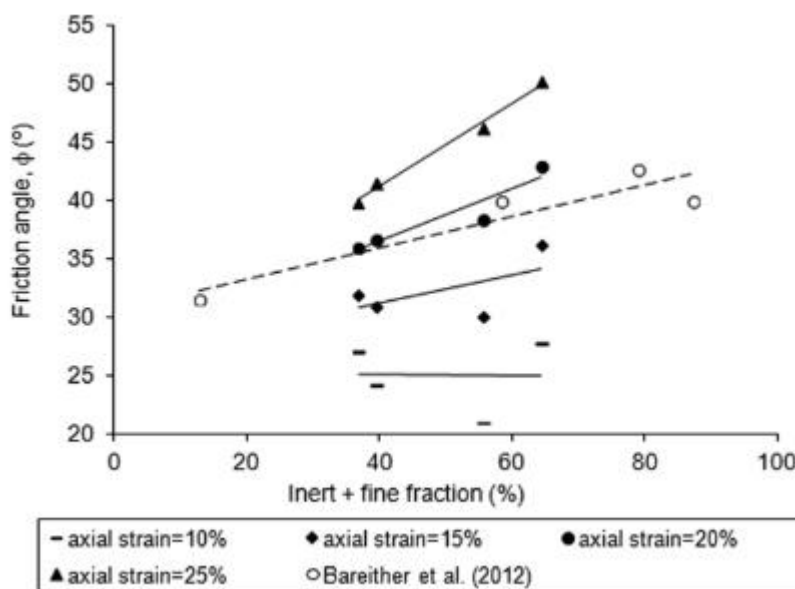
Figure 7 Angle of friction and proportion of inert and fine fraction

For slope stability purposes the landfill material can be split into paste and fibres. Given the high proportion of gravel, concrete, brick, etc the shearing resistance is likely to be dominated by the gravel or fibres and not the paste (ie the clay in this case). The current slopes are stable at a maximum of 1

in 3. The shear strength parameters of landfill waste depend on its composition and state of degradation. Given the age of the waste in this landfill the waste is likely to be well decomposed. Diaz-Beltran et al (2016) suggested landfill waste will have a mean value of 27°. Gomes et al (2013)¹ found that as waste ages the frictional resistance increases and cohesion reduces. The friction angle also increases with increasing displacement or strain and with increasing inert and fine fraction (Figure 7). Peak values occur at about 20% axial strain (Kaushal et al 2017²). Therefore, from the Gomes study the peak friction angle for this site (which is predominantly inert) is assumed to be 34° (which is at the low end of the range determined by Gomes et al for 20% axial strain). When combined with $c'=0$ (see below) this is suitably precautionary.

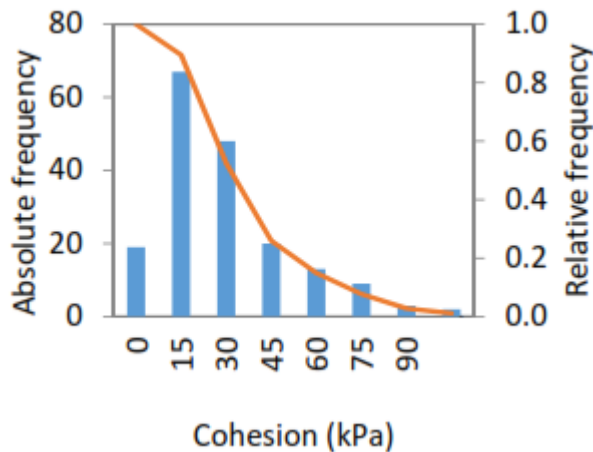
Figure 8 Cohesion in landfill waste (Diaz-Beltran et al, 2016³)

The evidence is that landfill waste will have some significant cohesion (Figure 8). Diaz-Beltran et al (2016) suggested landfill waste will have a mean value of 15kPa. However, in the absence of test data on the waste at this site it is conservatively assumed that $c' = 0$ kPa. This is a significantly conservative assumption in the analysis.

Therefore, for the existing waste material assume $\phi' = 34^\circ$ and $c' = 0\text{kPa}$.
