**(Heritage Impact Assessment - Archaeology -
West Sussex Archeology)**

**Heritage Statement for Proposed Works at Knepp Castle,
West Grinstead, West Sussex**

September 2019

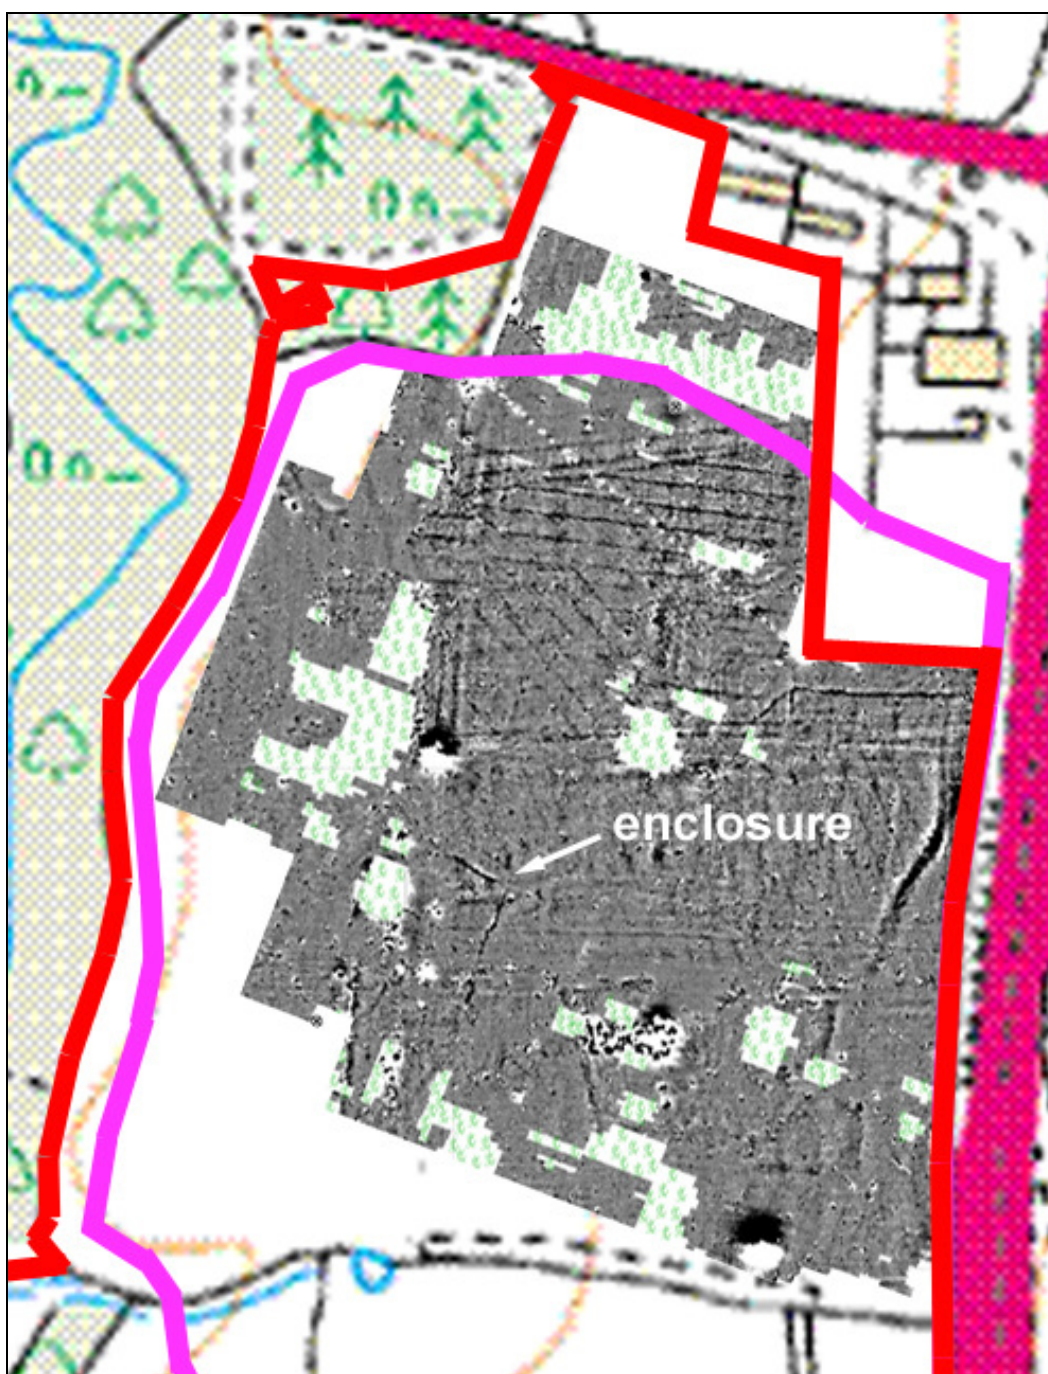
Figure 4 Buck Barn field showing the possible enclosure on the 2008 geophysical survey

2. The results of the 2008 geophysical survey had recorded a number of magnetic anomalies within Buck Barn Field, the majority of which, when investigated as part of the 2012 planning permission trial trenching, turned out to be associated with post-medieval or modern drainage. However, towards the south-west edge of the field, what appeared to be part of a small enclosure was noted, which proved to be of greater significance.

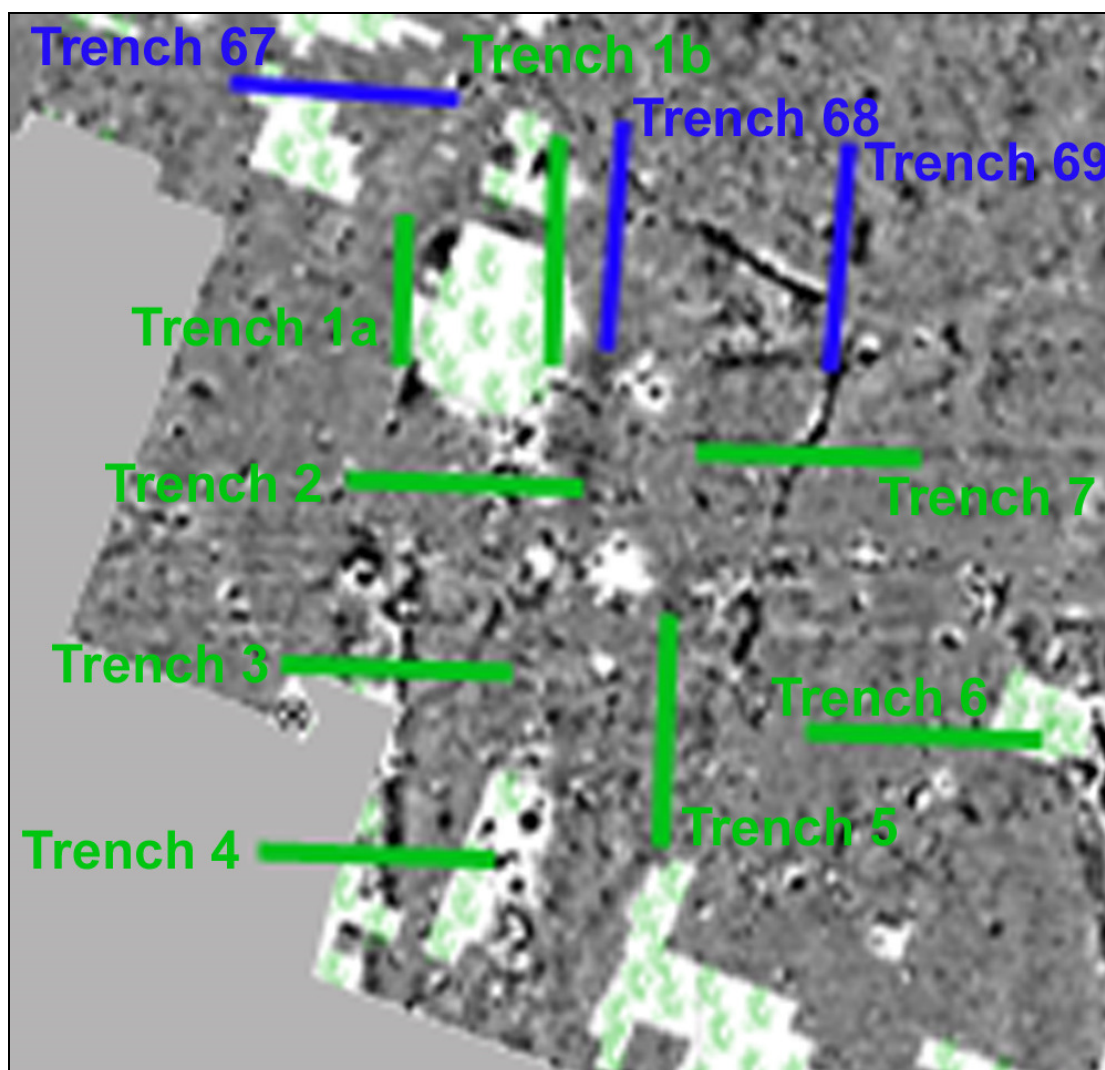
Figure 5 Extract from the 2008 geophysical survey showing the position of the trenches excavated in 2014 (Nos. 67 – 69) and 2019 (Nos. 1a, 1b & 2–7)

3. The programme of trial trenching following on from the 2012 permission, undertaken by WSA, has been ongoing since November 2013 within the fields immediately to the west of the A24. It was in two of these trial trenches (Nos. 68 & 69), over the possible enclosure noted on the geophysical survey within the Buck Barn Field, that features of an Iron Age and/or Romano-British date were found. This has now been supplemented by the results from an additional eight trial trenches excavated in September 2019 to the south and west (Nos 1a, 1b & 2-7).

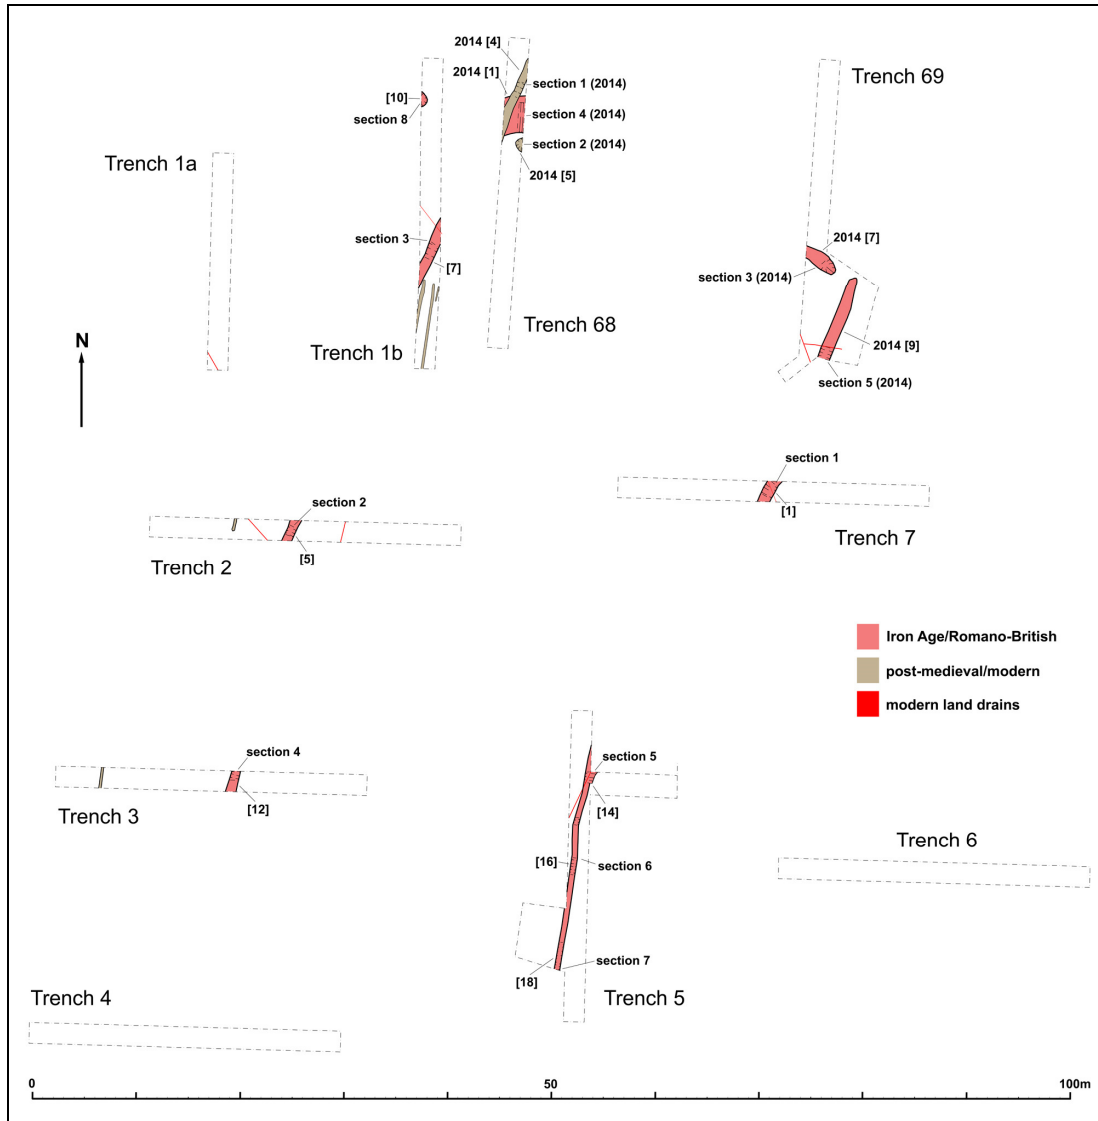
Figure 6 Plan of Trenches 1a, 1b, 2-7, 68 & 69

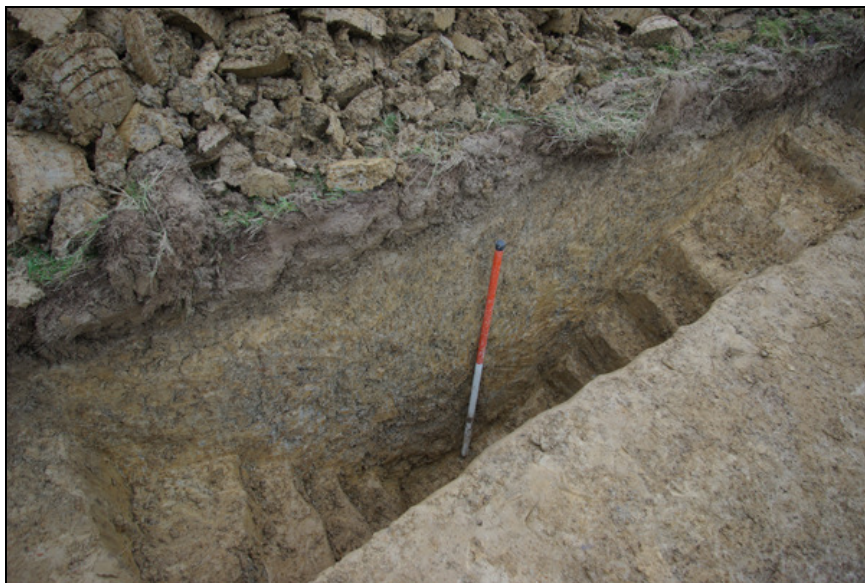
Figure 7 Section 4 (2014) across Ditch 2014 [1] in Trench 68, looking south-east

4. In Trench 68 a substantial curving ditch (2014 [1]) was recorded, c.3.5m wide and c.1m deep, with rounded base and sides sloping at c. 50° externally and c.30° internally. It was filled with mottled yellow and grey silty clay (2014 (2)) containing two sherds of Roman pottery, three fragments of fired clay, and a single burnt flint. Within Trench 68 there were also two other features, one a north-east to south-west running ditch (2014 [3]) and the other a small pit (2014 [5]). The former cut across the in-filled Ditch2014 [1], and is therefore clearly later in date, while the latter contained post-medieval/modern brick and post-medieval/modern pottery within its fill (2014 (6)). The ditch is likely to be linked to a medieval or later field boundary.

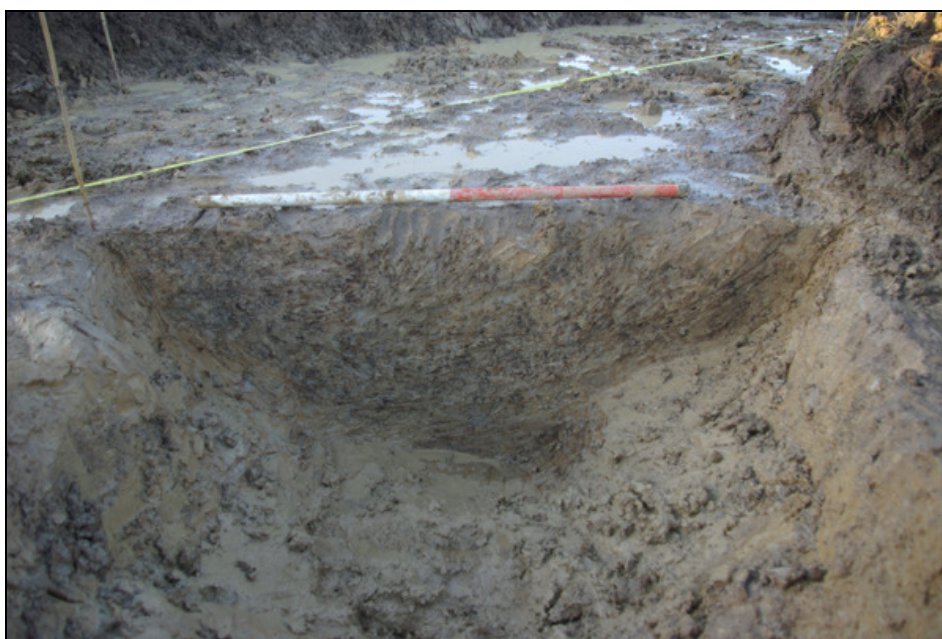
Figure 8 Section 3 (2014) across Ditch 2014 [7] in Trench 69, looking north-west

5. In Trench 69, two lengths of ditch were exposed, one running approximately north-south (2014 [9]), and the other east-west (2014 [7]). The latter stopped just shy of the former, leaving a gap of c.1.5m. Ditch 2014 [7], within the excavated section, was c.1.35m wide and c.0.6m deep, with rounded base and sides sloping at c.45°. It contained six sherds of Late Iron Age or early Roman pottery. Ditch 2014 [9], within its excavated section, was c.1.4m wide and c.0.55m deep, with rounded base and sides sloping at c. 50° externally and c.30° internally. It contained five sherds of Roman pottery.

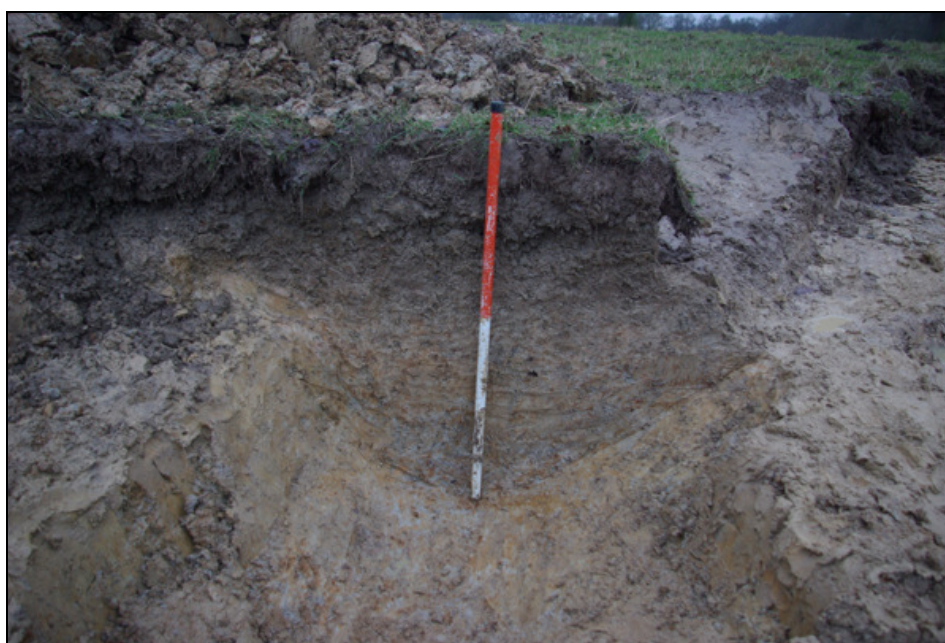
Figure 9 Section 5 (2014) across Ditch 2014 [9] in Trench 69, looking south-west

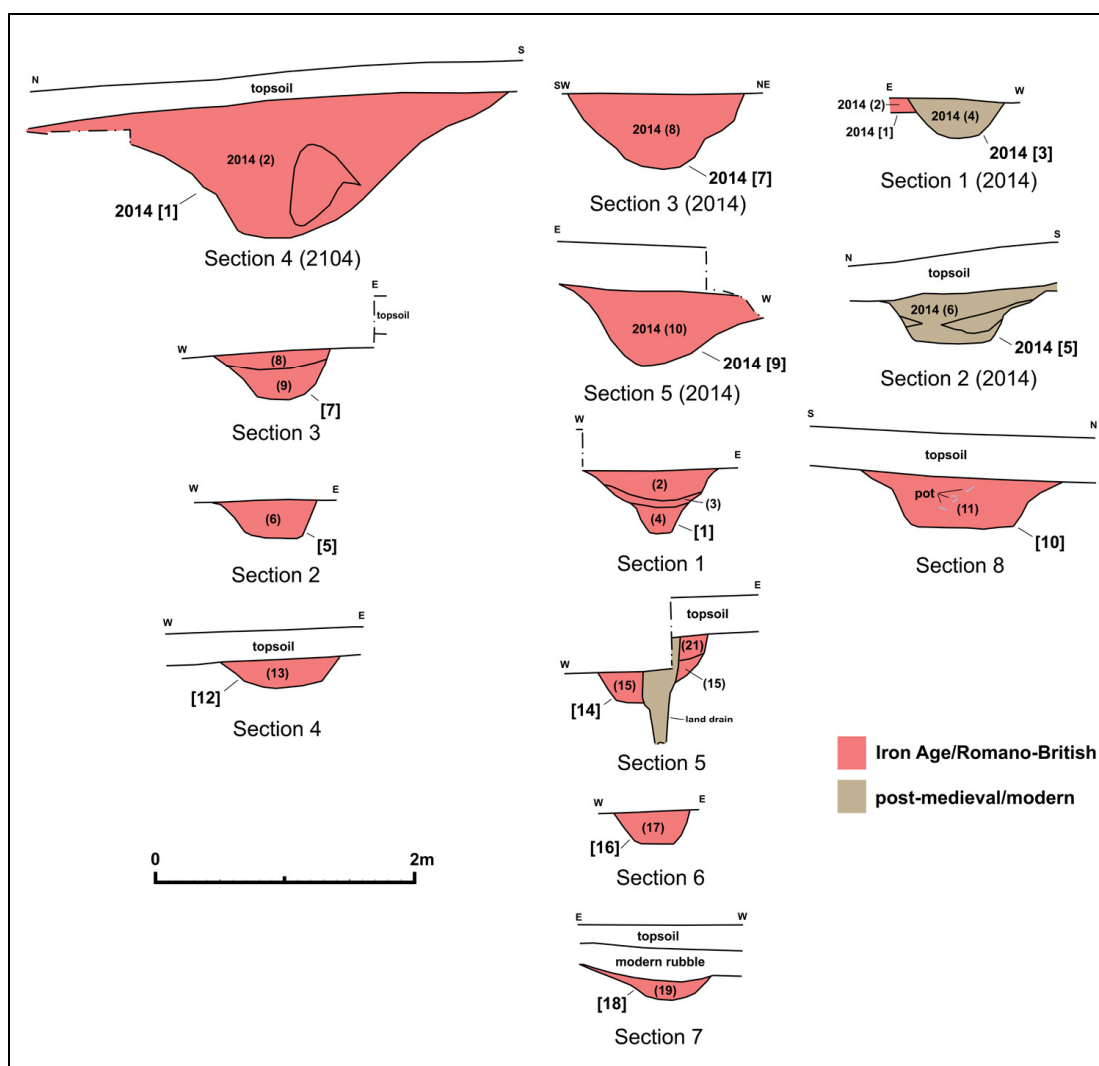
Figure 10 Sections across the excavated features. The column to the left shows all those from the western side of the enclosure, from north to south, while those in the central column are from the eastern side, again from north to south.

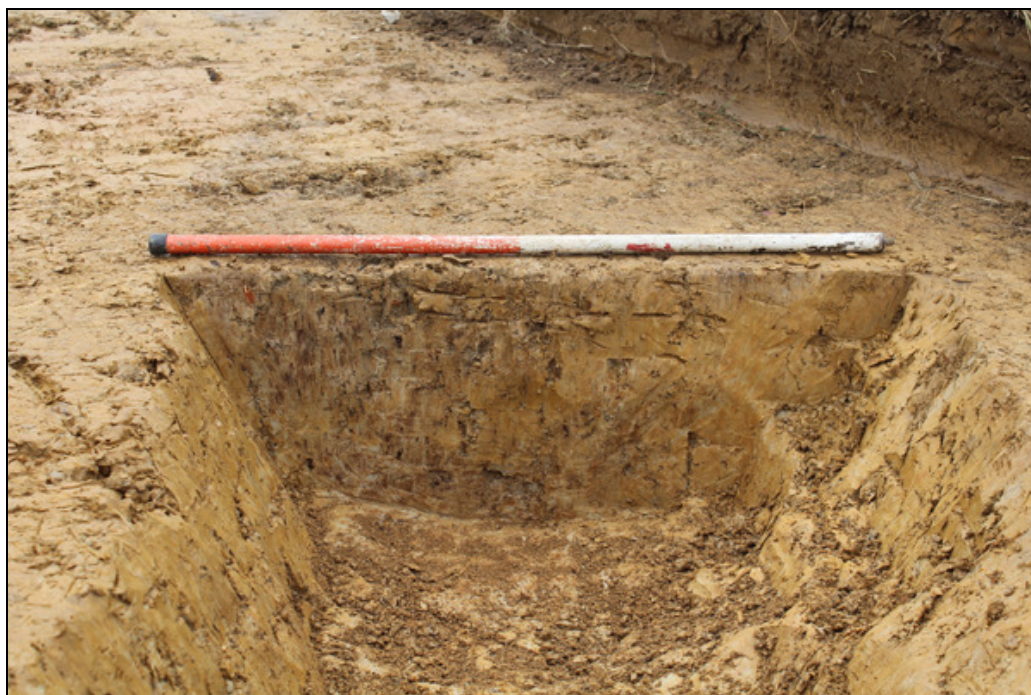
Figure 11 Section 3 across Ditch [7] in Trench 1b, looking south-west

6. Trench 1b contained a stretch of ditch running approximately north-east to south-west ([7]), and to the north a probable pit ([10]), only part of which lay within the trench. Ditch [7], within the excavated section, was c.0.9m wide and c.0.4m deep, with rounded base and western side sloping at c.50° and eastern at c.60°. It was filled with an upper layer (8), c.0.15m deep, composed of grey brown silty clay and a lower layer (9), c.0.25m deep, of yellow/orange/grey clay. Layer (8) contained a

single sherd of early Roman pottery and a large black pebble (231g). Pit [10], within its excavated section, was c.1.5m in diameter and c.0.4m deep, with a flat base and sides sloping at c. 60°. It was filled by a grey/brown/orange silty clay (11) and contained 74 sherds of early Roman pottery, the majority from one vessel, two fragments of Roman tile (23g) and a grey oval pebble (33g). At the south end of the trench were three narrow slots cut into the natural clay, partially filled with crushed chalk and brick. These are considered to be post-medieval or modern cart or machine tracks.

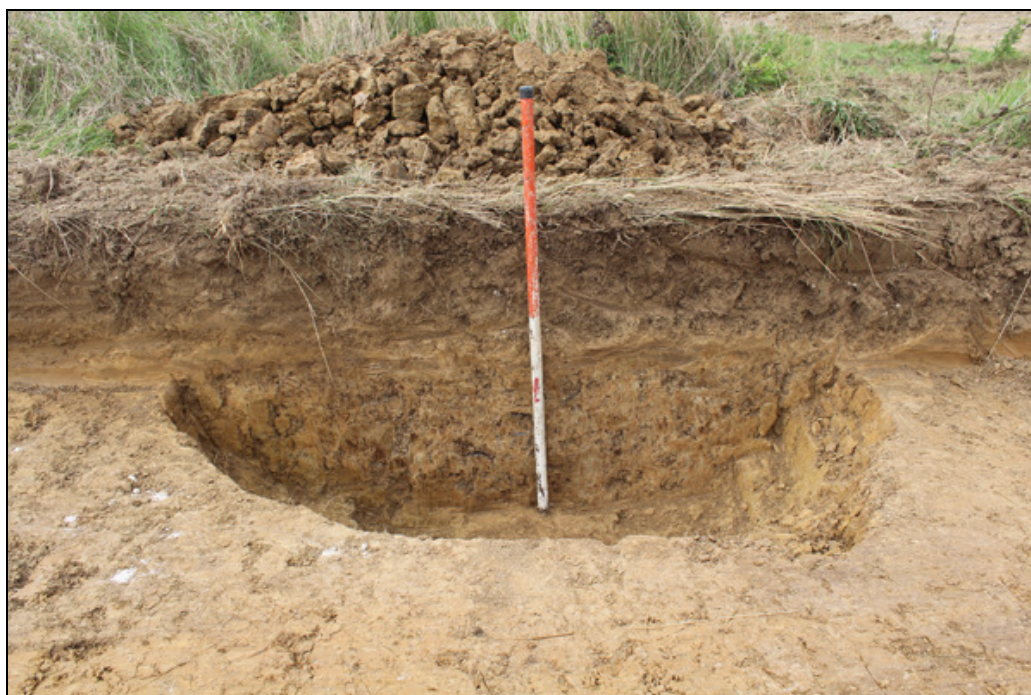
Figure 12 Section 8 across Pit [10] in Trench 1b, looking west

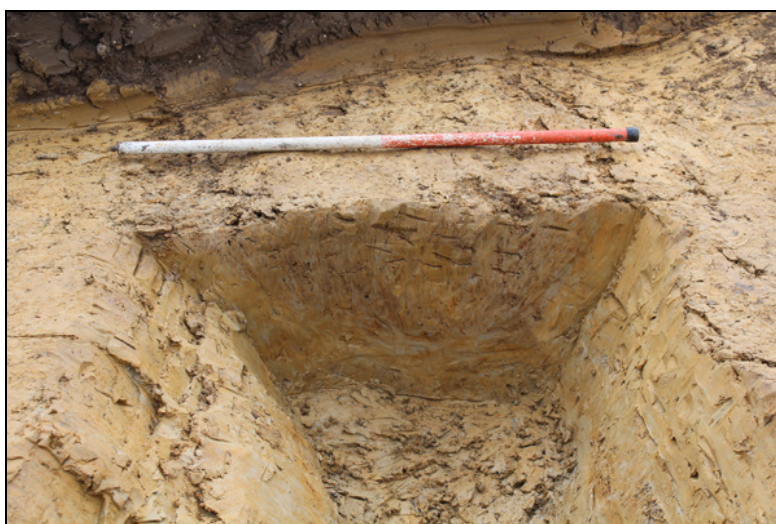
Figure 13 Section 3 across Ditch [5] in Trench 2, looking north-east

- Trench 2 contained a stretch of ditch running approximately north-east to south-west ([5]) which, within the excavated section, was c.0.75m wide and c.0.3m deep, with rounded base and western side sloping at c.50° and eastern at c.70°. It was filled with a single layer (6) composed of grey/yellow/orange silty clay, with occasional flecks of fired clay and charcoal. To the west of this ditch was another narrow slot cut into the natural clay filled with crushed chalk, and the cuts of two land drains were visible to both the east and west.

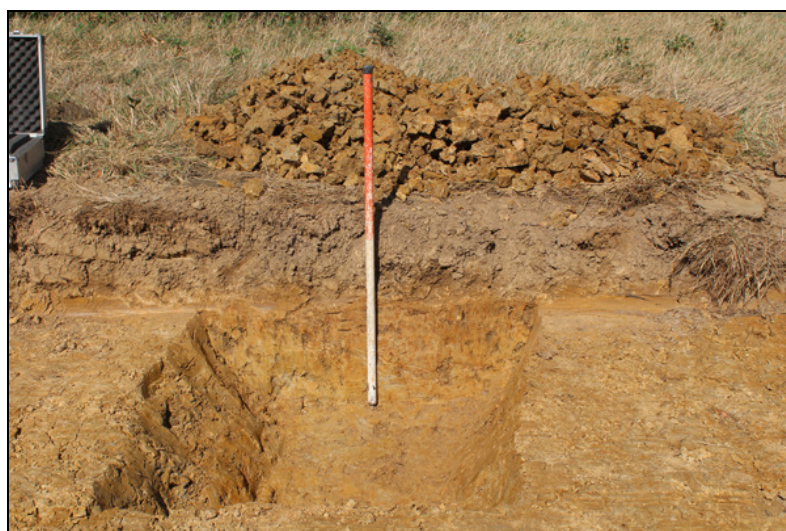
Figure 14 Section 4 across Ditch [12] in Trench 3, looking north-east

- Trench 3 contained a stretch of ditch running approximately north-east to south-west ([12]) which, within the excavated section, was c.0.9m wide and c.0.2m deep, with rounded base and western side sloping at c.40° and eastern at c.55°. It was filled with a single layer (13) composed of grey/orange silty clay, with occasional flecks of charcoal and two sherds of Late Iron Age pottery. Towards the western end of the trench there was another of the narrow slots cut into the natural clay filled with crushed chalk.

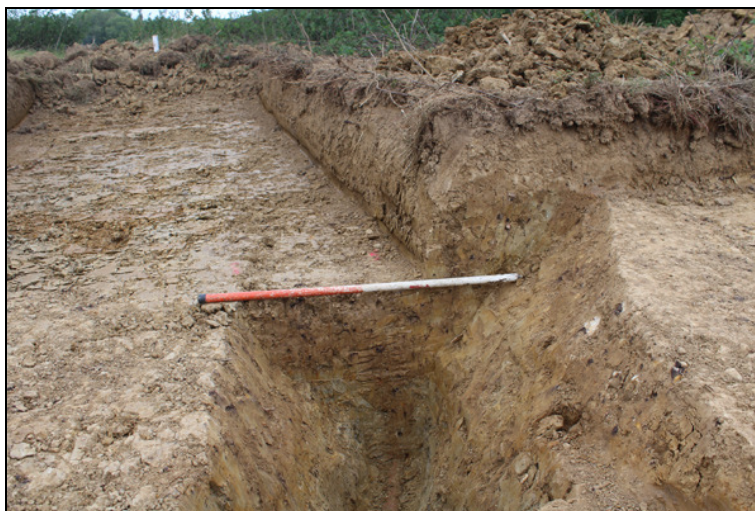
Figure 15 Section 5 across Ditch [14] in Trench 5, looking north-east

9. Trench 5, which was extended to both the east and west, contained a single long stretch of ditch running approximately north-east to south-west ([14], [16] & [18]). A slight, but clear, deviation in the course of the ditch towards the northern end of the trench might suggest the presence of some fixed object to the east, such as a large tree. At its northern end, in Section [14], the ditch was c.1m wide and c.0.5m deep, with rounded base and western side sloping at c.60° and eastern at c.50°. It was filled with an upper layer (21), c.0.2m deep, of grey brown silty clay and a lower layer (15), c.0.3m deep, of grey/brown clay silt. Layer (15) contained a block of Wealden sandstone (450g) which shows indications of use, possibly for crushing or hammering. The ditch at this point was crossed by a modern land drain. In Section [16] the ditch was c.0.6m wide and c.0.25m deep, with a flat base and western side sloping at c.55° and eastern at c.65°. It was filled with a layer (17) composed of grey brown clay silt with frequent Wealden sandstone fragments. At its southern end, in Section [18] the ditch was c.0.75m wide and c.0.15m deep, with rounded base and sides sloping at c.40°. It was filled with a single layer (19) of grey brown clay silt.

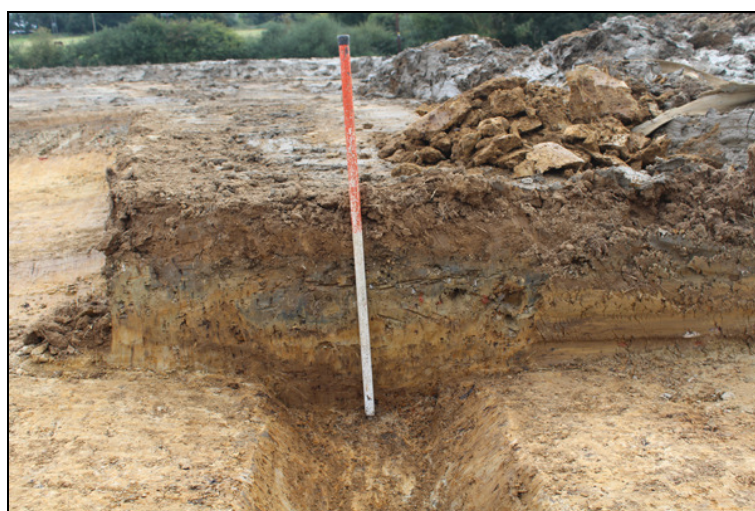
Figure 16 Section 7 across Ditch [18] in Trench 5, looking south-west

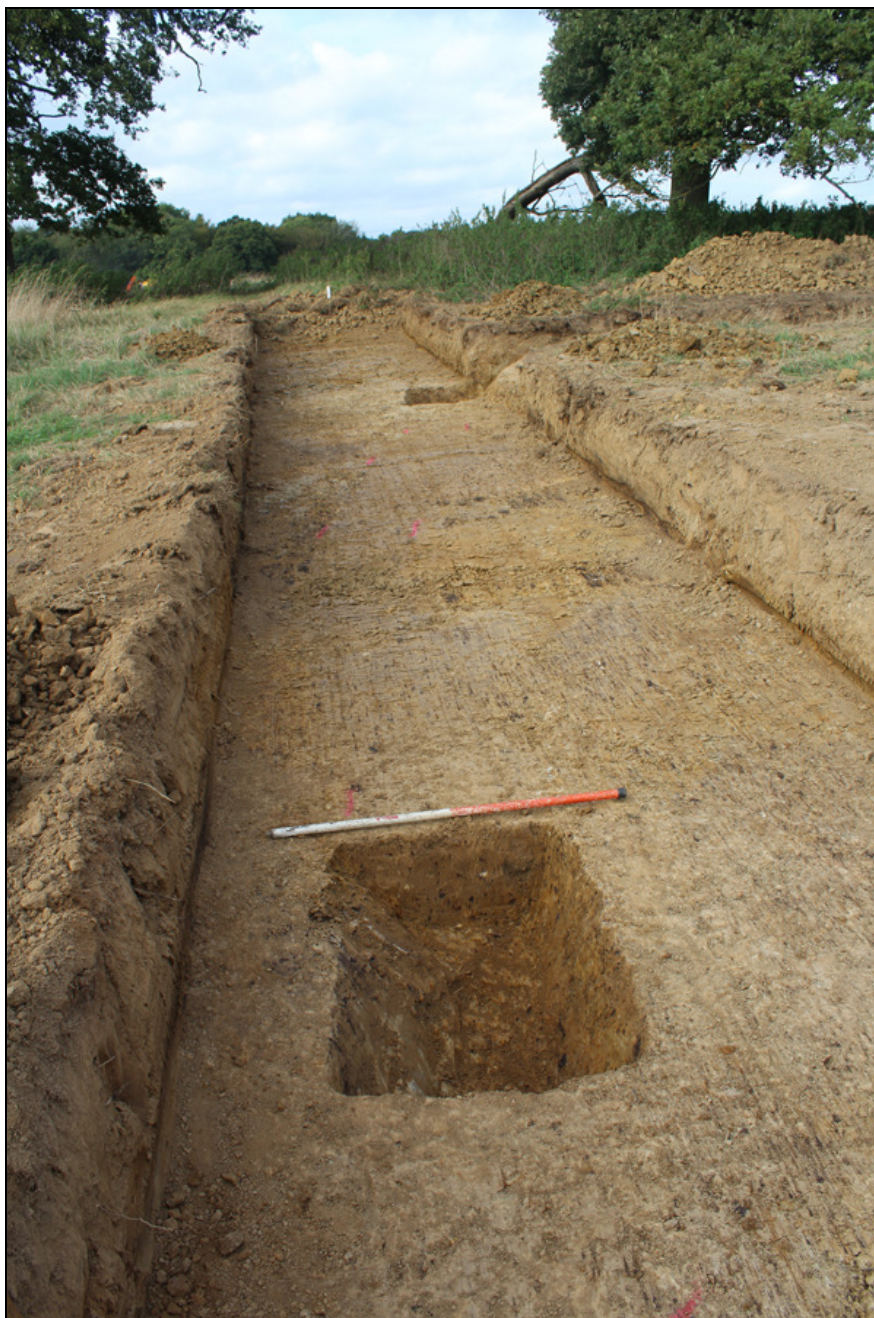
Figure 17 Section 6 across Ditch [16] in Trench 5, looking north-east. The deviation in the line of the ditch can be seen between this section and the one visible in the background

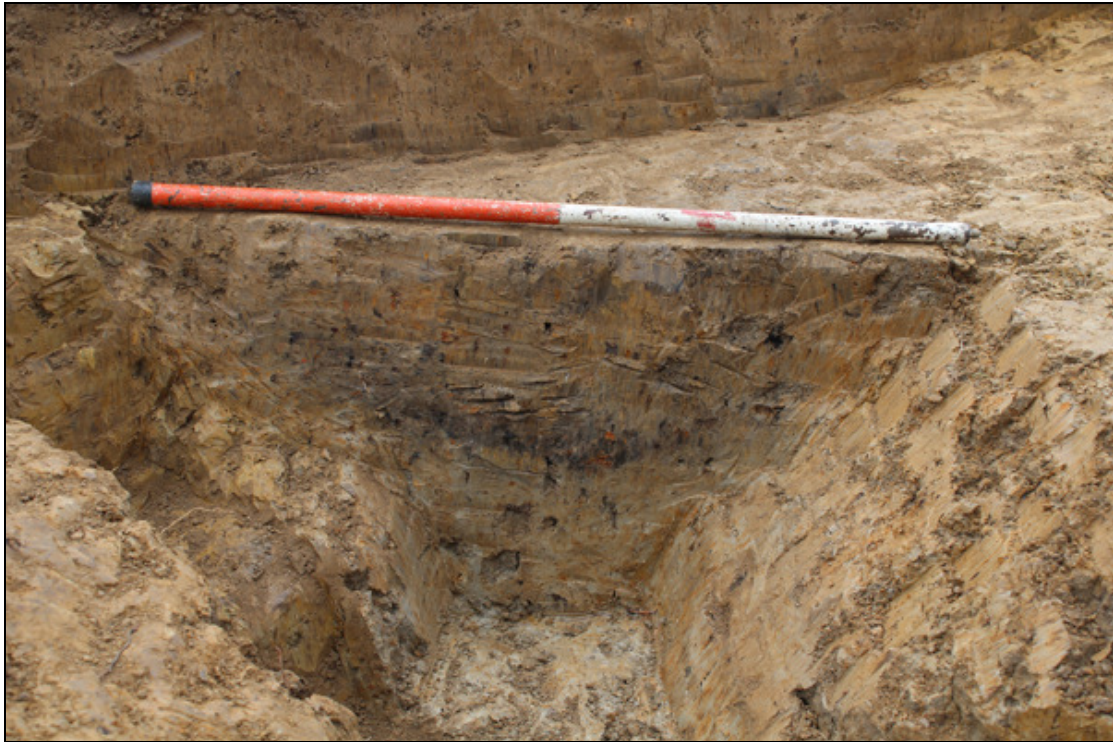
Figure 18 Section 1 across Ditch [1] in Trench 7, looking north-east

10. Trench 7 contained a stretch of ditch running approximately north-east to south-west ([1]) which, within the excavated section, was c.1m wide and c.0.5m deep, with a flat base and sides sloping at c.60°. It was filled with three layers: an upper (2), c.0.25m thick, composed of grey/orange silty clay, with occasional flecks of fired clay; a middle (3) composed of the same clay, c.0.05m thick, with abundant charcoal and frequent fired clay flecks; and a lower, c.0.20m deep, again of grey/orange silty clay. Layer (2) contained 19 sherds of Late Iron Age – early Roman pottery and three fragments of Roman tile (34g), Layer 3 contained 17 sherds of Late Iron Age pottery and Layer (4), 14 sherds of Late Iron Age pottery and a small white pebble (38g).

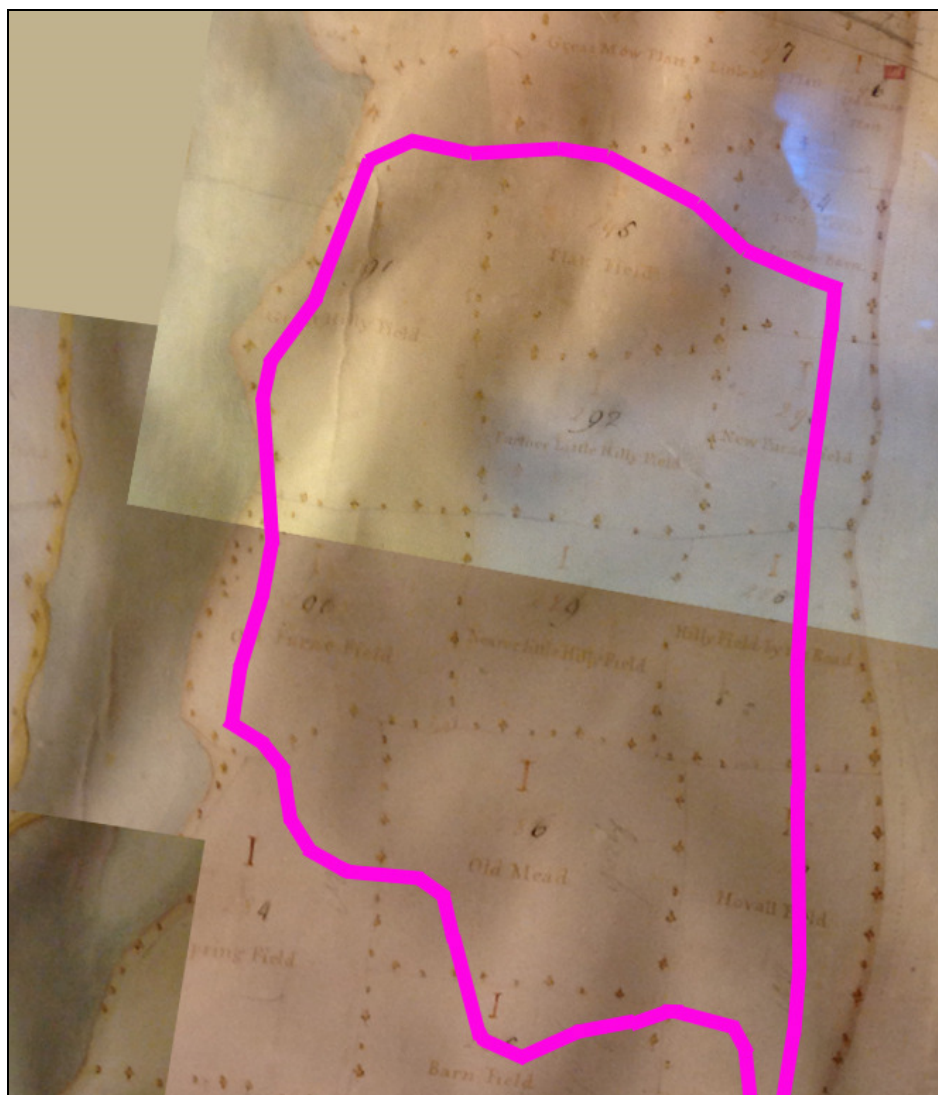
Figure 19 Extract from the 1754 Crow map of the Knepp Estate showing the Buck Barn area. The proposed scheme area is outlined in purple.

1. The earliest historic map of the Knepp Estate, drawn up in 1754 by James Crow (currently located in the hall of Knepp Castle), shows what is now Buck Barn field divided into ten smaller fields, of which nine lie wholly or in part within the proposed scheme, and are named as: “Great Mow Platt”, “Great Hilly Field”, “Platt Field”, “Two Acre By Further Barn”, “Further Little Hilly Field”, “New Furze Field”, “Old Furze Field”, “Nearer Little Hilly Field” and “Hilly Field by the Road”.

2. The building that on subsequent maps is to be called “Buck Barn” lies outside the site boundary, under the forecourt of the current service station, but on the 1754 map it sits within a field named “Old House Platt”, suggesting either that a house once occupied this site, or that the building changed its use.

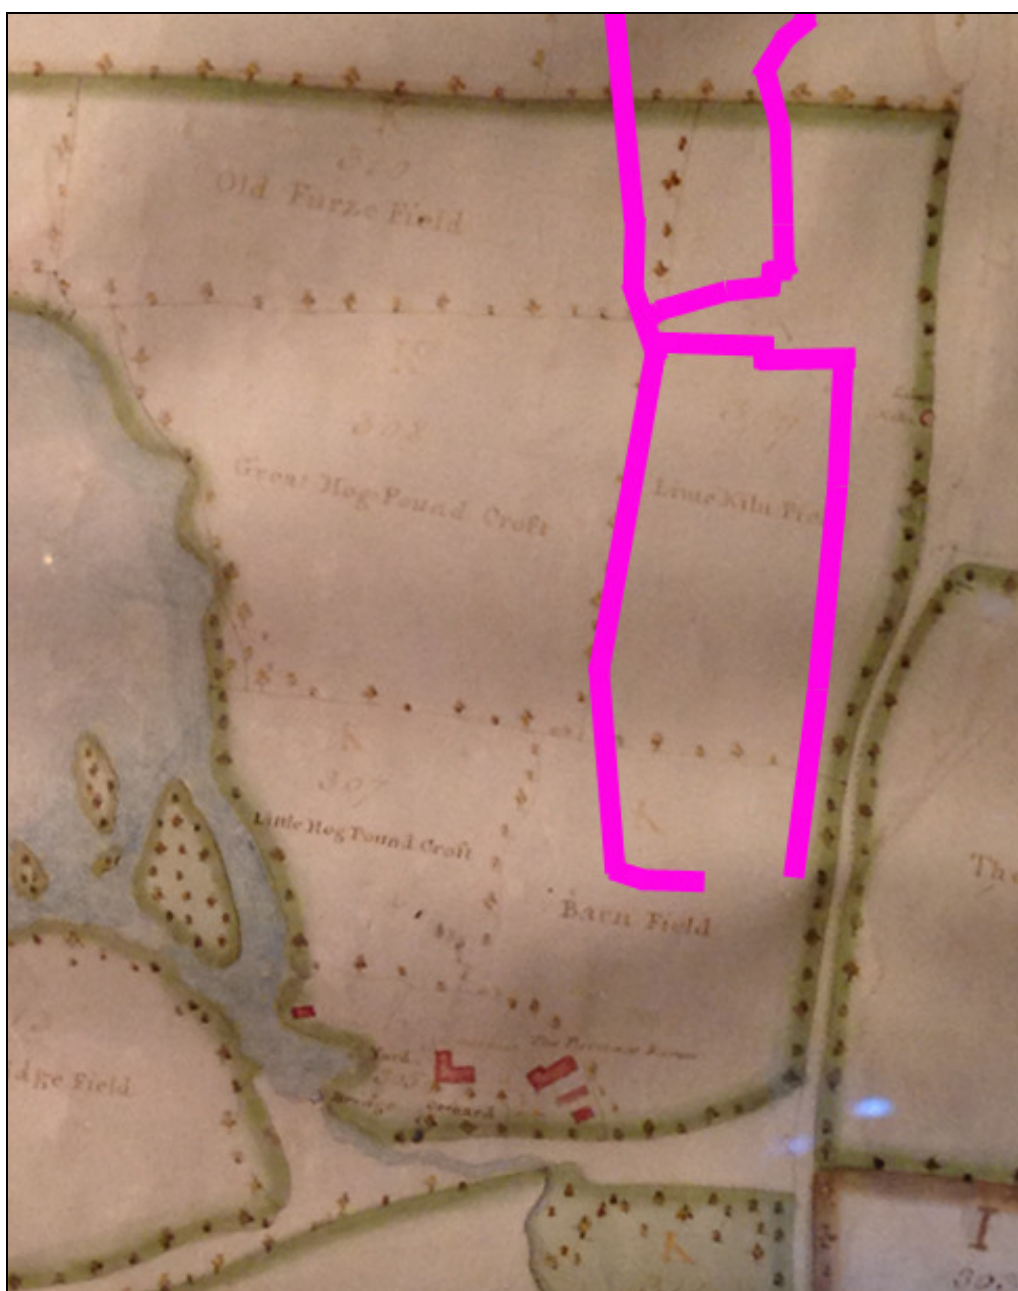
Figure 20 Extract from the 1754 Crow map of the Knepp Estate showing the Floodgate Farm area. The proposed scheme area is outlined in purple.

4. To the south, and adjacent to Floodgate Farm, now lie three fields, which were once two, the northern being named “Lime Kiln Field”, with the kiln depicted about half way up its eastern edge and now under the A24, the southern, still one field, named “Barn Field”, presumably from one of the adjacent farm buildings. Floodgate Farm itself is named “The Furnace Farm” on the 1754 map, perhaps providing some corroborative evidence that this was once the site of the post-medieval iron works. Aside from the principal dwelling, surrounded by gardens, a yard and an orchard, four buildings are shown, three to the east and one alongside the pond to the west. The south-east arm of the Mill Pond runs to a bridge adjacent to “Furnace Farm”, after which it narrows to a stream. If a furnace were to have once existed in this location, it is likely that it would have been positioned at this point, just below the bridge. There is a suggestion of a relief stream running around the north-east side of the Farm, which appears at this date to have been infilled or covered.

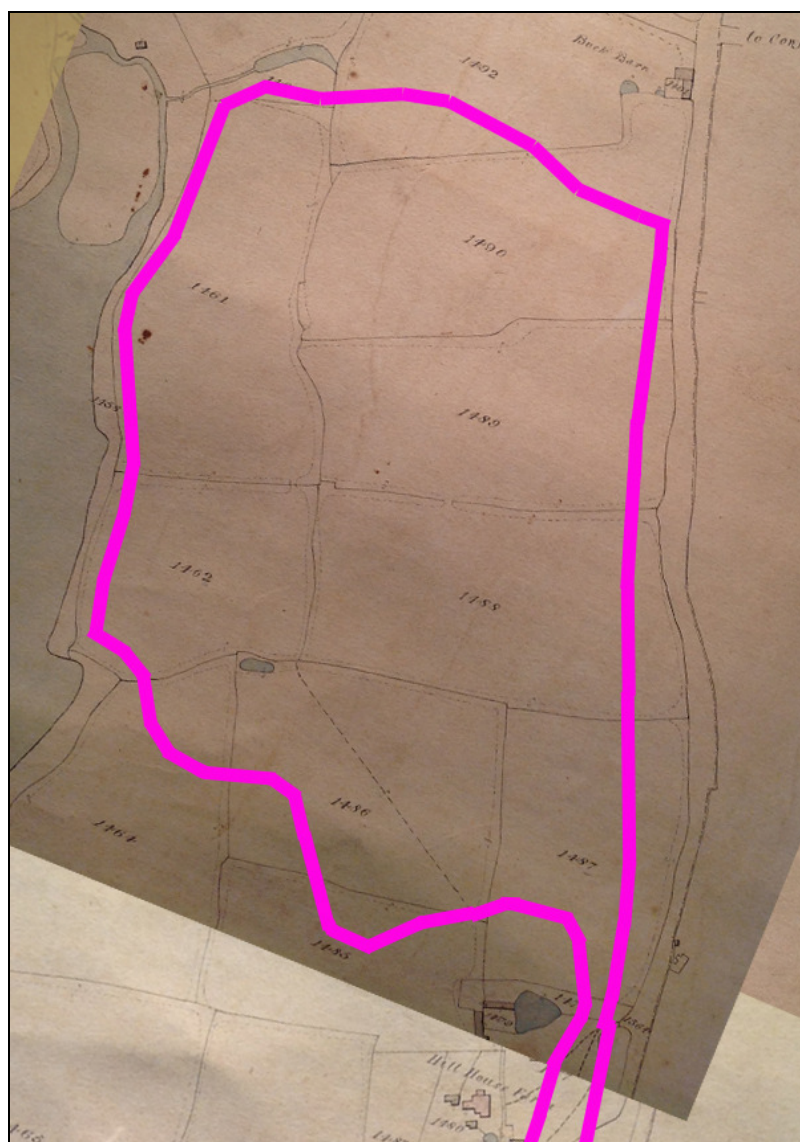
Figure 21 Extract from the c.1847 Tithe map of the Knepp Estate showing the Buck Barn area. The proposed scheme area is outlined in purple.

- The c.1847 Tithe map (WSRO TD/W108) is the next detailed map to record the Knepp Estate. Buck Barn field is still subdivided, but three boundaries have been removed, resulting in only six fields within the area of the proposed scheme. To the south, the fields to the immediate north of Hill House Farm remains the same, although the existing pond is now marked at the north-west corner of the central one. Hill House Farm is shown as little changed, but the fields to the south have now lost all their boundaries with their incorporation into the park of the recently built “Nep Castle” on the western side of Knepp Pond. The two building plots adjacent to the A24 remain.

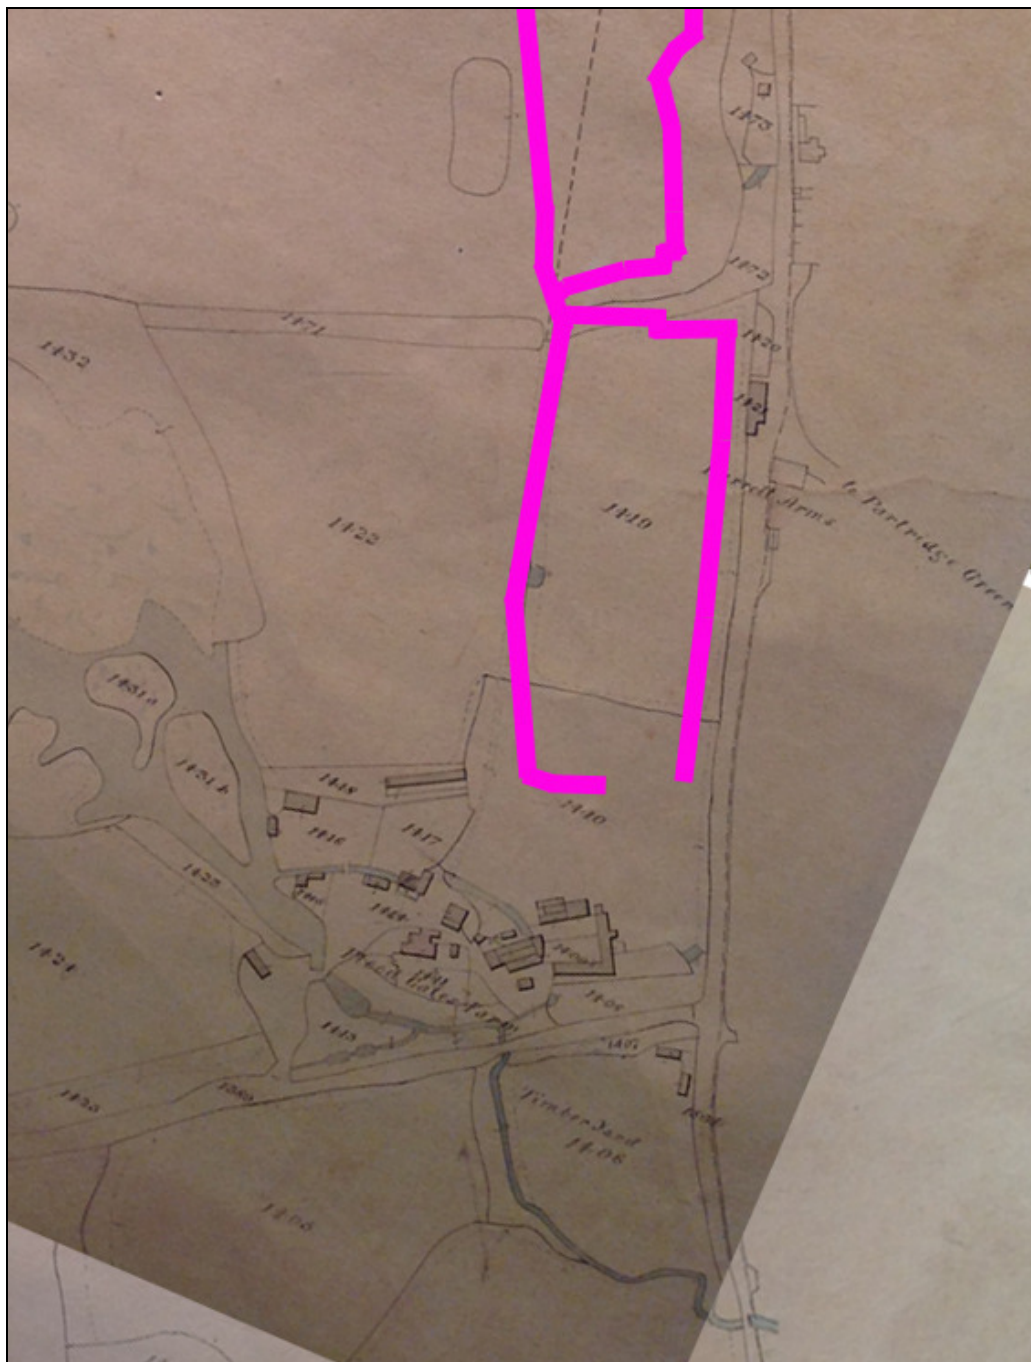
Figure 22 Extract from the c.1847 Tithe map of the Knepp Estate showing the Floodgate Farm area. The proposed scheme area is outlined in purple.

6. The two fields to the south, next to Floodgate Farm, which is labelled as such, are unchanged in outline from 1754, save that a new track has been laid across the northern, running east-west from the A24, cutting off its top end, which has been included within the park. In addition a pond is marked against its western boundary, and the lime kiln depicted in 1754 against its eastern side has been replaced with a building, opposite which, on the corner of the road to Partridge Green, another new structure appears, labelled “Burrell Arms”. The number of buildings forming “Flood Gates Farm” has increased considerably. The Tithe map also shows the possible relief stream, shown on the 1754 map, as an intermittently open leat running up to the eastern end of one of the Farm buildings. It is likely that this once held a water-wheel, possibly powering a mill, but perhaps more likely farm machinery.

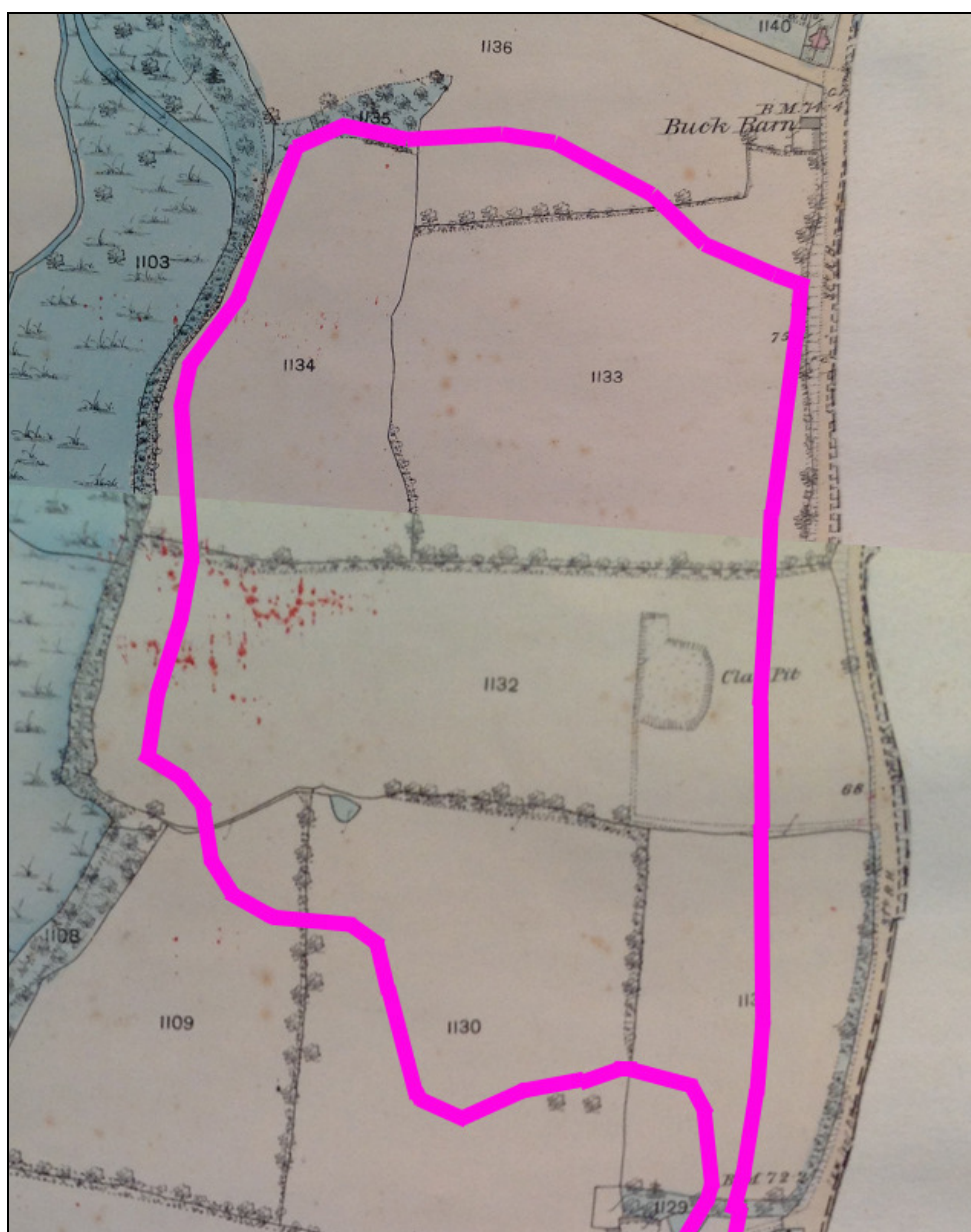
Figure 23 Extract from the 1875 OS 1st edition 1:2500 map showing the Buck Barn area. The proposed scheme area is outlined in purple.

7. The 1875 1st edition 1:2500 Ordnance Survey map shows the loss of a further two boundaries within Buck Barn field and the appearance of a “Clay Pit” close to its south-eastern corner, linked to the A24 by a trackway. It is probable that this clay pit is associated with the “Waterloo Brick Works” marked on the east side of the A24 on a map of 1862 (WSRO Add Mss 2009). The fields to the south are unchanged, save for the loss of the dividing boundary within the central field. Hill House Farm is largely unchanged, as is the parkland to the south and the two building plots adjacent to the A24, save that the southern now has an enlarged curtilage to the west. The two fields next to Floodgate Farm are unchanged, as is the building in their north-east corner.

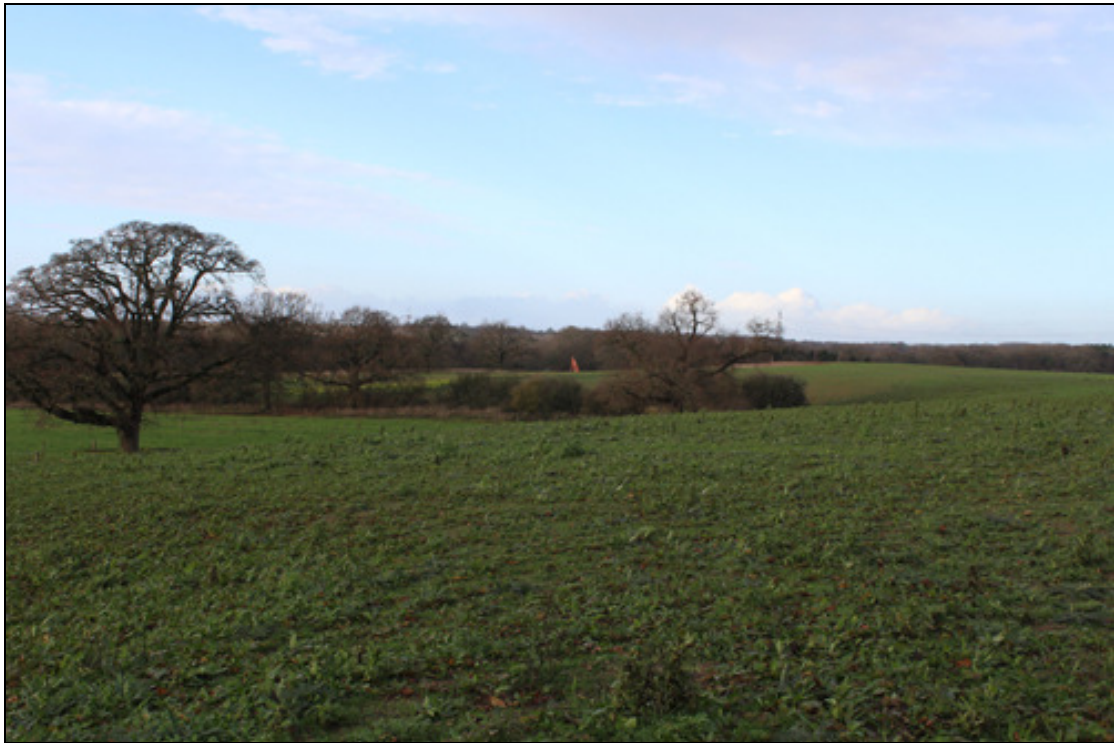
Figure 24 The Buck Barn field area, looking north-west from the top of the existing bund. The site of the Late Iron Age/Romano-British enclosure is on the ridge just to the right of the orange digger arm

1. A site visit was undertaken on 7th December 2018. The fields in the Buck Barn area, as stated above, have already been the subject of re-landscaping works, with a bund now extending along the eastern side of the field and round its north-eastern corner. Those parts of the field, and its neighbours to the south, which have not been covered with this new bund, still lie under pasture, with no discernible earthworks. The Late Iron Age/Romano-British enclosure sits upon a slight westwards running spur projecting from the main north-south ridge that forms the eastern side of the shallow valley in which the Knepp pond is located. This spur is currently topped by a small clump of mature trees which span the enclosure. The fields to the east and north-east of Floodgate
