**(Heritage Impact Assessment - Archaeology -
West Sussex Archeology)**

**Heritage Statement for Proposed Works at Knepp Castle,
West Grinstead, West Sussex**

September 2019

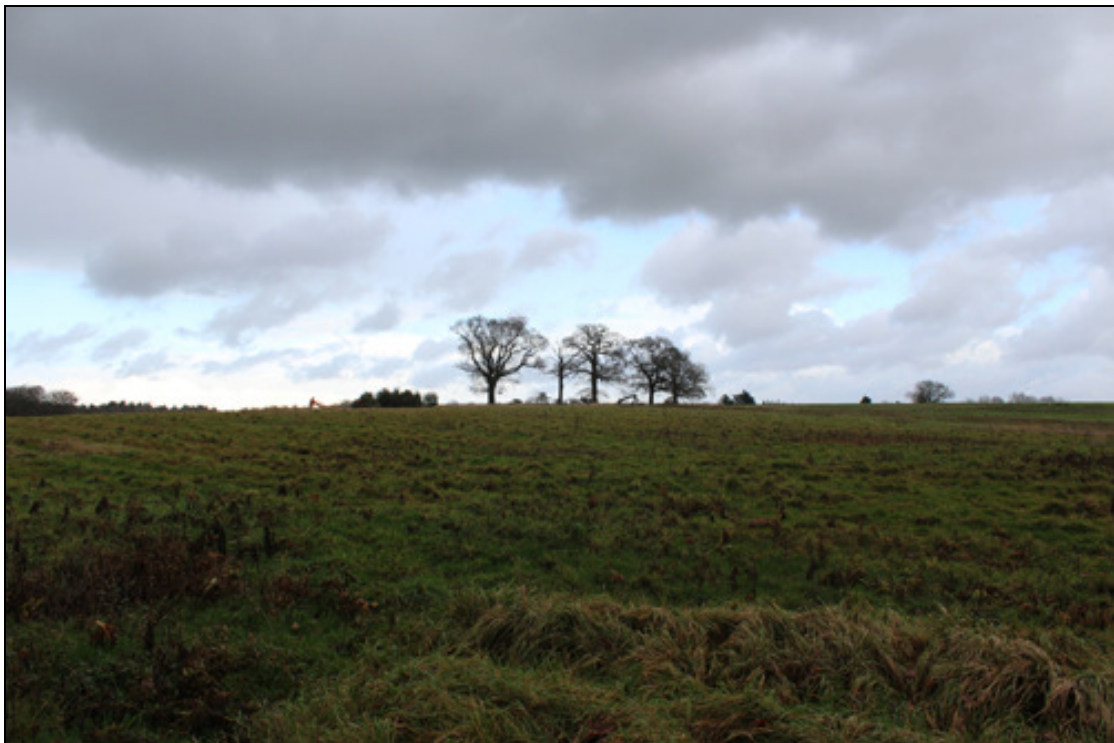
Figure 25 The site of the Late Iron Age/Romano-British enclosure, looking north-east from the south-west corner of Buck Barn field.
