FORD ENERGY RECOVERY FACILITY AND
WASTE SORTING AND TRANSFER FACILITY,
FORD CIRCULAR TECHNOLOGY PARK

ENVIRONMENTAL STATEMENT
TECHNICAL APPENDIX G: GROUND
CONDITIONS AND THE WATER ENVIRONMENT

FORD ENERGY RECOVERY FACILITY AND WASTE SORTING AND TRANSFER FACILITY, FORD CIRCULAR TECHNOLOGY PARK GEOENVIRONMENTAL DESK STUDY

Project number 1620007830-001
Version 1
Document type Report
Document number 1620007830-001-RAM-XX-XX-RP-YE-10002
Date 26/03/2021
Prepared by Brian Kerr and Bianca Hoad
Checked by Wendy Furgusson
Approved by Rachel Holloway
Description Geoenvironmental Desk Study

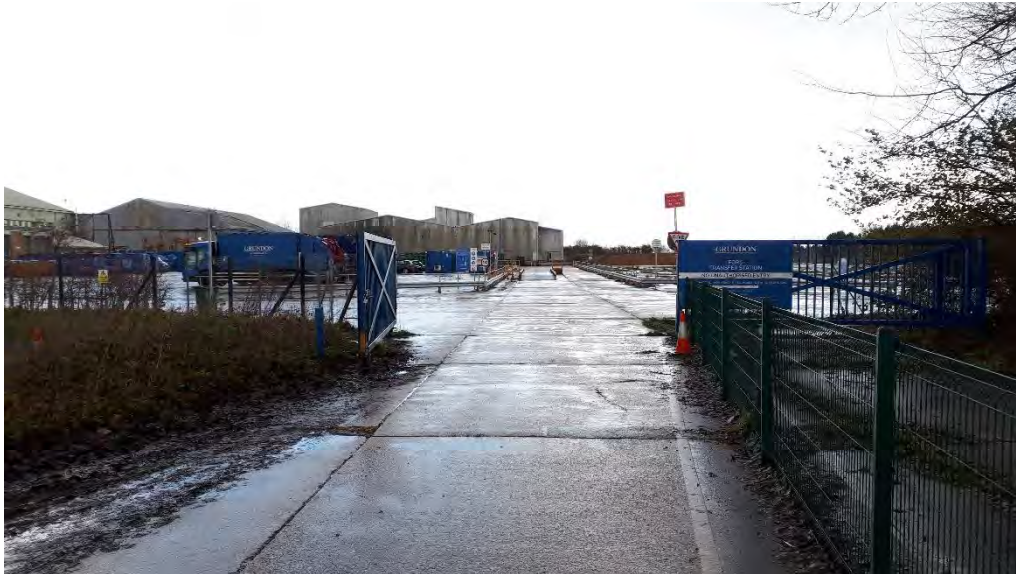
The site office is a series of portacabins, with the weighbridge adjacent to the site. No wheel wash facilities were noted by the weighbridge (see Plate 1).

Photo 1. Site entrance, weighbridge and site office (centre of plate). It should be noted that since the time of the site visit this is no longer the site entrance.

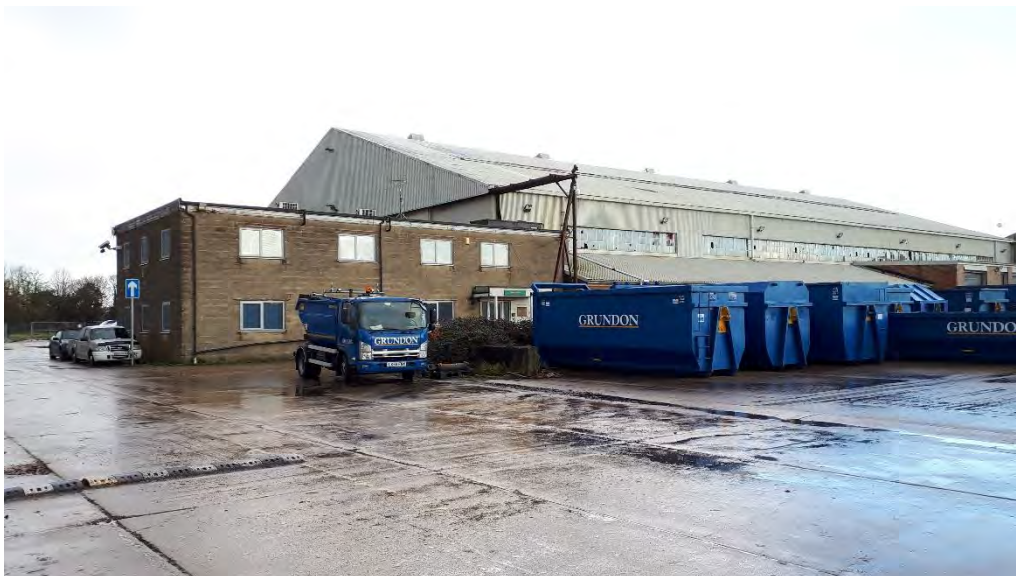
Photo 2. Hangar 1

The construction is steel frame with a corrugated cladding and a concrete floor. Currently, Hangar 1 is vacant, and no access was possible. A single-storey lean-to construction is located at the southern face of the hangar, which was formerly used as office space (see Plate 2 and Plate 3). On the western side of the hangar a bricked extension was noted which was formerly used as the sales office and was constructed in the 1980s.

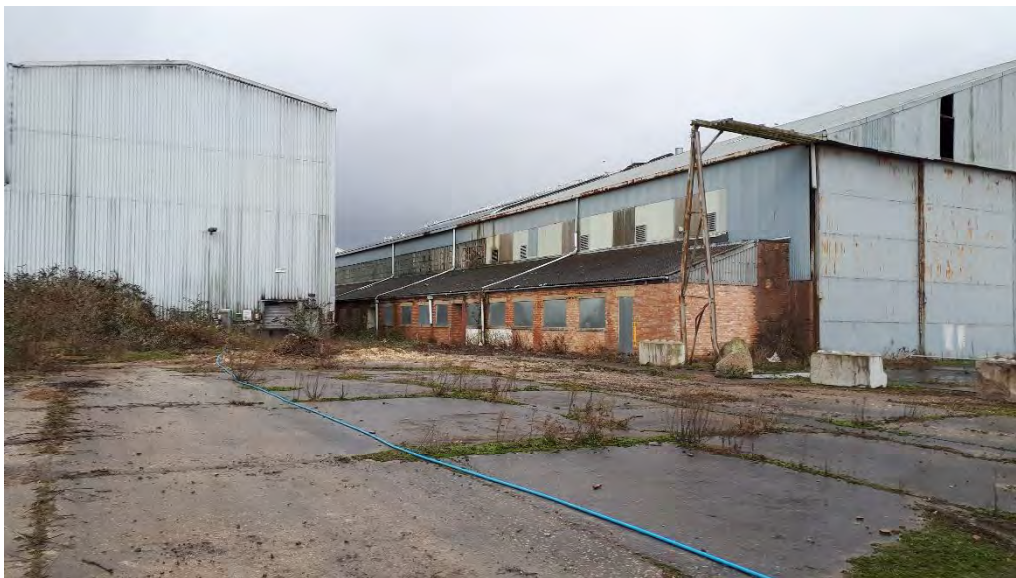
Photo 4. Hangar 2

Hangar 2 is located to the east of Hangar 1 and is also a steel frame, clad structure with a concrete floor. Currently, Hangar 2 is vacant, and no access was possible. There is a single storey lean-to building on the southern portion of the hangar (see Plate 4). On the northern side of Hangar 2 there are two separate, smaller single-storey buildings of brick construction. These are the former store and welfare offices (see Plate 5).

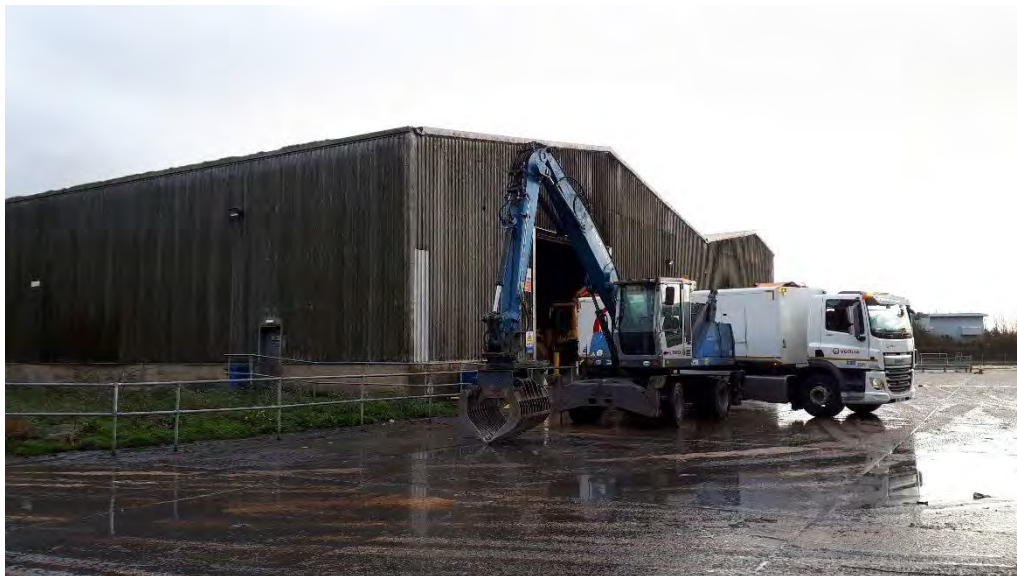
Photo 6. Main waste building

The main waste building is located approximately south of Hangar 2 and is currently used as an area for storing incoming waste (see Plate 6). The construction is steel frame with corrugated cladding and a concrete floor. The main entrance of the waste transfer building is from the eastern side, where the lorries enter to drop the waste. No access was possible during the site walkover. In front of the entrance is the vehicle wash down area and where the waiting lorries park.

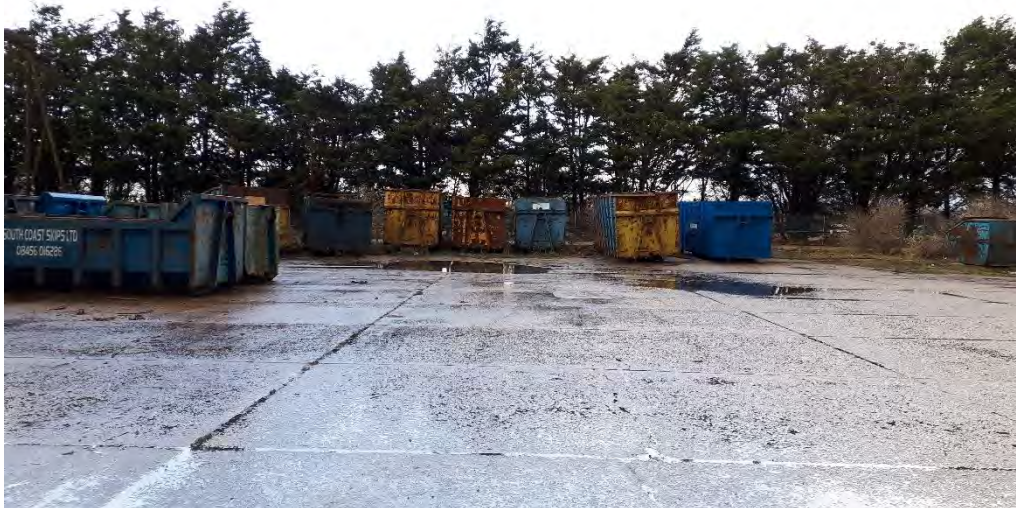
The external yard area (see Plate 7) is covered with concrete (rough mix), with vegetation noted to be growing in between the cracks. Surrounding Hangar 1 and Hangar 2 disused rails were noted within the concrete (see Plate 8). The northern external yard is used for storing empty waste bins and waste containers (see Plate 9). The southern external yard areas are currently not being utilised (see Plate 10). A large earth stockpile was noted adjacent to the waste transfer building and several smaller mounds of earth were noted in relation to the construction of the new access road in the south-eastern corner of the site (see Plate 11). Currently, it is unknown when these stockpiles will be removed.

Photo 7. Yard area, facing northwards

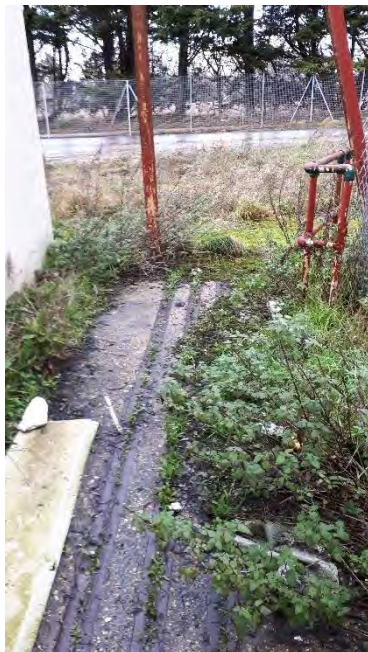
Photo 8. Old rails

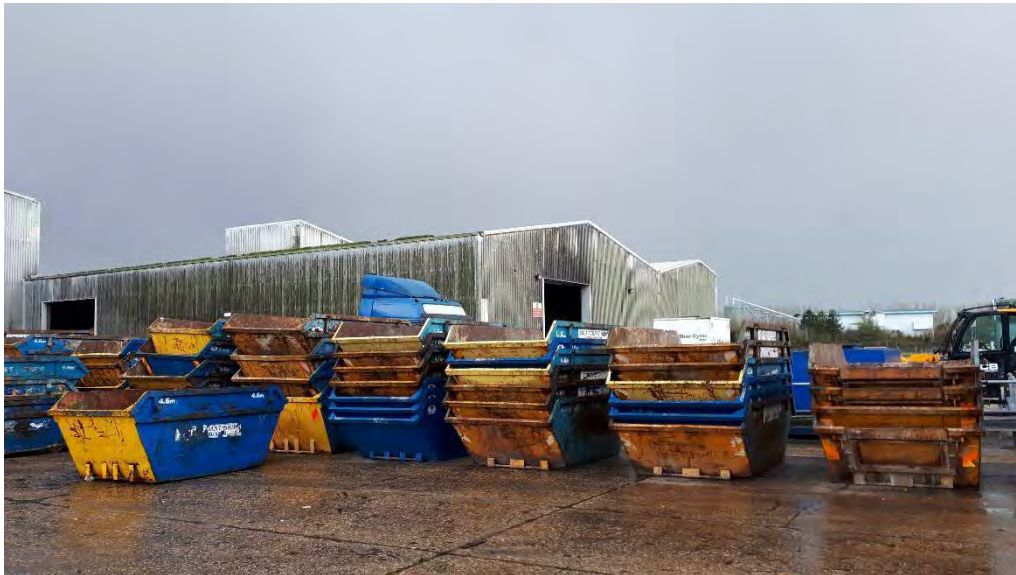
Photo 9. Northern external yard is used for storing empty waste bins and waste containers.

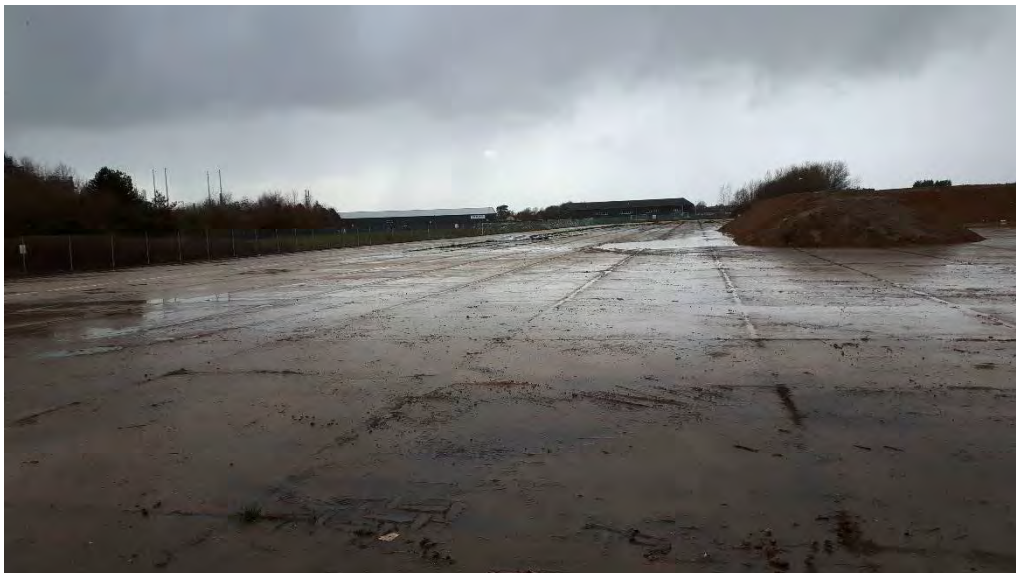
Photo 10. Southern external yard areas are currently not being utilised

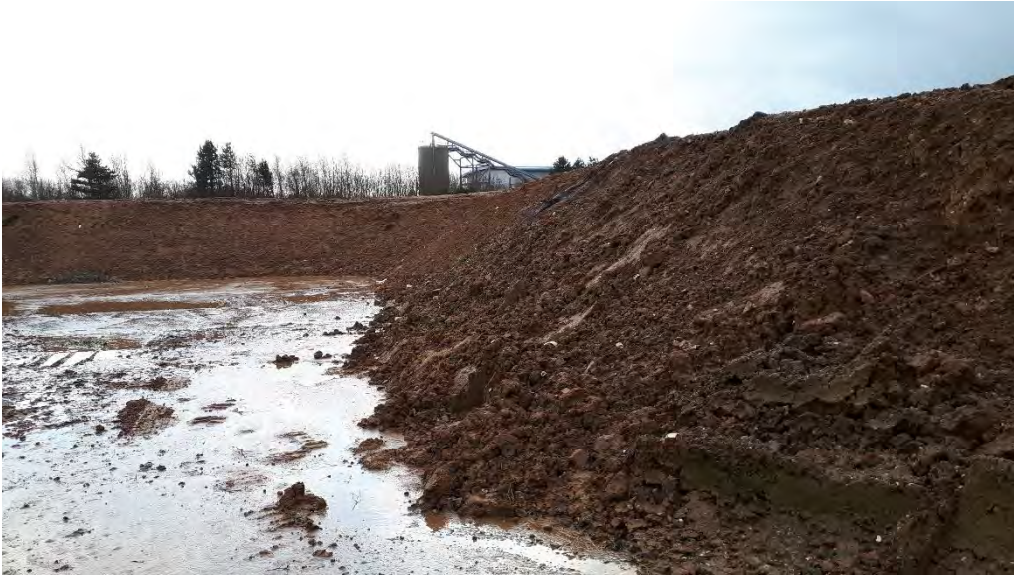
Photo 11. Earth stockpile

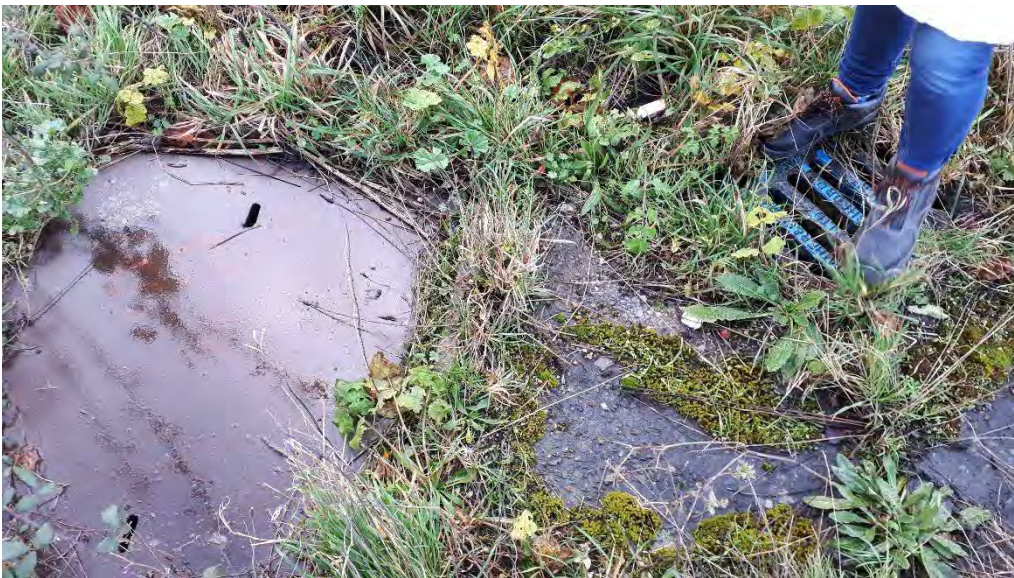
During the site walkover two manhole covers were noted, possibly indicating the presence of an interceptor or underground storage tank adjacent to Hangar 2 (northern side) (see Plate 12). In addition, directly in front of the Hangar 2 bricked lean-to an empty hollow hole covered by loose vegetation was noted. Historical desk-based information suggests the possible presence of interceptors, slurry pits or underground storage tanks (UST) (see Section 5.2 and Appendix G) in the vicinity. Due to the overgrown vegetation and uncertainty of the depth and contents of the hole it was deemed unsafe to investigate further (see Plate 13).

Photo 12. Cover Possibly Indicating the Presence of an Interceptor or Underground Storage Tank Adjacent to Hangar 2

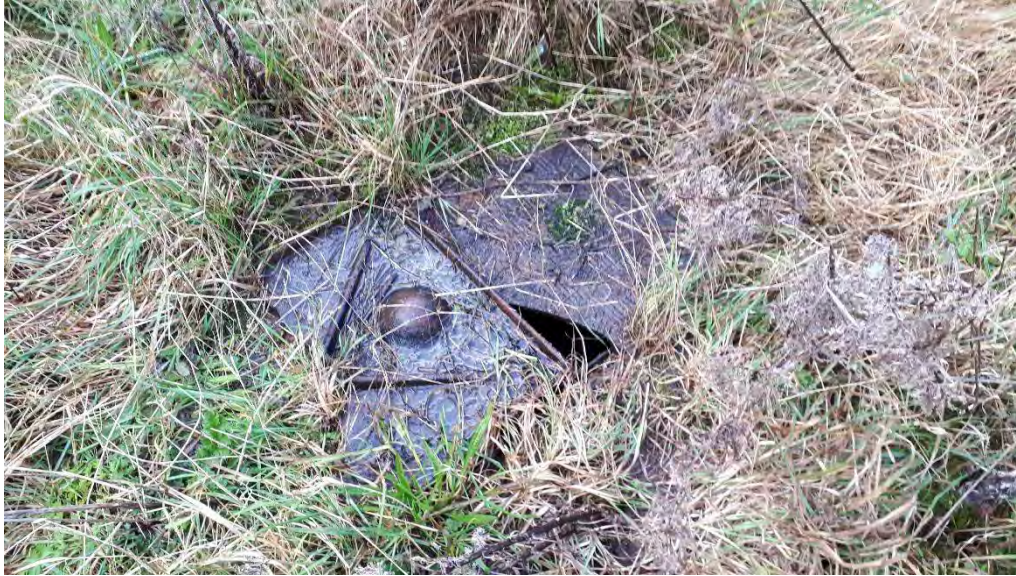
Photo 13. Cover Possibly Indicating the Presence of an Interceptor or Underground Storage Tank Adjacent to Hangar 2

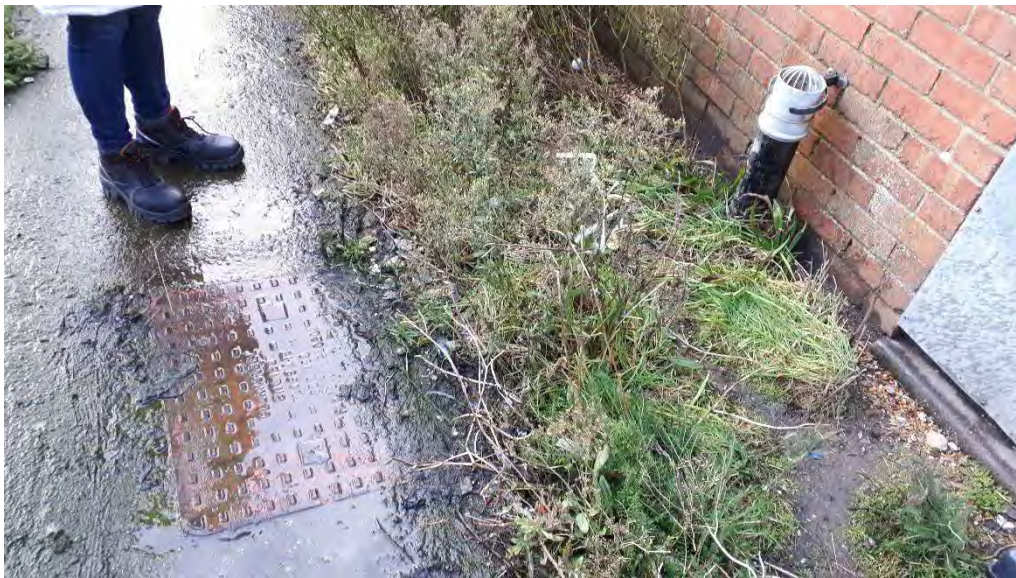
On the southern side of Hangar 2 (between Hangar 2 and the waste transfer building), a drain cover with a black pipe and white cap was noted. This may indicate the presence, or historical presence, of an underground tank or interceptor (see Plate 14).

Photo 14. Cover Possibly Indicating the Presence of an Interceptor or Underground Storage Tank Adjacent to Hangar 2

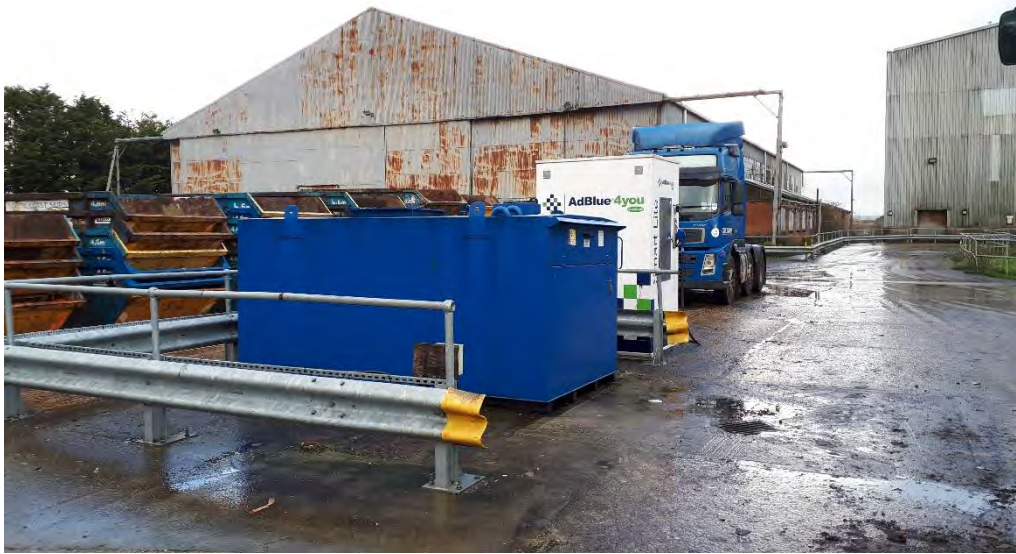
Within the centre of the site a 5,600 litres (l) oil tank (serial number 33588) was observed. The tank is associated with refuelling of onsite vehicles (see Plate 15). A spill kit was present adjacent to the tank. The tank appeared to be in good condition with no evidence of leaks or spillage on the surrounding concrete.

Photo 15. 5,600I Oil Tank

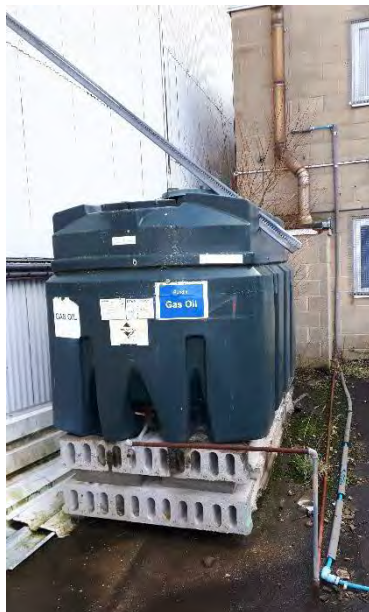
An above ground storage tank was observed at the western face of Hangar 1. The tank was labelled as containing gas oil (Bund 4) and is a Titan ES2500B, plastic internally banded tank with a capacity of 2,500 litres (l) (width 1,470 mm and height 1,550 mm). The tank sits on two concrete blocks/beams approximately one metre above the ground level above a concrete block which was free of staining (see Plate 16). Based on historical maps and desk studies, this tank is understood to have originally been located at the eastern-face of Hangar 1.

Photo 16. 2,500I Gas Oil Tank

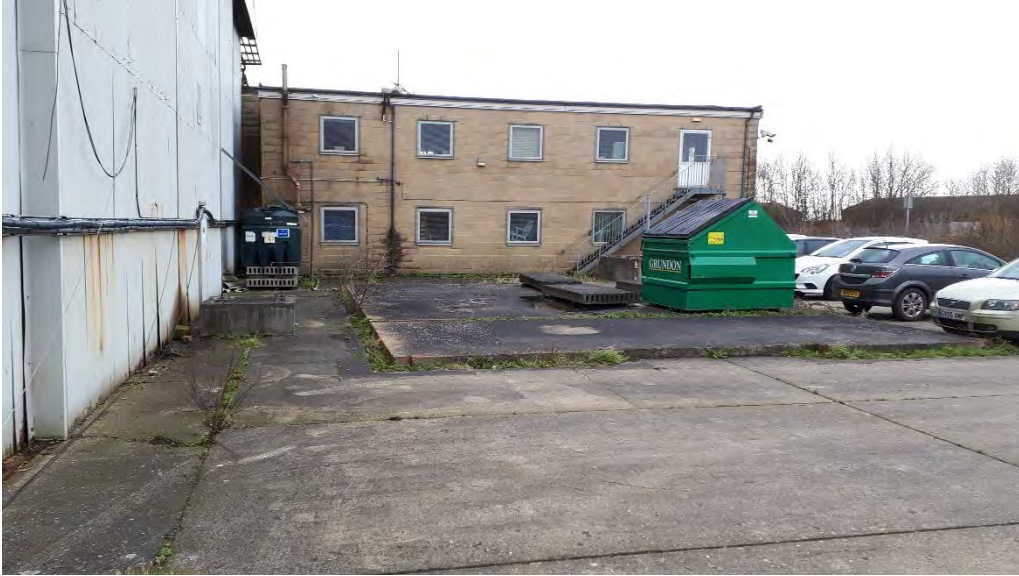
A banded concrete slab was observed at the western face of Hangar 1. This is understood to have been occupied by a boiler house containing a 40,000 l storage tank (containing heating oil). The boiler house and 40,000 l tank were no longer present at the time of the site walkover. The surface of the concrete slab was darker than the surrounding concrete hardstanding, however it was unclear if this was due to oil staining (see Plate 17).

Photo 17. Former Location of 40,000 l Tank Containing Heating Oil (now Occupied by Green Bin)

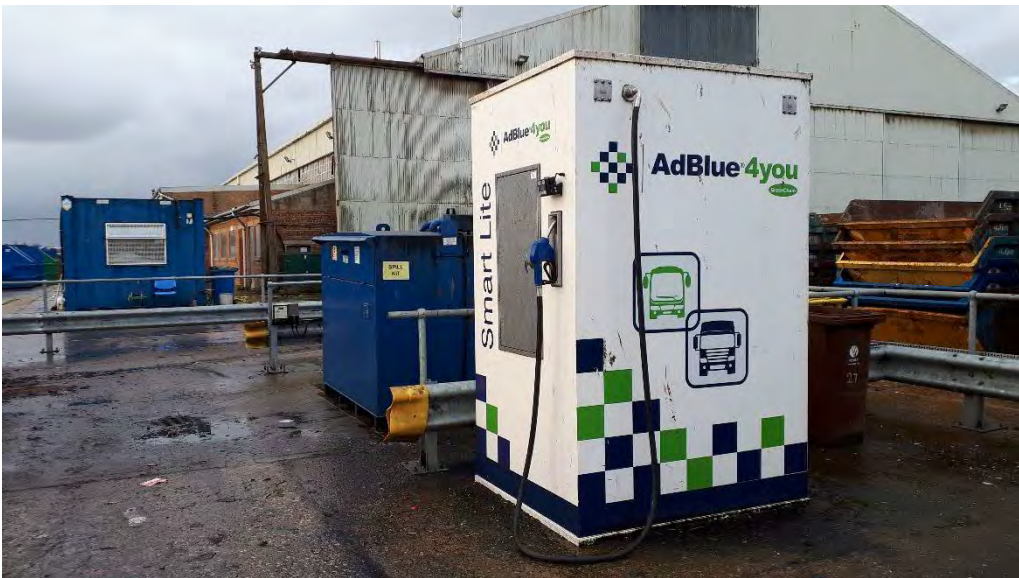
Adjacent to the oil tank located within the centre of the site an AdBlue (exhaust fluid) tank was noted for use by the lorries and onsite machinery. On the southern portion of Hangar 1 one oil tube was noted, however its contents were not identified (see Plate 18).

Photo 18. AdBlue Tank

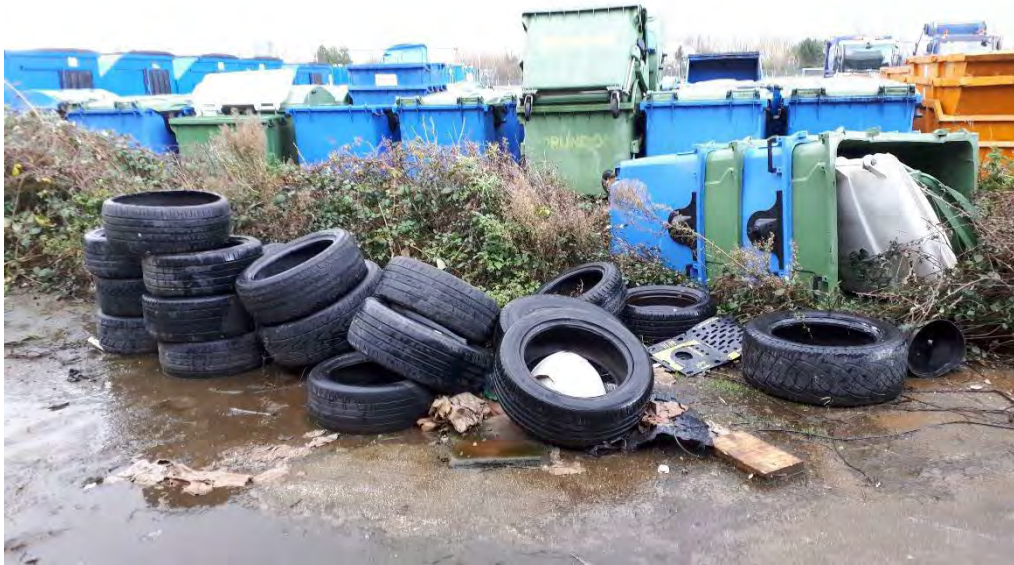
During the site walkover areas of stockpiled waste were recorded across site. The waste included old tyres, bikes, pipe work, metal cables, plastic, brick blocks and wooden planks (see Plate 19). Although no asbestos contaminating materials (ACMs) were noted within the stockpiled waste, there is the potential for ACM to be present onsite. Asbestos surveys undertaken in the buildings onsite in 2004 identified asbestos within the building fabric.

Photo 19. Fly Tipped Waste

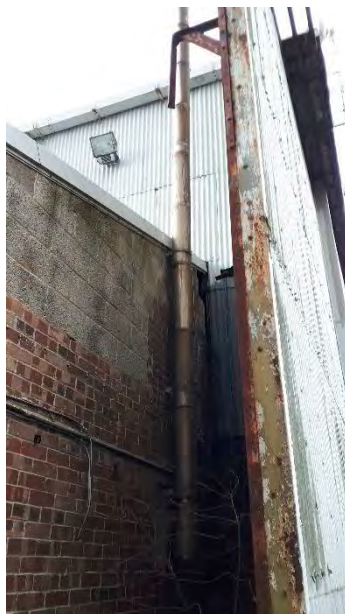
There was no evidence of any activities on site that would generate emissions to air that could be considered to present a significant environmental contamination risk to the ground. However, two disused metal piped chimneys were noted on Hangar 1 (see Plate 20).

Photo 20. Disused Metal Piped Chimney

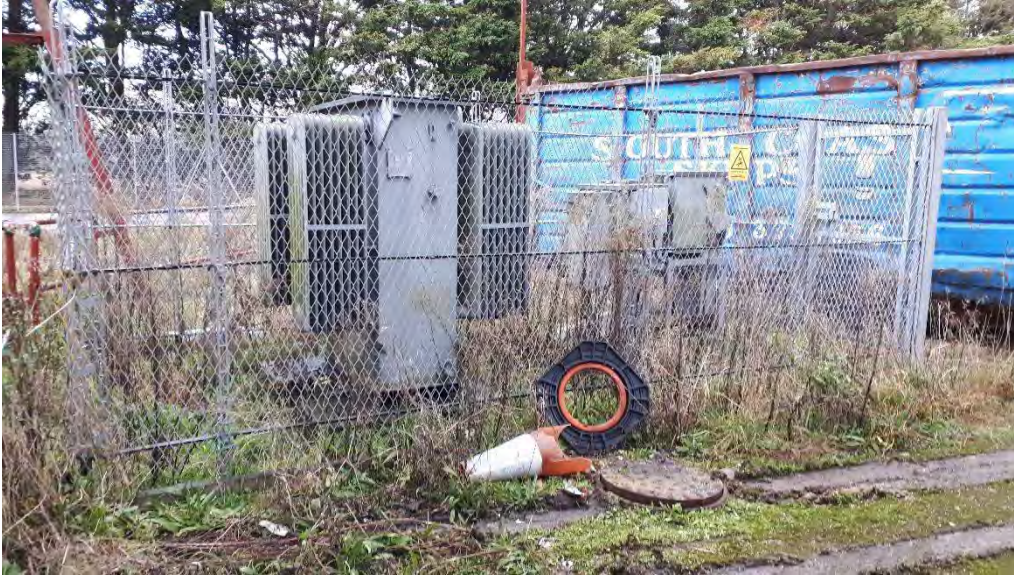
Three electricity sub-stations were noted to be present on-site, one located on the western side of Hangar 1 and two located at Hangar 2 (northern and southern portion of the building). The age of the electricity sub-stations is unknown; however, it is likely to coincide with the construction of the Hangars. The ground in the immediate vicinity of the electrical substations was observed to be free of signs of staining or discolouration, however it is unclear if they are still in use due to the overgrown vegetation (see Plate 21 and Plate 22).

Photo 21. Electricity Sub-station (Hangar 1)

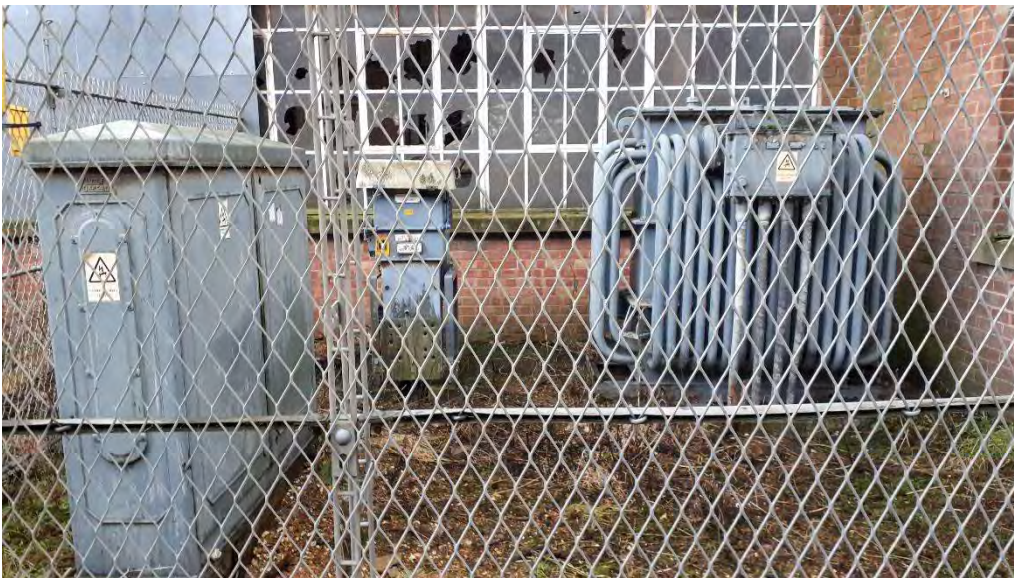
Photo 22. Electricity Sub-station (Hangar 2)

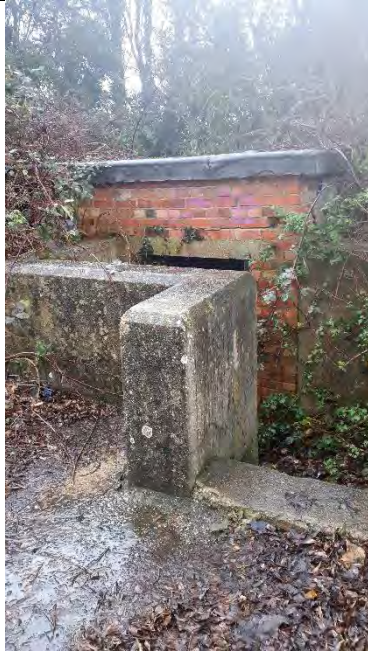
Photo 23. RAF Pumping Station/Bunker

The former RAF pumping station (which was located approximately 80 m north from the site boundary), which was noted to be a bricked bunker sunken into the ground and surrounded by concrete hardstanding (to the south) and scrub and woodland (to the north) (see Plate 23). It was noted that the bunker was filled with waste therefore access was not possible (see Plate 24).

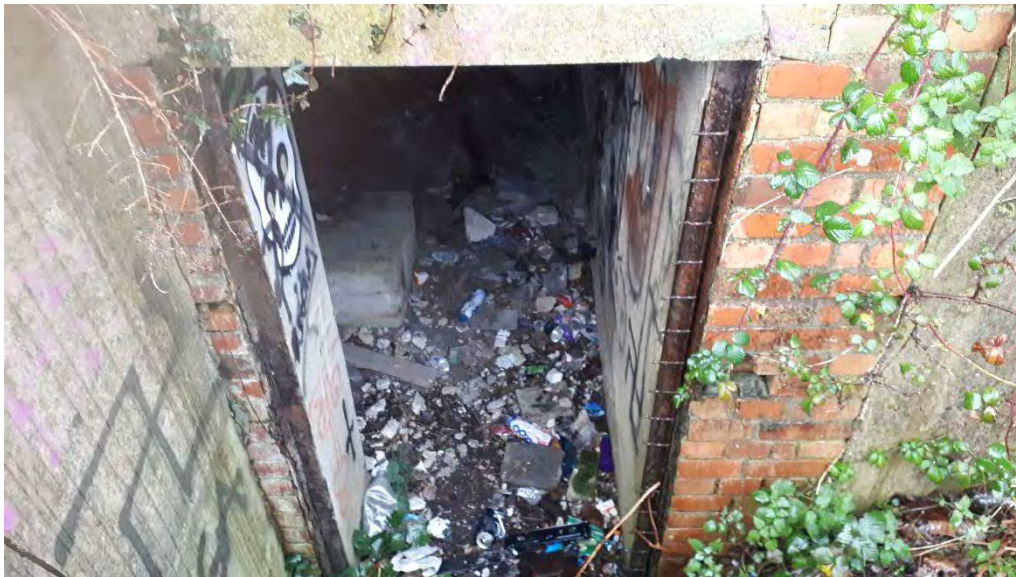
Photo 24. RAF Pumping Station/Bunker Filled with Fly Tipped Waste
