APPENDIX 3
STAGE 1 ROAD SAFETY AUDIT

Road Safety Audit Stage 1 Response Report

**FORD ENERGY
RECOVERY FACILITY
AND WASTE SORTING
AND TRANSFER
FACILITY, FORD
CIRCULAR TECHNOLOGY
PARK
STAGE 1 ROAD SAFETY
AUDIT RESPONSE
REPORT**

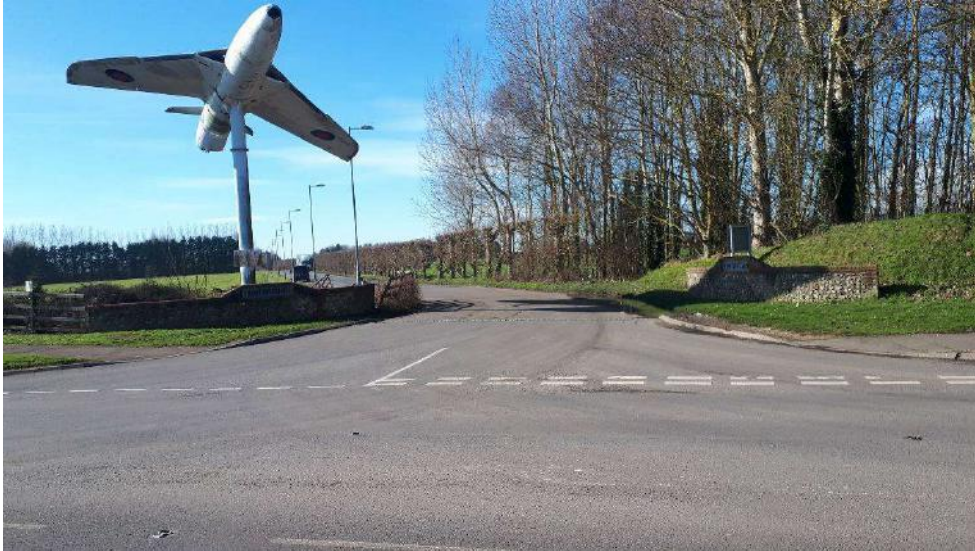
Figure 1.2: Development Site Access/Ford Road junction

The access is a ghost island priority junction (Figure 1.2) and appears to have been constructed with compound curve radii, as is typical of junctions with a high proportion of HGV movements. The junction has good visibility in either direction along Ford Road. A unique feature of the junction

is the siting of a Hawker Hunter mounted on a large concrete plinth and steel column. The RSA team have not raised this feature as a PROBLEM as there are no recorded PIAs at the junction and it is sited outside of the junction visibility splay, hence should not be considered as a directly attributable hazard to road safety.

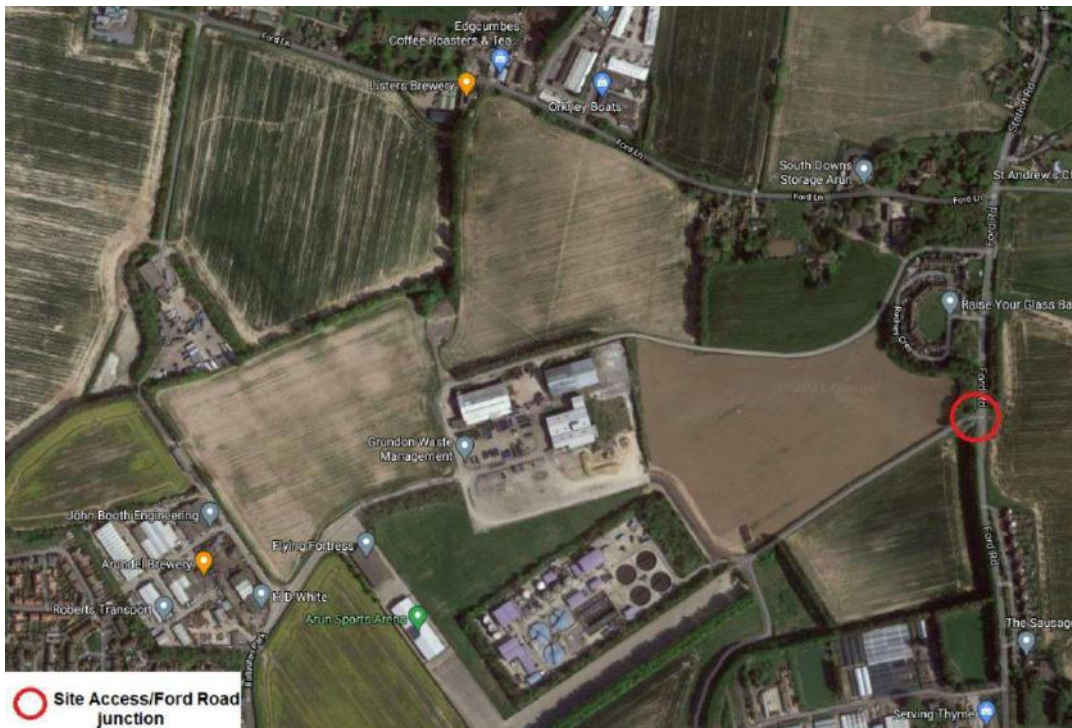
Figure 1.3: Site Access Junction Location

The study area noted to the RSA Team is the site access/Ford Road junction (Figure 1.3).

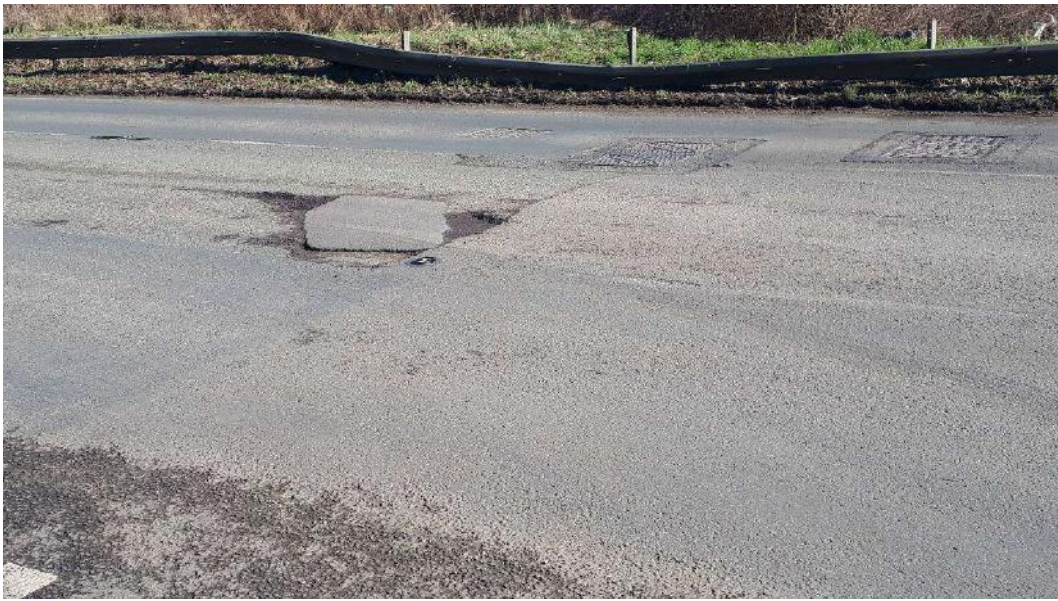
Summary: Existing damaged road surface presents low/variable skid resistance issues

The existing road surface is damaged, within the junction, which may cause stability issues for Powered Two Wheelers (PTWs) especially. The damage will also lower the skid resistance for traffic generally in a braking area.

Loss of control in the braking/turning area may cause head-on or side-swipe type collisions resulting in casualties to PTW riders at the most serious.

Photo A Damaged and hazardous road surface on Ford Road

Resurface carriageway over damaged areas to prevent identified collisions.

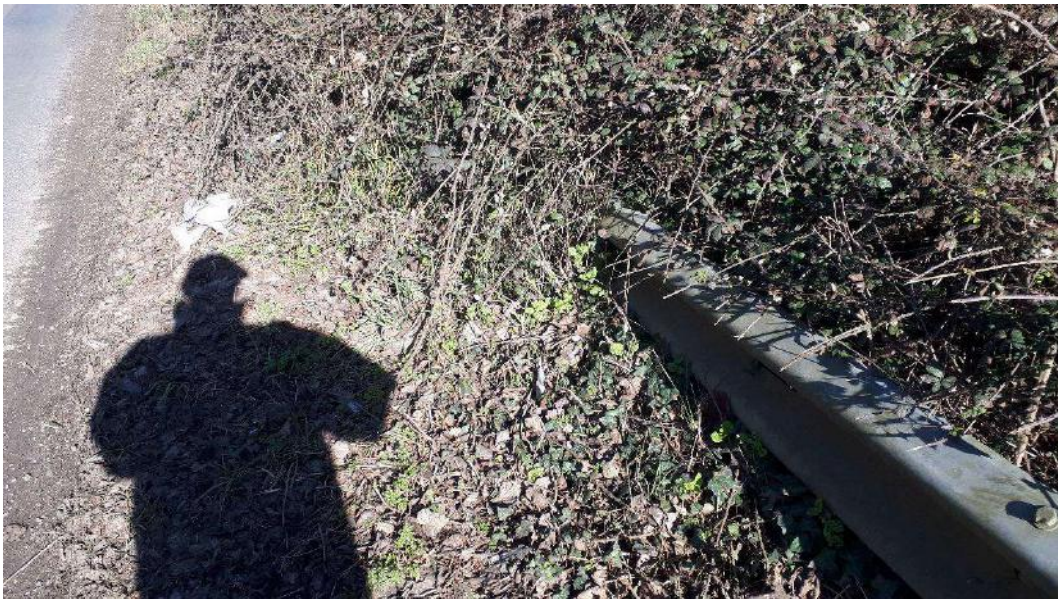
Summary: Existing damaged VRS non-compliant and presents a launch opportunity due to ramping

The existing VRS on the east verge of Ford Road at the junction, opposite the entrance to the site, is damaged and the non-compliant P4 terminal unit presents and launch opportunity for southbound errant vehicles due to a ramping effect.

Photo B Existing damaged VRS non-compliant on east side of Ford Road

Install a compliant terminal to the VRS to prevent identified collisions. Repairs to the damaged VRS should be undertaken.

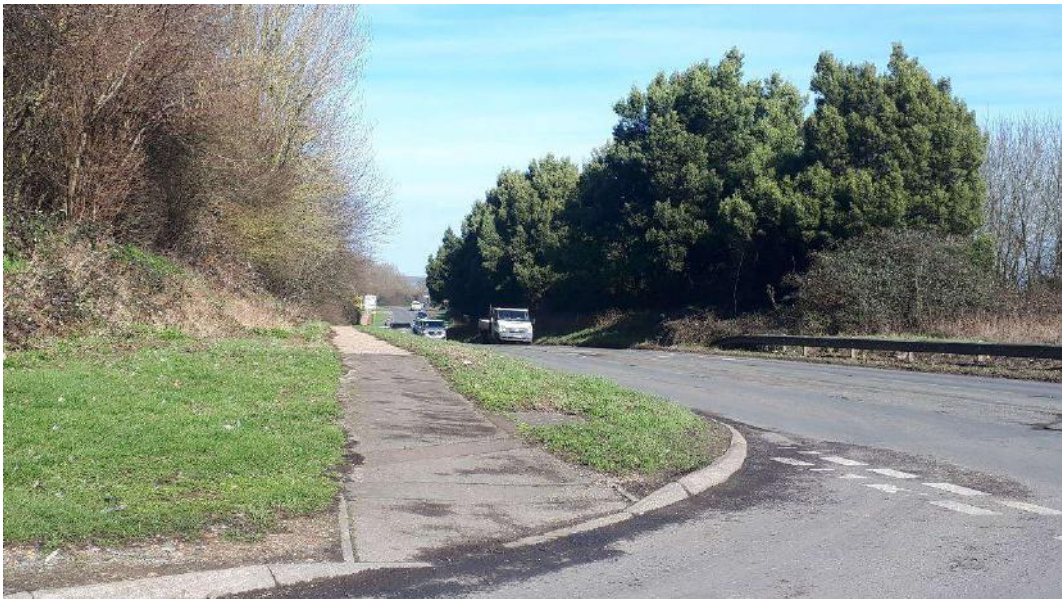
Photo C Ford Road showing existing VRS opposite site entrance

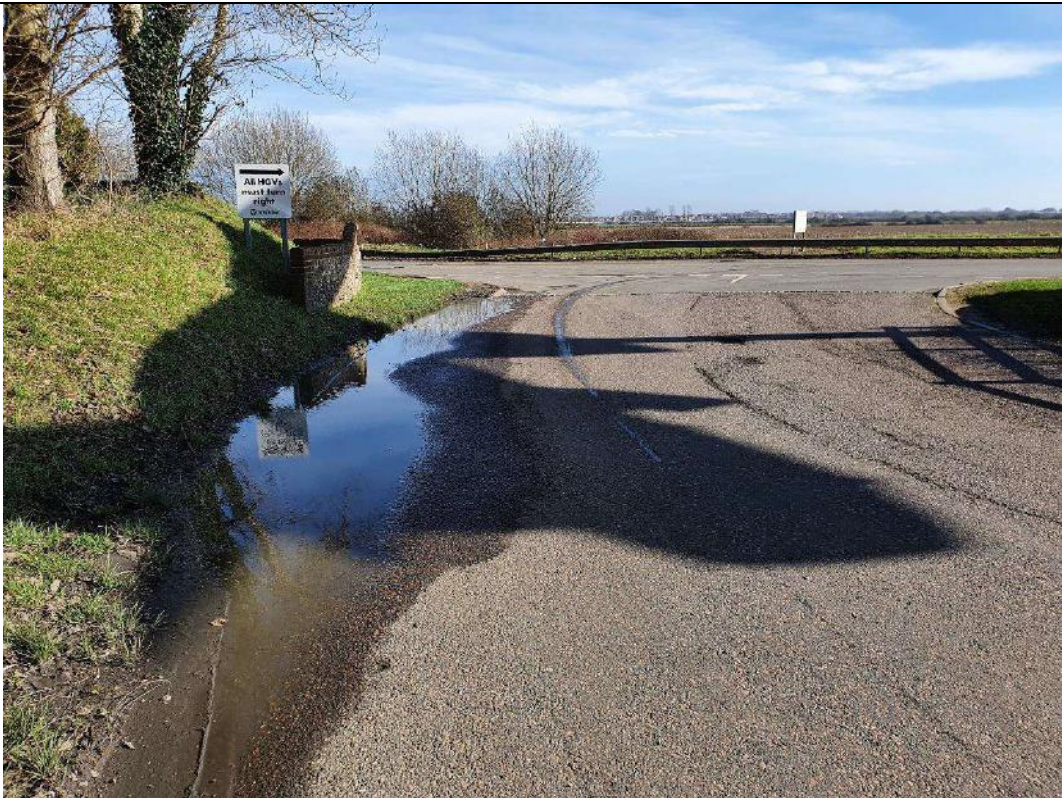
Despite the weather being sunny and warm with no obvious evidence of recent rain, during the site visit the Auditors noted ponding of water in the north channel of the site access road, close to the junction.

Photo D Ponding of water on site access road

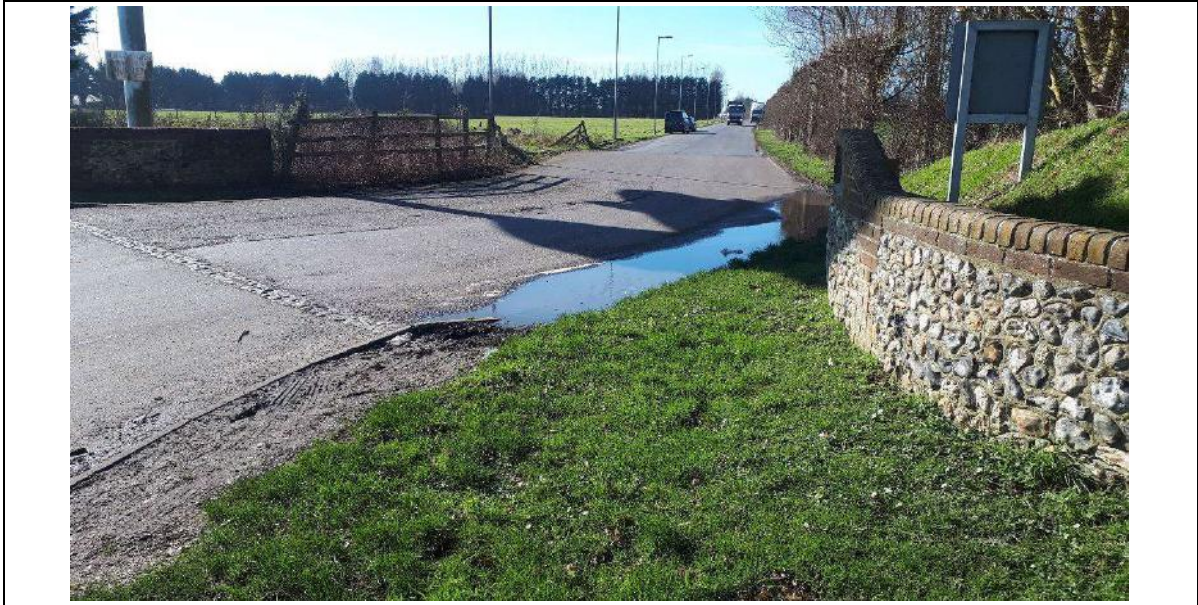
Photo E Ponding of water on site access road

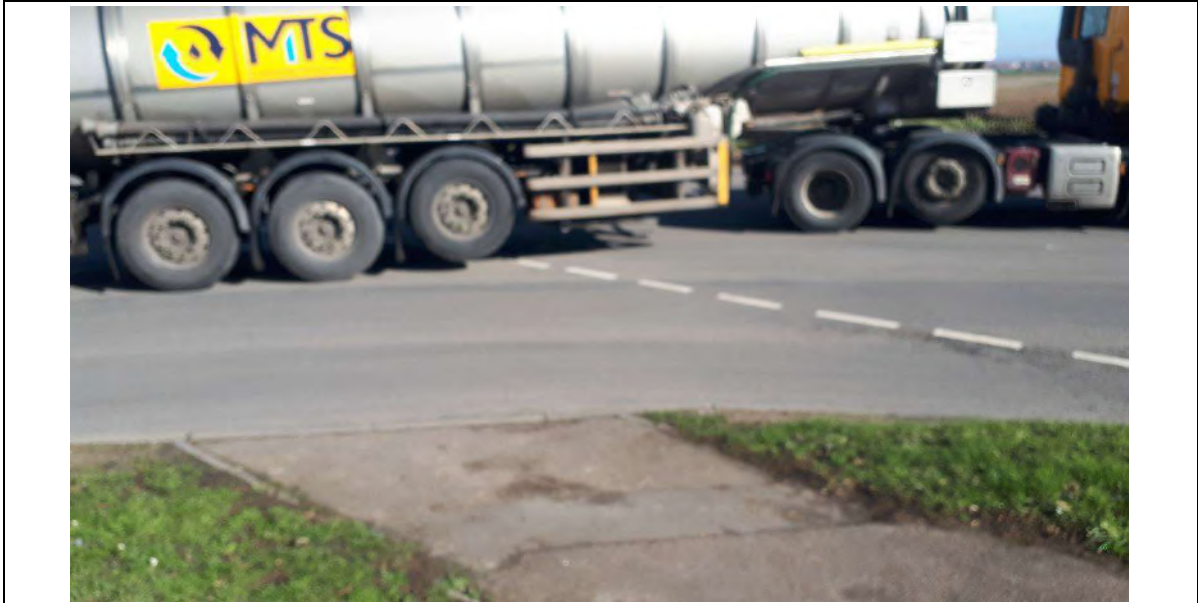
The Auditors noted that large vehicles were having difficulty in maintaining lane discipline when turning into or out of the junction, partially caused by higher than suitable speeds of vehicles and partly because the junction is too narrow for the configuration that includes the angle formed by the site access road. These difficulties were observed for the movements:

The Audit Team acknowledges that although there have been no reported PIAs there may be damage-only collisions that the Audit Team are not aware of and furthermore the increased vehicle flows as a result of intensification of use of the junction will increase the likelihood of a vehicle/vehicle collision type accident.

Photo F Large vehicle turning right out of site access road

Widen the junction to permit large vehicles to maintain lane discipline and complete manoeuvres without crossing into oncoming lanes. Special care will be required to accommodate the drainage channels and box culverts noted in section 2.8 of this Audit Report.

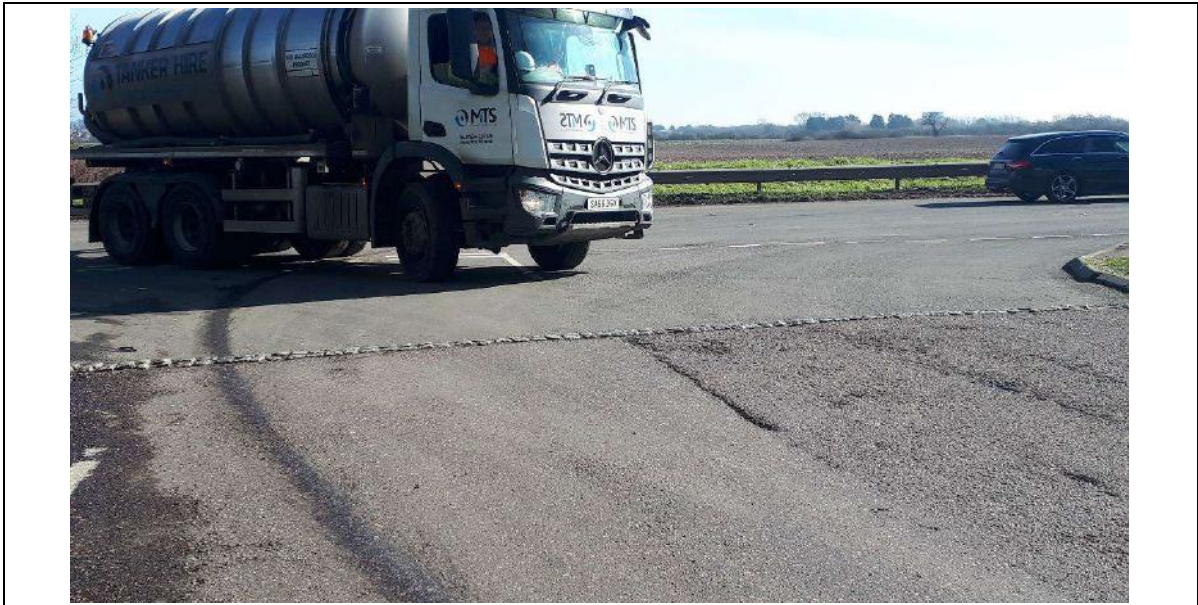
Photo G Large vehicle turning right into site access road

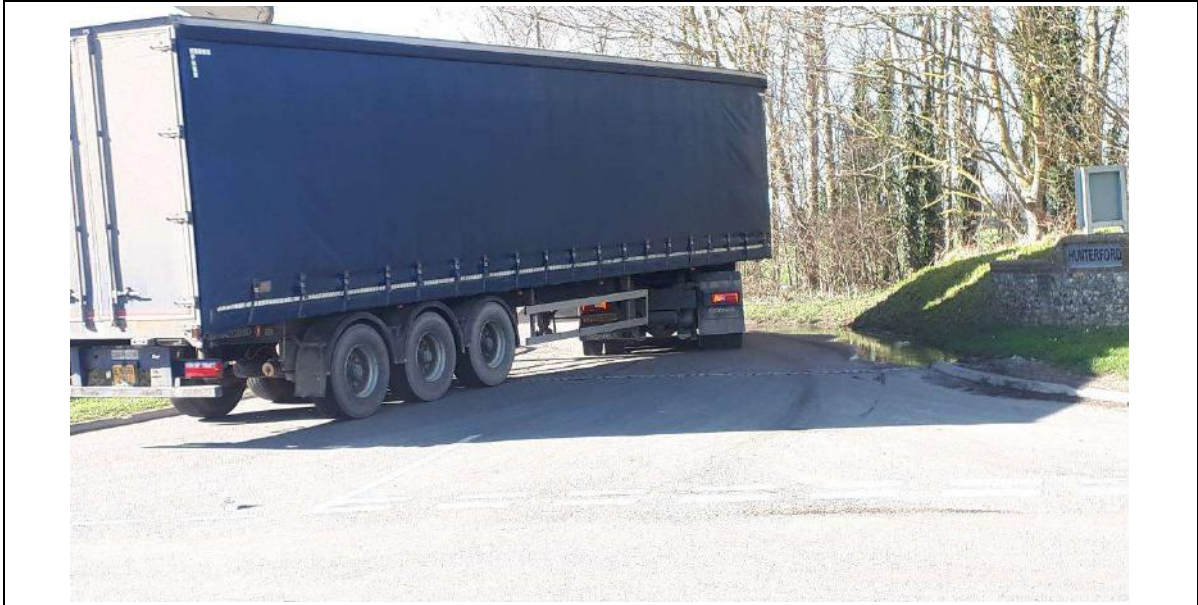
Photo H Large vehicle turning left into site access road

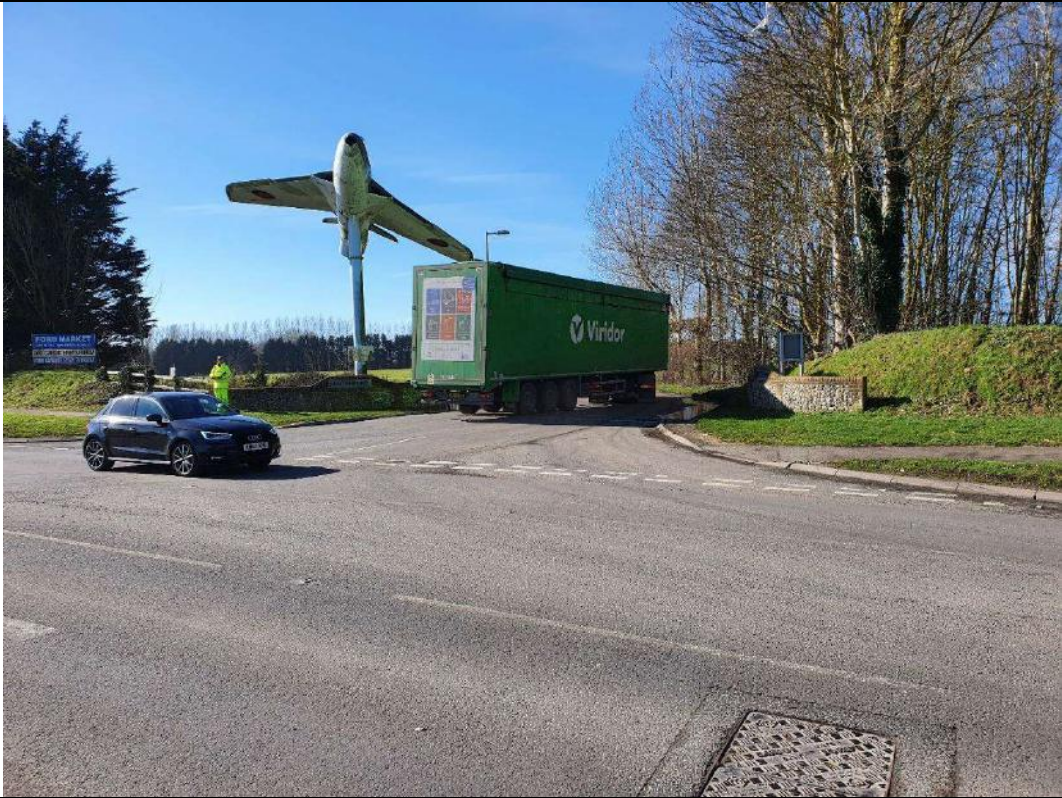
Photo I Large vehicle turning left into site access road

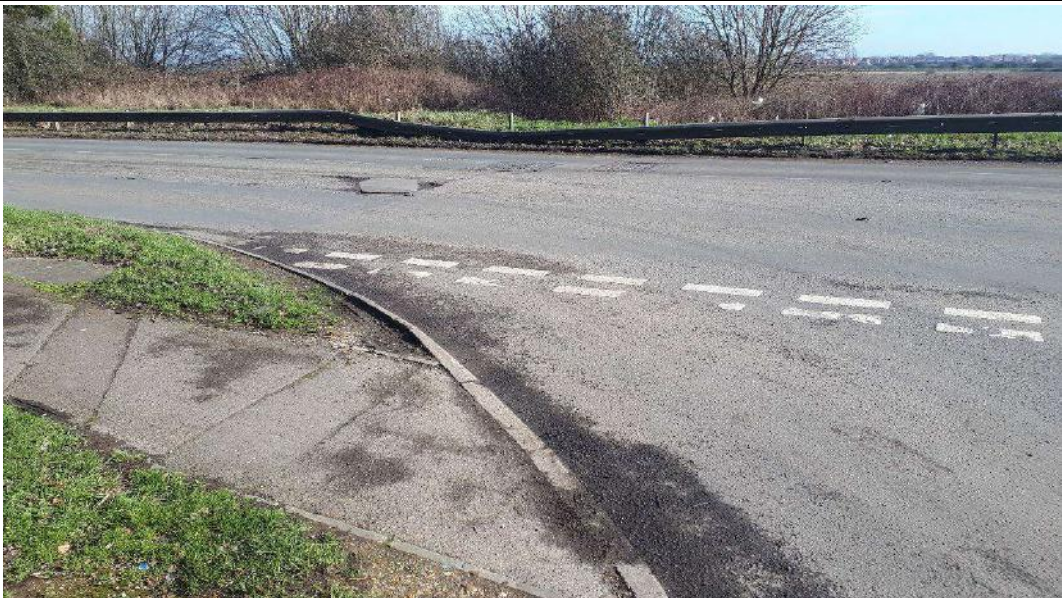
The Auditors noted that ghost-island carriageway markings on Ford Road were generally illegible.

Photo J Ford Road carriageway markings illegible

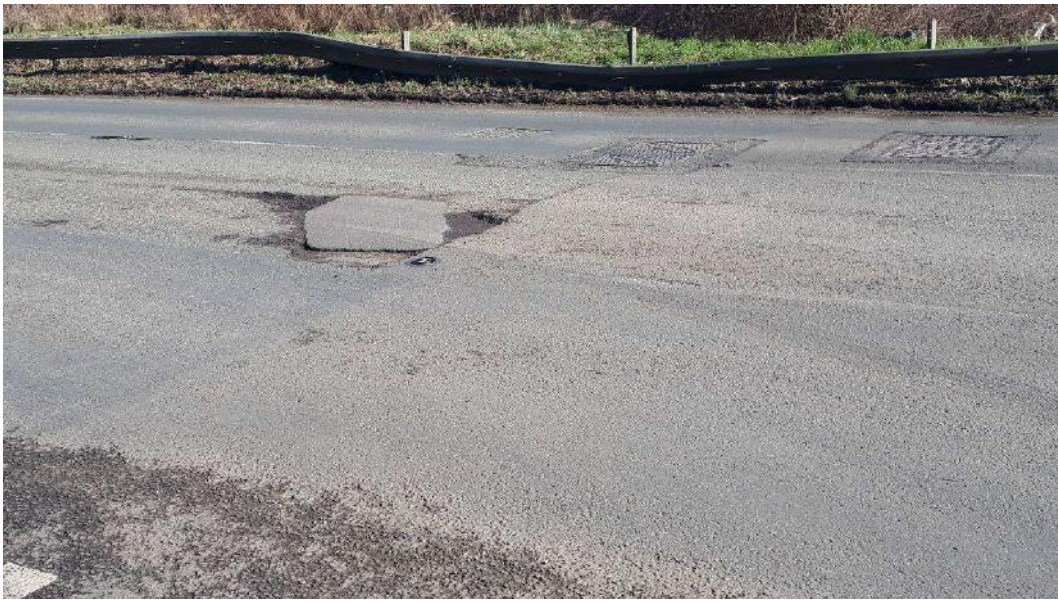
Photo K Ford Road carriageway markings illegible

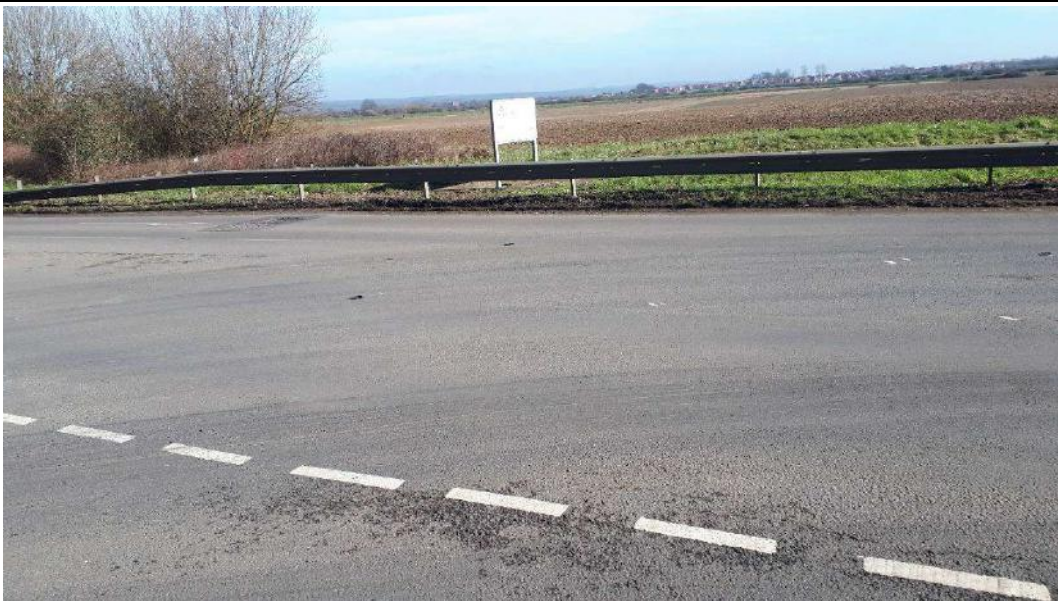
Photo L Ford Road carriageway markings illegible

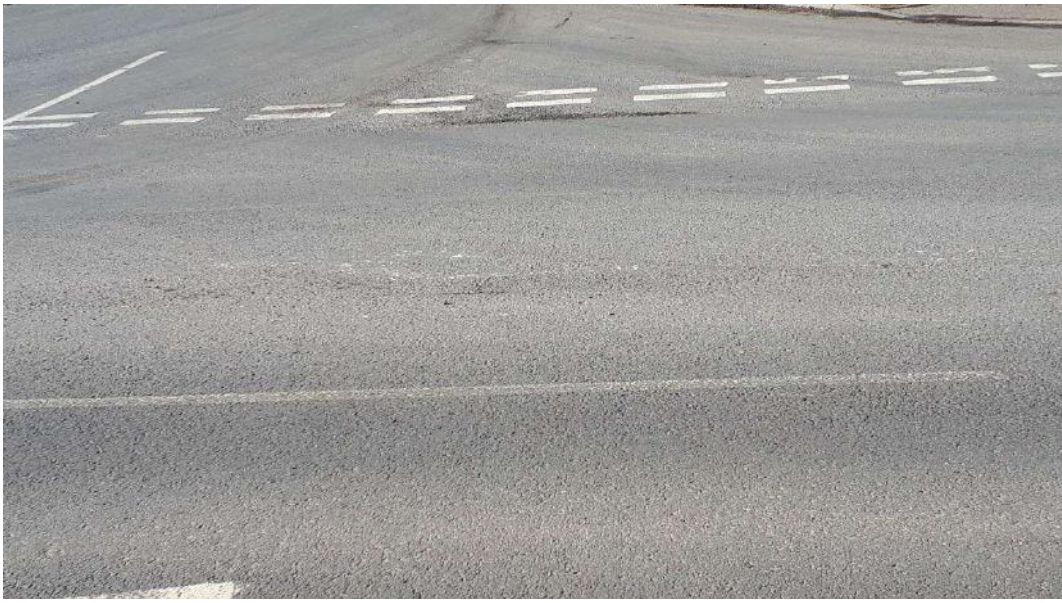
Photo M Ford Road carriageway markings illegible

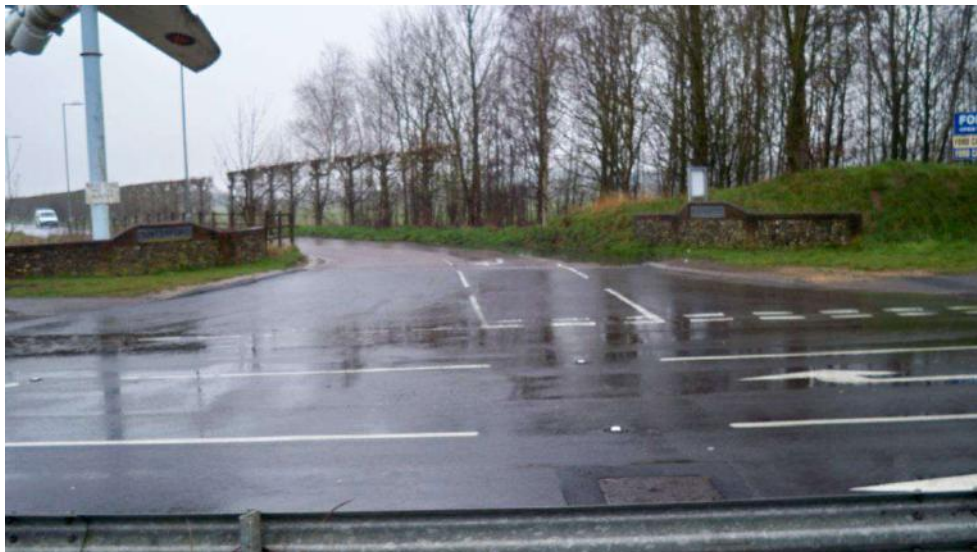
Figure 2.2: Site Location Plan

The access is a ghost island priority junction (Figure 2.2) and appears to have been constructed with compound curve radii, as is typical of junctions with a high proportion of HGV movements. The junction has good visibility in either direction along Ford Road.

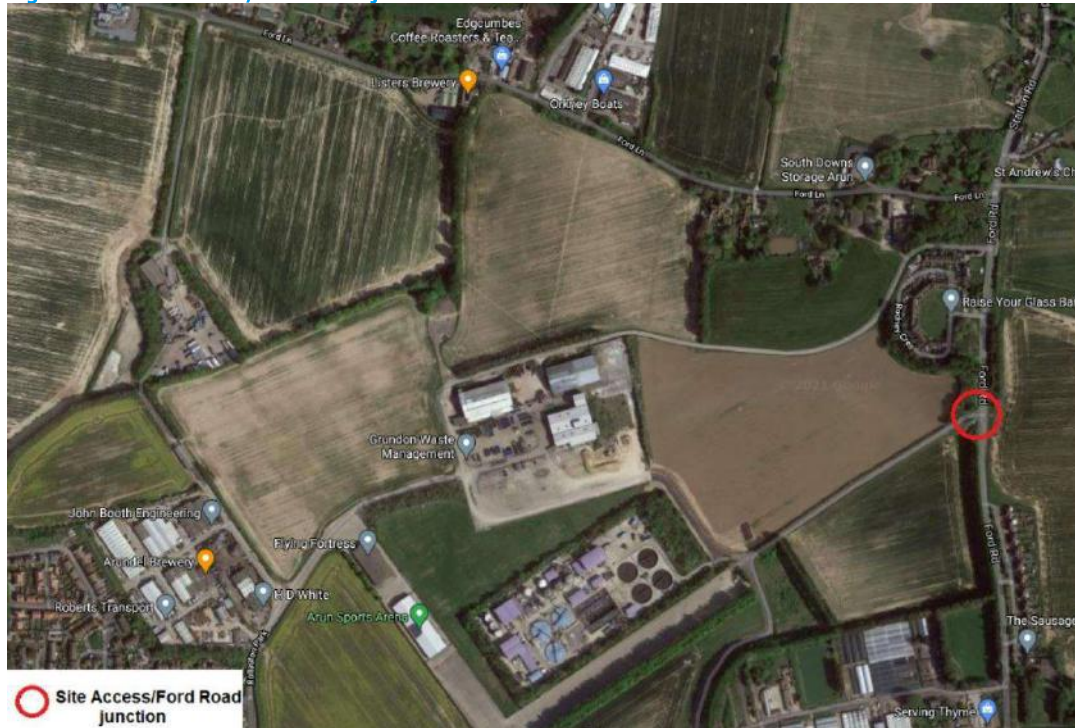
Figure 2.3: Site Access/Ford Road junction

The study area that needs to be considered by the RSA Team is the site access/Ford Road junction (Figure 2.3).

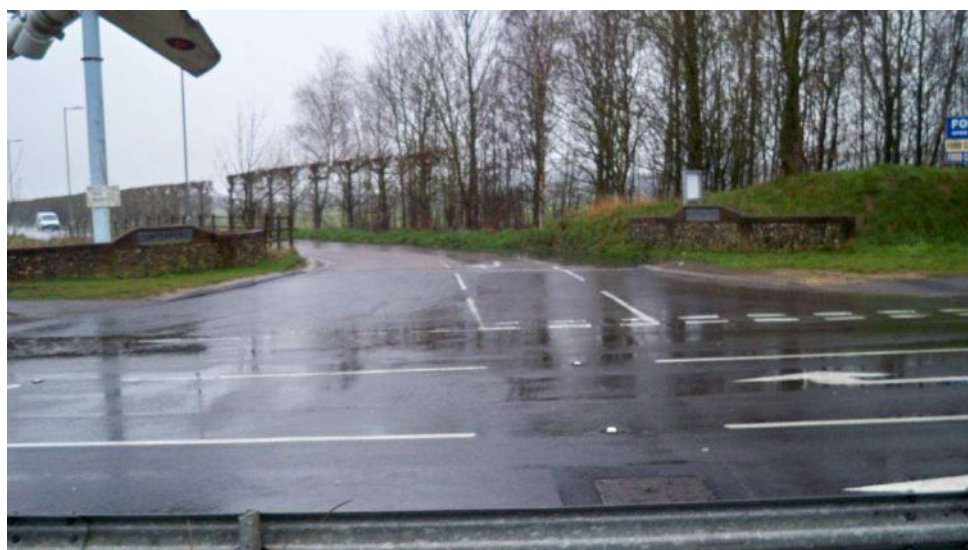
Figure 1: Access junction with Ford Road (looking west)

12. The access junction is shown in the figure below. The access is a ghost island priority junction and appears to have been constructed with for compound curve radii, as is typical of junctions with a high proportion of HGV movements. The junction has good visibility in either direction along Ford Road.
13. A footway running north-south along the west side of Ford Road crosses the access road without deviation from its course. Dropped kerbs are provided across the access road. The visibility between the footway and the access road i.e. between pedestrian and site vehicles, is good.

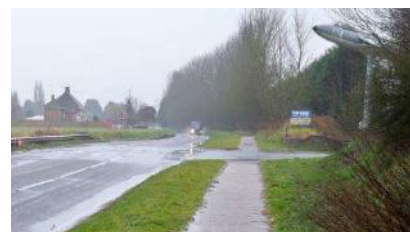
Crossing Name:		1) Ford Road / Site Access		
Factor	Score	Weight factor	Weighted score	
Crossing provision	1	5	5	
Deviation from the desire line	2	3	6	
Performance	1	5	5	
Crossing capacity	1	1	1	
Delay	0	3	0	
Legibility	0	1	0	
Legibility for sensory impaired	-1	3	-3	
Dropped kerbs	2	3	6	
Gradient	1	1	1	
Obstruction	2	1	2	
Surface quality	1	3	3	
Maintenance	1	1	1	
TOTAL			27

Comment: A good crossing point that is direct and with dropped kerbs. However, there are no tactiles. There is good visibility between pedestrians and vehicles exiting the access road.

Works: None proposed
