# Road Safety Audit Report

**Incorporating  
Stage 1 Completion of Preliminary Design; and  
Design Organisation Response to items raised.**

## **Proposed highway works and intensification of an existing access to a proposed Clay Pit off Loxwood Road**

<b>Job no</b>	RSA-20-158	<b>Issue no</b>	3	<b>Date</b>	March 2021
<b>Prepared by</b>	JJF	<b>Verified by</b>	FB	<b>Approved by</b>	JJF
<b>Filename and Path</b>	Fenley/Road Safety Audits/RSA-20/RSA-20-158-3

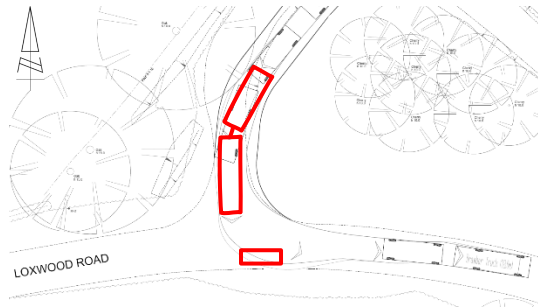
**Location Plan:**

<b>A.3</b>	<b>JUNCTIONS</b>
<b>A.3.1</b>	<b>PROBLEM</b>
<b>Location:</b>	Proposed access
<b>Summary:</b>	Width of the bellmouth is insufficient for two vehicles to pass one another
<b>Acc Type:</b>	Sideswipes as well as head-on and rear end collisions
<p>Loxwood Road is single carriageway rural road that is derestricted (subject to a 60mph speed limit), accommodates a number of bends where forward visibility is restricted and forms a link between the A281 at Rudgewick to the east and Loxwood to the west. An off-line lay-by is present off the northern side of Loxwood Road that forms a loop and allows for parking as well as access to a single dwelling and a gated access to Tilhill Forestry. Although the Audit Team are unsure if it is generally the case, observations made during the site visit associated with this Stage 1 Road Safety Audit show that vehicles access the lay-by from the west and exit via the access to the east. The proposals that are subject to this Stage 1 Road Safety Audit include the minor widening of the access to the west and provision of a 5.5 metre wide carriageway to allow access to the existing gated entrance to the application site. The existing lay-by to the northwest of the proposed carriageway, is to be retained for parking. No works are proposed to the section of the lay-by to the east of the existing gated entrance. It is understood that the proposed works are to facilitate the movement of HGV's picking up and dropping off materials within the application site with up to 21 HGV's expected to be observed per day generating 42 HGV movements. The documents</p>

provided with the Audit Brief, identify that the proposed minerals extraction site is to operate between 8am and 6pm. The scheme drawings provided with the Audit Brief, illustrate the swept path of the expected vehicles; an 18 metre drawbar truck and a 10.2 metre large tipper and identify shows that the access is not adequate for these vehicles or a domestic car and one of these vehicle, to pass one-another. Should a vehicle arrive whilst a vehicle attempts to egress, one would be required to wait within the Loxwood Road carriageway. Whilst a stationary vehicle within the carriageway that where forward visibility is restricted could lead to rear end impact collisions, a vehicle attempting to ingress or egress whilst opposed by another vehicle, could lead to sideswipe or head-on type collisions.

It is recommended that the width of the bellmouth is increased to allow for a domestic vehicle to enter whilst a HGV waits to exit.

Accepted – It is now proposed to widen the existing bell mouth to allow for a domestic vehicle to wait in the access whilst a large tipper is able to turn without impediment. This is an improvement over the existing situation.

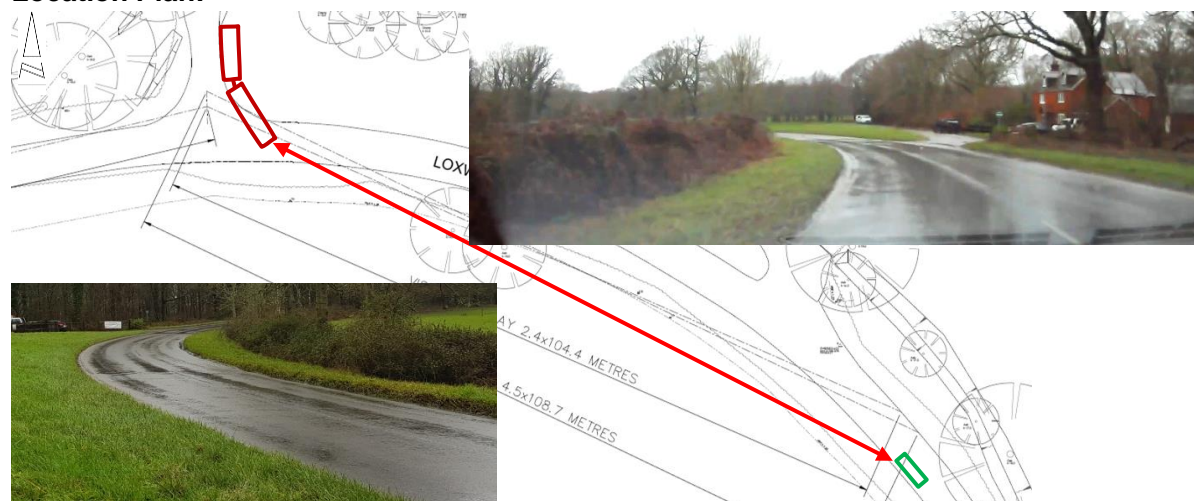
**Location Plan:**

**A.3.2 PROBLEM**

**Location:** Loxwood Road east

**Summary:** HGV's are required to encroach the opposing lane when exiting

**Acc Type:** Head-on collisions

Loxwood Road is single carriageway rural road that is derestricted (subject to a 60mph speed limit), accommodates a number of bends where forward visibility is restricted and forms a link between the A281 at Rudgewick to the east and Loxwood to the west. An off-line lay-by is present off the northern side of Loxwood Road that forms a loop and allows for parking as well as access to a single dwelling and a gated access to Tilhill Forestry. Although the Audit Team are unsure if it is generally the case, observations made during the site visit associated with this Stage 1 Road Safety Audit show that vehicles access the lay-by from the west and exit via the access to the east. The proposals that are subject to this Stage 1 Road Safety Audit include the minor widening

of the access to the west and provision of a 5.5 metre wide carriageway to allow access to the existing gated entrance to the application site. The existing lay-by to the northwest of the proposed carriageway, is to be retained for parking. No works are proposed to the section of the lay-by to the east of the existing gated entrance. It is understood that the proposed works are to facilitate the movement of HGV's picking up and dropping off materials within the application site with up to 21 HGV's expected to be observed per day generating 42 HGV movements. The documents provided with the Audit Brief, identify that the proposed minerals extraction site is to operate between 8am and 6pm. The scheme drawings provided with the Audit Brief, illustrate that the swept path of the expected vehicles; an 18 metre drawbar truck and a 10.2 metre large tipper which identifies that the vehicles encroaches the opposing lane westbound of Loxwood Road when exiting. The level of visibility to and from westbound drivers approaching the access, is restricted due to the horizontal alignment / bend in the road as well as vegetation on the inside of bend within lane not under control. A westbound vehicle travelling in free flowing conditions may become aware of an HGV travelling along the access road but is unlikely to be aware that the vehicle turning out of the access onto Loxwood Road, would block their path. Moreover, due to the achievable visibility of it is unlikely that the driver of an egressing HGV will become aware of an approaching vehicle and will commence their manoeuvre and approaching Loxwood Road, however the driver of an egressing HGV is unlikely to become aware of a vehicle approaching from the west at a safe distance with the achievable visibility restricted to below 90 metres. A vehicle encroaching the opposing lane that is not visible to approaching vehicles, could lead to head-on collisions as well as heavy braking and loss of control type incidents.

It is recommended that eastern corner radius of the bellmouth is increased to ensure that the expected vehicles are not required to encroach the opposing lane where it would not be visible to approaching traffic.

Accepted – The existing bell mouth is to be widened to accommodate the turning needs of a large tipper lorry exiting the site without having to cross the oncoming carriageway. The westbound carriageway will therefore remain clear, eliminating the possible conflict identified by the Auditors.

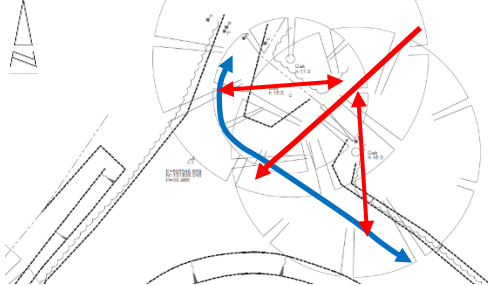
<b>A.4.1</b>	<b>PROBLEM</b>
<b>Location:</b>	Existing lay-by
<b>Summary:</b>	Non-motorised users may not be clearly visible to HGV drivers
<b>Acc Type:</b>	HGV pedestrian collisions
<p>Loxwood Road is single carriageway rural road that accommodates grass verges and allows access to a number of bridleways, public footpaths and other rights of way. An off-line lay-by is present off the northern side of Loxwood Road that forms a loop and allows for parking as well as access to a single dwelling and a gated access to Tilhill Forestry. A bridleway is accessible off the northwest side the lay-by, adjacent to the gates access. Users of the bridleway were observed travelling along the Loxwood Road verge as well as parking within the lay-by. The proposals subject to this Stage 1 Road Safety Audit are to undertake highway works in order to facilitate an access to a minerals extraction site by HGV's with 21 expected throughout the day. No lighting is present in proximity of the lay-by or is it proposed and HGV drivers have a limited view of pedestrians. The access to the existing bridleway is situated immediately adjacent to the existing gates access and intervisibility between the proposed access and users of the bridleway, is restricted by vegetation. Non-motorised users travelling between the bridleway and lay-by may not therefore be clearly visible particularly during the hours of darkness. An HGV driver not slowing to ensure their path is clear before exit from the minerals extraction site to the lay-by, may therefore</p>

<p>not become aware of a user at a safe distance which could lead to a non-motorised user being struck by a vehicle.</p>	
<p><b>RECOMMENDATION:</b></p>	
<p>It is recommended that intervisibility is provided and measure is provided to ensure egressing drivers stop / slow to an appropriate speed before entering the layby to ensure they become aware of a non-motorised user of the bridleway.</p>	
<p><b>Location Plan:</b></p>

<p><b>DESIGN ORGANISATION RESPONSE</b> provided by Nick Culhane on the 18<sup>th</sup> March 2021 following formal issue of this Stage 1 Road Safety Audit on the 18<sup>th</sup> February 2021</p>	
<p>Accepted - The scheme will include appropriate signing at the site egress warning drivers to be cautious of pedestrians using the layby.</p>	
<p><b>A.5</b></p>	<p><b>ROAD SIGNS, CARRIAGEWAY MARKINGS AND LIGHTING</b></p>
<p><i>No Road Safety Concerns regarding ROAD SIGNS, CARRIAGEWAY MARKINGS AND STREET LIGHTING have been raised at this stage</i></p>
