LOXWOOD CLAY PIT DEVELOPMENT

Water Chapter

Doc ref: 4463-CAU-XX-XX-RP-O-0302.A0.C2

Project Title: EIA Water Chapter

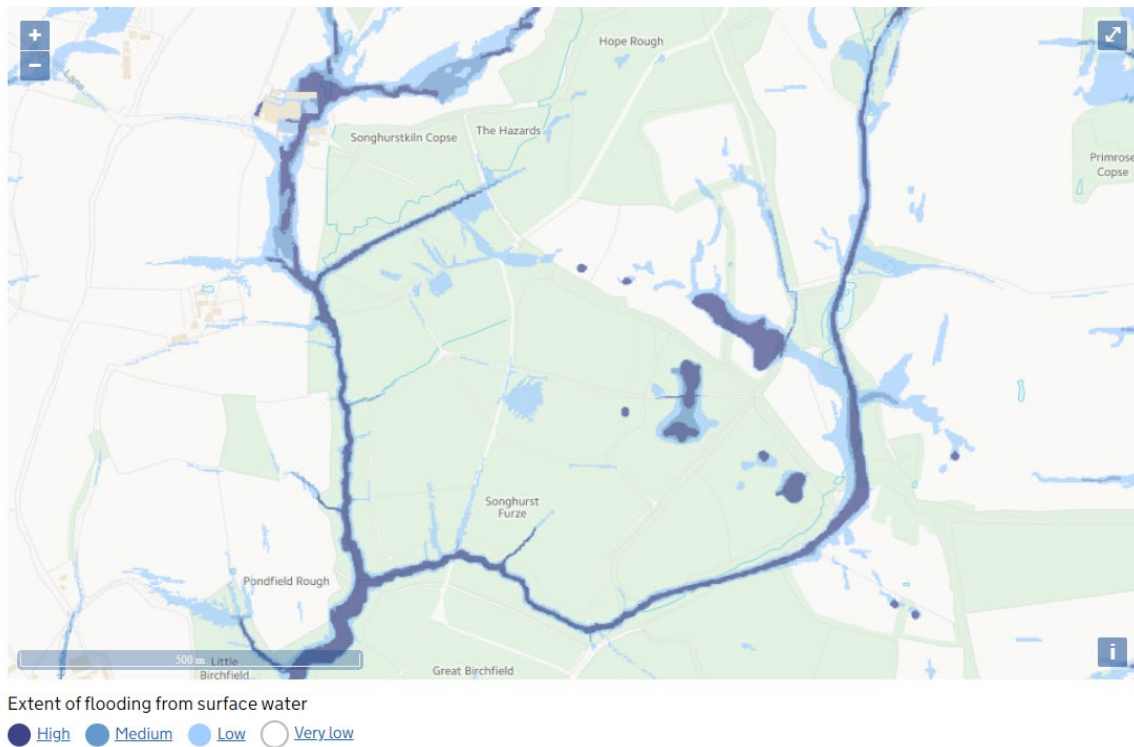
Figure 4: Flood Risk Map –Surface Water- Environment Agency web-data.

4.6.4 In relation to surface water flooding (as a result of rainfall events), the Site is at a Very Low risk of flooding. There is a very small area of land just beyond the eastern extent of the mineral extraction area which is at a high risk of flooding and a very small point beyond the south western corner of the site boundary at a Low risk of flooding (likely associated with extreme rainfall events). These areas are coincidental with much localised topographic low points and would not pose a constraint to development.

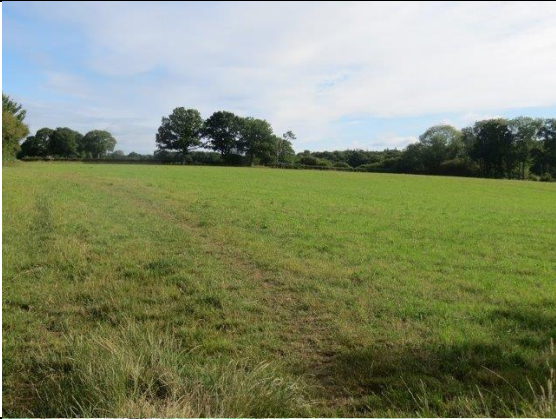
504338 131809	N/A	Photo taken looking north east towards the woodland from the footpath to the east of Loxwood. Note gentle slope of land
2

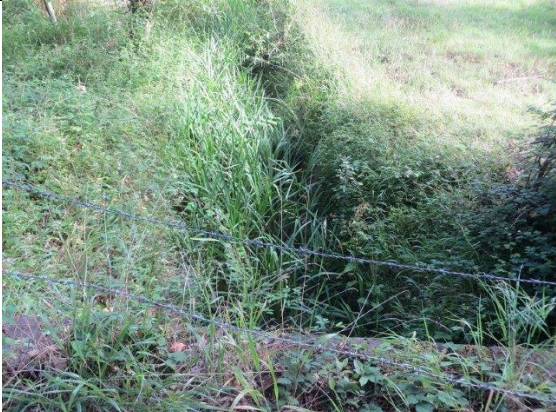
504588 131794	Dry	Upstream of Loxwood Road Bridge. Plant debris and petals in the base of the channel indicates flow had not occurred recently. Depth of channel estimated to be 1.5m deep by 2m wide within a broader valley.

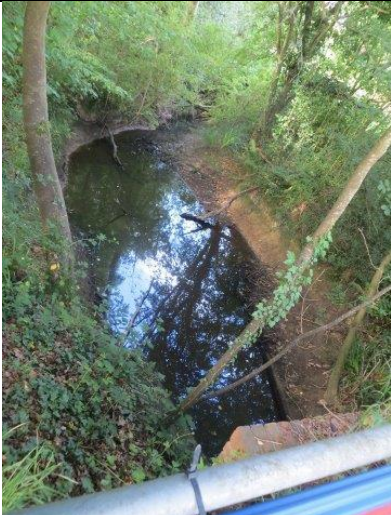
504588 131779	Still / Stagnant, No Flow	<p>Down stream of Loxwood Road bridge. A large stagnant pool of water. Water level was approximately 0.2m below the invert level of the concrete channel beneath the road. No flow beneath bridge. No flow in pool.</p> <p>In the far ground of the image, the channel is dry indicating no flow. Water body appears to be contained within erosional feature.</p>
4

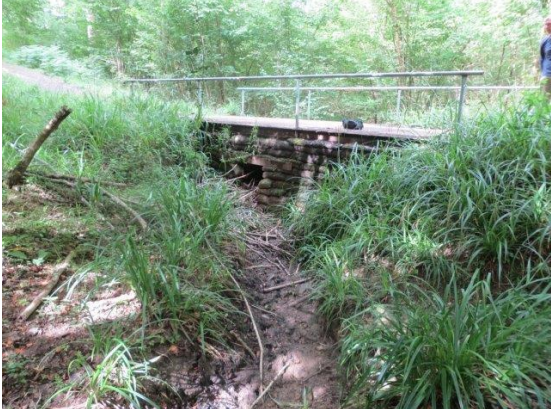
504765 132515	Dry	Culvert beneath Woodland access track showing incised channel and construction of bridge.

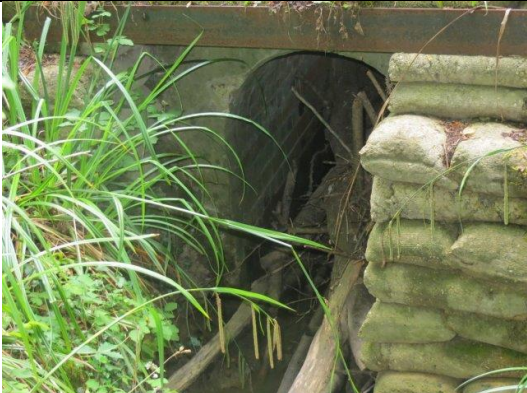
504765 132515		Close up image of collection of debris within the culvert.
6

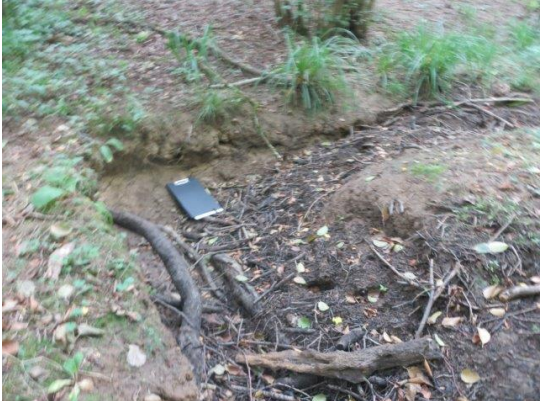
504775 132529	Dry	<p>Upstream of culvert, incised drainage channel. Channel was approximately 1.5m across and 0.5m deep at the location marked by clipboard.</p> <p>Channel contained large amount of woodland debris of a variety of sizes.</p>

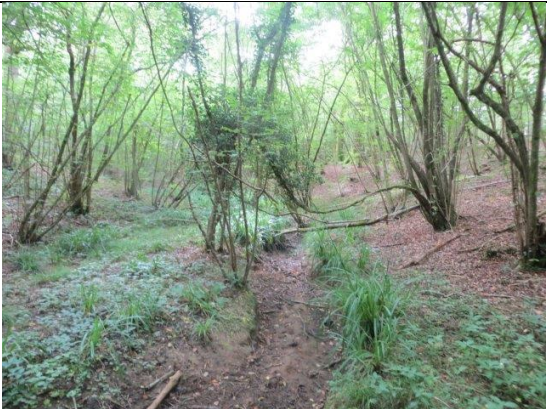
504786 132515	Dry	200m further upstream, channel less incised with maximum depth 0.3m
8

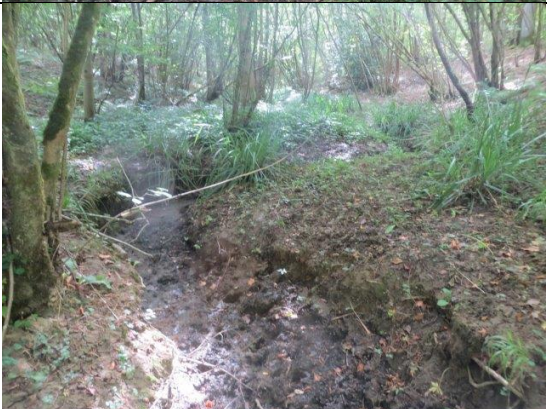
504755 132515		Channel down stream of culvert in sloping valley. The base of the channel was dry by soft. No water was observed in larger depressions. Channel narrower than upstream and more contained

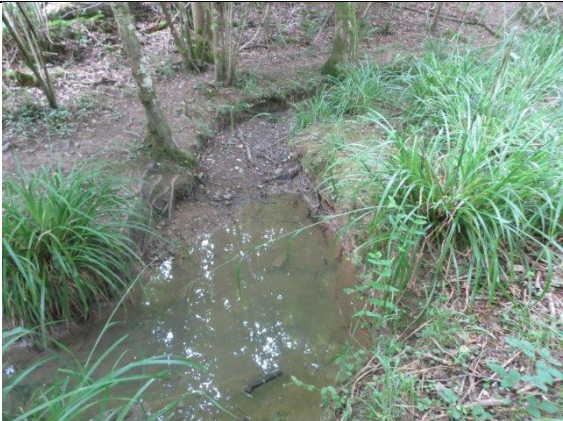
504760 132515	Still / Stagnant, No Flow	Standing water in pools down stream of culvert. Broad shallow channel approx. 1.2m wide can be observed
10

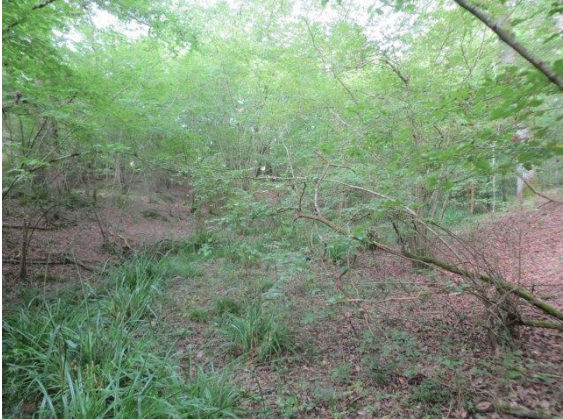
504745 132507	Dry	Drainage ditch meandering through valley.

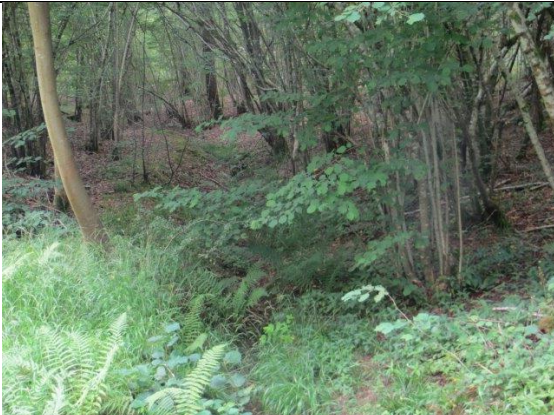
504882 132662	Dry	Image showing gentle slope with drainage channel at base.
12

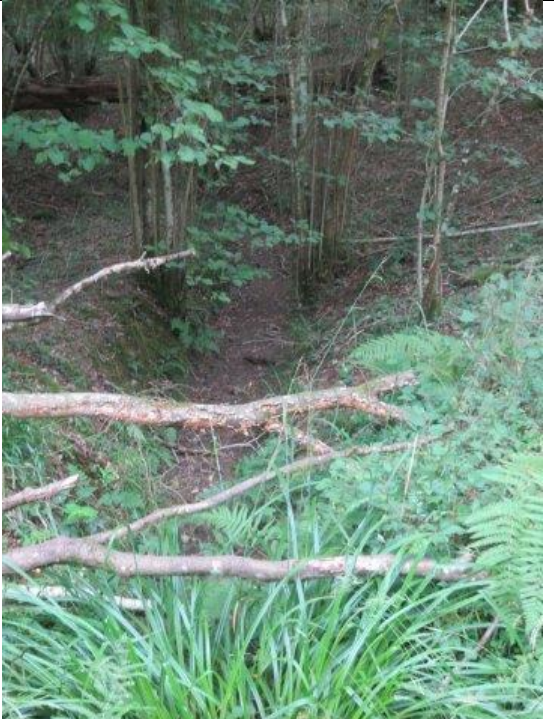
505051 132669	Dry	Culvert under track from site. Concrete construction 35cm diameter discharging into channel into woods, Dry, no flow.

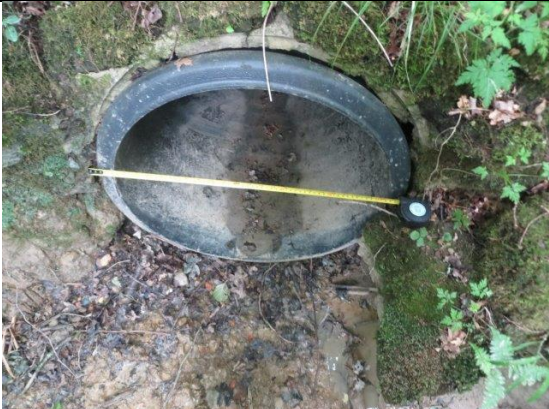
505400 132662	Dry	610mm culvert beneath main footpath Dry
14

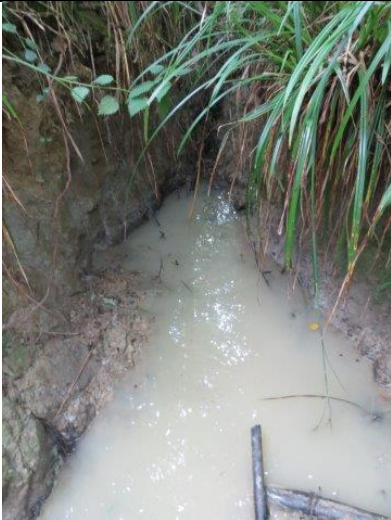
505400 132662	Still / Stagnant, No Flow	Over deepened base of channel adjacent to culvert. It is noted that despite there no being any flow, the standing water still contained as high concentration of silt.

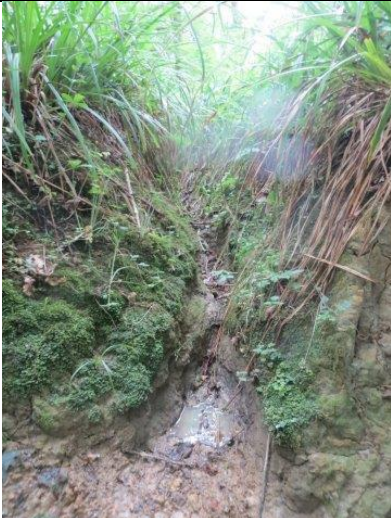
505400 132662	Dry	Natural drainage channel entering from the North. Mossey near vertical sides. No flowing water and heavily vegetated.

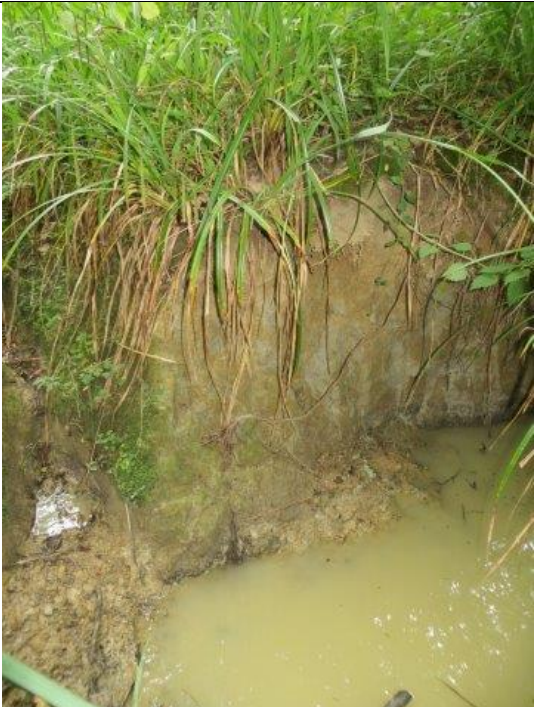
505400 132662	Still / Stagnant, No Flow	<p>Vertical 1.2m clay walls exposed. No evidence of any laminations or siltstone bands near surface.</p> <p>Photo also indicated that root zone penetration of the vegetation is limited to the top soil area.</p> <p>Standing water in erosional feature in base.</p>
17

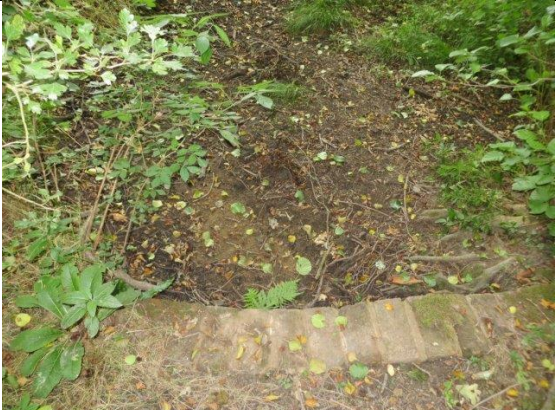
505412 132632	Dry	Upstream main channel crossing point.

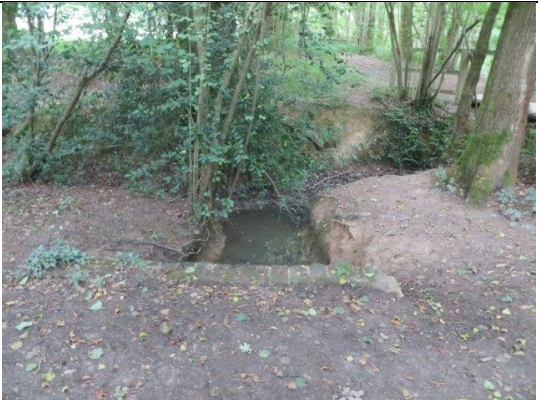
505412 132632	Still / Stagnant, No Flow	Down stream main channel crossing point Man-made channel
19

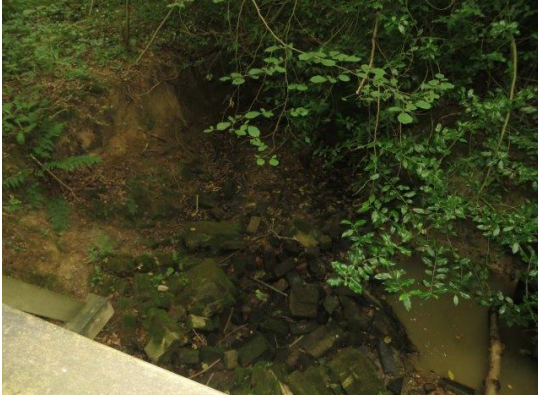
505412 132632	Dry	Looking down at channel at down stream side, large open channel with brick debris and scour features.

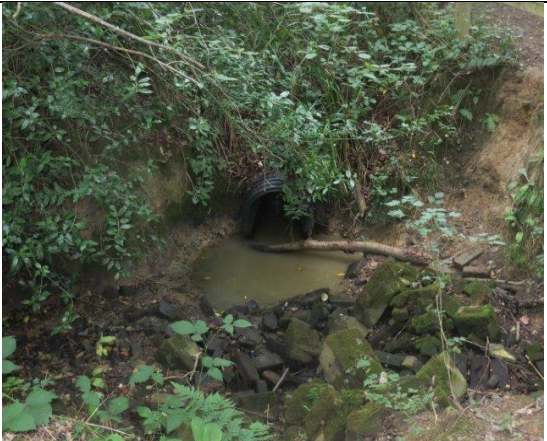
505412 132632	Still / Stagnant, No Flow	Closer image of 19 above. Vertical banks can be observed with scour feature containing standing water.
21

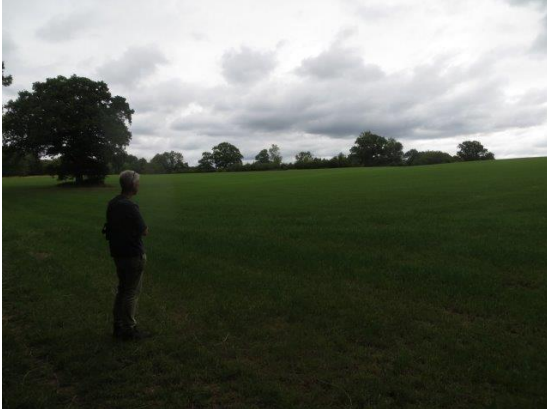
505471 132787	N/A	Photo taken into south east towards the crest of the hill contain a small pond. This pond is approximately 10m above the Site.

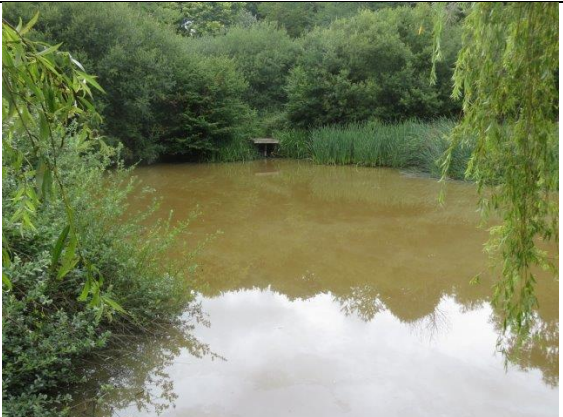
505441 132868	Still / Stagnant, No Flow	Pond to East/Northeast of site. Photo looking North west from corner of footpaths.
23

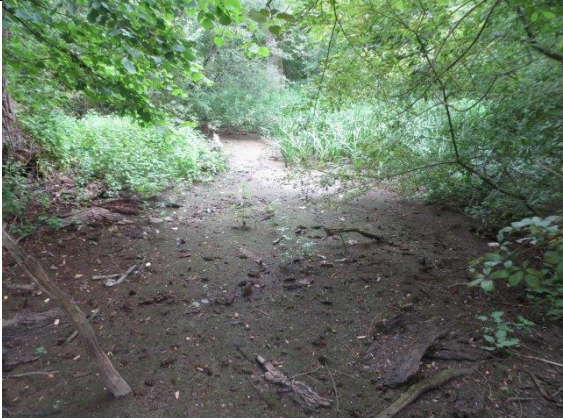
505426 132934	Dry	<p>Northern Edge of pond showing silty base and edge of pond. There is approximately a 1 drop from natural ground levels to the dry base of this area of the pond, indicating that water levels may increase and still be contained within this pond area.</p> <p>Note absence of vegetation suggest this area may be wet more often than dry.</p>

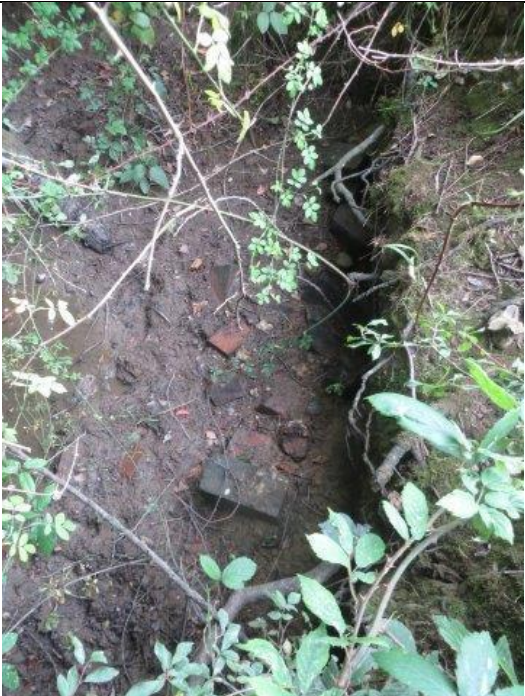
505426 132956	Dry	Pond - inflow into pond dry
25

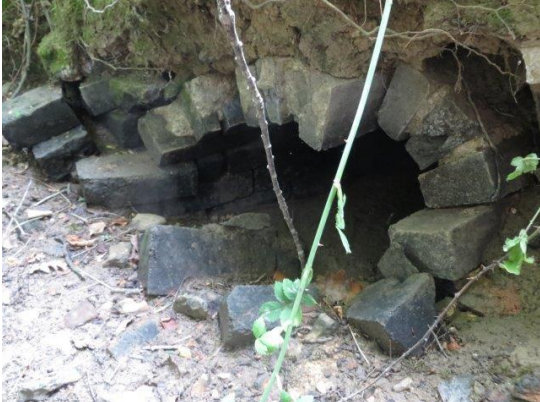
505426 132956	Dry	Collapsed brick lined culvert representing the inflow to the pond.

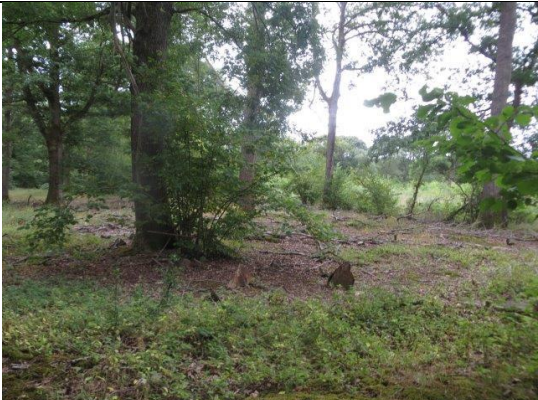
505162 132912	N/A	Photo of slopes towards the site. Southerly direction
27

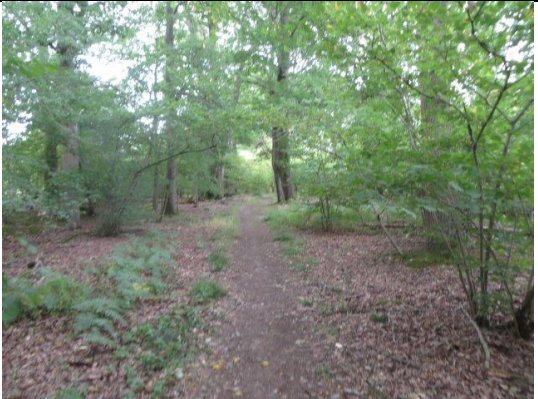
505015 132985	N/A	Forest track along Northern boundary. Very gradual slope

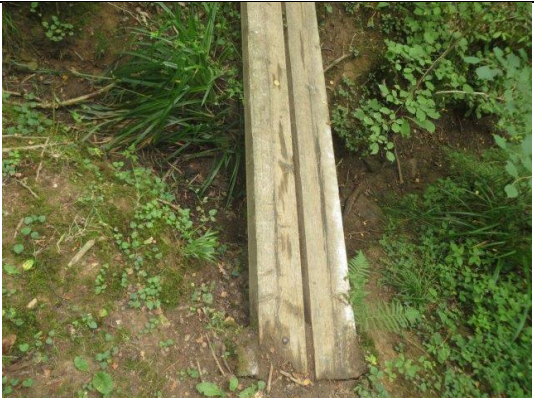
504897 133088	Dry	Origin of drainage ditch to the north west of site. Shallow incised drainage channel that extends further north east towards Hope Rough.
28

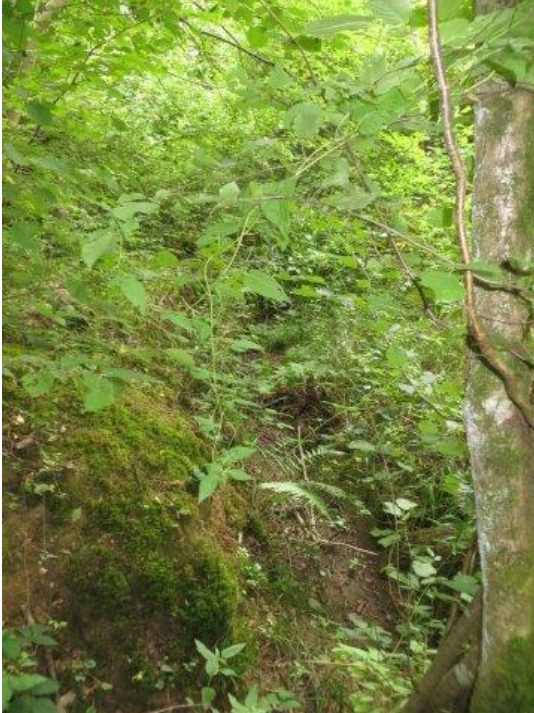
504912 133103	Dry	10m north east of point 28 looking upstream of channel within woodland. Well defined boundaries. Photo 31 indicated erosional features within this area.

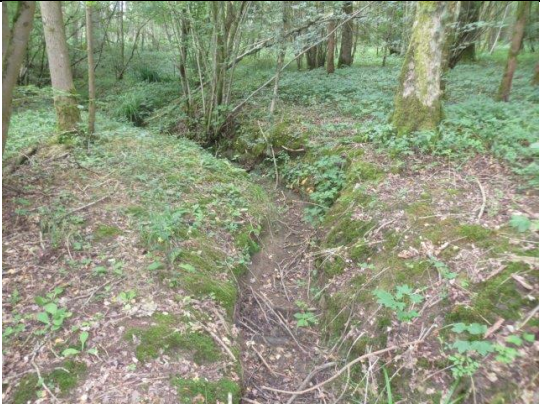
504897 133088	Dry	Looking downstream of location 28. Incised channel meandering through trees. Steep sided and flat bottomed. 0-3m – 0.5m wide. Depth of channel estimated 0.5m.
31

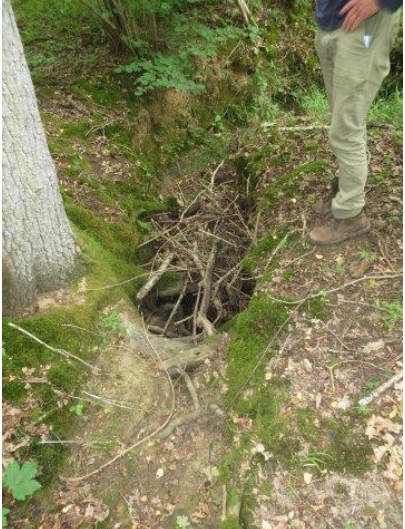
504912 133103	Dry	Erosional feature by tree root. Significant scouring and erosion of sediment. Lots of woodland debris accumulated over scour feature including some sizable branches relative to the channel dimension. Channel estimate 0.5m. Scour feature dropped approximately 1m.

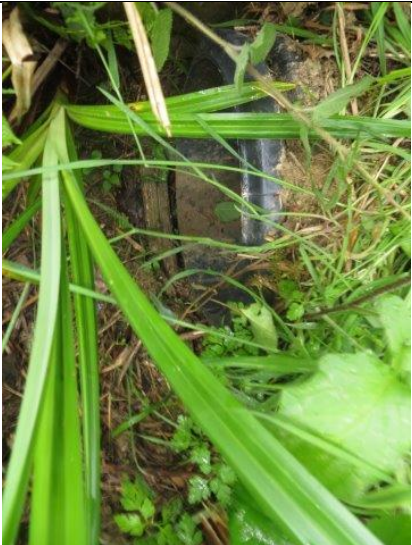
504912 132897	Dry	Culvert under track on western boundary of site 210mm diameter rigid pipe.
33

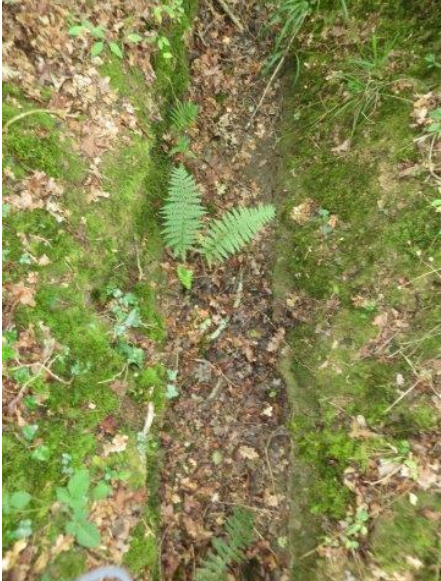
504912 132897	Dry	Dry channel in woodland associated with culvert in location 32. Channel appeared very deep estimated 1.2m by 0.3m wide. Vertical sides and flat bottomed.

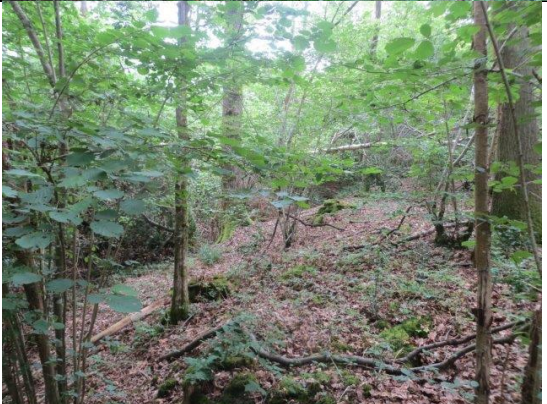
504765 132787	N/A	View northwest looking towards valley on western boundary of site. Note the relatively steep slope towards valley floor.

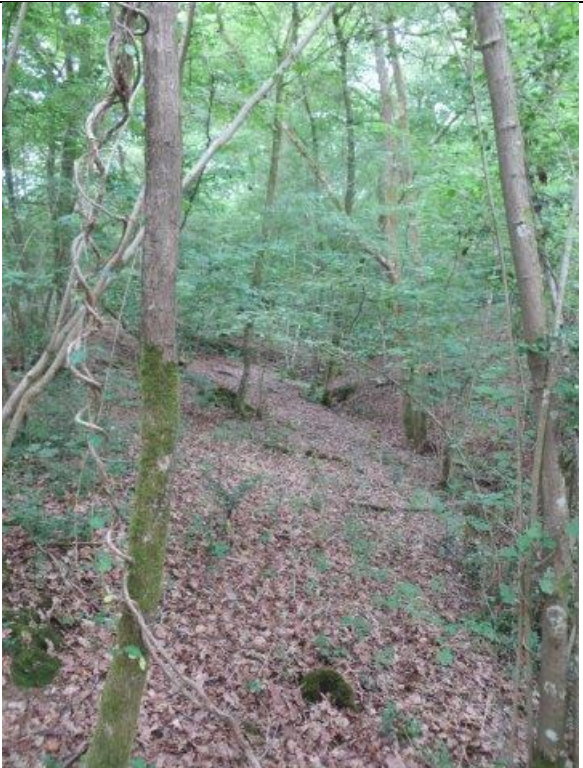
504765 132787	N/A	View southwest looking towards valley on western boundary of site. Note the relatively steep slope towards valley floor.
37

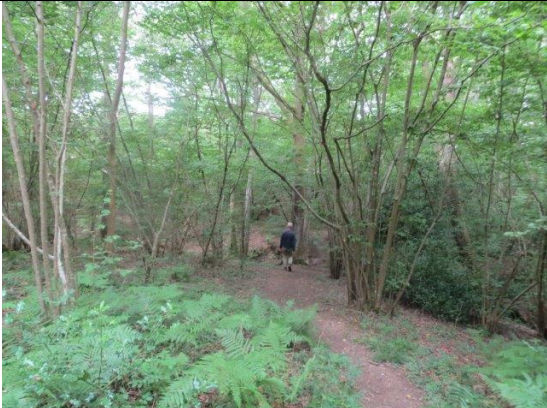
504735 132779	N/A	View west of more moderate trackway into the base of the valley floor.

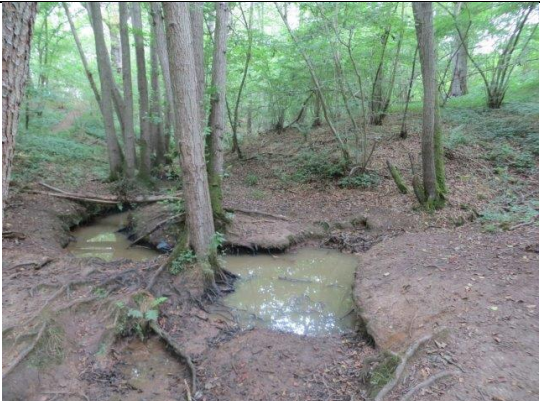
504676 132757	Still / Stagnant, No Flow	<p>Confluence of the stream arising from north and the drainage channel associated with the site.</p> <p>Standing water associated with scour features. No flow.</p>
39

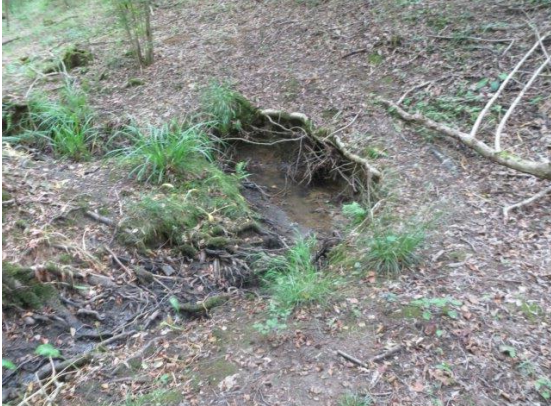
504676 132757	Dry	<p>Narrow incised channel joining at confluence above. Scouring and erosional features apparent in base.</p>

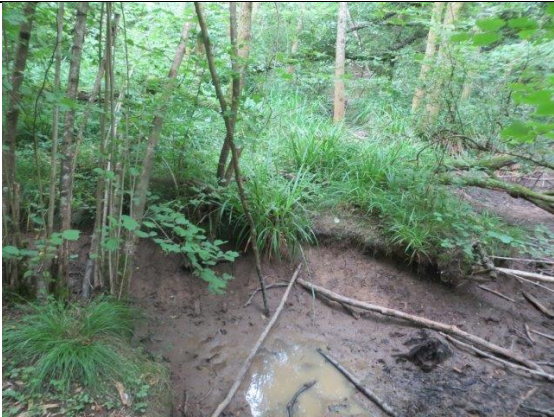
504647 132632	Still / Stagnant, No Flow	Wider channel in base of valley, shallower channel with some undercutting on edges near vegetation. Dry with occasional puddles of standing water.
41

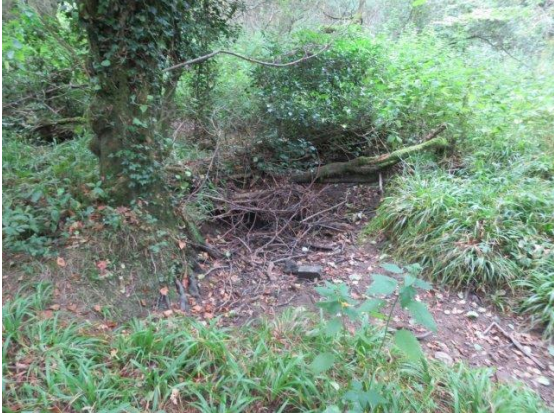
504735 132485	Dry	<p>Just down stream the channel broadens and is braided in the base of a second former fishing lake. The main channel appears to be heavily laden with woodland debris.</p> <p>Channel not shown on OS map, however flow clearly continues down this valley feature.</p>
43

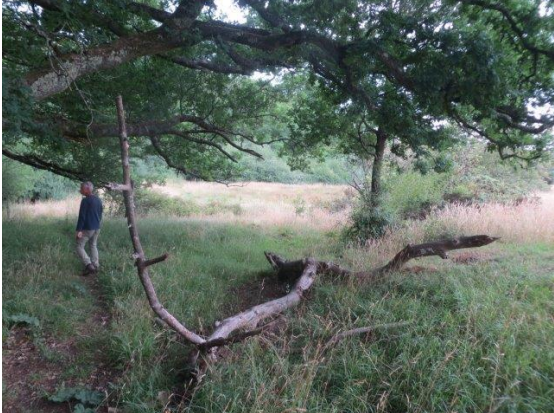
504529 132250	N/A	<p>Land on western boundary of valley indicating a very gentle to flat topography. Base of valley estimated to be between 5-8m from base to the field.</p>

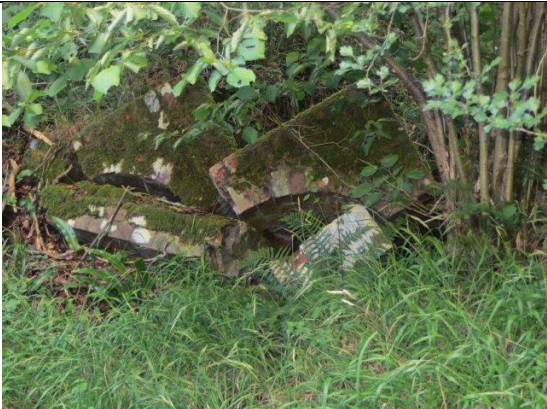
504559 131912	N/A	Down stream of second dam and image of collapsed culvert/sluice channel. The OS map indicates that the stream should appear from this location however no channel was apparent.
45

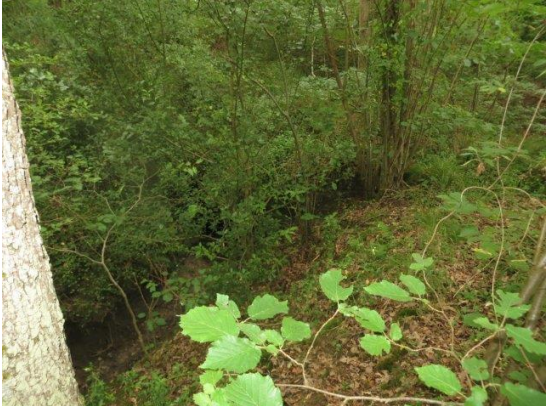
504603 131853	N/A	The dam embankment in the foreground indicates and estimated 3-4m between crest and apparent base of the bund. The embankment appeared intact along its length until the far eastern boundary

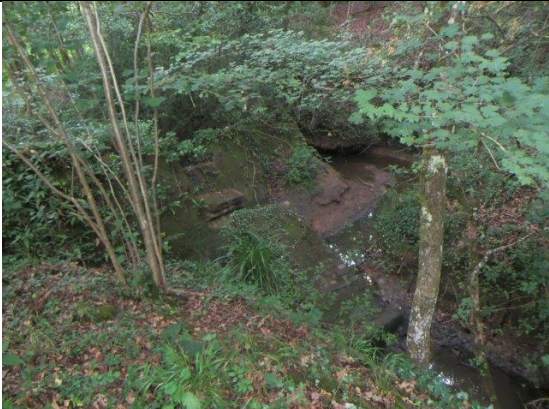
504603 131853	Dry	<p>Far eastern edge of dam embankment indicating a deeply incised channel both through the embankment and upstream. This was dry with the exception of standing water in scour features.</p> <p>Brick structures were observed collapsed into the channel. The depth of the channel was estimated at 2m below the valley floor at this point.</p>
47

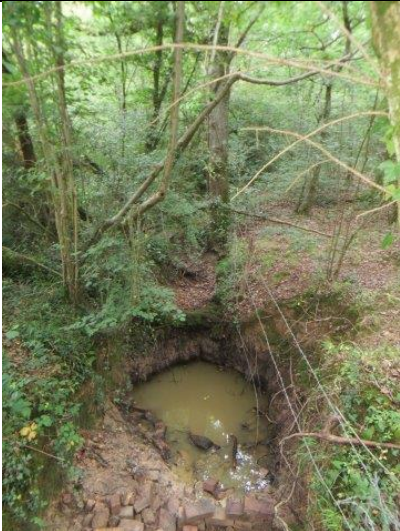
504618 131868	Still / Stagnant, No Flow	<p>View looking upstream from new footbridge</p> <p>Large scour feature and collapse of a brick work structure (possibly former footbridge).</p> <p>Stagnant water in scour feature no flow.</p>

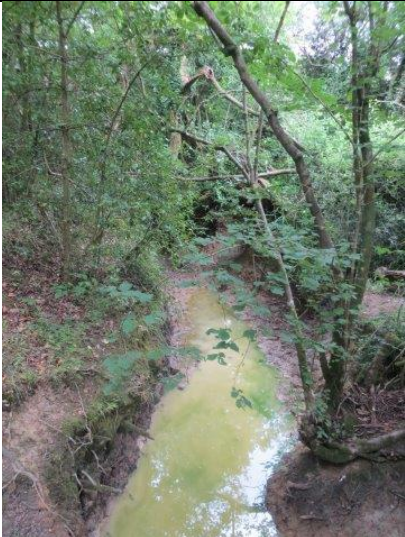
504618 131868	Still / Stagnant, No Flow	<p>View looking down stream of footbridge</p> <p>Scour feature continues with over deepened channel and stagnant water. End of ponded water can be observed in the far ground of the image. No flow.</p> <p>Channel more that 3m wide and more than 1.5m deep below the footbridge.</p>
49

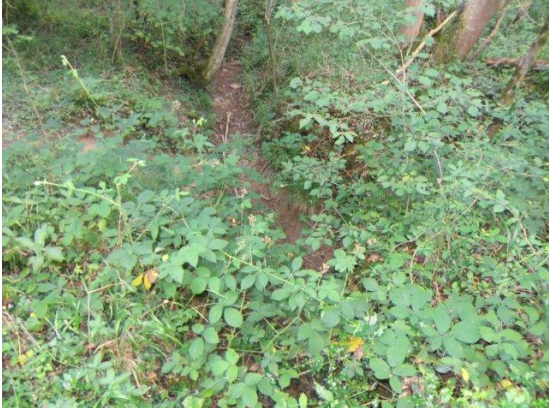
504750 132074	Dry	Unmarked drainage channel crossing the woodland.

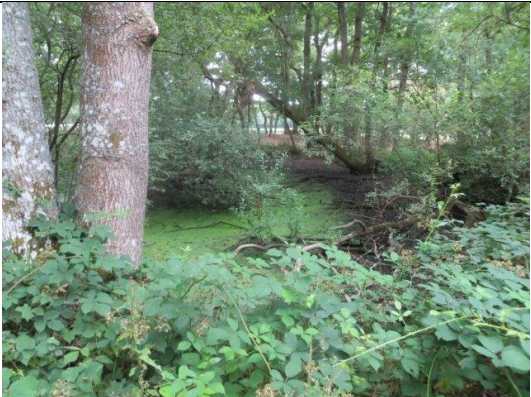
504868 131882	Still / Stagnant, No Flow	View south of pond to the south of the woodland Small pond <20m. fed by small drainage channel however dense undergrowth
51

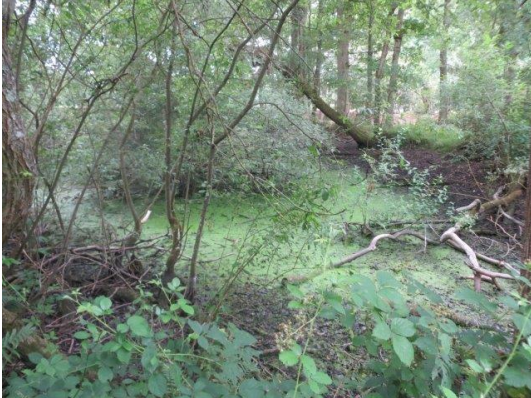
504868 131882	Still / Stagnant, No Flow	View of southern extent of pond. Water level was below the established vegetation line. Expose bed was soft silt. No access to the water edge due to the ground conditions. Pond had very shallow sloping slides Top of slope approximately 0.5m above exposed base.

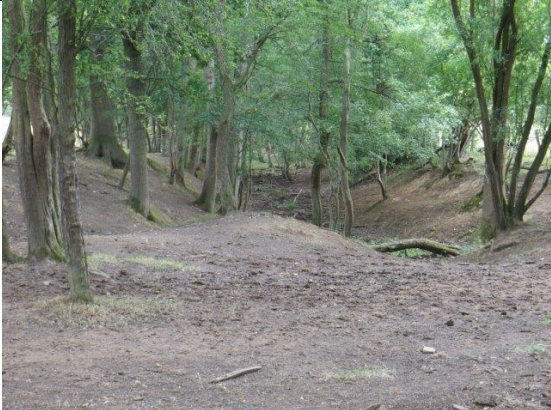
504897 131824	Dry	View south/south west of a sunk lane feature which also channel any overland flow form the surrounding areas. No access however feature appeared to be about 1.5m below surround land

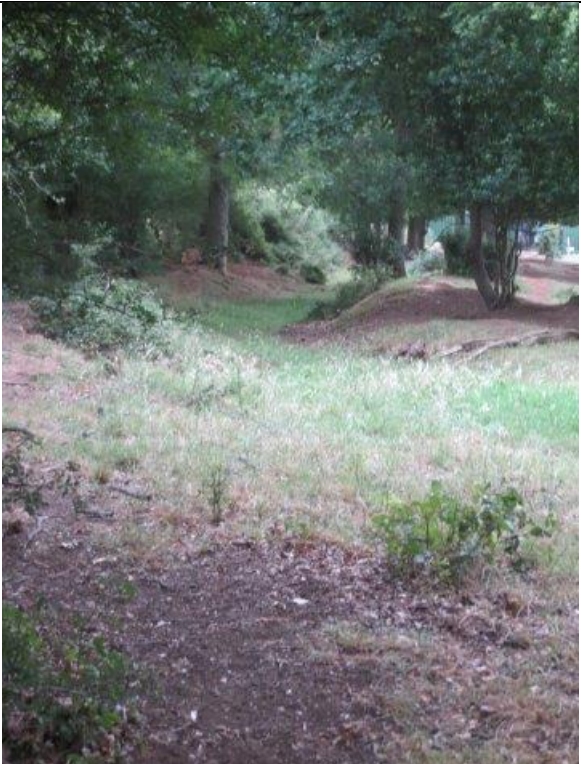
504897 131824	Dry	View down axis of lane/channel feature.
