**Archaeological Desk Based  
Assessment Report and  
Heritage Impact Assessment  
on Loxwood Clay Pits,  
Loxwood,  
West Sussex**

Project No. CBAS1192

By Chris Butler & Emily Walsh

September 2020

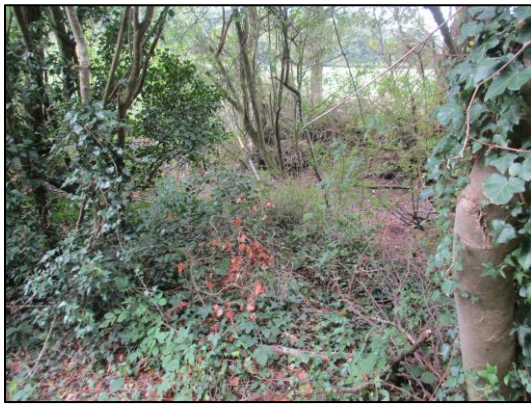
Plate 4: Pond (1)

1. Just prior to entering Hurst wood, there is a pond on the south side of the track (TQ 05521 31967). This is first shown on the Tithe map at the junction of the fields and wood. It is very overgrown, and at the time of the site visit appeared to contain little or no water (Plate 4). This may have originated as a small quarry pit.

- 6.10** Apart from the clay pits associated with the brickworks there was no other evidence noted for quarrying activity across the Site, although there is evidence for quarrying in the broader landscape (Fig. 32). The pond noted at Site 1, may have originated as a small quarry pit.

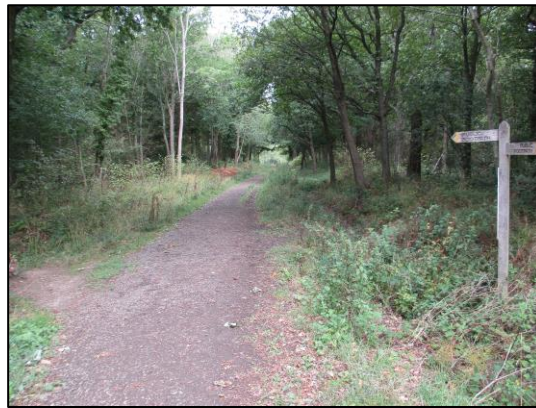
Plate 5: Track through Hurst Wood

5.2.3 On entering Hurst Wood the track is a modern metalled track which continues through the wood in a north westerly direction. This track was constructed between 1961 and 1974 and has a shallow ditch with an external low bank on each side. The original track through the wood (shown on the 1876 OS map) runs along its southern boundary before turning north to rejoin the modern track (at Site 3 below). The woodland on either side here is oak, becoming predominantly conifer at the western end of Hurst Wood, although no trees of any age were noted.

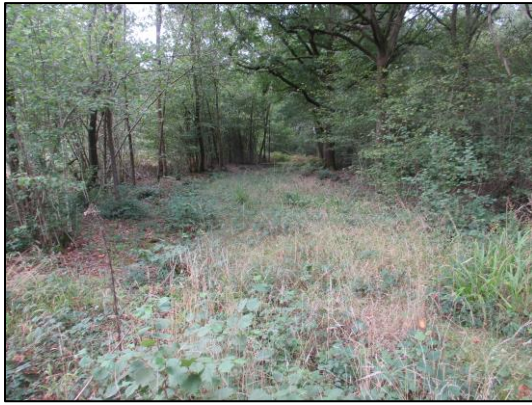
Plate 6: Bank and ditch on west edge of  
Hurst Wood (2)

2. On the western edge of Hurst Wood there is a north-south orientated bank and ditch (Plate 6), which is its boundary, noted on the historic mapping from the Tithe map onwards. The ditch is shallow (c250mm deep) and the bank is low (c.300mm high). It has been merged into the modern bank and ditch on the track edge. TQ 05401 32080.
3. The old track rejoins the modern track on its south side, and is cut by the bank and ditch of the modern track. TQ 05315 32122.

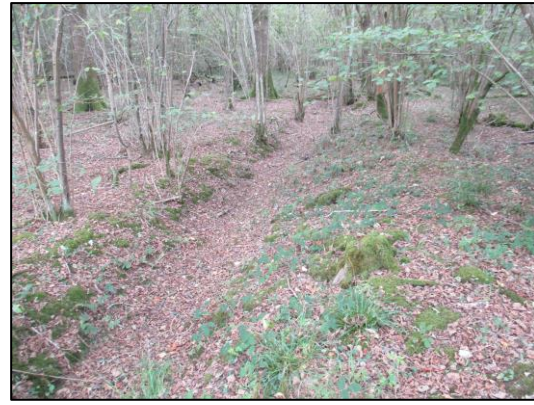
Plate 7: Ditch (4)

4. A north-south orientated ditch c. 2m wide and 0.5m deep noted on both sides of the track (Plate 7). On the Lidar this can be seen to extend south to join the boundary on the western side of Beggars Copse to the south of Caddick Copse, and to the north of the track it curves northeast to join another boundary bank and ditch (6), but is not shown on any historic mapping. Note the field to the west of Beggars Copse has probable ridge and furrow showing on the Lidar. TQ 05294 32135.

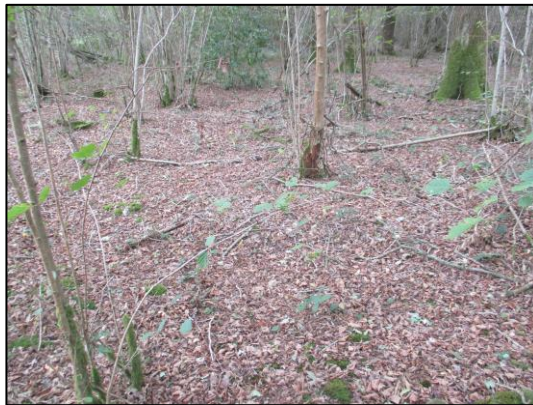
Plate 8: Drainage linears (5)

5. On the south side of the track there are a number of parallel shallow linears (grips), each c. 0.5m wide and 250mm deep (Plate 8) which run east-west through the woodland, c.4 to 5m apart, extending either side of ditch 4. These are probably for drainage, and are oriented to follow the slope, and are a common feature in later Post medieval managed woodland. On the Lidar only the deeper linears show up, at approximately 20m intervals. TQ 05290 32112.

- 6.6** Other woodland management features noted on both Lidar and the ground truthing were the parallel linear features noted within the woodland areas at the Site. These are almost certainly associated with drainage and are small ditches or ‘Grips’ running downslope and probably into streams. The ‘Grips’ were dug to a spade’s depth and width, and perhaps formed part of a more extensive network of drainage<sup>52</sup>, and are a common feature of 19<sup>th</sup> century woodland management, especially associated with newly created plantations. Now they are partly in-filled or blocked, due to lack of maintenance, and appear today as parallel ridges/channels running downslope within the woodland.

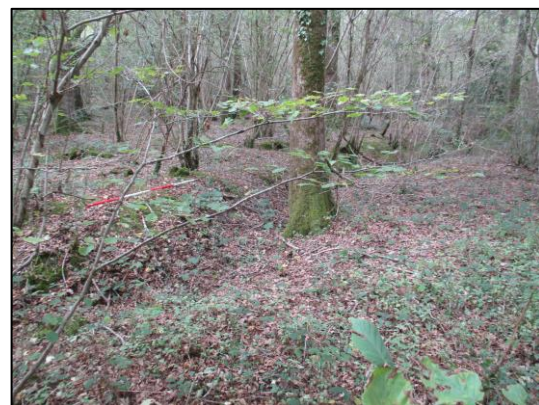
Plate 9: Ditch (6)

6. The western and northern historic boundary to Caddick Copse shows as a feature on the Lidar, also continuing west along the south side of the track to form the historic boundary between Great Scrubbs to the south and Woodlands Furze to the north (Feature 8), and is first shown on the 1897 OS map (Fig. 22). This feature survives as a ditch, c. 2m wide with a slight bank 300mm high on its east side. A potential feature showing as a northeast-southwest bank/ditch feature on the Lidar to the east of ditch 6, could not be located on the ground. TQ 05262 32158.

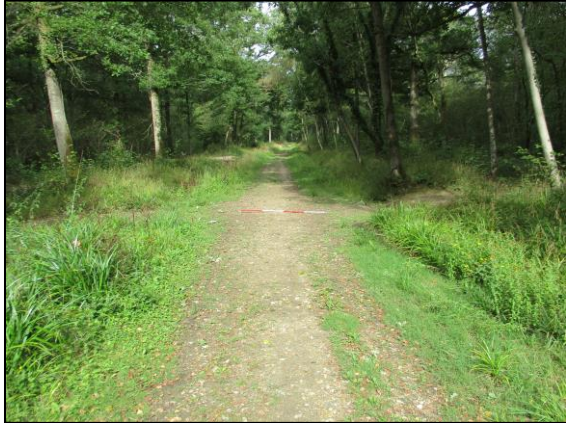
Plate 10: Track junction (7)

7. This is a track junction (Plate 10) with a historic track, shown south of the track on the 1876 OS map, and extending northwards by 1897. The historic track is still extant but has no flanking bank and ditch (Plate 11). The woodland here is predominantly young coppice and numerous oaks, although none are of any significant age (Plate 12). TQ 05189 32214.

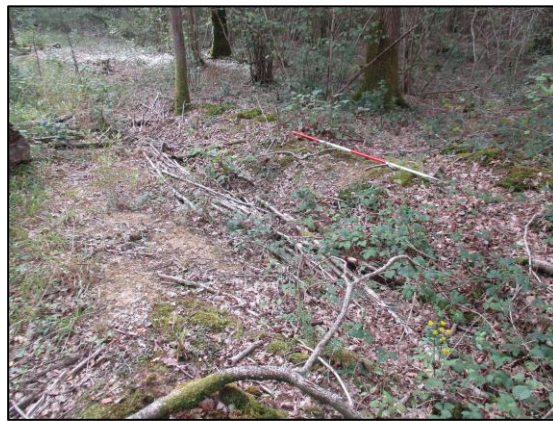
Plate 13: Boundary (8)

8. Continuation of Feature 6 continuing west along the south side of the track to form the historic boundary between Great Scrubbs to the south and Woodlands Furze to the north (Feature 8); c. 1m wide and 300mm deep with a slight bank on each side c. 300mm high (Plate 13). TQ 05164 32226.
9. Boundary bank first shown on the 1897 OS map separating Great Scrubbs/Woodlands Furze to the east and Great Birchfield to the west. Comprises bank 0.6m high with a slight ditch on its west side to the north of the track (Plate 14), and to the south of the track the ditch is larger c.1.5m wide and 0.6m deep with a smaller bank on its east side. TQ 05130 32256. Note that the coppice is planted over this boundary feature and therefore post dates it.

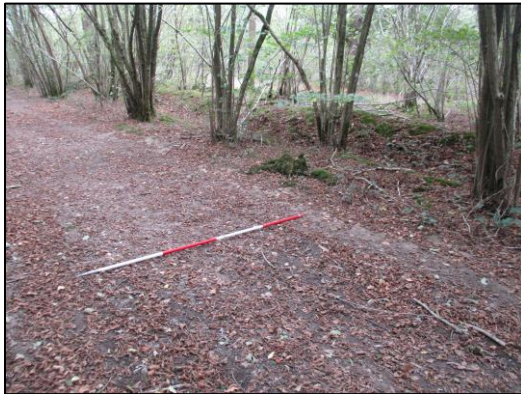
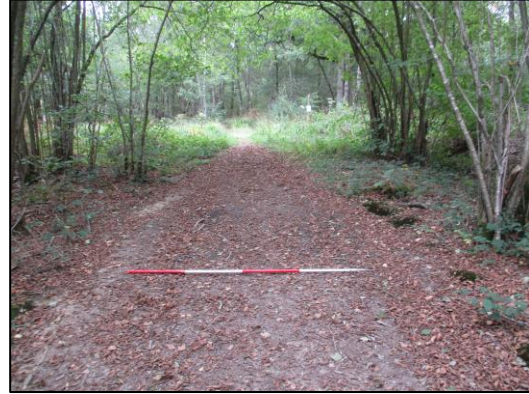
10. Northeast-southwest trackway c. 7m wide crosses access road (TQ 05028 32347), first seen on the 1876 OS map, connecting Woodhouse Farm and Brick Kiln Farm to the north with Loxwood Road. Prior to this it was a field boundary. It has a bank and inner ditch on each side of the track. The ditches are c. 1.5m wide and 0.5m deep, and the banks are c. 1.3m wide and 0.4m high. Coppice is planted over the banks and ditches (Plates 15 & 16). On the northeast side of the junction there is a braided trackway running parallel to the track, suggesting the track has migrated westwards to its current location

Plate 15: Trackway (10) to the south

Plate 16: Trackway (10) to the north

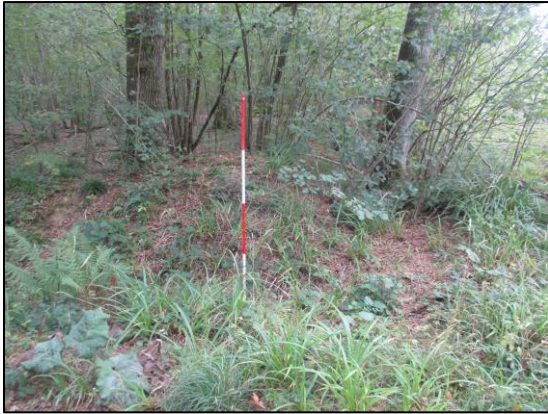
Plate 20: Boundary bank (12)

12. The boundary between Songhurst Furze and Thirteen Acres is formed by a bank c. 0.75m high and 1.5m wide which turns to run along the east side of the track to the north (Plate 20). It has a ditch on the south side which also continues along the track, which is c 1.5m wide and 0.4m deep. The bank also continues westwards on the west side of the track where it is very overgrown. TQ 04847 32486. Historic maps show a track on the south side of this boundary bank, but there was no trace of this during the survey.

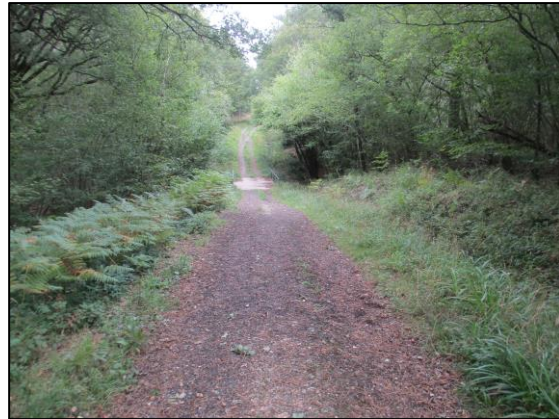
Plate 21: Bridge (13) looking north

13. The track drops down to a modern concrete bridge with metal railings over the stream (Plate 21). TQ 04847 32525. The stream was narrow with a broad flood plain with coppice (Plates 22 & 23). The area around the stream was inspected for evidence of charcoal burning platforms or other industrial activity, but none was seen.

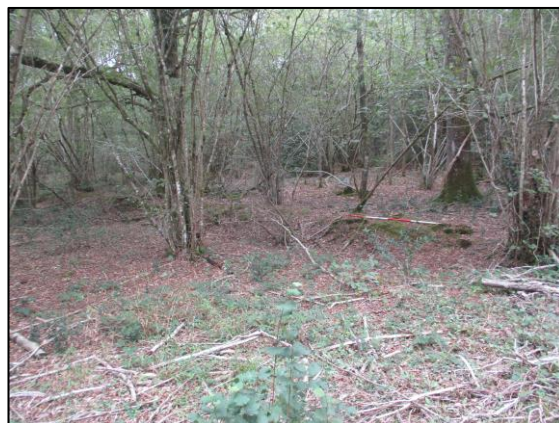
Plate 24: Boundary bank (15)

15. A boundary bank to the west of the track is first shown on the 1897 OS map. It is c.1.5m wide and 0.6m high with a ditch on the south side c. 1.5m wide and 0.4m deep (Plate 24). It has coppice growing over it. TQ 04892 32638.

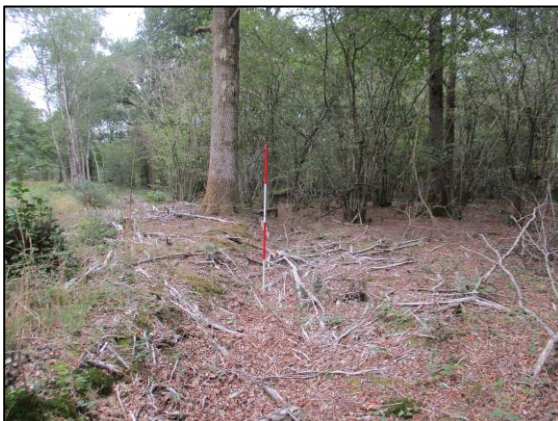
Plate 27: Bank & ditch (17)

17. A bank and ditch orientated northeast-southwest runs northeast from just north of the track junction (TQ 04923 32721). The bank is c. 1.5m wide and 0.3m high, with the ditch on its east side being c. 2m wide and 0.25m deep (Plate 27). Coppice and established oak trees are growing on this feature with some of the trees potentially being >100 years. This feature can be traced on Lidar and on the ground running northeast to Track 18 (see 32) and may reflect an earlier boundary, which is respected by the drainage to its east and west sides (see 30).

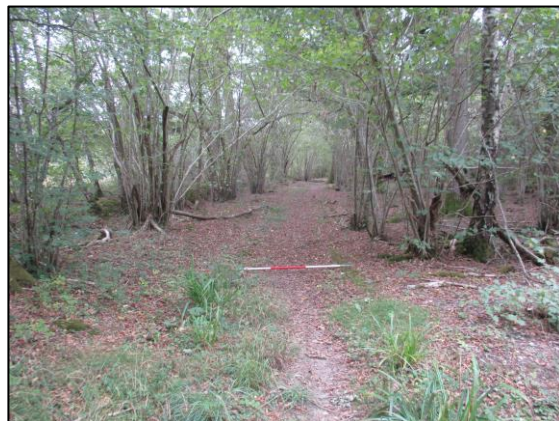
Plate 28: Track (18)

18. An east-west track (Plate 28) first shown on the 1876 OS map, and previously on the Tithe as a field boundary, runs east through the centre of the Site from its junction with the track on the eastern boundary (TQ 04941 32807). Same as 27

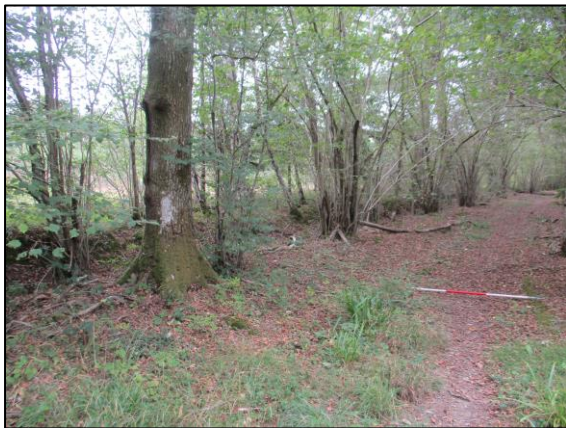
Plate 29: Bank & ditch (19)

19. A bank c. 2m wide and 0.4m high runs along the north side of Track 18 (Plate 29) and turns to run north along the east side of the track running along the western boundary. It has a ditch on its outside (west and south sides) which is c. 2m wide and 0.4m deep. Trees and coppice grow over the bank and ditch. TQ 04946 32828.

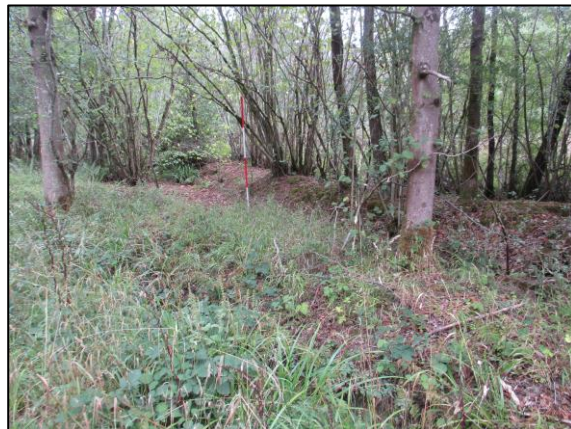
Plate 30: Bank (20)

20. The bank continues north along the western boundary track and becomes more substantial. The track swings to the northwest, but the bank continues north (Plate 30) turning slightly to the northeast, before becoming overgrown and lost in the plantation/vegetation. TQ 04956 32955. On the 1912 OS map this bank feature is shown as a track curving around the northwest corner of the development site, however due to the overgrown nature of this part of the site it was not possible to locate this feature, however it is clearly shown as being extant on the Lidar.

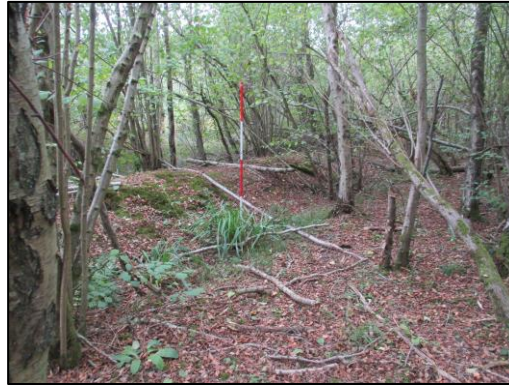
Plate 31: Boundary bank (22)

21. A number of ditches were noted at this location (TQ 04984 32980). They merge and enter the development site from The Lane, breaching the bank (22) which runs along the northern boundary of the development site. The 1920 OS map notes that there are 'Rises' in this northwest part of the site, suggesting a spring or wet ground is located here.
22. The boundary bank running along the north side of the Site and separating the Site from The Lane is c. 0.5m high and 1.5m wide, with a ditch on its outside (north) c. 1.2m wide and 0.3m deep at TQ 04989 32969 (Plate 31), although this varies in places. It is covered with coppice.

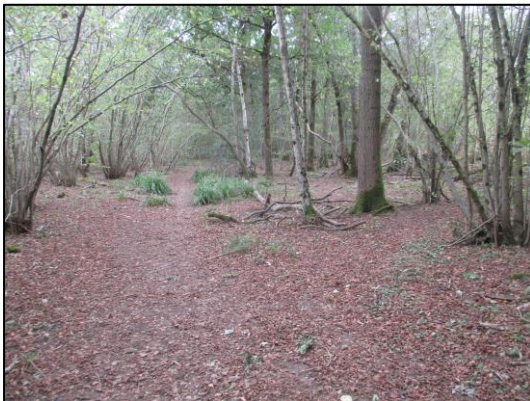
Plate 32: The Lane at the west end

23. The Lane is a broad 'ride' running along the entire northern side of the Site from c. TQ 04955 32998 to TQ 05297 32770. It is c.20m wide at its west end narrowing to c 10m wide at TQ 05110 32897 through to the east end. At the west end there is no distinct path and the entire ride is covered with coppice and larger trees (Plate 32), but where it narrows there is a more distinct path with coppice and established trees at the edges (Plate 33). The Lane is bounded by Bank 22 on its south side, and a similar bank and ditch on its north side, with fields barely visible beyond.

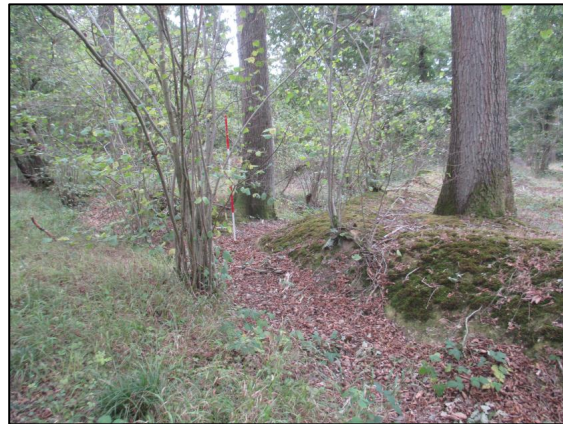
Plate 35: West side of 'V' (24)

24. The bank (22) turns southeast at c. TQ 05139 32877 (Plate 35) and after a short gap also continues along the north end of the Site. This is the east side of the 'V' shaped area that was formed by 1912, and shows on the Lidar. Within the 'V' the vegetation does not change from the surrounding coppice and trees

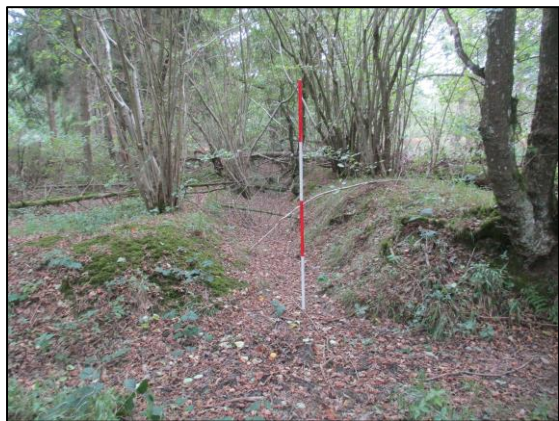
Plate 36: East side return of 'V'

25. The eastern return of the 'V' is at c. TQ05163 32875 (Plate 36). Although the bank and ditch around the three sides of the 'V' varies, each is broadly c. 2m wide and there is an overall depth/height of 1m.

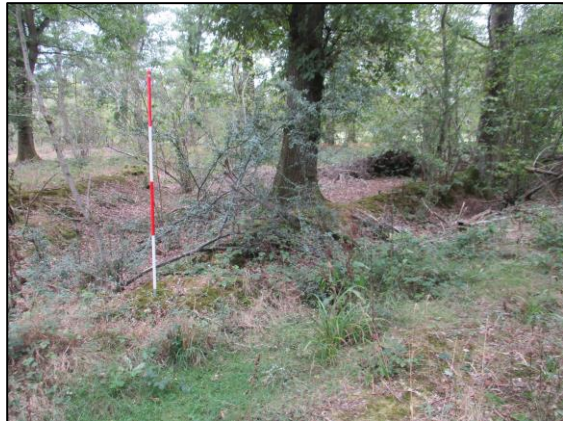
Plate 37: South end of 'V'

26. At the south end of the 'V' (Plate 37) the ditch and bank continues initially southwards, then bending round to the southwest, where it is less well defined (Plate 38), before stopping at the east-west track (27) (Plate 39) where it turns, merging into the bank running along the north side of this track towards the west.

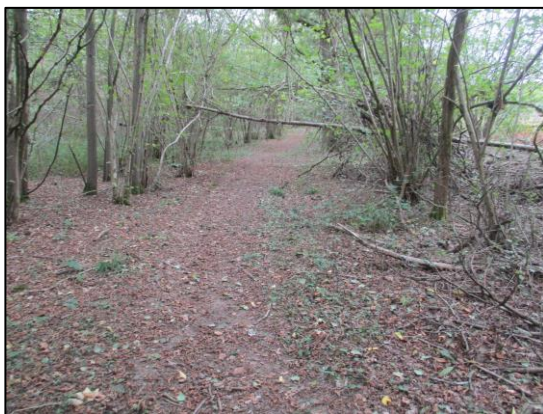
Plate 40: Track 27 looking west

27. East-west track running through the centre of the Site, first shown on the 1876 OS map, and previously on the Tithe as a field boundary. Same as 18. To the west of TQ 05106 32765 it is a clear track (Plate 40) with coppice along the edges and a bank (29) on its north side. To the east of this point it heads northeast, but is completely overgrown and could not be traced on the ground in this direction.

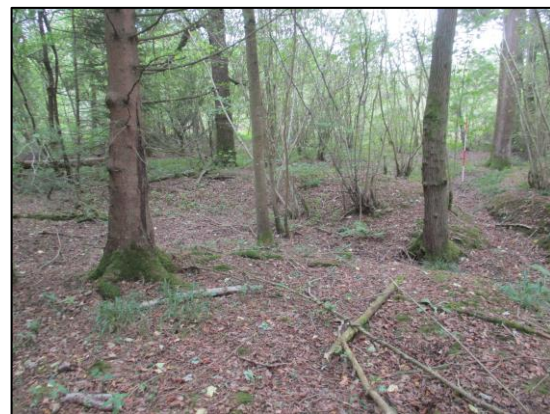
Plate 41: Pond (marked by ranging pole)  
and ditches (28)

28. A possible pond and ditches running south into a stream. TQ 05117 32741. Some of this may be man made and appears to be a spring/risings, which probably only contains water in the winter. Further south this becomes 34. This shows on the Lidar although partly hidden by conifers. The OS mapping shows a boundary running north-south at approximately this location, then turning southwest, although this was not identified on the ground, it may be the stream was this boundary.

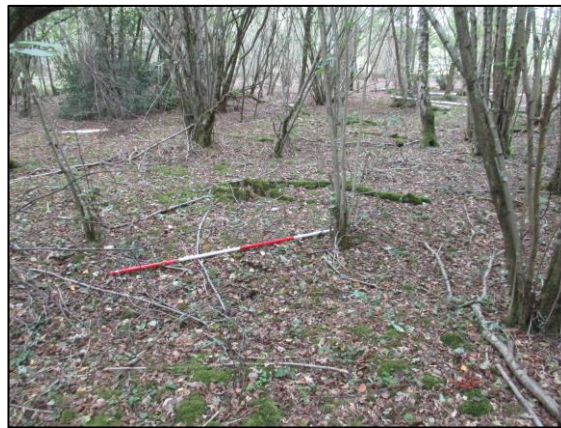
Plate 44: Parallel drainage runs (30)

30. To the south of Track 27 is an area of parallel drainage runs (grips), running north-south downslope, c. 200mm deep and 0.75m wide, and approximately 3 to 5m apart (Plate 44). TQ 05012 32754.

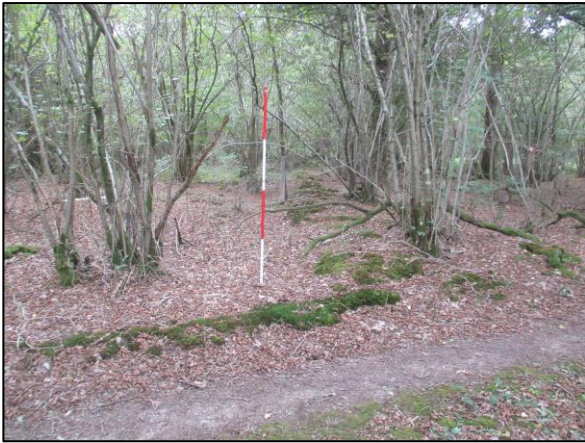
Plate 45: Bank 32 meeting Track 27/18

32. The northern end of Bank & ditch 17 was noted at TQ 04983 32790 (Plate 45). It is c. 1m wide and 250mm high, with little trace of a ditch here. It stops at the track (27/18), merging with a low bank which turns east along the south side of the track for a short distance. This area is largely coppice, and there are traces of the parallel drainage runs on its east and west sides.

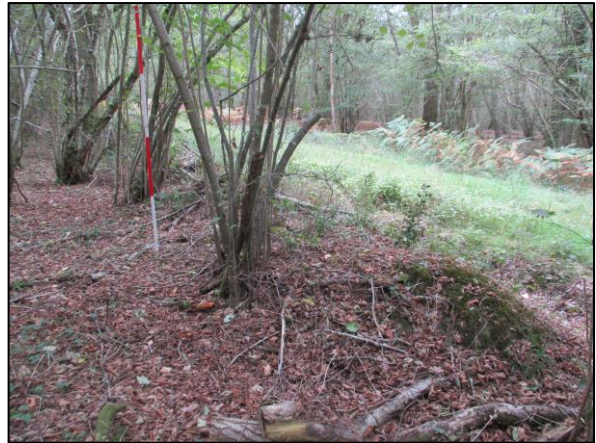
Plate 46: Bank 33

33. On the north side of the track there is a ditch, with a small bank c. 300mm high and 1m wide on the wood side (TQ 04973 32688). There is coppice growing on the bank (Plate 46).

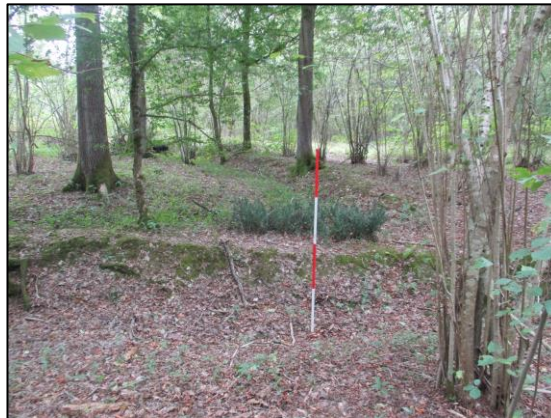
Plate 47: Bank 34 in the background with the stream  
(marked by ranging pole) in the foreground

34. A short length of bank runs from close to the stream, almost parallel to the track, on the line of the boundary shown on the 1876 OS map. The bank continues out of the site to the south of the track which has cut through the bank when the track was re-aligned northwards between 1961 and 1974. The bank is c. 1.2m wide and 300mm high with a slight ditch on its north side (Plate 47).

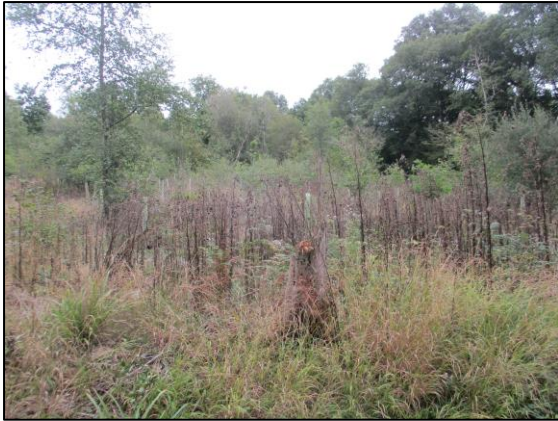
Plate 48: South eastern part of Site

- 5.3.7 The track continues past the stream to meet Track 35 at the southeast corner of the Site. There is no bank or ditch on either side of the track here, which was re-aligned between 1961 and 1974. There is recent plantation in this eastern part of the site, which was a field on the Tithe map, and remained open through to the 1920 OS map, after which it has become plantation. The southern part of this area is plantation (Plate 48) with thick ground vegetation, whilst further north it becomes a very scrubby woodland (Plate 49), in both cases making access and surveying almost impossible. Very little shows on the Lidar for this area, although there are some faint northeast to southwest aligned linears, which could be remnant ridge and furrow from when it was a field. A northwest to southeast aligned track shown on the 1974 OS map was not located.

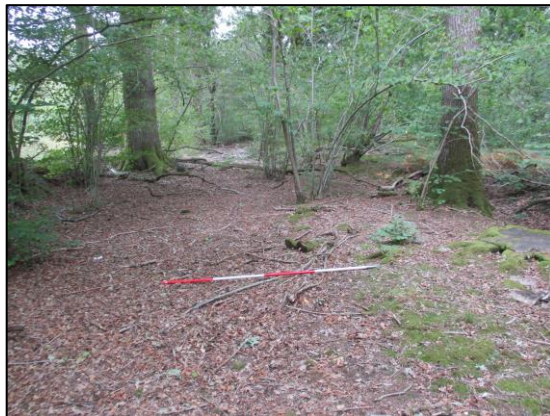
Plate 50: Track 35 looking north

35. Track 35 is an 8m wide north-south orientated ‘ride’ (TQ 05154 32607), with a bank and ditch on either side, which runs up the eastern boundary of the Site (Plate 50) to meet the east-west track at 36. The banks are c.0.75m high and 2m wide. The ride is no longer used, and the modern track runs parallel to its west side on the site boundary. The ride narrows towards the north end. To the south it becomes a hollow way (Plate 51), which deepens as it curves round to the southeast to join Track 10.

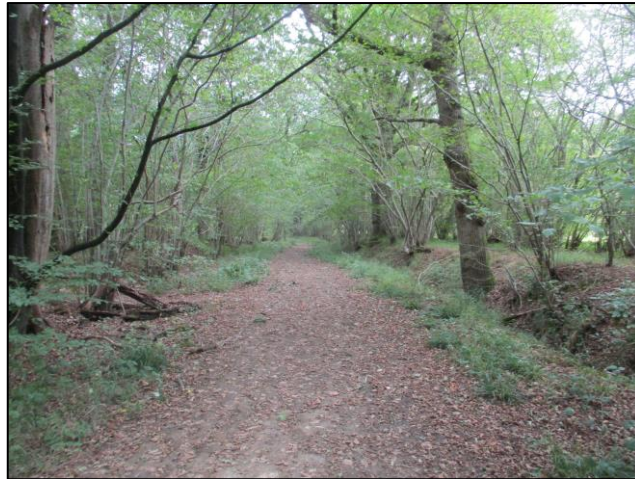
Plate 52: Track 23 looking west from junction (36)

36. At the northeast corner of the site Track 35 meets and crosses Track 23 (The Lane) at TQ 05297 32770, which is c. 6m wide with banks and ditches along both sides (Plate 52). Track 23 broadens out and is less distinct as it heads further east. Track 35 continues north with distinct banks and ditches on either side. There is no outlook from the Site to the north or east due to the significant tree cover. There are grass fields to the north of The Lane.

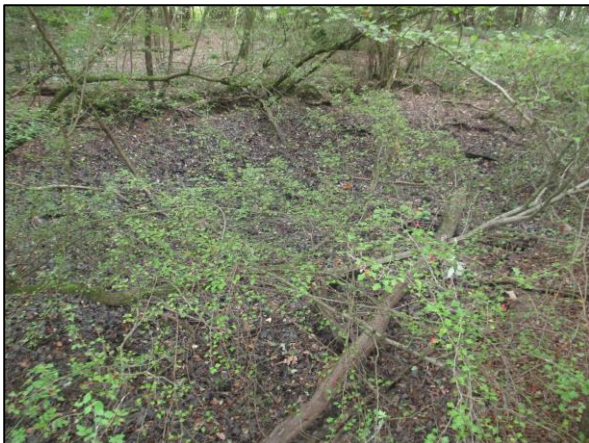
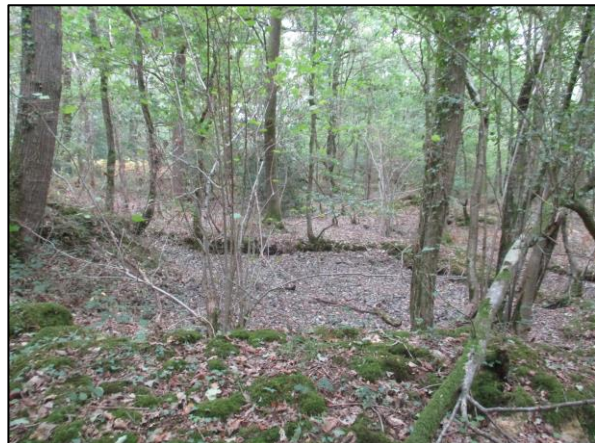
Plate 53: Clay pit

37. A number of clay pits associated with the brickworks are visible to the east of the track (TQ 05627 31913), although now overgrown by scrub woodland (Plate 53 & 54). Other larger clay pits extend further east into Pephurst Wood.

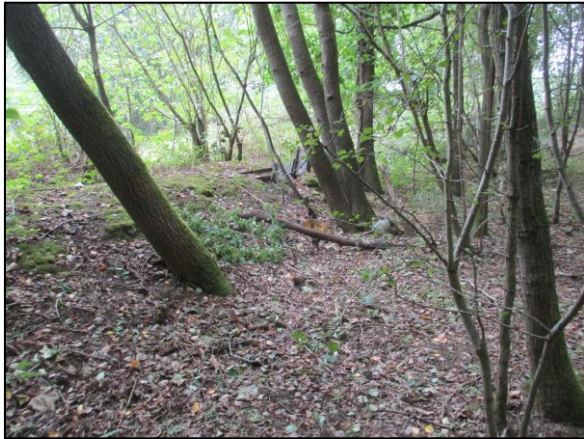
Plate 55: Mound in brickworks area

38. A mound, (Plate 55) possibly incorporating building remains, c.12m x 5m in size and 1m high (c. TQ 05617 31871), together with pieces of machinery is situated to the northeast of the entrance. Numerous bottles and items of pottery, and metalwork, were noted on the ground in this area (Plate 56). An area of concrete hard standing is located to the south of this mound (Plate 57).

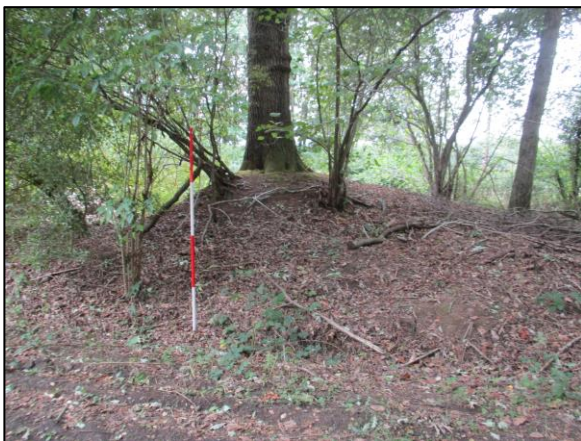
Plate 58: Mound on kiln site

39. Just to the north of the entrance and immediately adjacent to the west side of the access track is another mound (Plate 58). This is c.1.8m high and in excess of 6m in diameter (Plate 58), and is covered with trees. This is on the location of a Kiln marked on historic OS mapping (TQ 05558 31848).

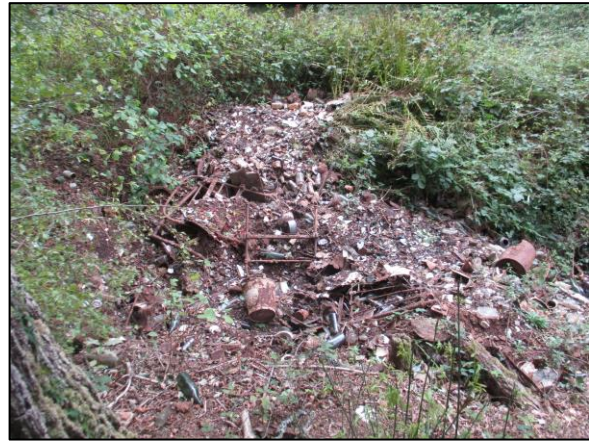
Plate 59: Bottle and pottery dump

Immediately to the north of this mound, and probably in a depression, there is a large quantity of glass, pottery and metal items which appear to have been dumped here (Plate 59). No samples were taken, but from a brief look, this dump would appear to date from the early 20<sup>th</sup> century, possibly contemporary with the closure of the brickworks.

- 6.9** The local clay provided a good source of raw material for brickmaking, with two brickworks in the vicinity of the site. Brickkiln Farm to the northeast and the brickyard at Pephurst Wood adjacent to the entrance to the access road. Both were under the tenancy of Stephen Knight in 1842. Brickkiln Farm is outside of the area surveyed and the proposed development has no impact on it. The brickyard at Pephurst Wood has extensive clay pits in the wood, and two mounds which may cover the demolished kilns or other buildings (Fig. 31). There may also be other remains of drying shed and other structures for which the remains are ephemeral or preserved below ground and not seen on the site visit. There are also large quantities of discarded artefacts lying on the ground surface and the large rubbish dump adjacent to one of the mounds.

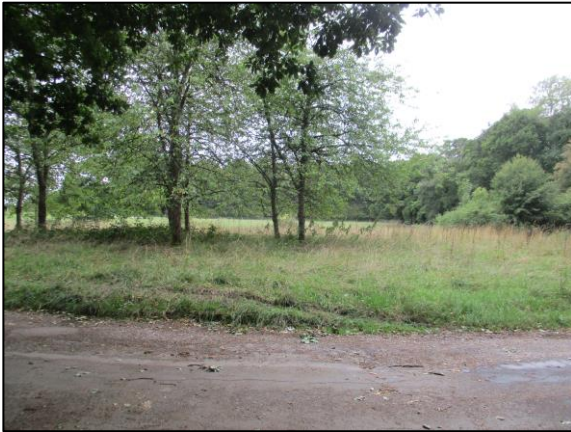
Plate 60: Layby location of infilled clay pit

40. A ditch was noted running north from the west side of the entrance to the site, and probably runs up towards the mound (39), although it is very overgrown.
41. Directly opposite the entrance in the layby a large clay pit is shown on the historic mapping (Plate 60). This appears to have been infilled and is now an area of grass and small trees (TQ 05552 31810).
42. Immediately to the east of the entrance to the site is another clay pit (Plate 61), which extends along the boundary between the layby and the wood (TQ 05587 31834).

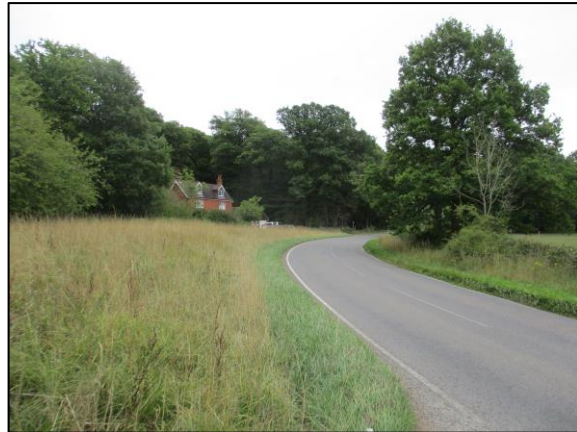
Plate 63: Cottage from west end of layby

5.5.2 A cottage is situated at the east end of the layby (Plate 62) and is first shown on the 1912 OS map (Fig. 31). It is set back into the wood from the road, and is accessed from the layby. There is no direct line of sight with the entrance to the site, but it can be seen from the western entrance into the layby (Plate 63). The cottage is not a Listed Building, although it may be considered a non-designated heritage asset due to its age and possible connection with the brickworks.

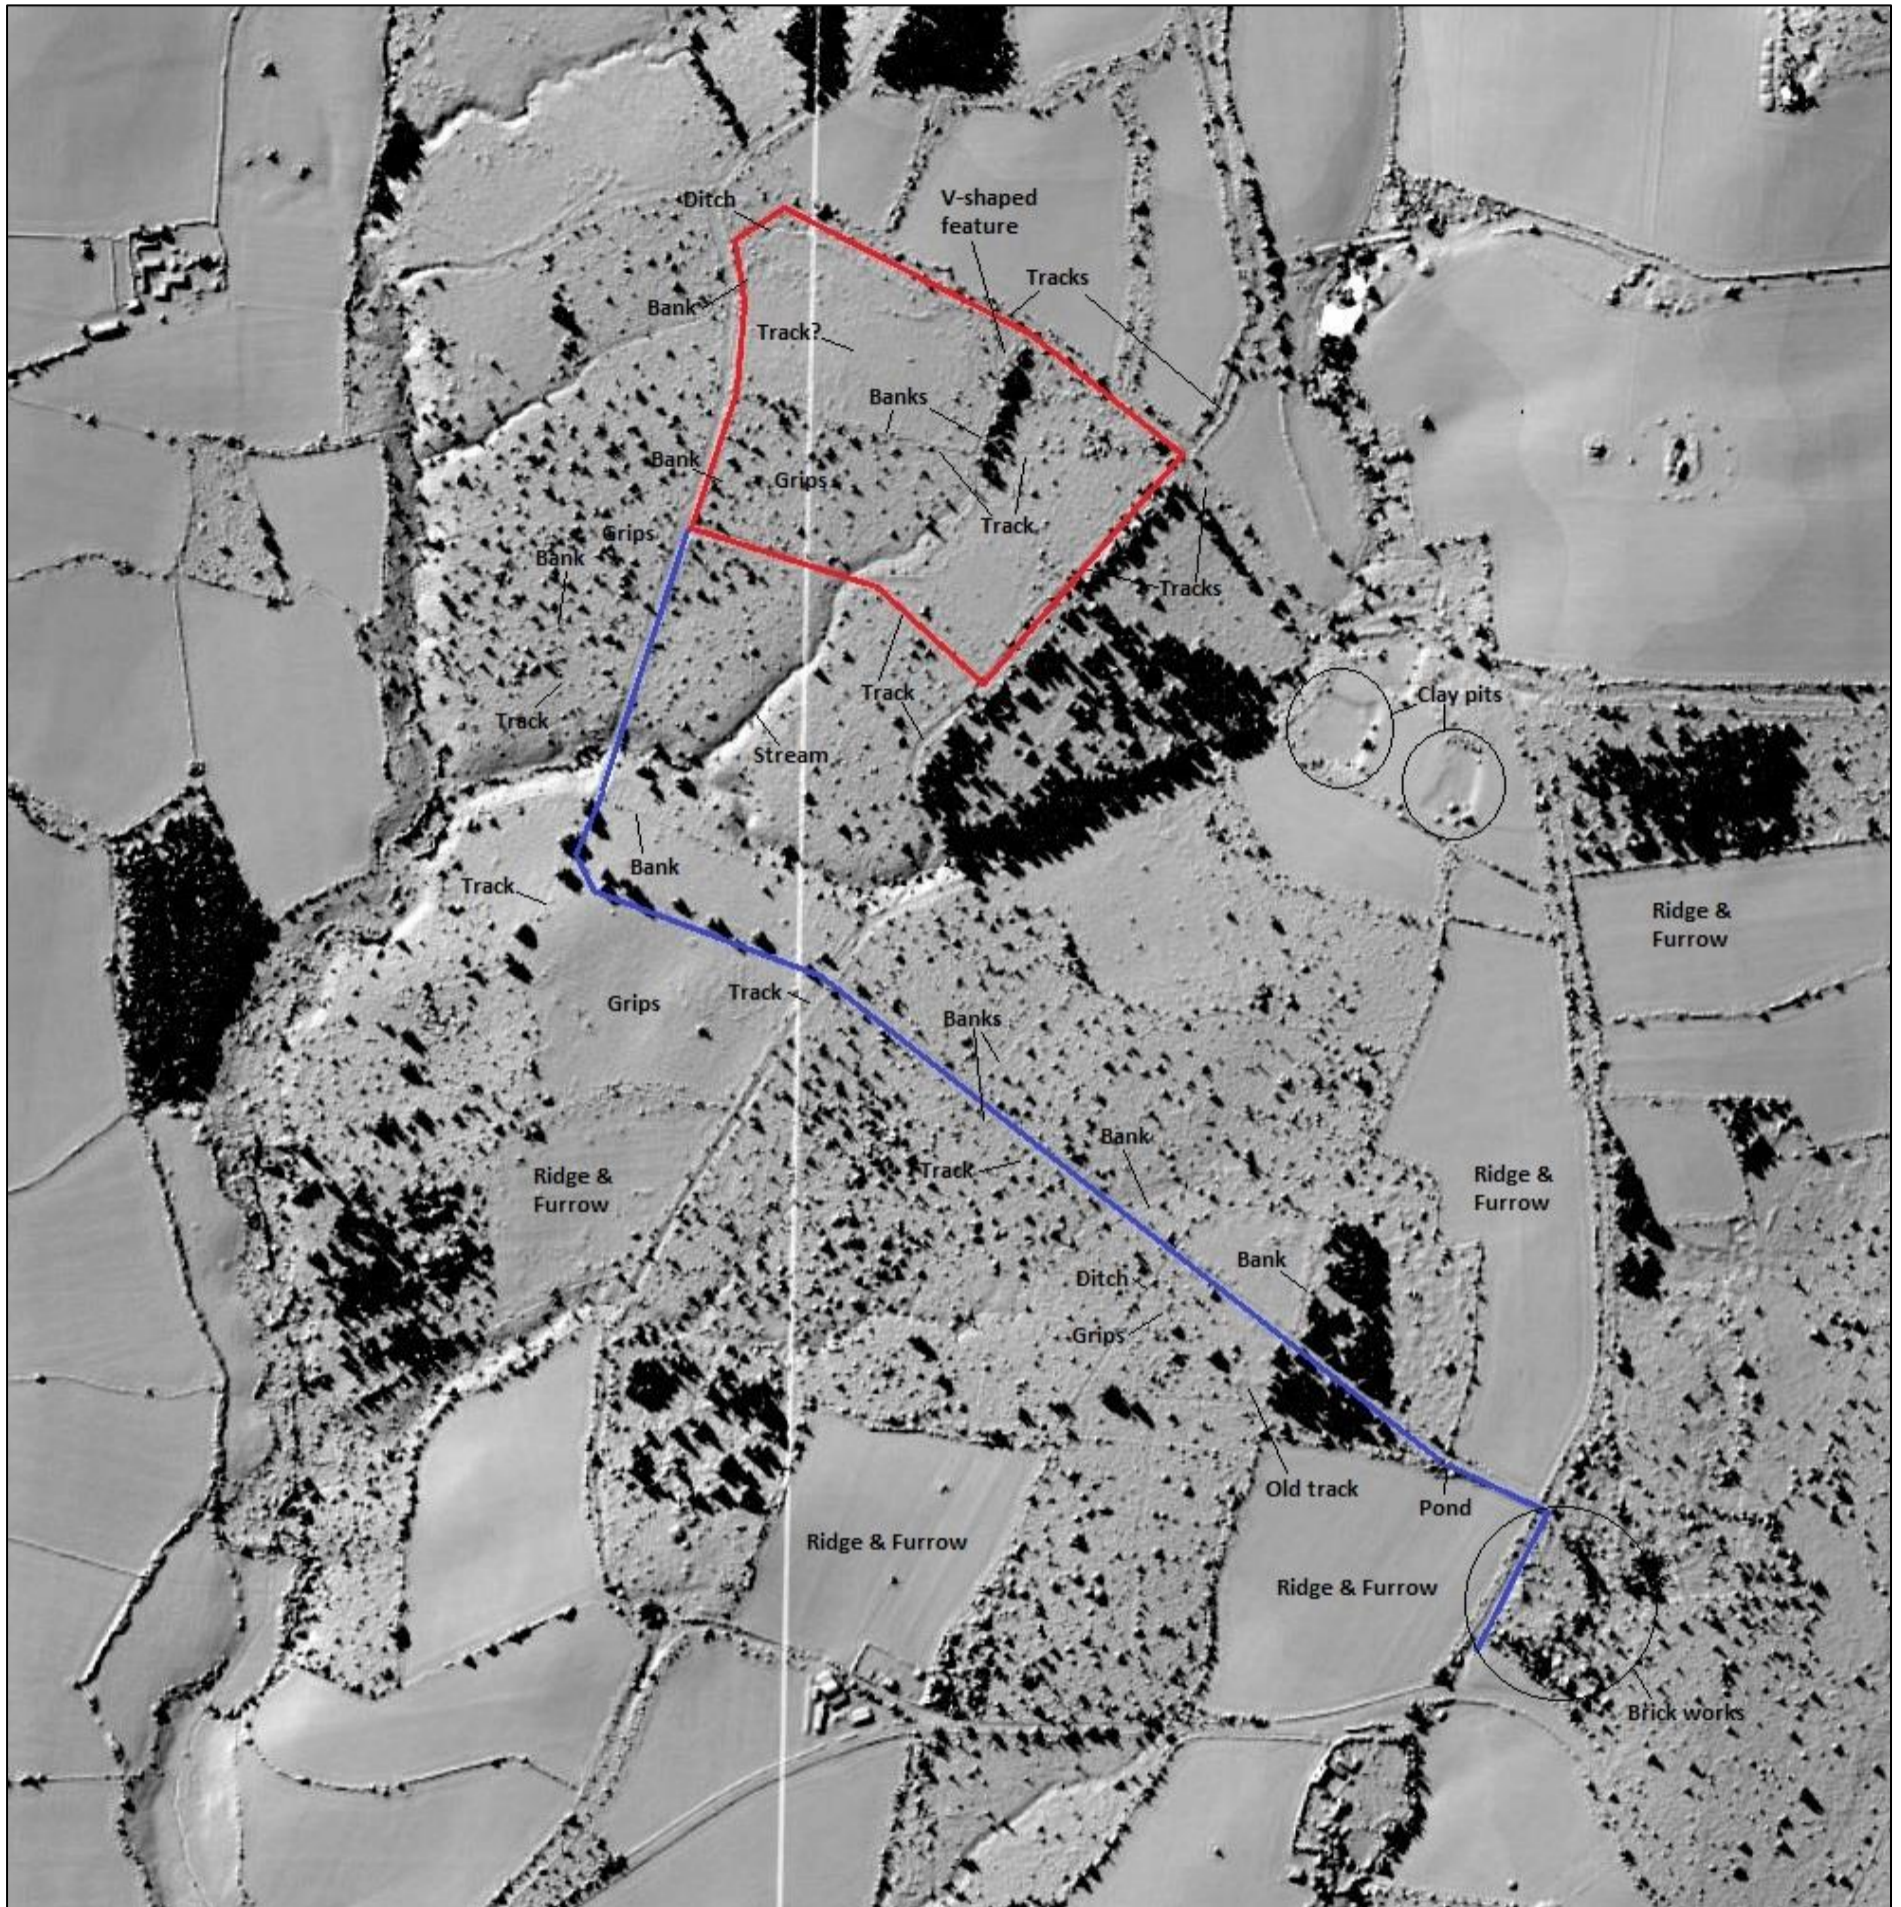
Fig. 35: Marked up Lidar image

5.3.3 A number of possible features can be seen on the Lidar in this north western part of the development site (Fig. 35). A north-south orientated boundary bank (31) could not be seen at the northern side of the site, and the vegetation prevented any access in this area. Similarly, a potential boundary or track running east-west through this north western part of the site could not be found.
