**Wisborough Green  
Exploratory Well  
Site, West Sussex**

**Findings of  
Arboricultural  
Assessment**

Prepared by:  
**The Environmental  
Dimension  
Partnership (EDP)**

January 2014  
Report Reference  
**EDP1902\_01c**

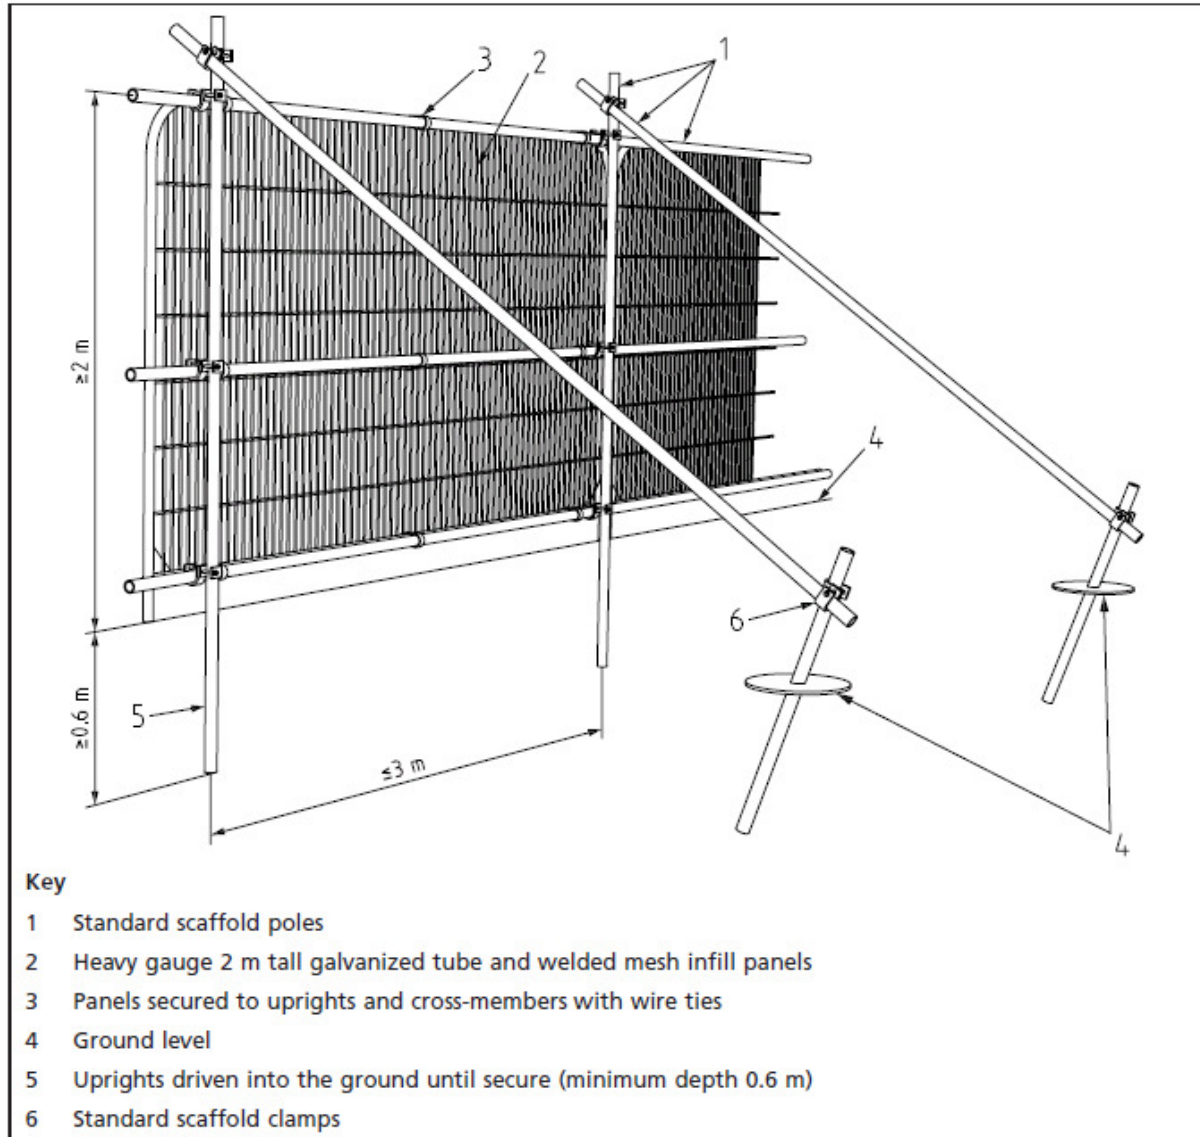
## Appendix EDP 4 Tree Protection Barrier on Scaffold 2.0m High (Extract from BS 5837:2012, Figure 2 'Protective Barrier')

- The maximum extent of the RPA is capped at the equivalent of a circle with a radius of 15m.
- 3.12 Protective barriers should be fit for the purpose of excluding construction activity and special attention should be paid to ensuring that they remain intact throughout the construction process. It is recommended that protective barriers should be erected in accordance with the recommendations given in BS5837:2012 reproduced as **Appendix EDP 4**.

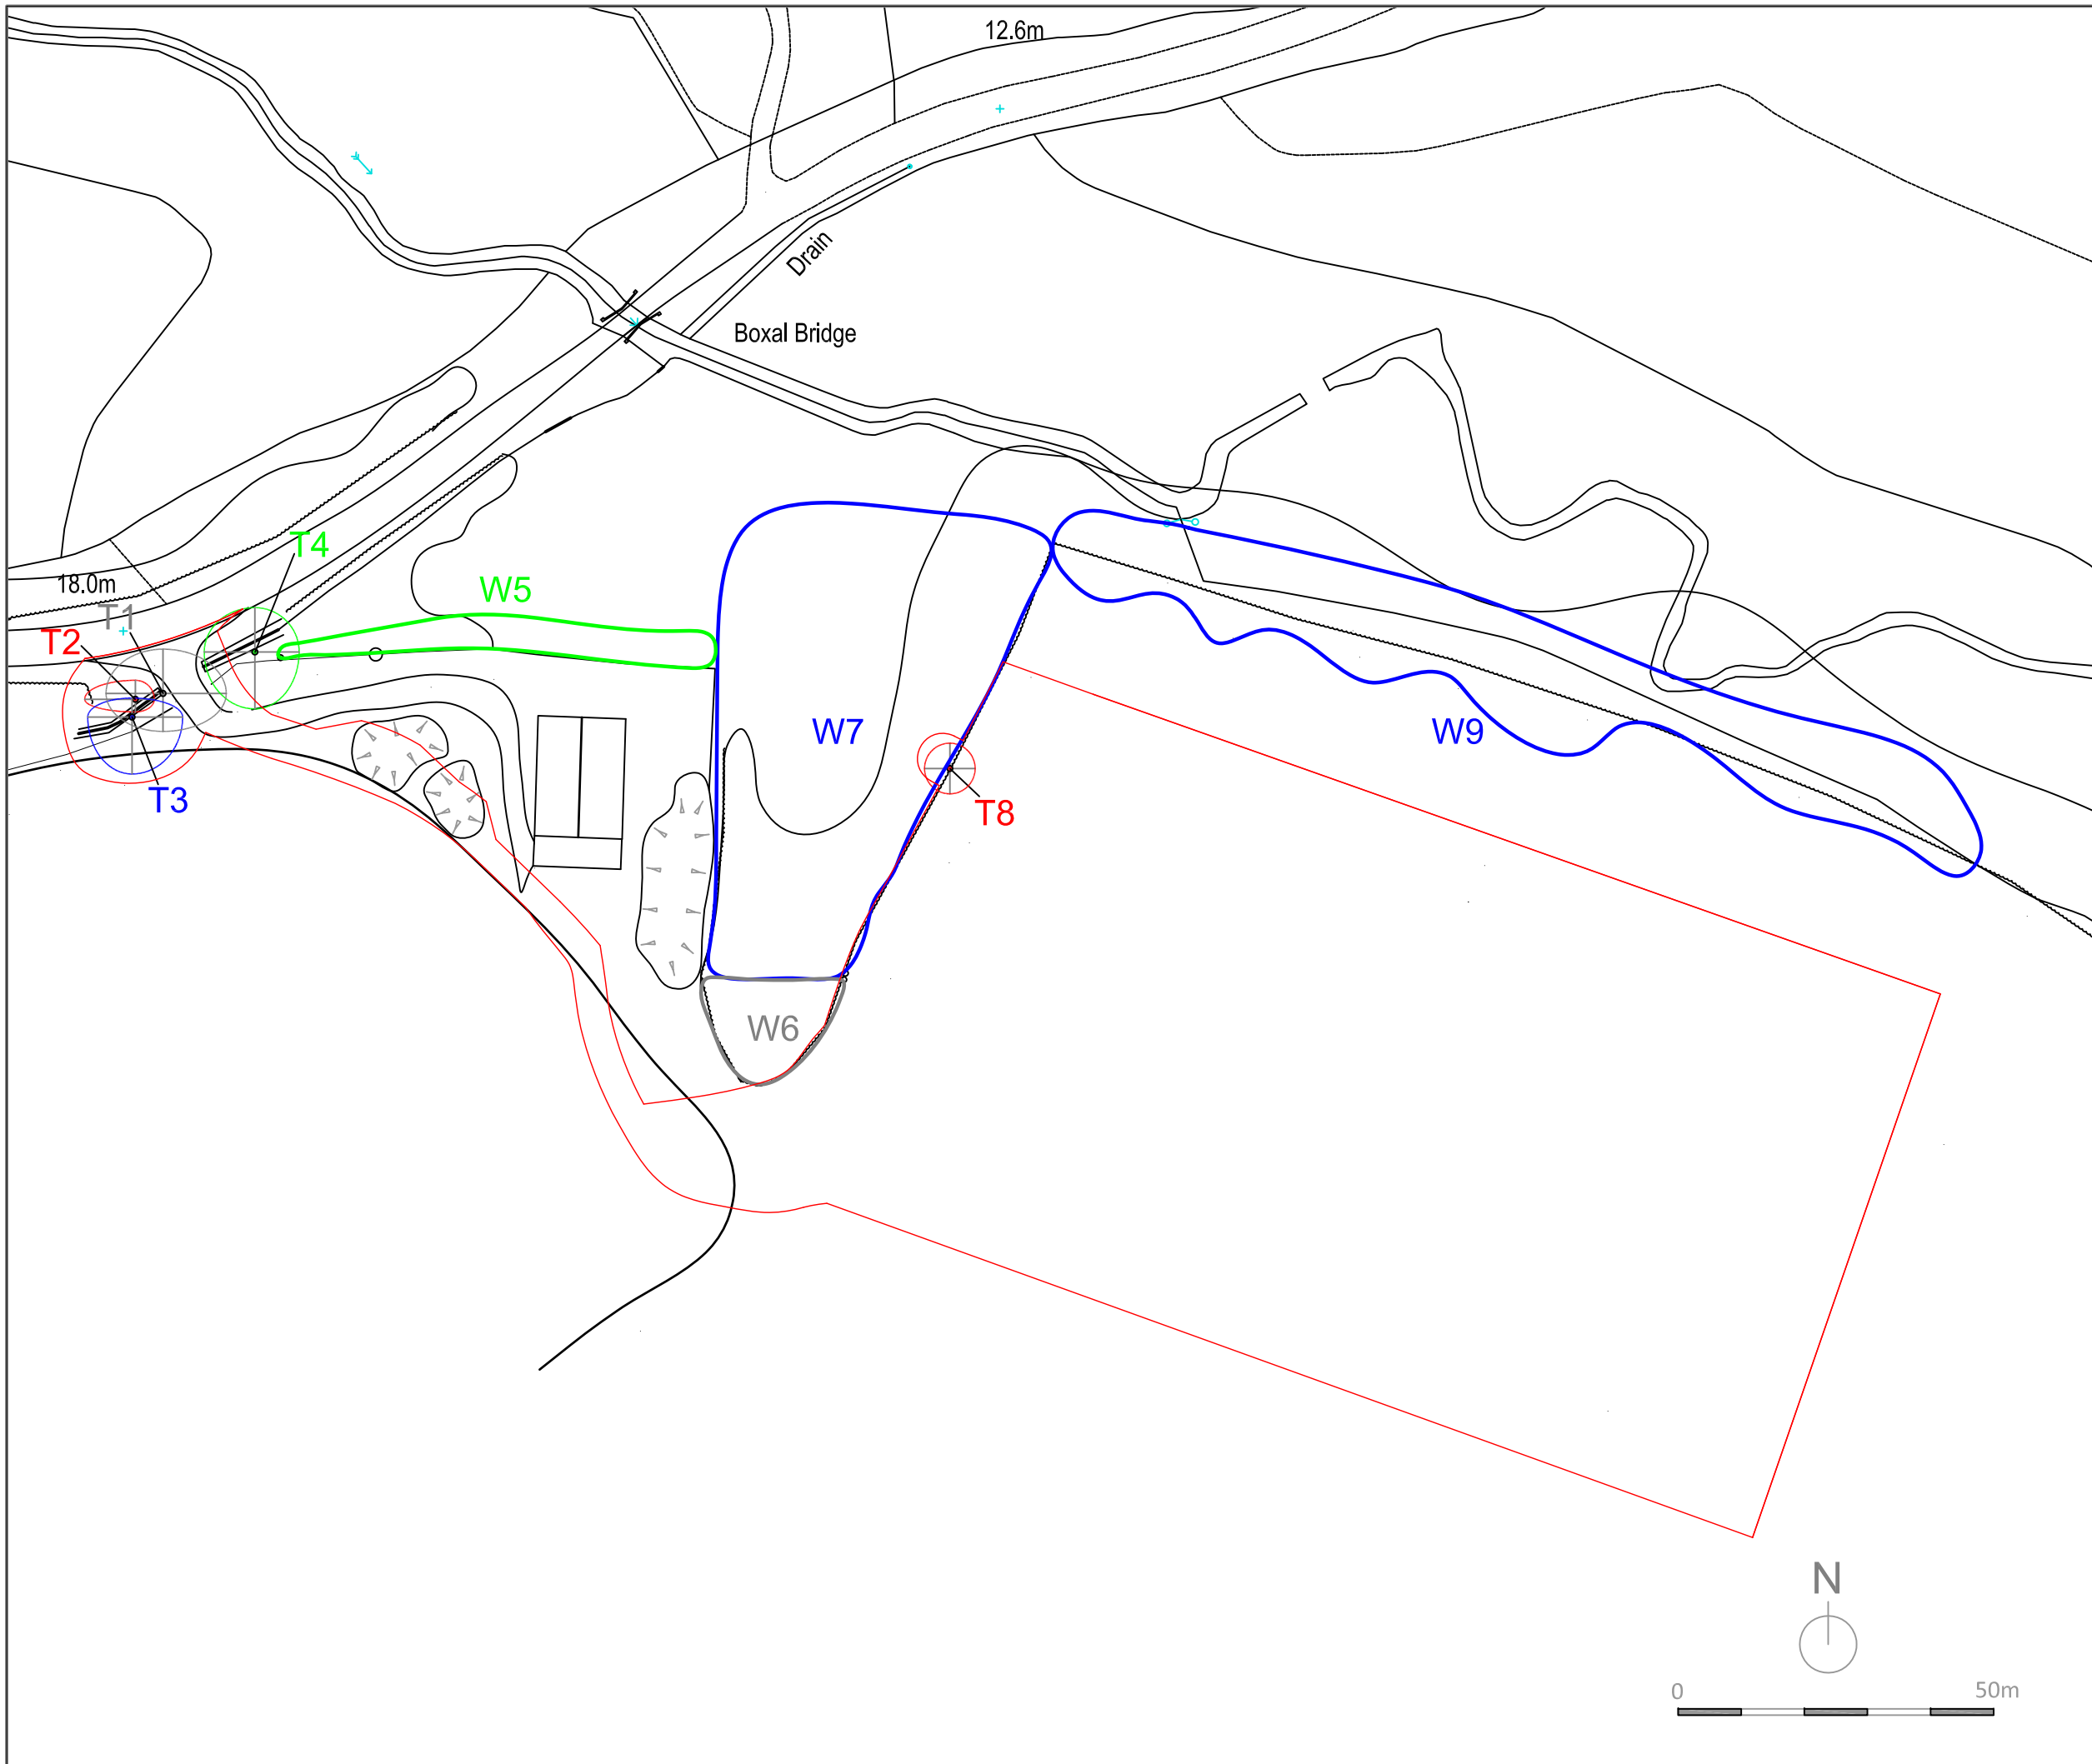
**Plan EDP 1: Tree Survey Plan**

- 2.7 **Plan EDP 1** provides information about the relative merits of the trees in arboricultural and landscape terms. Distribution across the category range is depicted in **Table EDP 3**. Across the site there are 2 (22.2%) 'A' grade items of high quality and value; 3 (33.4%) 'B' grade items of moderate quality and value; 2 (22.2%) 'C' grade items of low quality and value and 2 (22.2%) 'U' grade items considered unsuitable in the current site context.

- 6.3 Findings for the 5 individual trees and 4 woodlands are included as **Schedule EDP 1** and illustrated on **Plan EDP 1** of this report.
- 6.4 The tree population is predominately semi-mature to mature in age, although it is acknowledged that the woodland groups encompass trees of a range of ages. The tree stock consists of a broad mix of native broadleaved trees of varying condition and form.

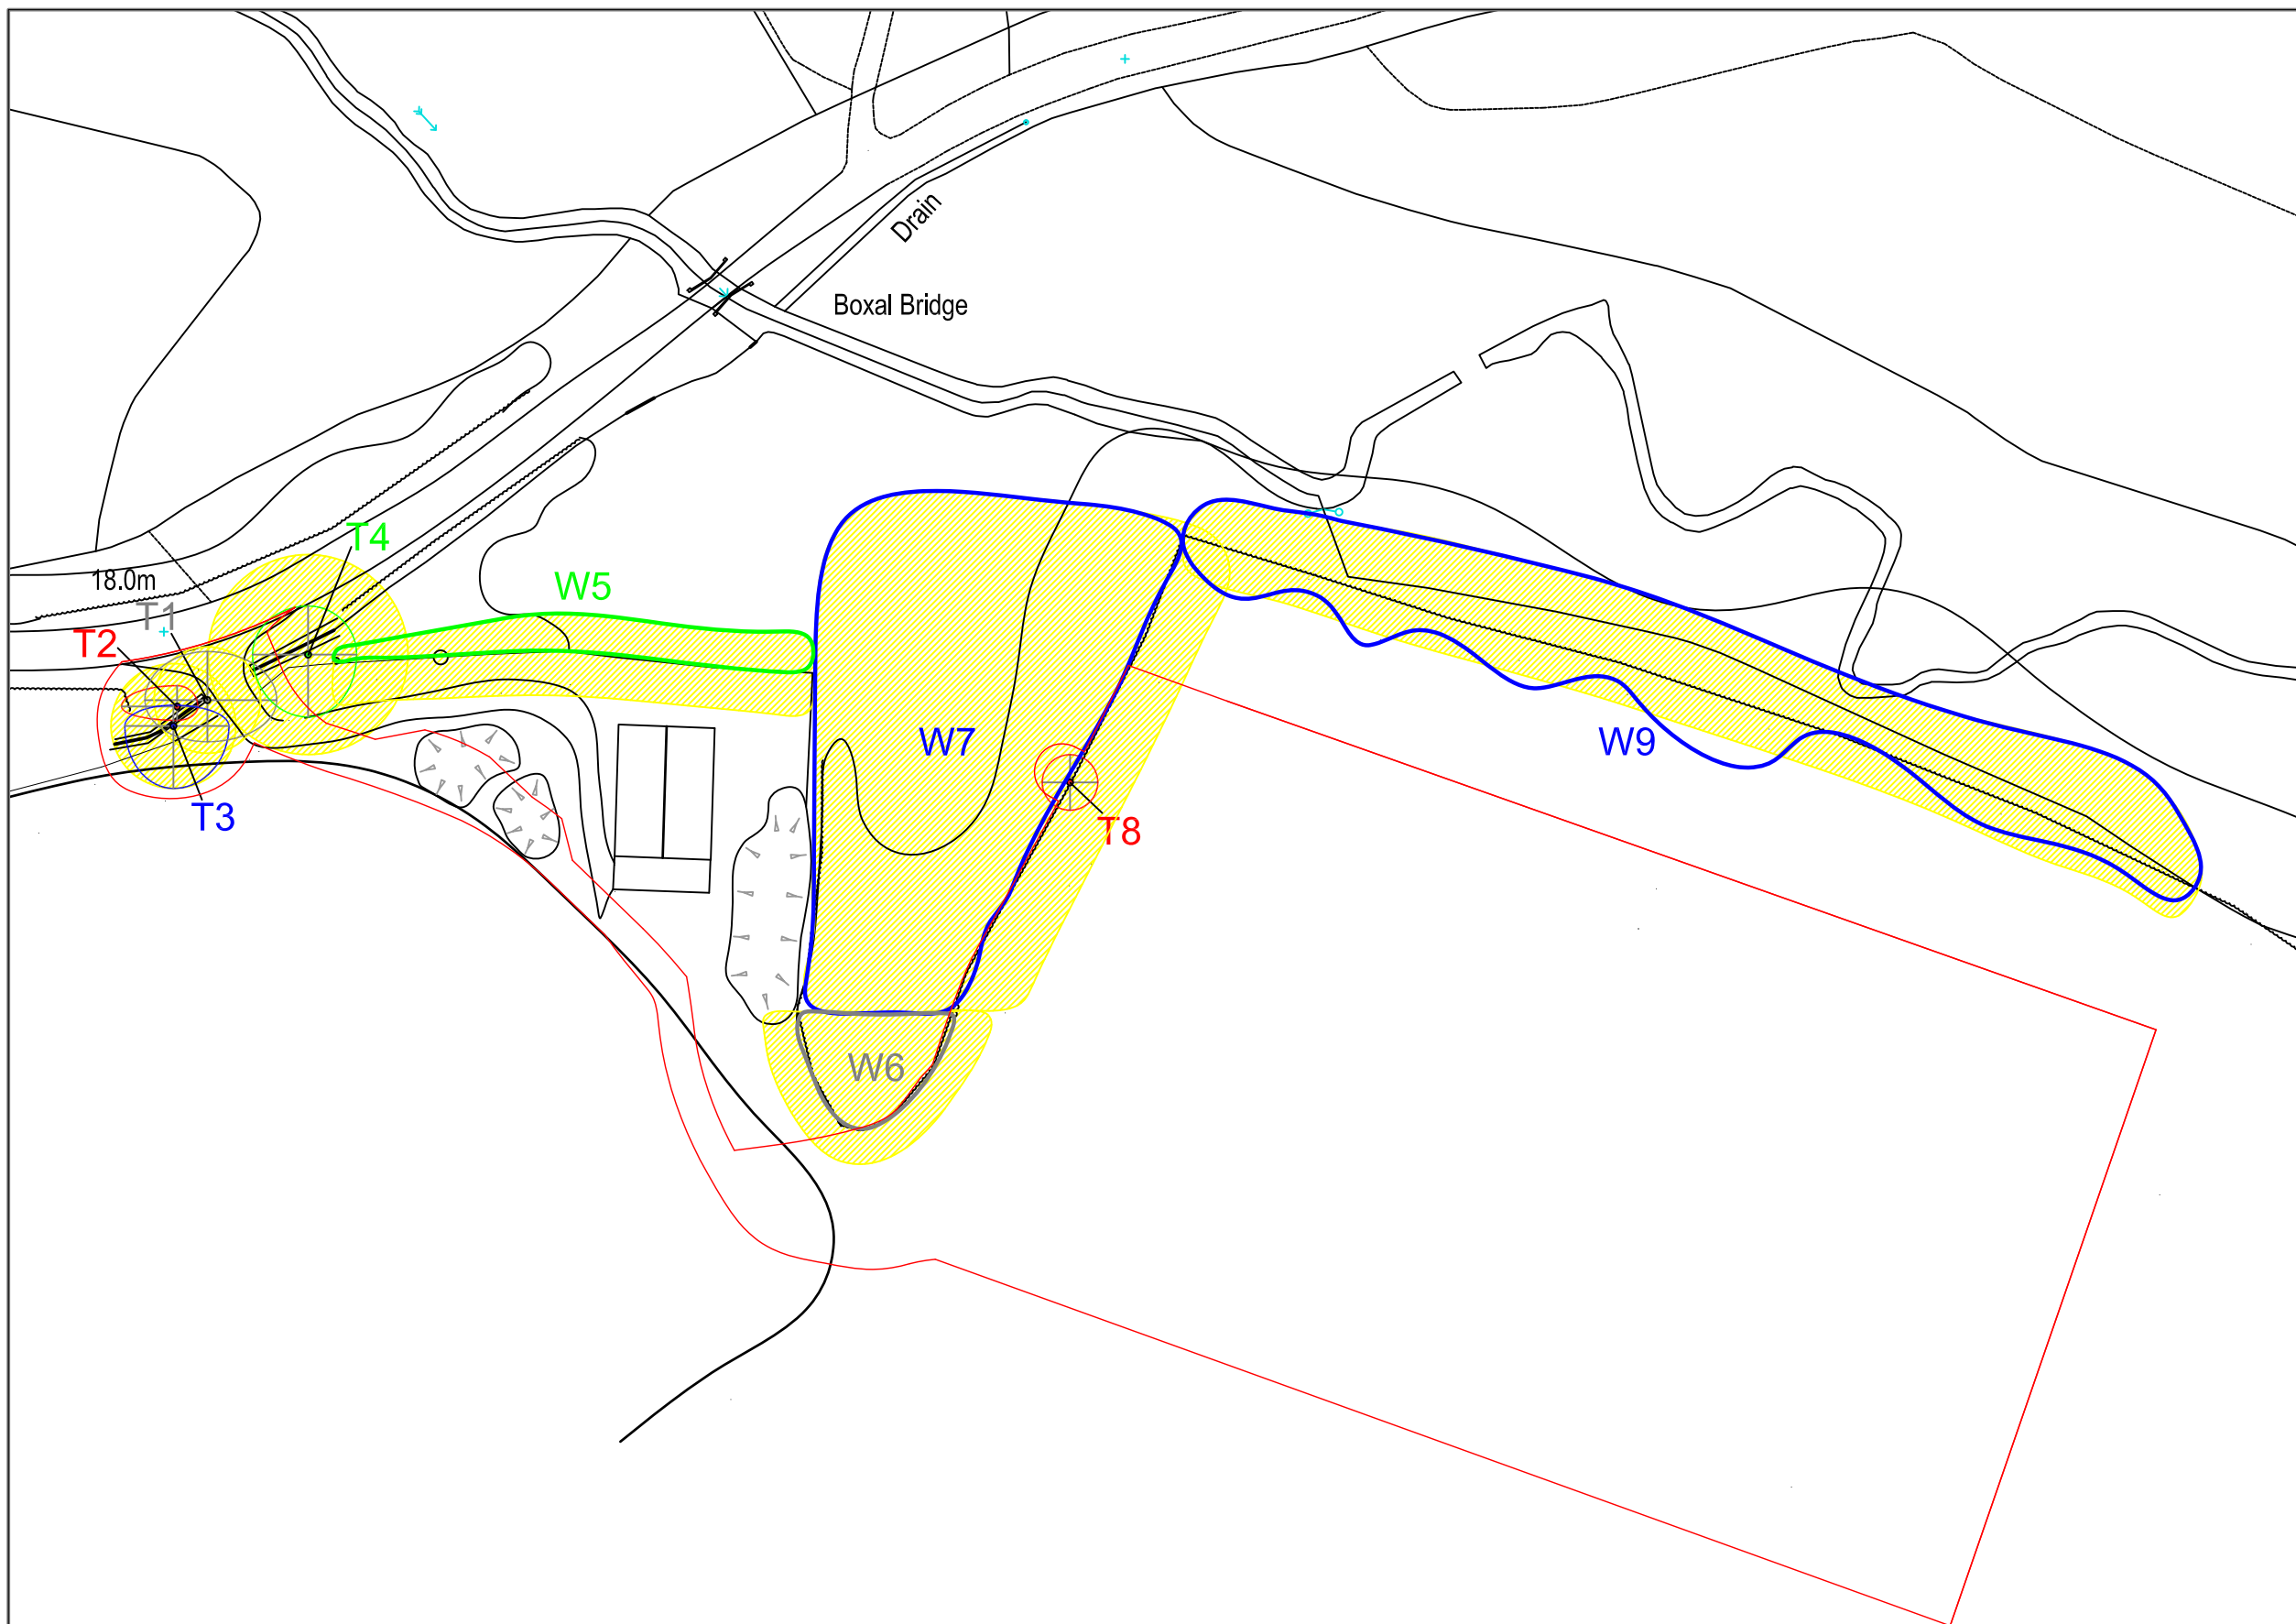
date 22 AUGUST 2013  
drawing number EDP1902/05b  
scale 1:1000 @A3  
drawn by DS  
checked JM

been considered without reference to the development proposals for the site. **Plan EDP 2**, The Tree Constraints Plan, illustrates the constraints imposed by the tree stock throughout the development parcel, specifically in connection with the recommended root protection areas (RPA), as described in the tree constraints schedule (**Schedule EDP 2**), calculated using the methodology set out in Section 4.6 and Annex C and D of BS5837:2012.

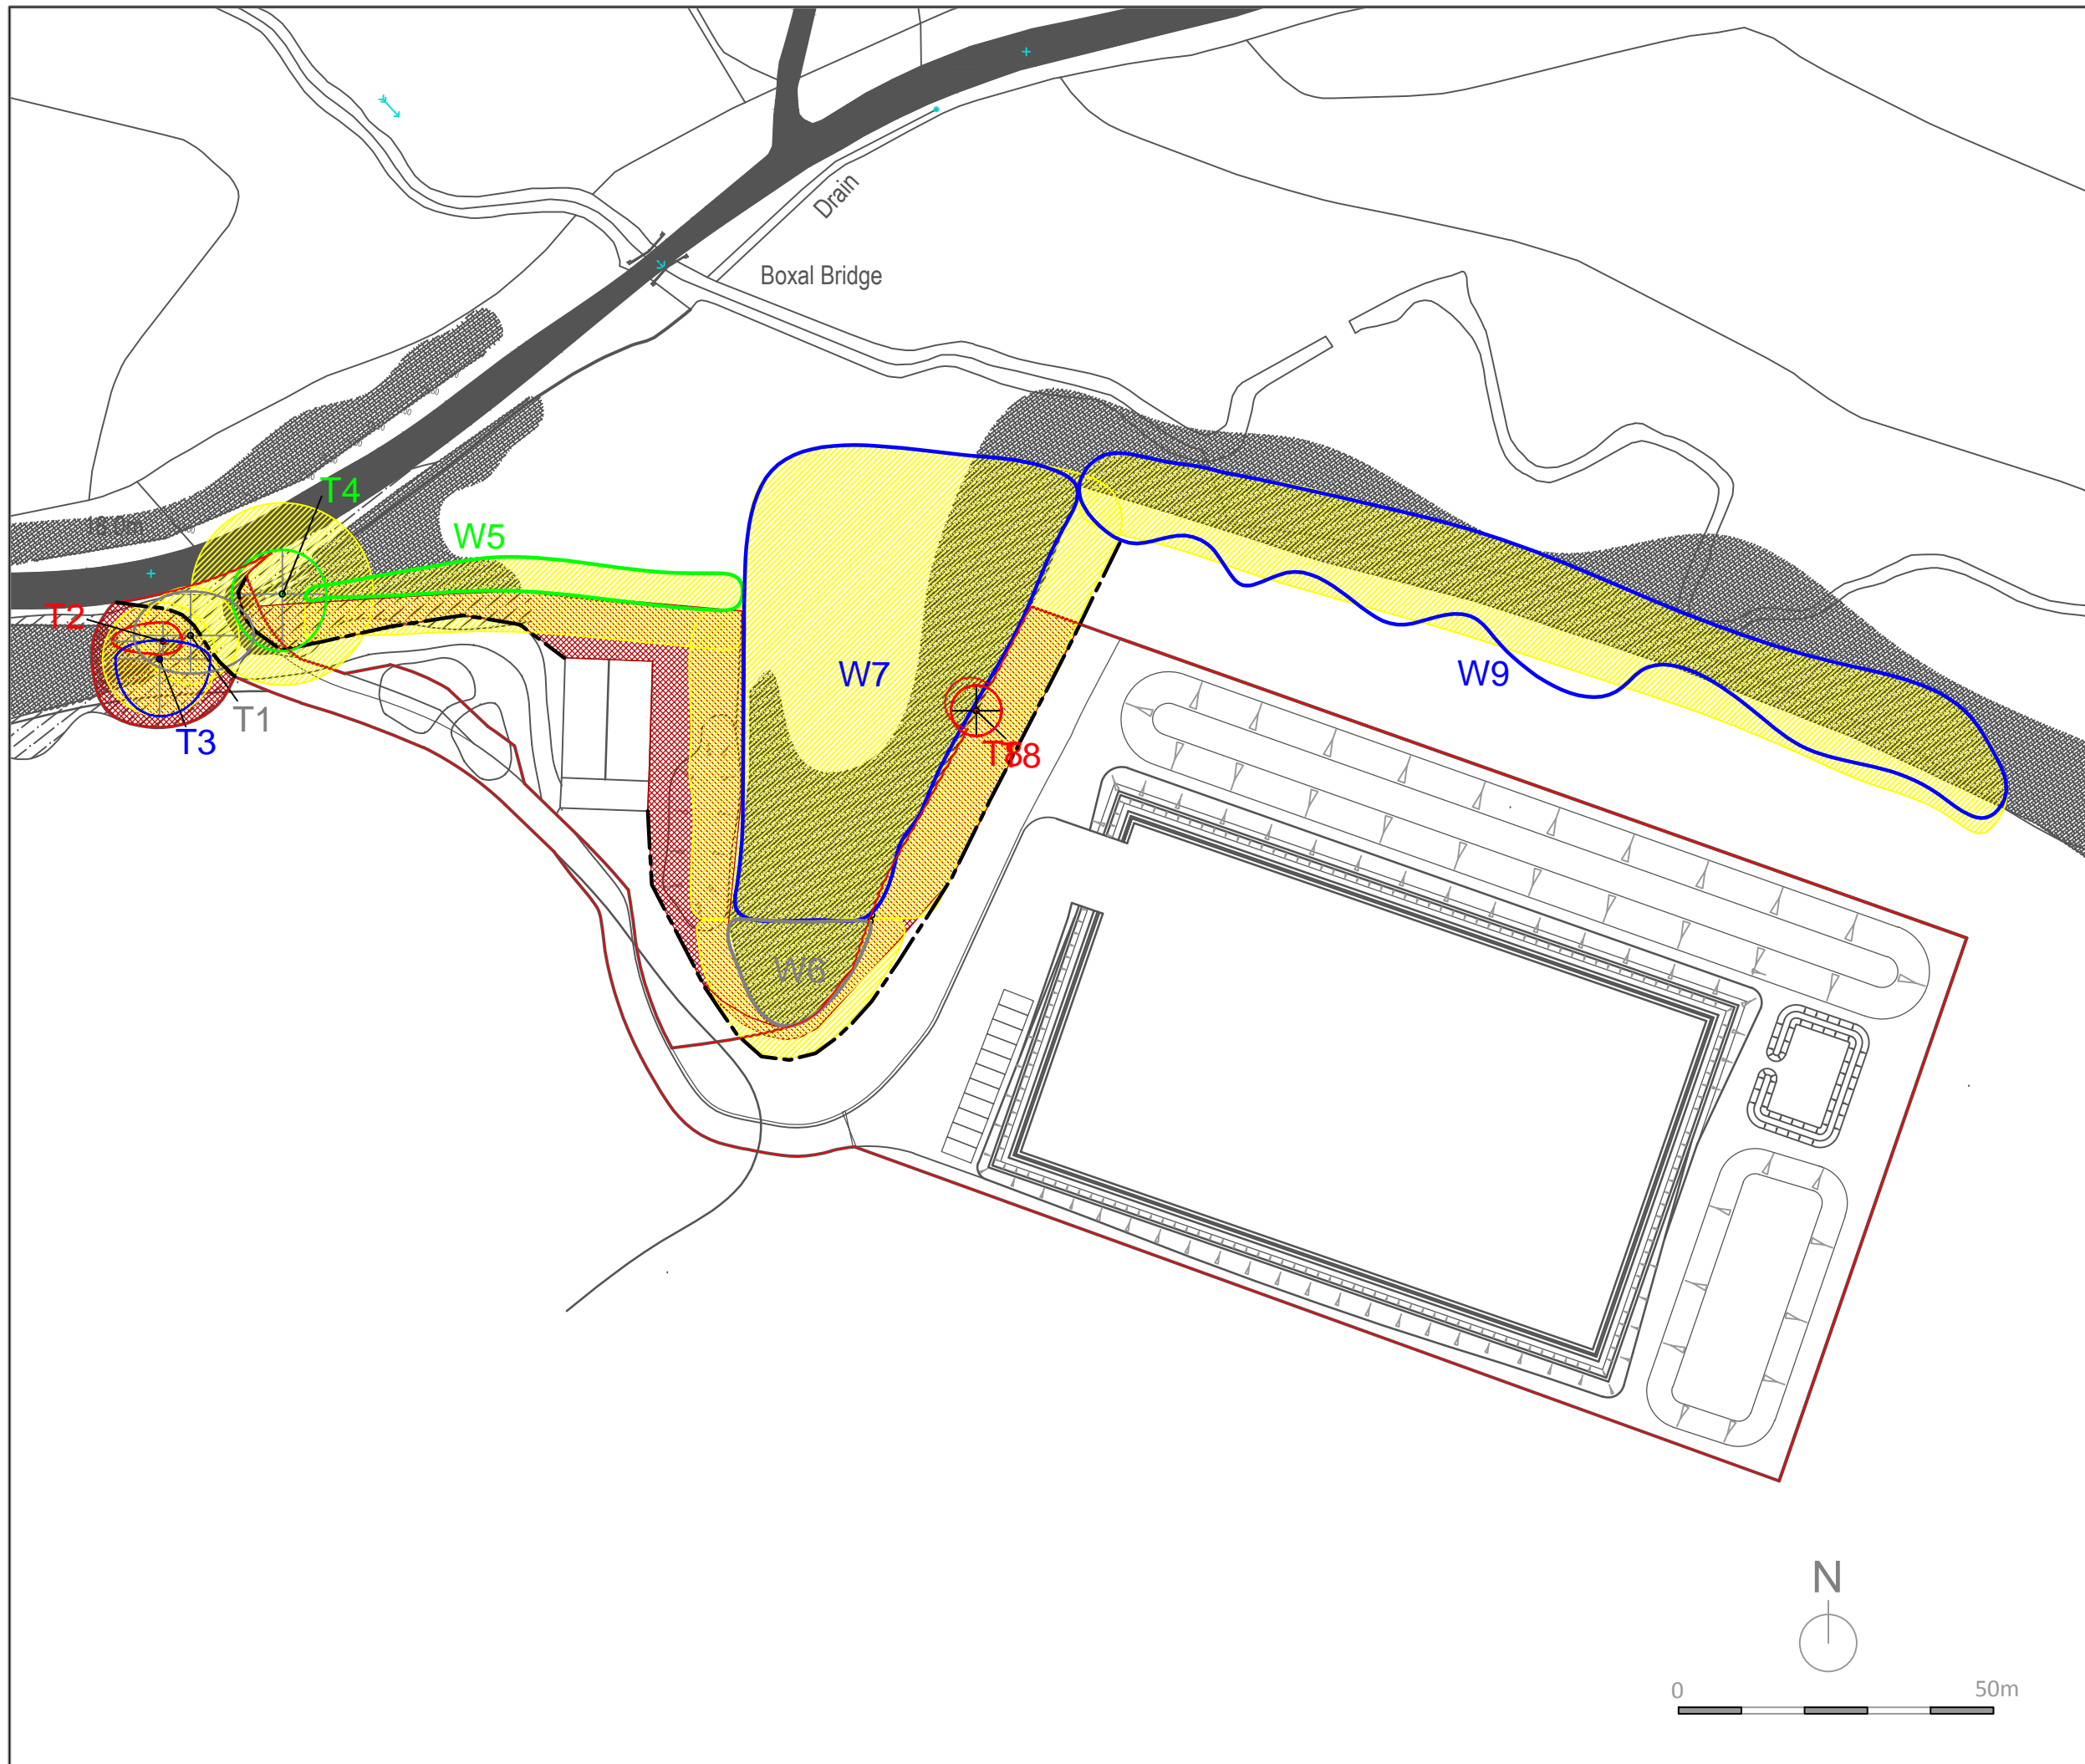
- 3.9 To ensure appropriate protection is afforded to the roots the extent of the RPA shall be defined by means of the installation of protective barriers in accordance with the recommendations given in Section 6.2 of BS5837:2012. The extent of this enclosed area, known as the Construction Exclusion Zone (CEZ), is depicted on **Plan EDP 3**.

- 3.13 It is proposed that the final line of protective barriers will be agreed with the Local Planning Authority prior to development commencing on site.
