**Appendix 9.2: Historic Building Record for Stock  
Belonging to the Wealden Brickworks, Langhurstwood  
Road, Horsham, West Sussex**

HISTORIC BUILDING RECORD FOR STOCK BELONGING TO THE  
WEALDEN BRICKWORKS, LANGHURSTWOOD ROAD,  
HORSHAM, WEST SUSSEX

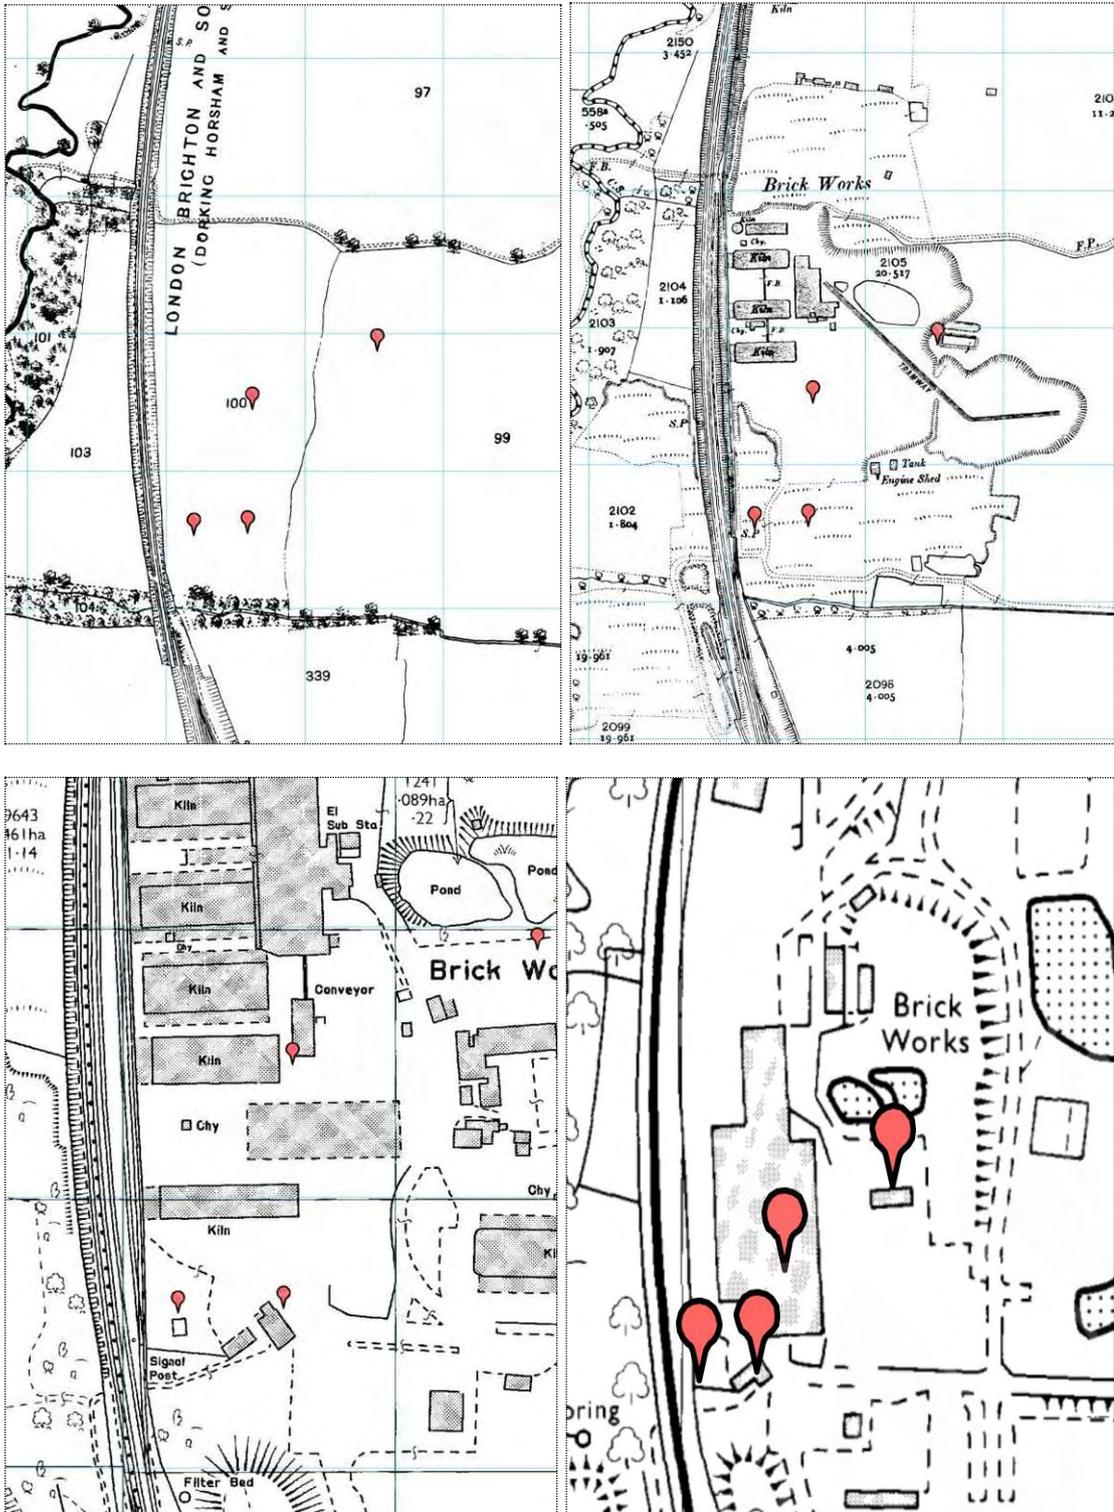
For this element of the report, four historic maps were consulted; the earliest dating to 1875 (**Figure 4 Map 1**). This map shows the site of the former brickworks to be a series of enclosed fields, several of which are surrounded by coppice or the remnants of ancient woodland. To the west of the site and cutting through the landscape from north to south is the London, Brighton and South Coast Railway (Dorking, Horsham & Shoreham Branch).

According to the Ordnance Survey map (National grid Series) of 1976, the site had been greatly extended to include up to 10 kilns, additional processing buildings and offices (**Figure 4 Map 3**).<sup>7</sup> It is probable that during this time the site reaches its zenith in productivity. Based on the layout of the site, three of the four buildings included within the study are present on this map. Present on this map is the boiler room, the office/reception building and the air-blown heating system that would have fed into at least two of the Scottish kiln-types.

By the time of the publication of the OS map of 1993 (**Figure 4 Map 4**), the brickworks was in serious decline and as a result many of the buildings from the previous map had been removed. It is probable that several kilns were in use during this time. A large steel-sheeted shed was constructed during this time with a later addition added to the north sometime after 1993. It is probable that the heat exchange unit from the 1970s was still in use during this time.

**Figure 4:**  
**1875, 1912, 1976 and 1993 Ordnance Survey mapping**  
(red points indicate the location of the buildings)

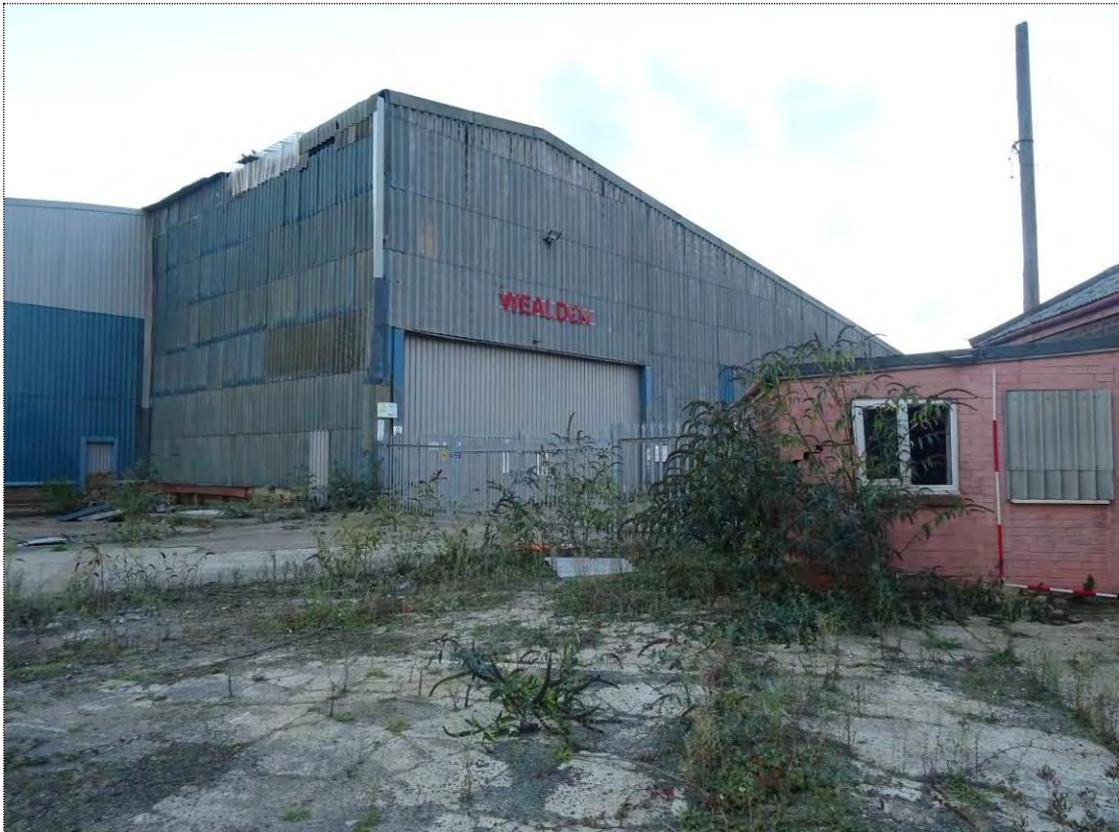
Plate 1. The Main Building, referred to as the shed, looking NE

This large fabricated shed stands within the western section of the site, standing over a number of former kiln sites (**Plates 1 to 12**). The building, orientated north-south is constructed in three phases; the earliest located as an extension at the southern end (**Plates 1 & 2**) with the main shed divided into southern and northern parts. This multi-phased building is constructed of a series of large bolted-on steel frame units (delineating its current elevation and roof pitch). The steel-frames are covered with steel square-ridged corrugated sheeting.

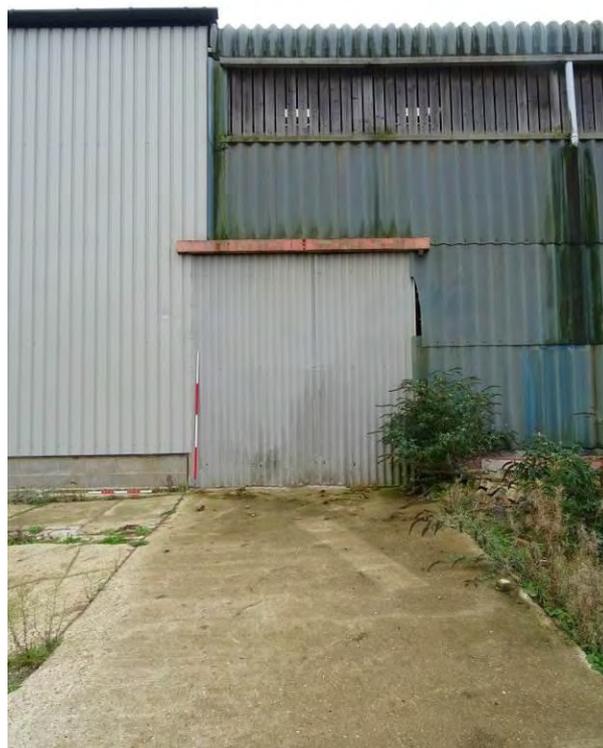
Plate 6. The rear section of the Main Building, showing the join between the old and new builds, looking east

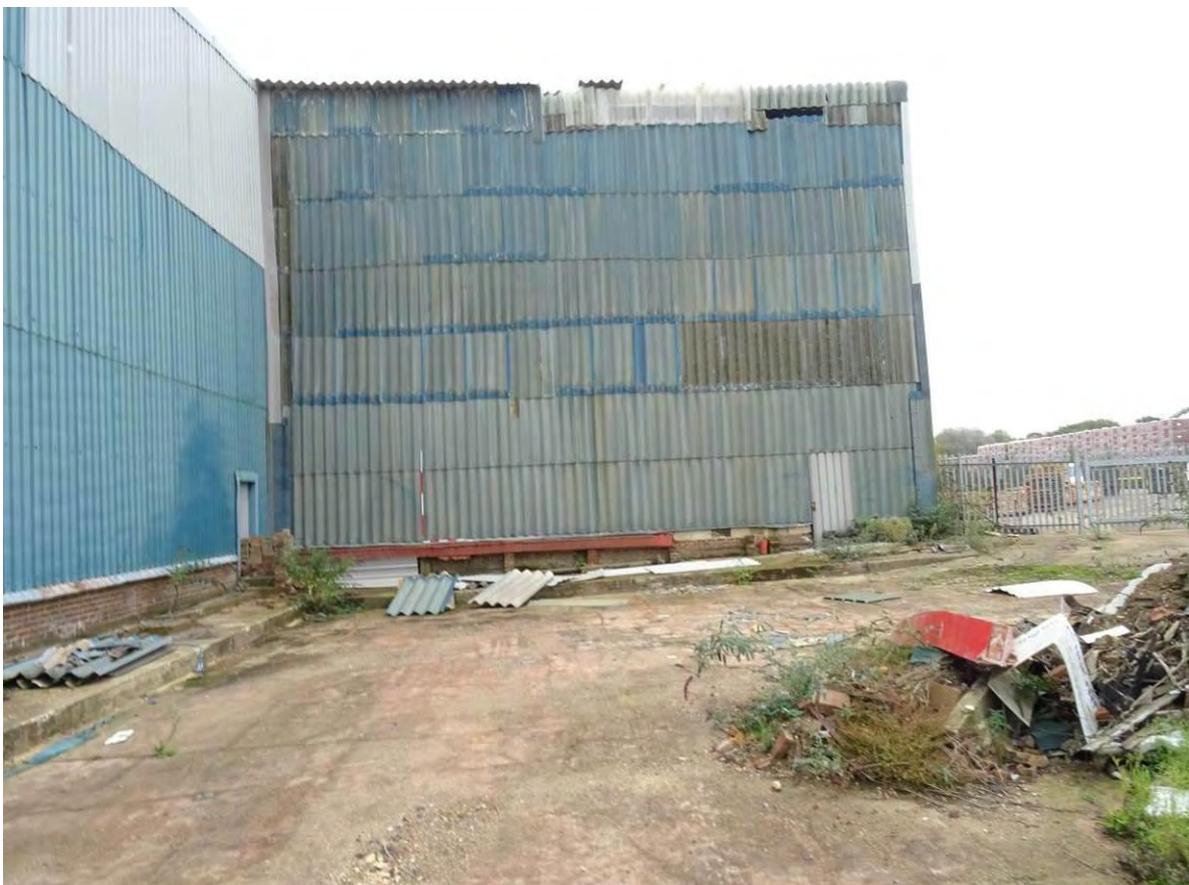
Plate 8. Older section of the Main Building, looking east

The precise dating of when the three phases were constructed is unknown; however, based on historic mapping, the earliest building date suggests c. 1980, whilst the second and third phases are estimated to post-date 1990. It should be noted that elements of earlier building activity may have been incorporated into the shed build. This assumption is based on exposed brickwork that is found within a west-facing elevation of the southern section of the shed (**Plates 8 to 10**).

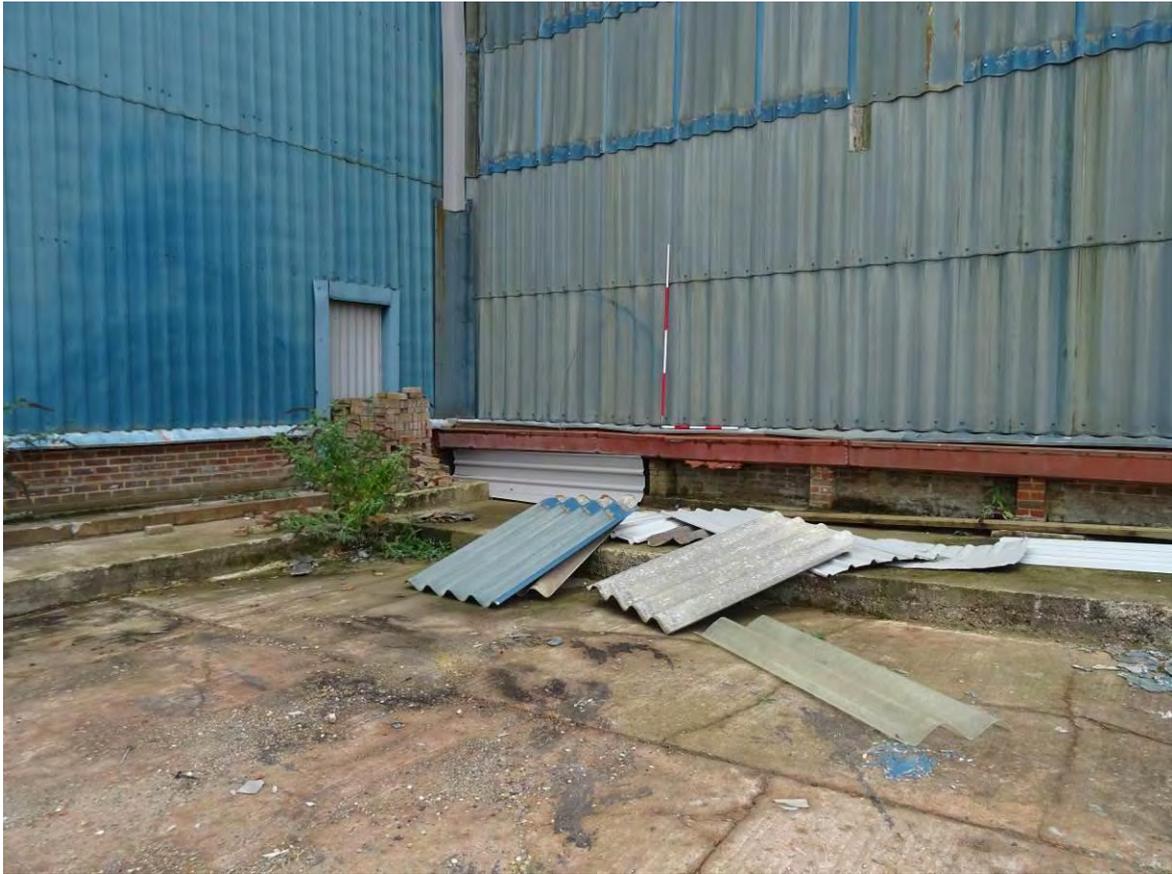
Plate 9. Corner section of the Main Building, showing the join between the two construction phases

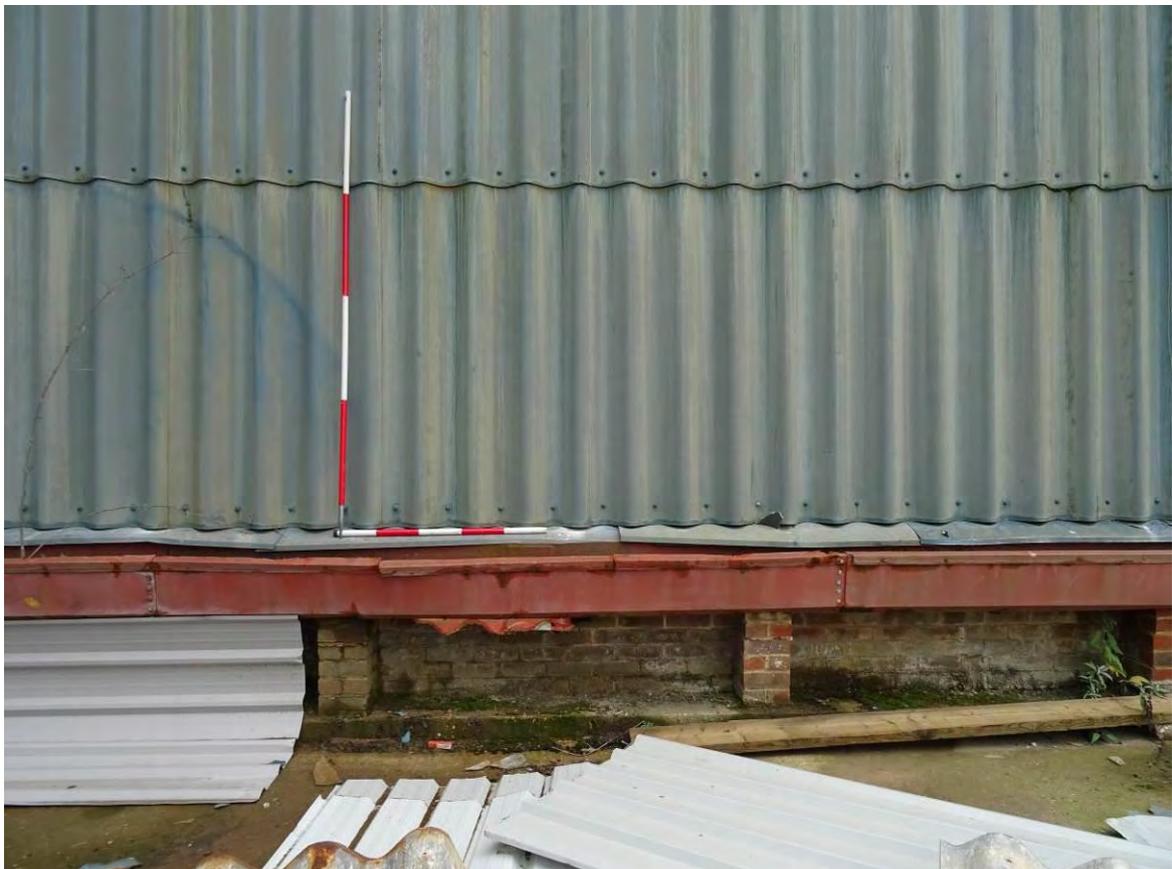
Plate 10. Mid-to Late 20<sup>th</sup> century brickwork underneath the corrugated metal sheeting, looking east

Incorporated into the southern extension elevation is a single sliding door which occupies much of the original building section. Above this opening is the name of the brickworks 'Wealden' (**Plate 1**). The earliest section of the shed is visible from the south and east (**Plates 3 and 4**), with a clear join between the two phases located along the eastern elevation (**Plates 5 and 6**). At the southern end of the building, there appears to be evidence of building/structures immediately in front of the southern range (**Plates 7 and 8**). The three building phases all appear to sit on a low brick plinth, which itself sits on a concrete base (e.g. **Plates 9 and 10**). The building measures c. 185 (N-S) by 70 m (E-W) [at its widest points]. Concerning the southern section of the shed, a steel joist, forming part of the superstructure of the building, rests over the brick plinth (**Plate 10**).

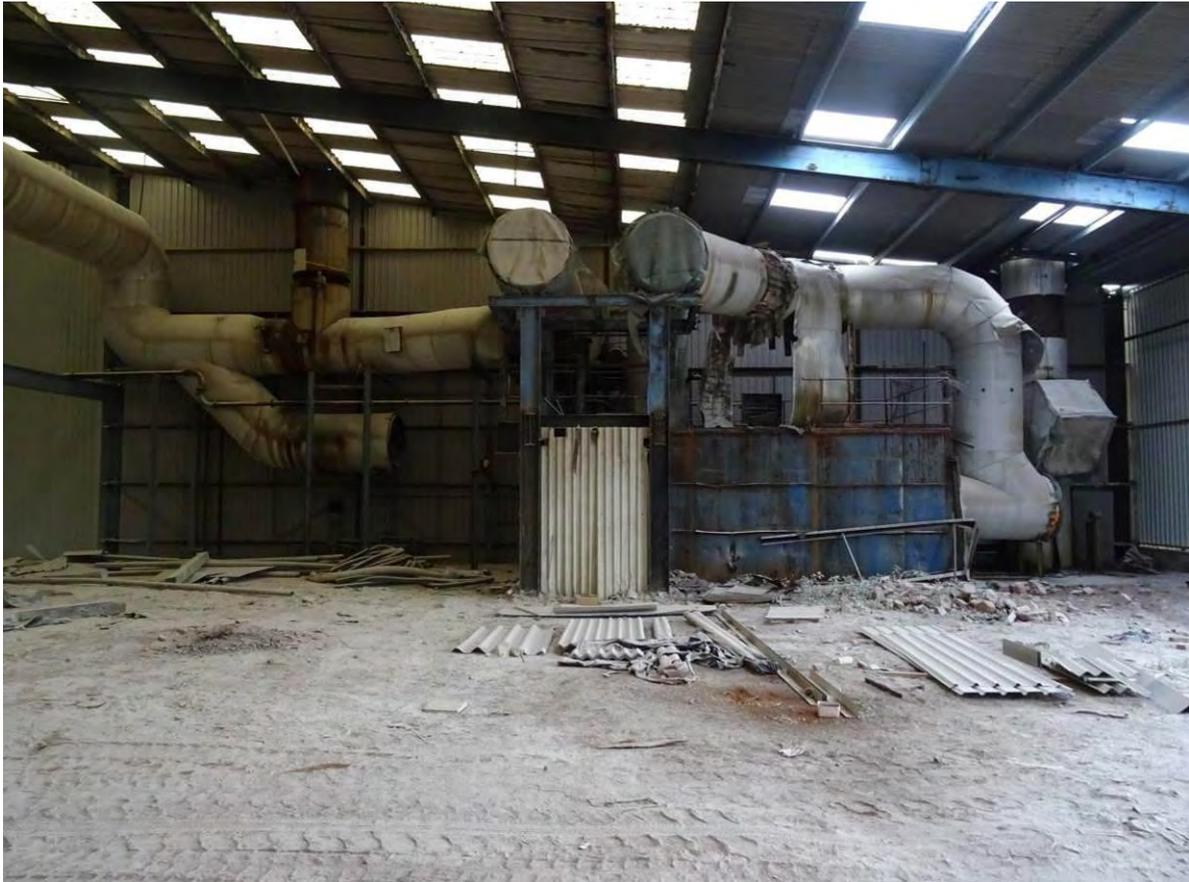
remains of a heat exchange system (**Plate 13**), originally used to blow hot air around a series of [Scottish] kilns. Inspection of this apparatus reveals that the system is relatively new, probably contemporary with the final kiln production during the later part of the 20th century (c. 1980).

Plate 13. View showing redundant heating ducts and heating exchange system, looking north

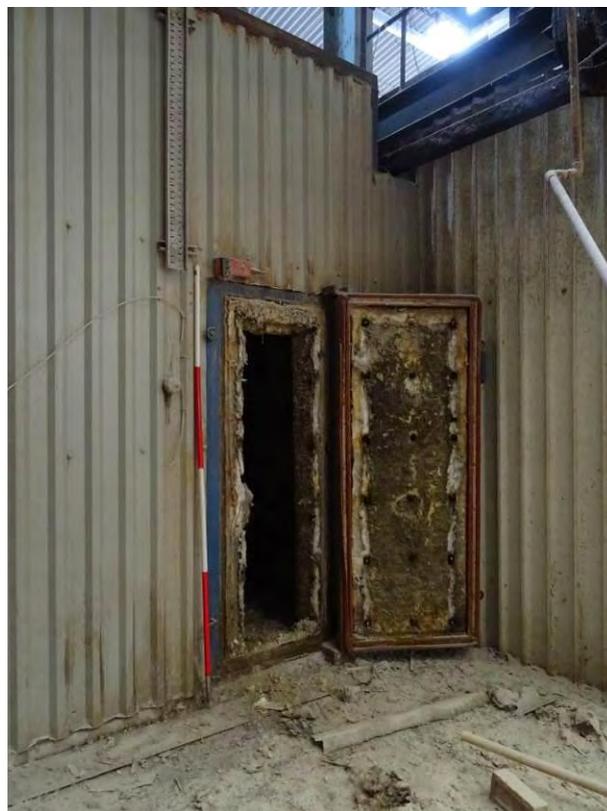
Inspection of the heat transfer station, associated with the heat exchange system showed that this was largely intact (**Plate 14**).<sup>9</sup> The room comprised a series of vertical partitions that were lagged with compressed asbestos lining. Heat would have been generated via a gas or electricity supply and then circulated from the transfer station via the metal-sheeted ducts into each of the kilns (**Plates 15 to 19**). Hot air (at a prescribed constant temperature) would have been circulated via strategically-placed air convectors placed between each kiln (**Plate 20**). Although the kilns no longer stand, there is evidence of a concrete platform which stands to the south-west of the ducting (**Plate 21**). The size and shape indicates that a Scottish kiln (rather than a Hoffmann kiln) was in use; however, there was no evidence of the loading hatch or the firing holes.

Plate 14. Gas-fired heating transfer station,  
Located against the northern internal wall looking SE

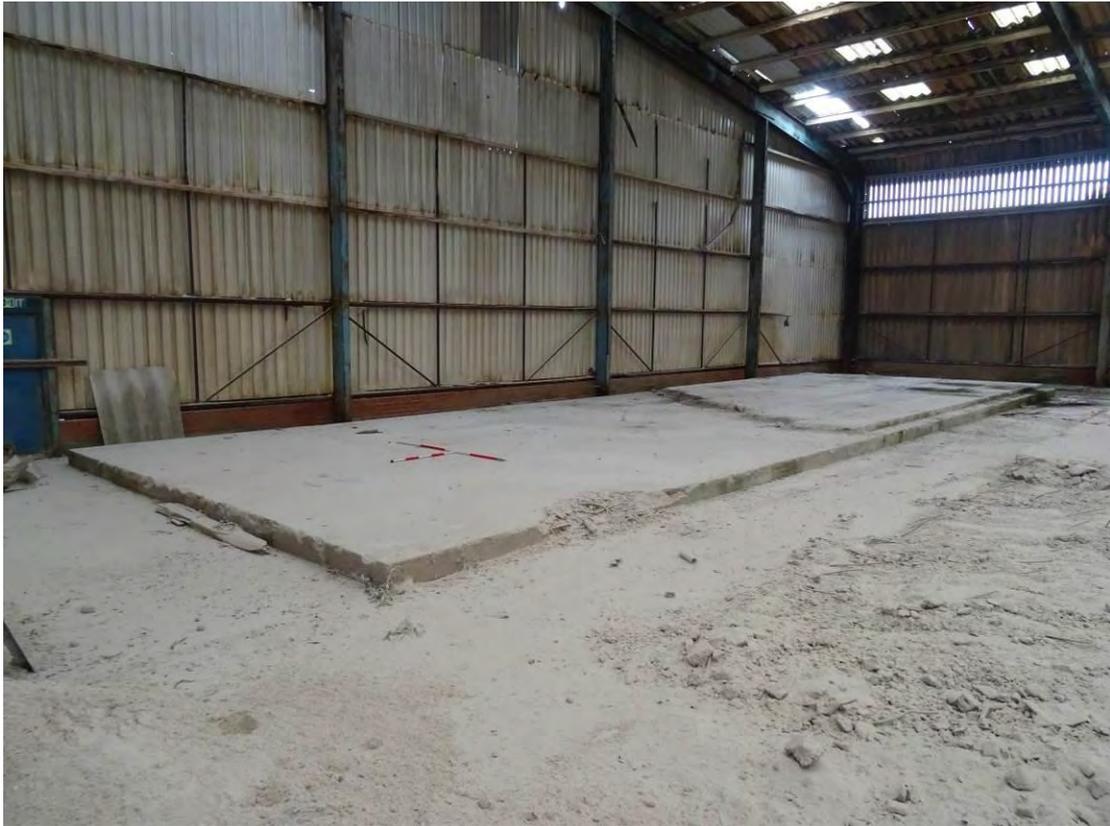
The Hoffmann kilns present on the 1912 Ordnance Survey mapping appear to have been replaced by the mid-1970s by probable gas or electrically-driven kilns. This new kiln technology worked on the same processes as a Hoffmann kiln, that of an interconnecting passage or ducting system that transferred thermostatically-controlled hot air from an heat exchange unit (**Plate 15**) to a single kiln or multiple kilns. Within the main shed there is clear evidence of this process (see **Plates 13 to 21**). The historic mapping of 1976 suggests that all of the 10 kilns present on site were heated in this way. The heat exchange from this process would have provided a constant and continuous high temperature that could be sustained indefinitely. The heat exchange, via a series of (in this case) thin metal-lined ducts could be maintained from one kiln to another without any loss of heat. Unlike its predecessors whereby one room [kiln] was initiated heated [fired] before the next, the kiln system at the Wealden Brickworks would be heated simultaneously, forming a heat exchange circuit. Currently surviving within the shed are three pieces of evidence which reflect this process: the heat exchanger (**Plates 13 to 16**), the ducting (**Plates 17 to 20**) and a single concrete platform that once formed the floor of a probable kiln (**Plate 21**).

Plate 21. The platform of one of the dismantled kilns, located within the southern section of the shed, looking SW

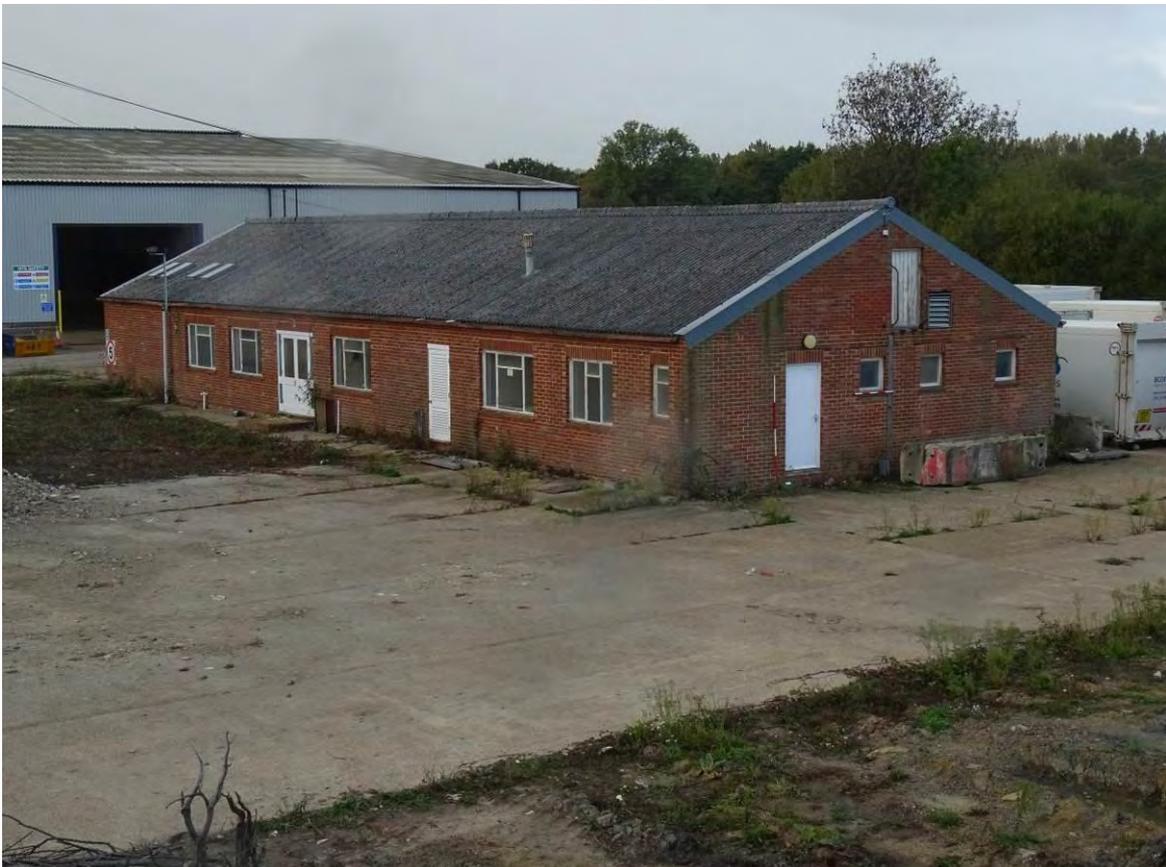
The building, constructed of *rustic*-style brickwork and supporting a pitched compressed asbestos sheeted roof, is accessed by a centrally-placed double door opening on the southern elevation (**Plate 22**); redundant door and window openings occur on each elevation. Many of the door and window casements are not symmetrical (**Plate 23**). The southern elevation comprises a set of five slightly recessed window openings that are arranged unevenly across the elevation; a similar arrangement is present on other elevations. The window casements comprise four window panes that are arranged in an 'H' design (e.g. **Plates 26 - 29**). Each metal window casement sits on a [imperial-sized] 6" tiled sill (note: there are no lintels).

Plate 22. General view of the Welfare Building, looking NW

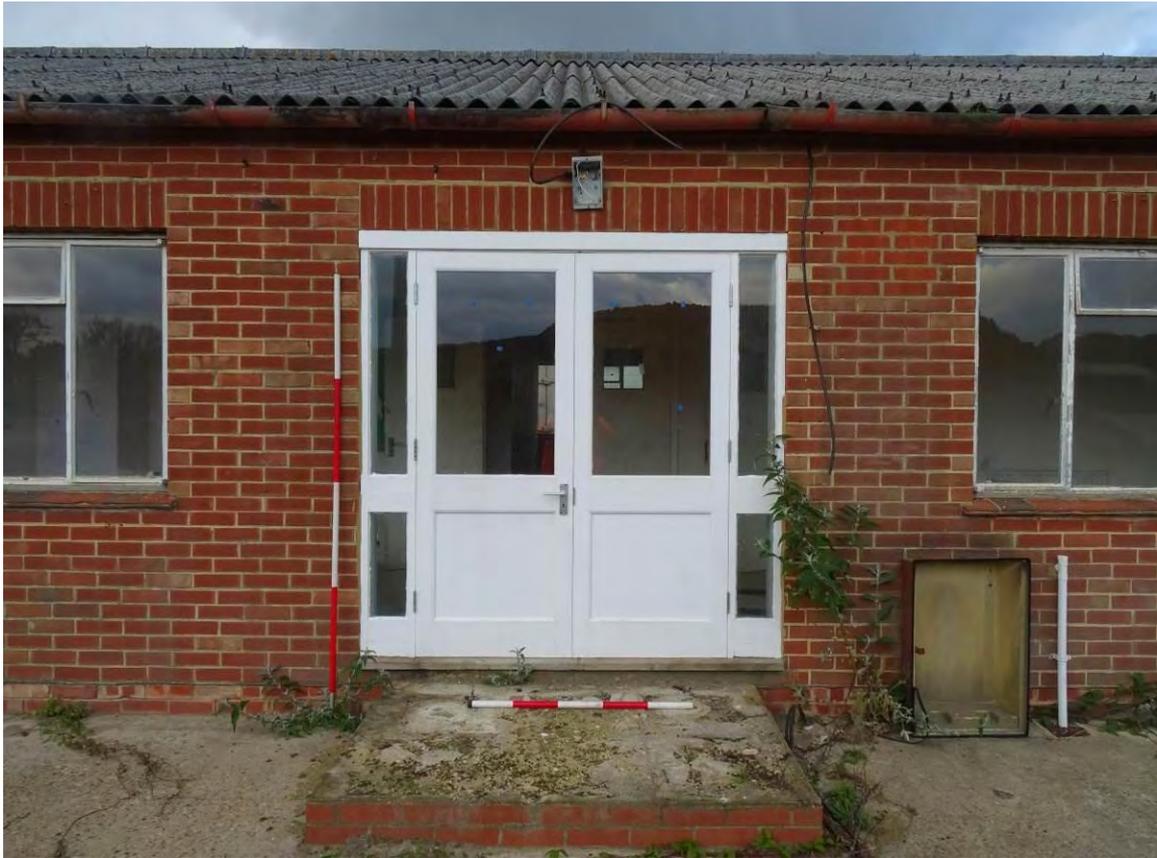
The main access to the building is via a UVPC double-door casement with side window openings on either flank (**Plate 25**). The door casement is probably a replacement for an earlier one. Immediately in front of the main access is a brick-lined step.

employee welfare. It should be noted that the original use of this building is unknown, and it is possible that it was used as offices at one time. Access to the building is located along the southern elevation (**Plate 25**). The main access leads to a rectangular reception area with door openings on all flanks (**Plate 30**).<sup>10</sup>

Plate 25. Detail of the southern elevation showing main entrance

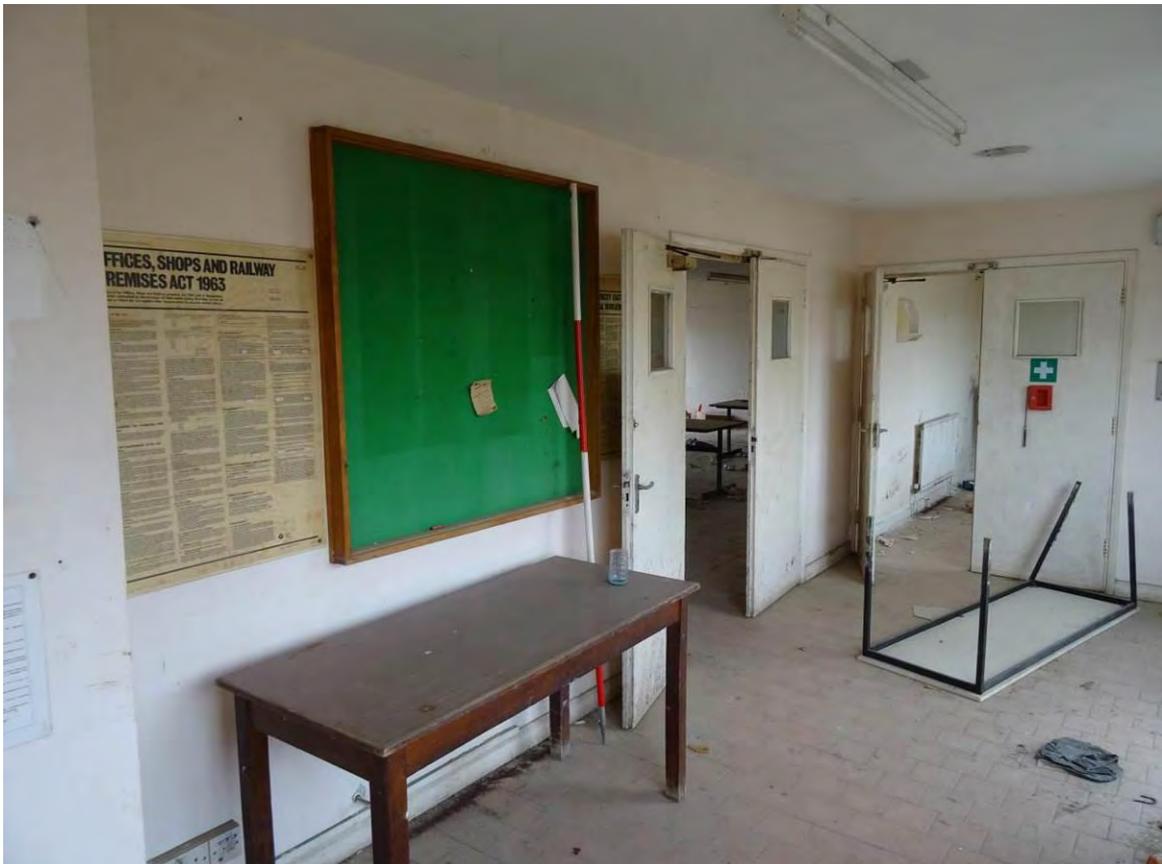
Plate 30. Lobby area within the southern section of the Welfare Building, looking NE

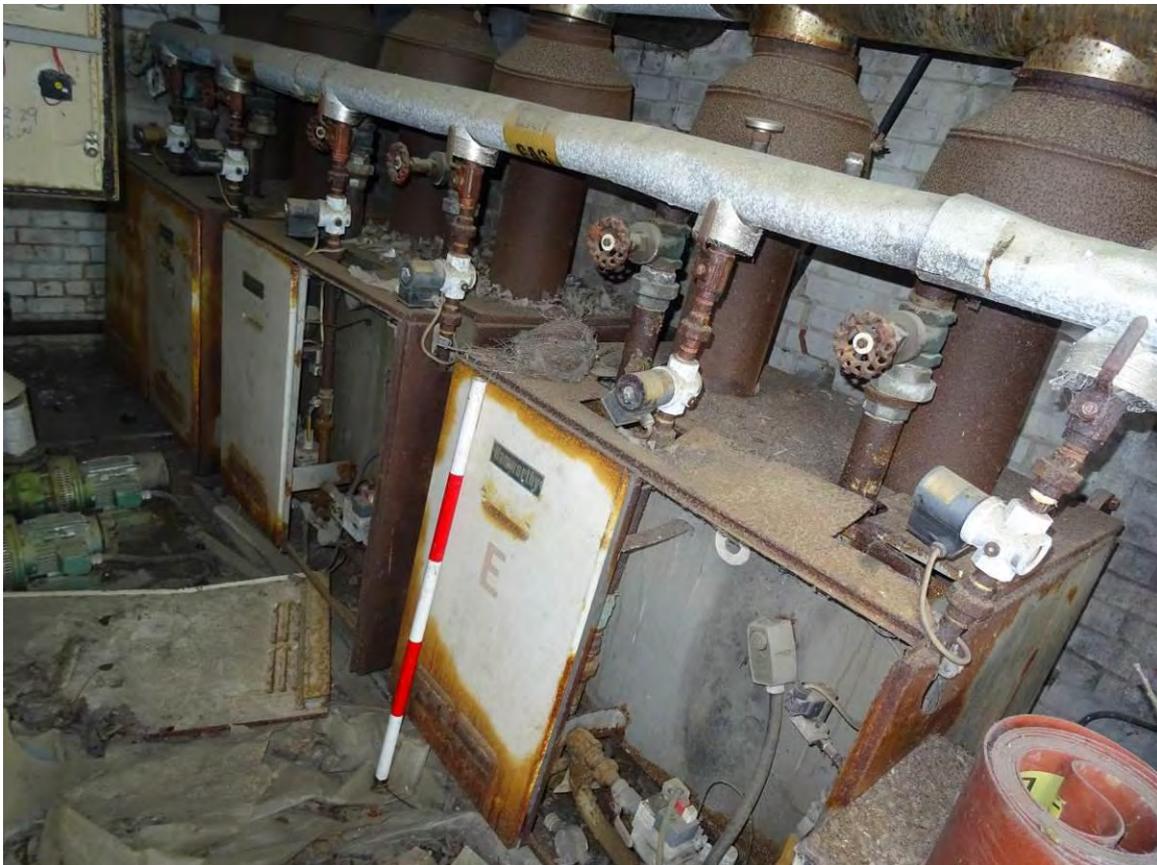
The internal arrangement of the surviving machinery is rather confused. It is clear that up to four Hamworthy condensing boilers stood against the western side of the building (**Plates 53 and 54**). All four boilers fed into condensing apparatus above each unit and their source of power was via an electrical junction box, located on the eastern wall of the building (**Plate 55**). Heat output was controlled by at least two gasket burners (**Plate 56**). The use of the boilers are unknown; however, it is more than likely that based on their British Thermal Unit (BTU) output, they were not used within the kiln heating process, but an adjacent building lay between the Boiler House and the Reception building which might have required this level of heating.

Plate 53. Internal view of the gas-fired boiler condensing range, looking SW

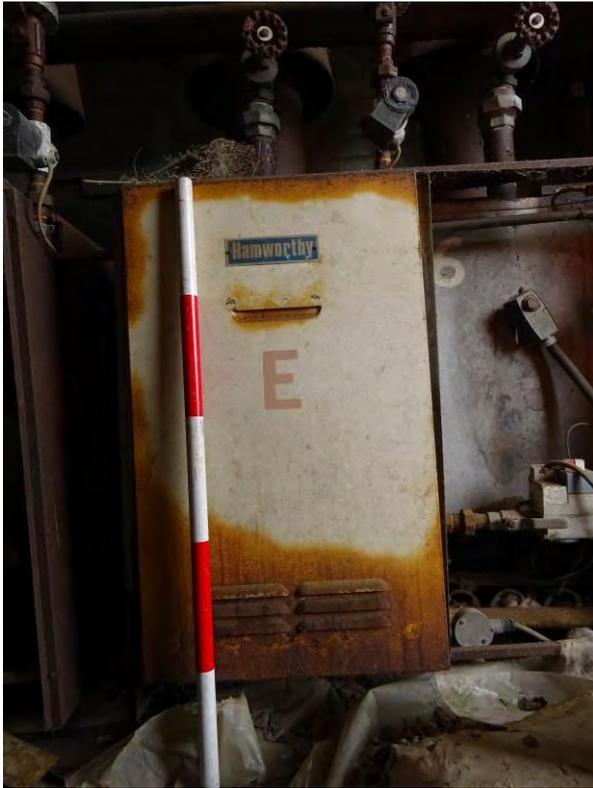
Plate 54. Detail of one of the Hamworthy boiler condensers, looking west  
Plate 55. Electrical circuit board box connected to the eastern wall, looking south

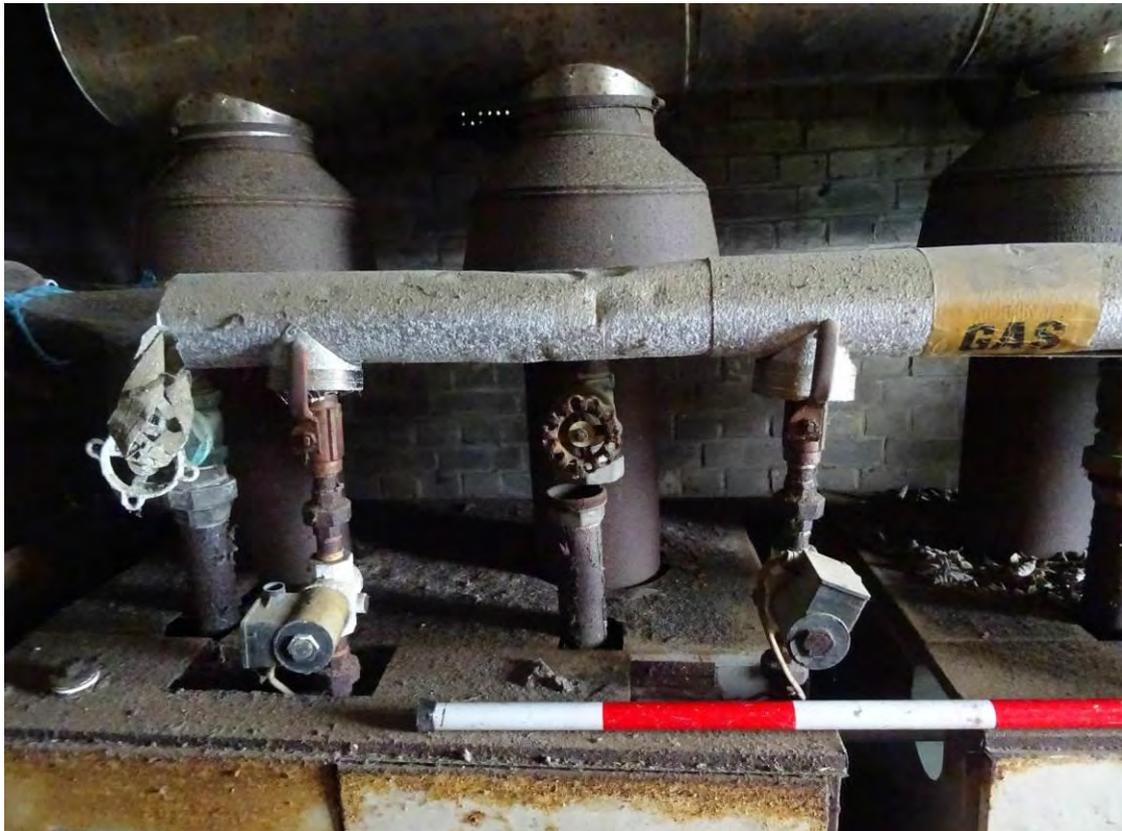
Plate 56. Valve system for the release of excess steam, located about the boiler system

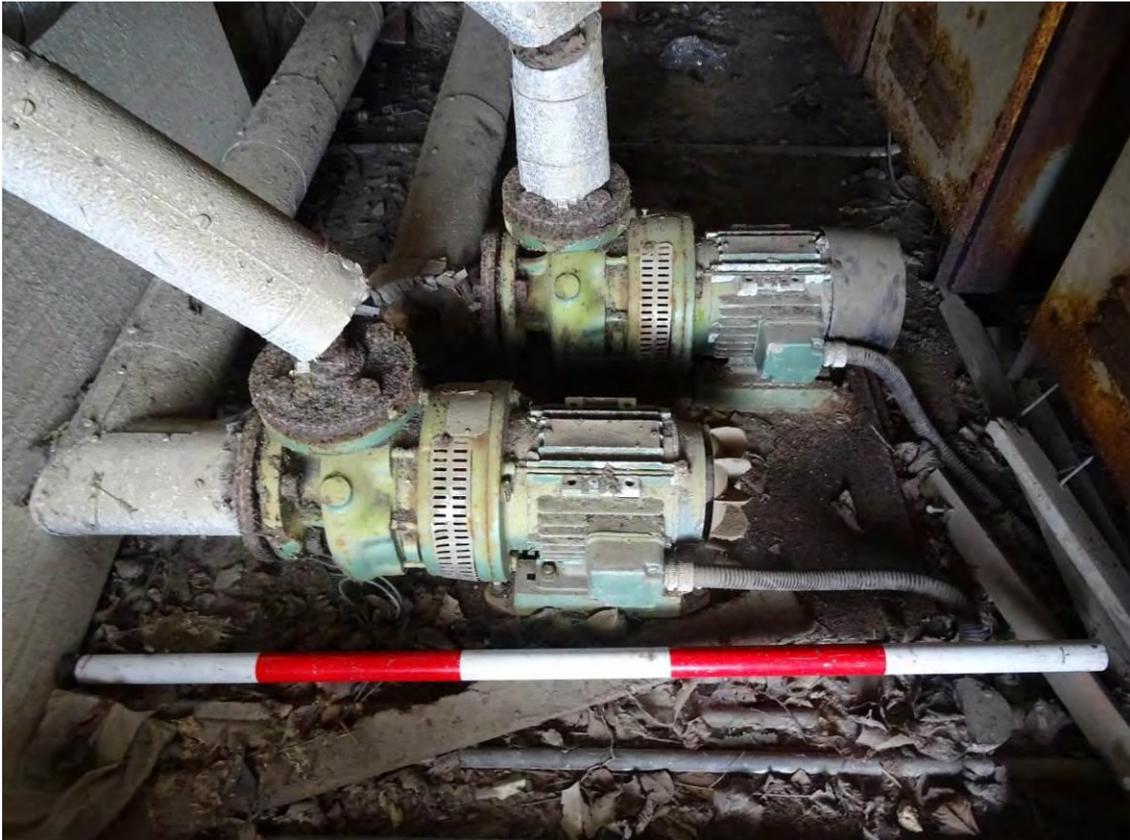
Plate 57. Two of potentially five gasket burners located east of the boiler units
