Appendix 12.1: Preliminary Ecological Appraisal

Ecological Appraisal

Wealdon Brickworks

Britaniacrest Recycling Ltd

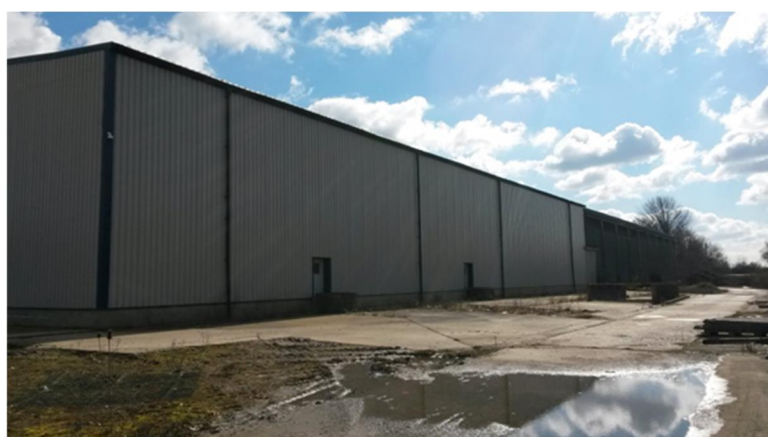
Figure 3-1: Main steel frame building

- 3.2.1 The main building within the site is a large steel-framed storage shed measuring 70 x 190m (Figure 3-1). The building is open and well-lit, with corrugated metal panelled walls and roof. The southern section of the building is older and in poorer condition than the recently extended northern section. The building is classified as being unsuitable for roosting bats.

- 4.3.4 The main storage shed building and smaller buildings to the north of the site are considered unsuitable for bats.

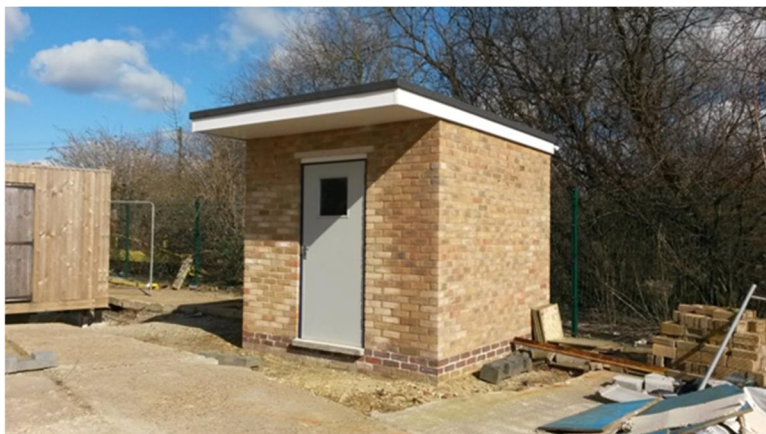
Figure 3-2: Small 'kiosk type' building

- 3.2.2 Two small buildings lie to the north of the main storage shed, the first of which is a flat, felt roofed brick building and the second a wooden shed (Figure 3-2 and 3-3). Both are recently constructed and in good condition, with no suitable features for roosting bats.

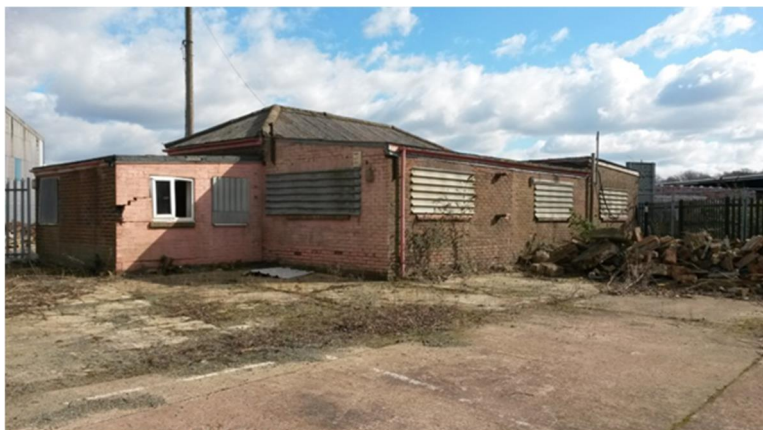
Figure 3-4: Reception building

- 3.2.3 A disused former reception building is located to the south of the site (Figure 3-4). The reception is brick walled with a pitched asbestos roof. A large crack along the brickwork on the north-western elevation provides an opening in the exterior wall creating potential access in the wall cavity (Figure 3-5). The opening has low potential to be used as a roost site by bats. A disused nest lies in the base of the crevice.

- 3.2.4 All of the buildings windows have been boarded over with the exception of one, however no suitable features or signs of bats were recorded within the visible interior.

- 5.1.3 The former reception and small southern building have previously been used by nesting birds and will be demolished in the proposed development. For demolition activities outside of the bird breeding season (March to August inclusive), there should not need to be any consideration of nesting birds. Between March and August it will be necessary to ensure beforehand that birds are not nesting within the buildings. This should be established by an ecologist undertaking a nesting bird survey within 48 hours prior to work commencement. Active nests, if present, would need to be protected.
- 5.1.4 The remaining buildings within the site are of negligible value for roosting bats and nesting birds.

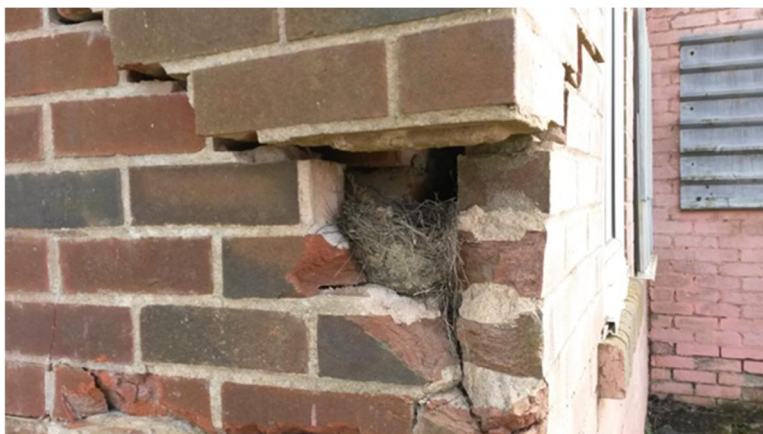
Figure 3-5: Damaged brickwork on the reception building

- 4.3.1 It is evident that both the former reception and small southern building have degraded since the 2013 ecological site survey, with the corrugated metal panelling previously boarding the buildings now partially removed and significant cracks and holes in the brickwork of both.

- 4.3.2 The former reception building has potential to be used by crevice roosting bat species with a section of damaged wall providing an extensive opening the cavity wall. The feature is only 1.5m above ground level and has an old bird nest in the cavity. These characteristics would reduce the likelihood of use by bats but would not preclude use. With a single feature, the building is classified as having low potential value for bats.

- 5.1.1 Since the 2013 ecological walkover survey the former reception and small southern building have noticeably degraded and are now in a poor state of repair. An opening between a cavity and external wall on the former reception building now confers this building with low potential value for bats.
- 5.1.2 In accordance with BCT guidelines, it is recommended that a dawn / dusk survey is undertaken to establish the status of the building as a bat roost. The survey should be undertaken between May and August. Further mitigation will be necessary if bats are found to be using the feature.

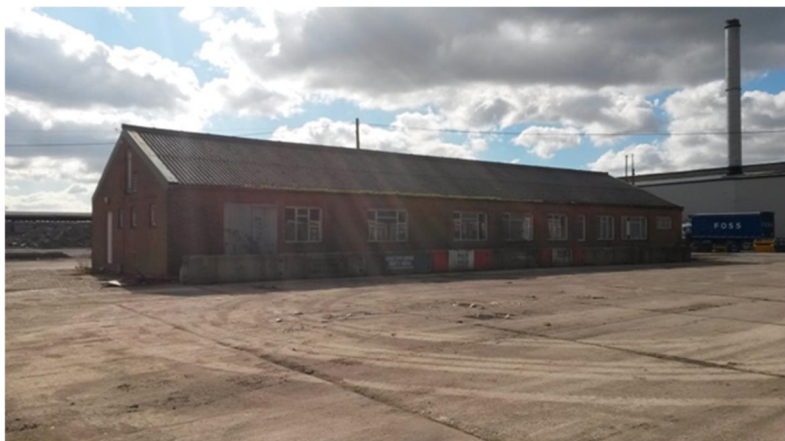
Figure 3-6: Office building

- 3.2.5 To the centre of the site is a former office building of similar construction to the reception building though in a better state of repair (Figure 3-6). The building is generally well-sealed, with only a few small cavities considered to be of negligible value for use by bats.

- 4.3.3 A few small cracks and openings were also recorded on the office building, however none of these are likely to extend into cavities of significant value for bats.

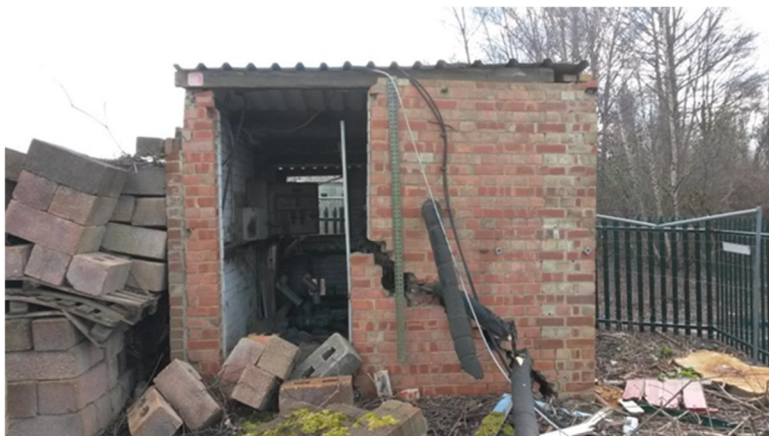
Figure 3-7: Outbuilding

- 3.2.6 A small, brick building lies to the south-west of the site (Figure 3-7). The building has a flat corrugated metal roof and is in poor condition, with the door and windows removed. While the building is unsuitable for bats, several inactive bird nests were found inside.

- 4.4.1 The small southern building and reception building both offer suitable habitat for small nesting birds and the remains of nests were found in both. The remaining buildings within the site are considered to be of negligible value for nesting birds.

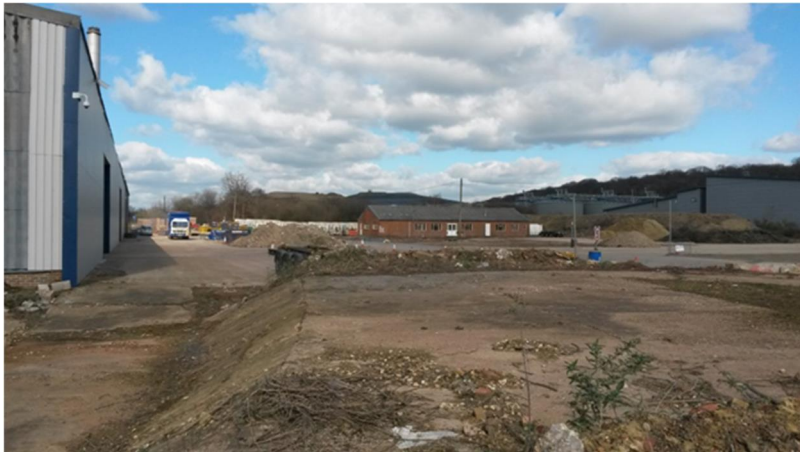
Figure 3-8: Hardstanding

- 3.3.1 The majority of the site comprises hardstanding and bare ground, as shown in Figure 3-8. Vegetation is limited to disused areas at the edges of the site, and small sections of regenerating vegetation around the buildings.

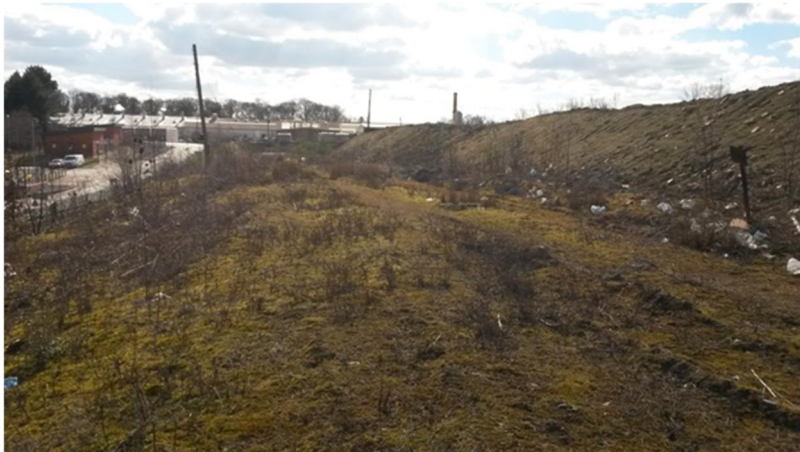
Figure 3-9: Mounded ground in north-eastern part of the site

- 3.3.2 A tall ruderal and ephemeral / short perennial mosaic has colonised open areas within the site, as shown in Figure 3-9. This is most extensive to the north-east of the site where ruderal vegetation has established on a large bank.
- 3.3.3 Mosses dominate the ground cover in these areas, interspersed with herbs such as colts-foot *Tussilago farfara*, barren strawberry *Potentilla sterilis* and creeping buttercup *Ranunculus repens*. Frequent strands of dead tall ruderal vegetation are present, including teasel *Dipsacus fullonum*, common ragwort *Jacobaea vulgaris* and docks *Rumex* species.

- 5.3.1 The remaining habitat within the site is unlikely to support protected species, comprising a low diversity of common flora with value in context of the site only. It is recommended that vegetation removal is phased, beginning with the innermost vegetation and extending outwards from the site's centre. This will allow a gradual movement of fauna outwards into surrounding the habitat.

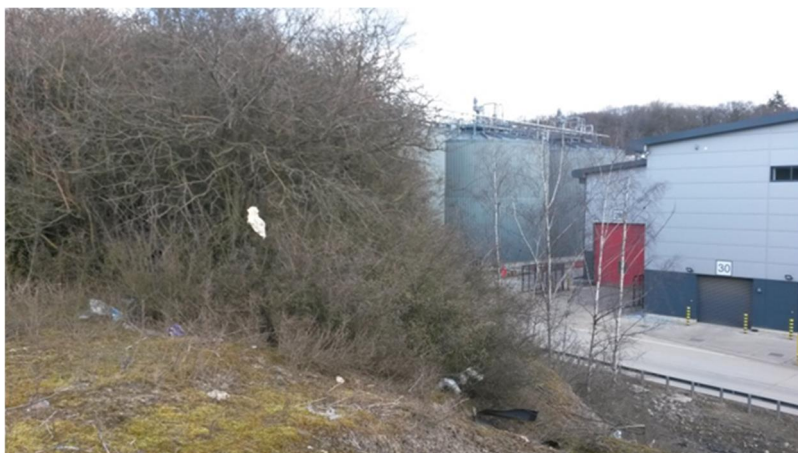
Figure 3-10: Scrub on north-eastern site boundary

- 3.3.4 Butterfly bush *Buddleja davidii*, bramble *Rubus fruticosus* sp., grey willow *Salix cinerea* and silver birch *Betula pendula* scrub has self-seeded throughout the site, forming denser stands to the north and north-east of the site, as shown in Figure 3-10. Rose *Rosa* sp., hawthorn *Crataegus mongyna* and pedunculate oak *Quercus robur* saplings are additionally present along the eastern bank.

- 4.4.2 While the majority of the scrub within the site is sparse, denser areas are present on the margins of the site, which provide nesting opportunities. Given the context of these scrub and the industrial nature of the site, nesting birds would be expected to be limited to common and widespread species.

- 5.2.1 There is potential for nesting birds to use the denser areas of scrub to the north and north-east of the site. If scrub removal within the bird breeding season is necessary, it should first be ensured that no birds are nesting within the scrub. As with the pre-demolition building nesting bird survey, this should also be established by an ecologist visiting the site within 24 hours prior to work commencement.

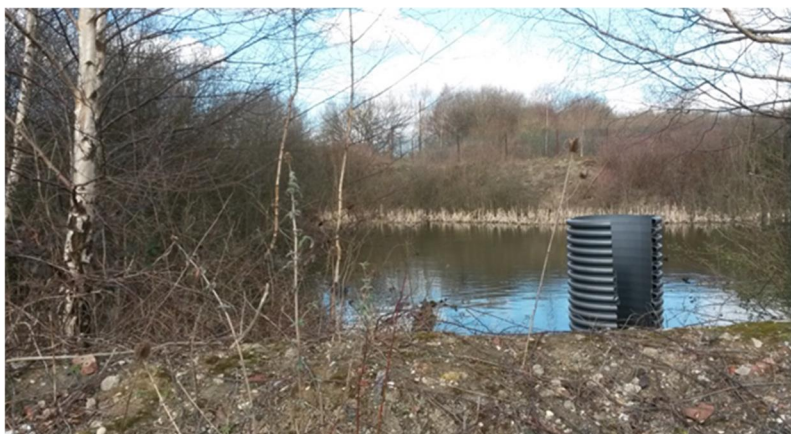
Figure 3-11: Off-site ponds

- 3.3.7 To the west, a mature woodland of oak and birch trees lies beyond the railway bordering the site. A small section of plantation woodland is located north of the access road to the site.
- 3.3.8 To the north of the site is a fenced area containing two ponds, surrounded by steep banks covered by scrub and tall ruderal vegetation (Figure 3-11). Observed from within the site, both ponds appeared to have good water quality with an estimated depth of at least 1m.

- 3.3.9 A total of eight ponds lie within 250m of the site. A great crested newt survey undertaken in 2013 found great crested newts to be present in two ponds located 220m north-east of the site (Appendix 1 of this report).
- 3.3.10 Great crested newts were found to be absent from the five other ponds that were surveyed. This includes the two aforementioned ponds north of the site, as well as one pond 20m north of the access road and two ponds 160m south of the site. An additional pond lies 150m west of the site beyond the railway.

- 5.4.1 The habitat within the site is of poor quality for great crested newts and it is considered unlikely that they would be present on-site. It is therefore anticipated that, in line with the 2013 ES ecology chapter, the proposed development would have no direct impacts on great crested newts.
- 5.4.2 Great crested newts will move through terrestrial habitats in the landscape and can establish new breeding ponds. The presence / absence of great crested newts in the ponds adjoining the site boundary should be reconfirmed in 2016 given that several breeding seasons have lapsed since the previous survey.

- 5.4.3 Due to the proximity of the ponds, good practice protection measures will be required to during construction and future operation to avoid the potential for pollution or contamination of the adjoining off-site ponds.
