## Appendix 11.1: Ground Conditions Desk Study

Ground Conditions Desk Top Study  
On Behalf of  
Britania Crest Recycling Ltd

**Date:** November 2016

**Our Ref:** JER6755

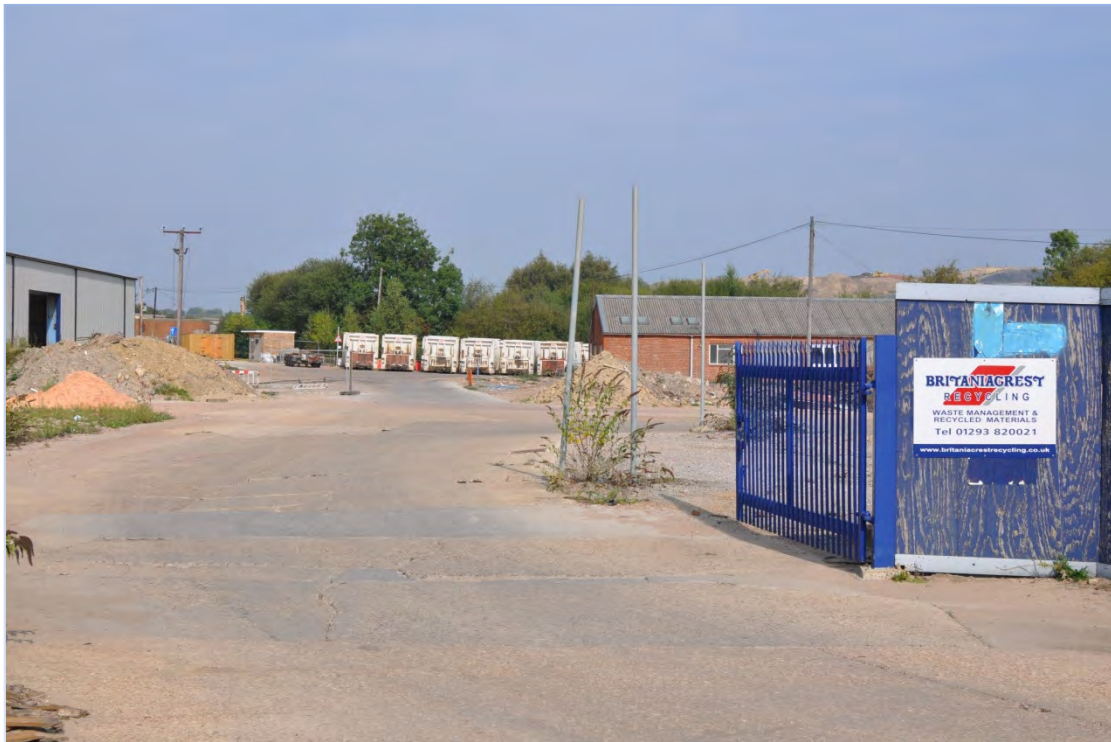
Plate 1: View looking north from site entrance

- 2.11 South: Current Wienerberger Brickworks directly south of the site (Plate 1).
- 2.12 West: Railway line and green fields.

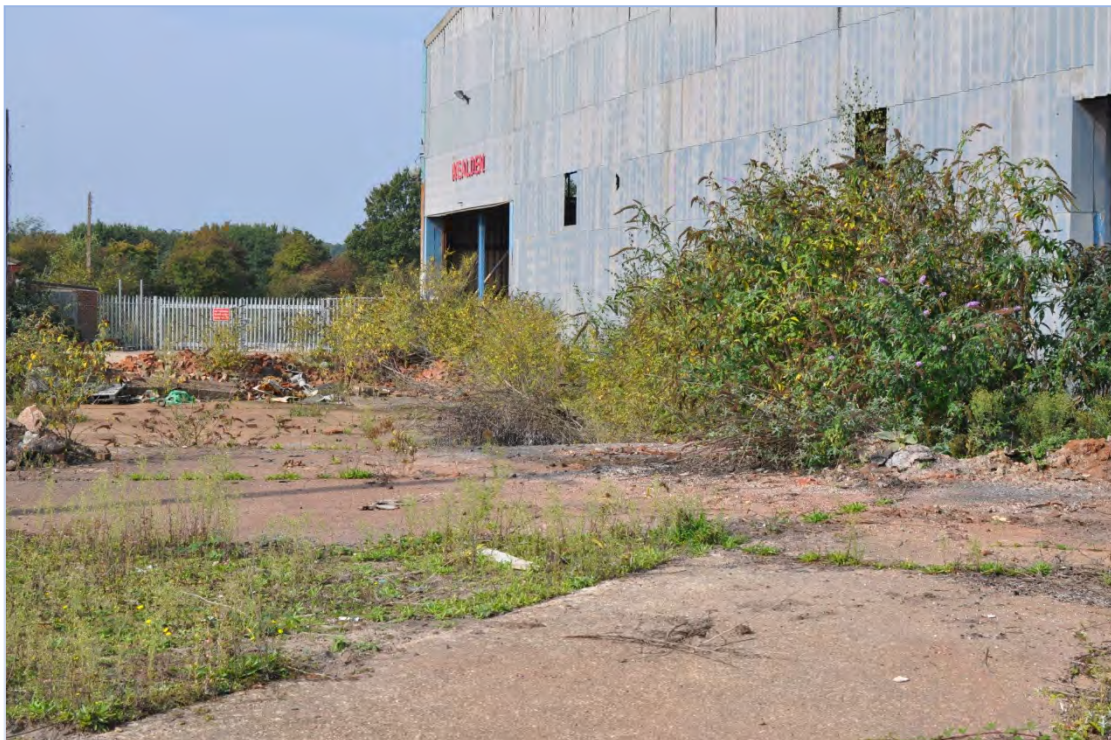
Plate 2: Southern facade of main building

<b>Address</b>	Langhurstwood Road, Horsham, West Sussex
<b>National Grid Reference</b>	TQ 171 343
<b>Size (ha)</b>	3
<b>Occupier(s)</b>	Biffa Waste Services Ltd
<b>On-site Operations</b>	Former brickworks
<b>Buildings</b>	<p>The site (see Plate 2) comprises the southern part of a disused brickworks building, a disused canteen (Plate 4) and a hardstanding area (Plates 5 and 6).</p> <p>The brickworks building on site is a one storey shed which contained:</p> <ul style="list-style-type: none"> <li>• A clay preparation plant and the moulding/extruding plant to form the bricks in the northern section (Plate 7);</li> <li>• A gas powered drying area in the west section (Plate 8);</li> <li>• Gas powered kilns (Plate 9) used to fire the bricks, with fume collection (Plate 10) system and filter in the eastern section (Plate 11); and</li> <li>• A production lane control unit in the middle of the shed (Plate 12).</li> </ul> <p>The different process areas are connected via a railway / tram line (Plate 13) where bricks used to be carried away via conveyors.</p> <p>The processing lanes were two storeys high with a drying / burning shed and gas supply at the bottom and fume collection system at the top.</p> <p>The building itself is in poor condition with holes in the walls (Plate 16).</p> <p>The roof tiles are likely to be made of asbestos cement (Plate 17).</p> <p>During the site walkover, no water run-off collectors were observed at the site.</p>

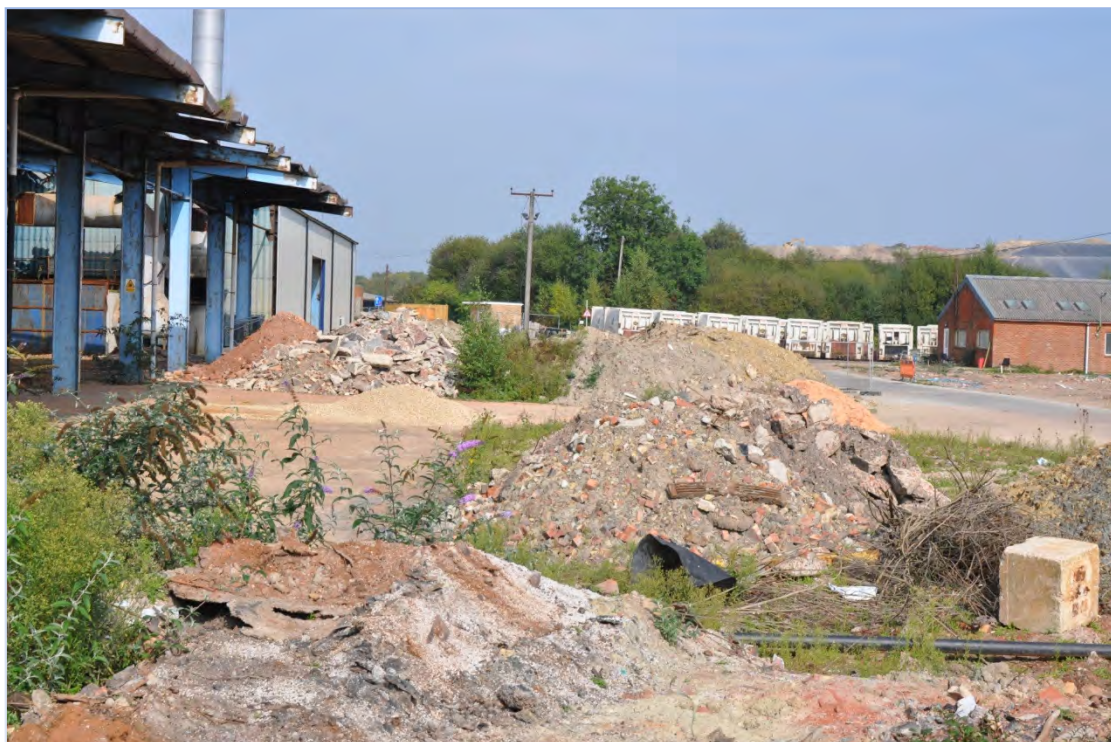
**Plate 3: View north along eastern edge of main building**

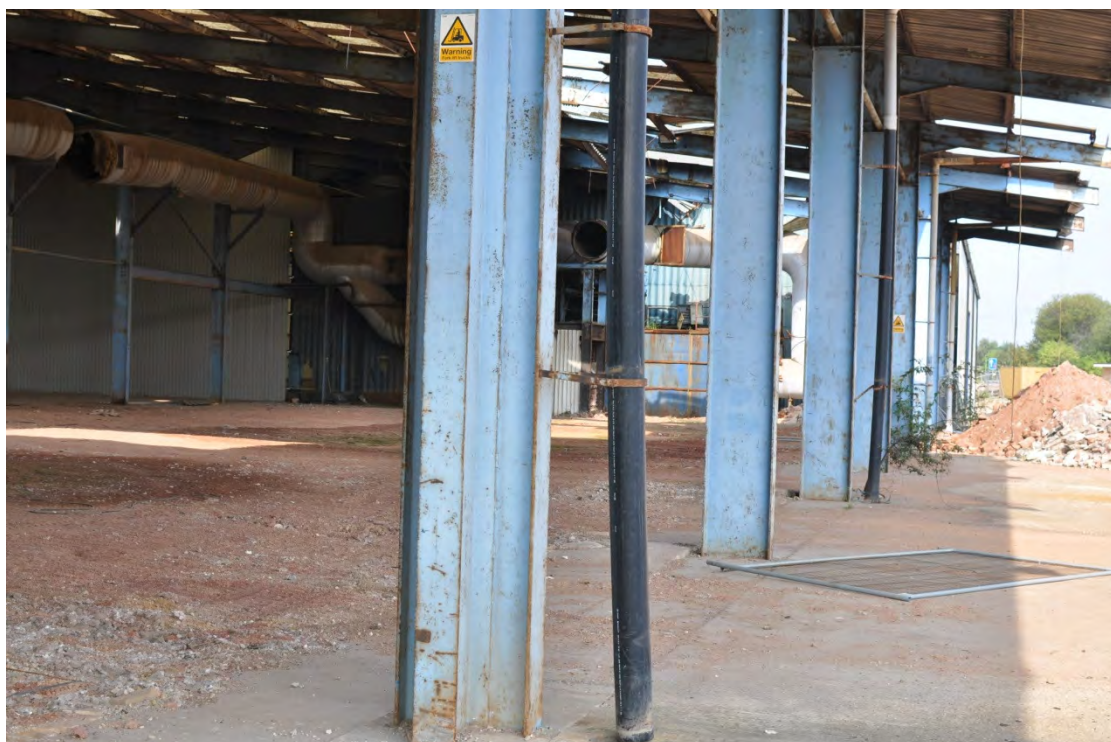
The roof and external walls of the un renovated section of the building are believed to be constructed from asbestos containing materials. These are in a very poor condition and fragmented asbestos sheet was noted both within the buildings and around much of the exterior of the building on the surface of the site. The newly renovated section of the building had been stripped of suspected asbestos containing materials and re clad in with metal sheeting.

**Plate 4: Main building interior – un renovated section**

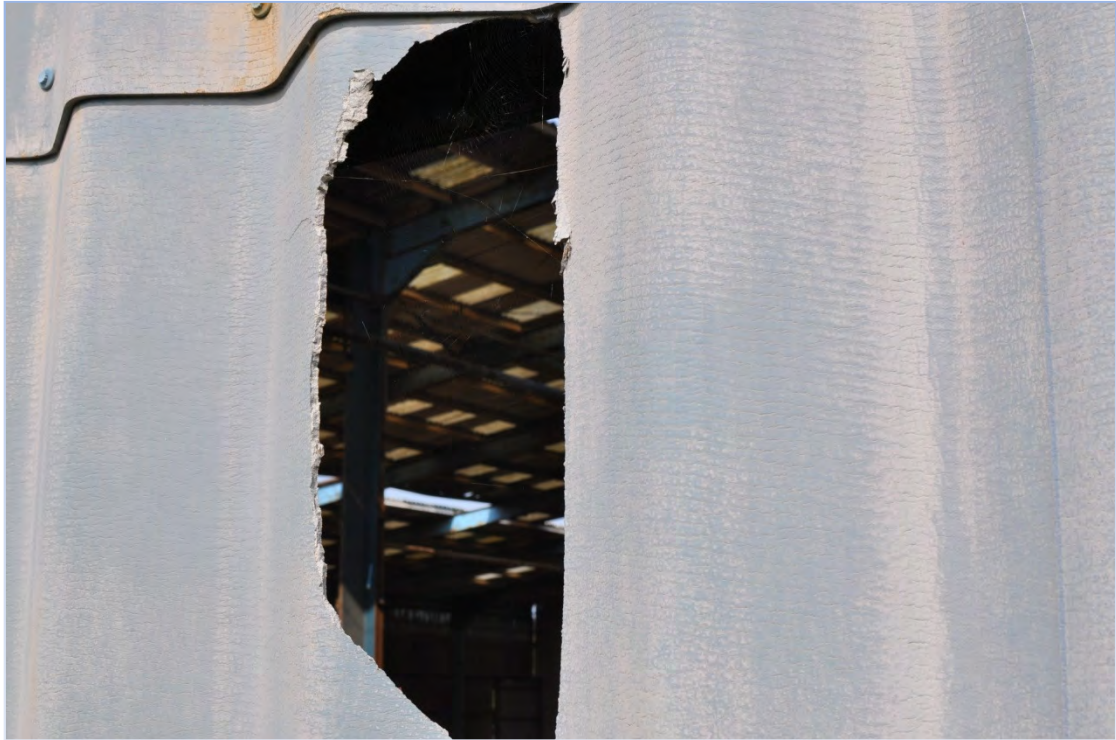
**Plate 5: Damaged suspected ACM's**

- Possible Asbestos Containing Material (ACM) was identified in the building fabric of existing buildings at the Assessment Site. The material was noted to be in a poor state of repair and damaged potential ACM was said to be on the floor surrounding the buildings.
- Historical activities at and around the Assessment Site which may have resulted in contamination or may lead to engineering constraints include excavations / quarrying, rail workings, storage tanks and brickworks.
- Historic landfilling has occurred in an area north of the Assessment Site.
- There is a high potential for Made Ground to be present underlying the Assessment Site.
- A preliminary risk assessment identifies that there is the potential for ground contamination sources to be present from historical land uses and that further ground investigation may be required.

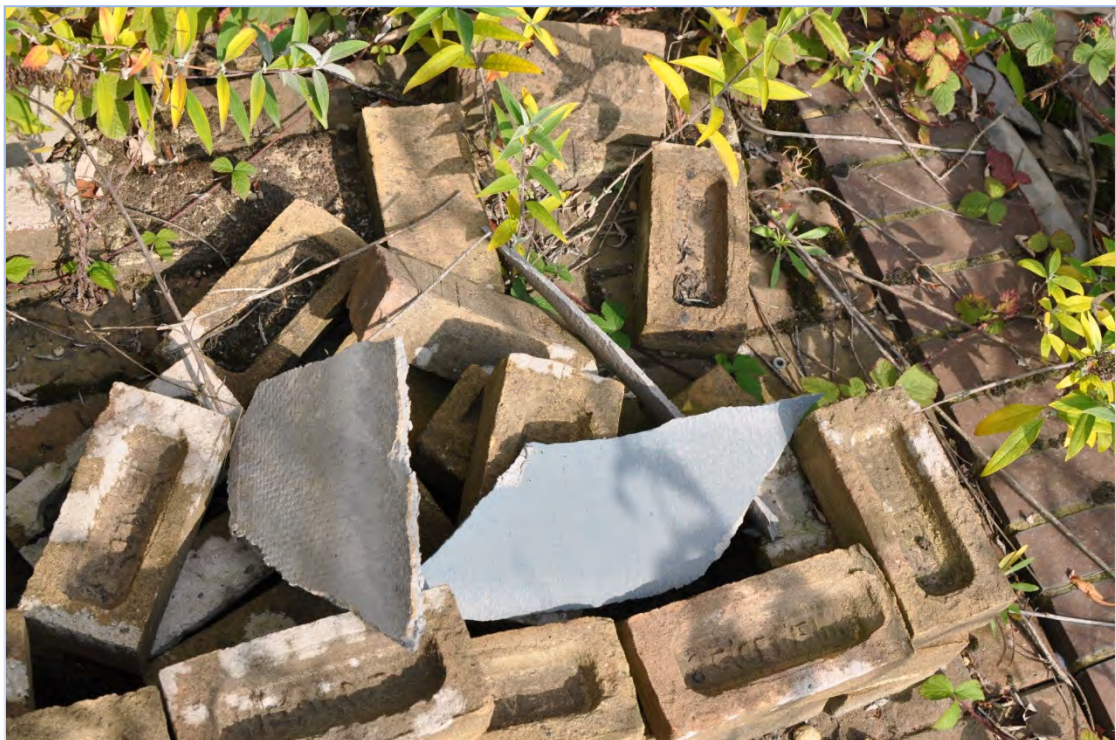
**Plate 6: Suspected ACM debris**

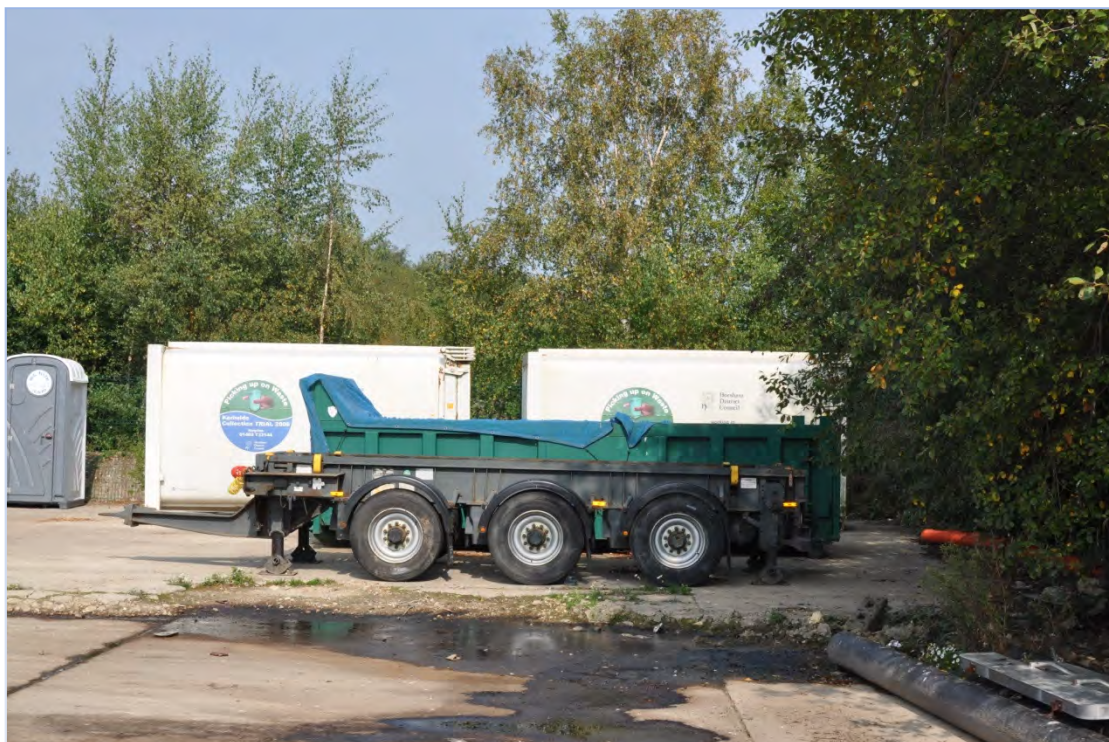
An area of concrete hardstanding to the north east of the site was being used for storage of waste collection skips. A brown/black leachate was observed on the hardstanding in sections of this area.

**Plate 9: Trailer and bin storage in the north east.**

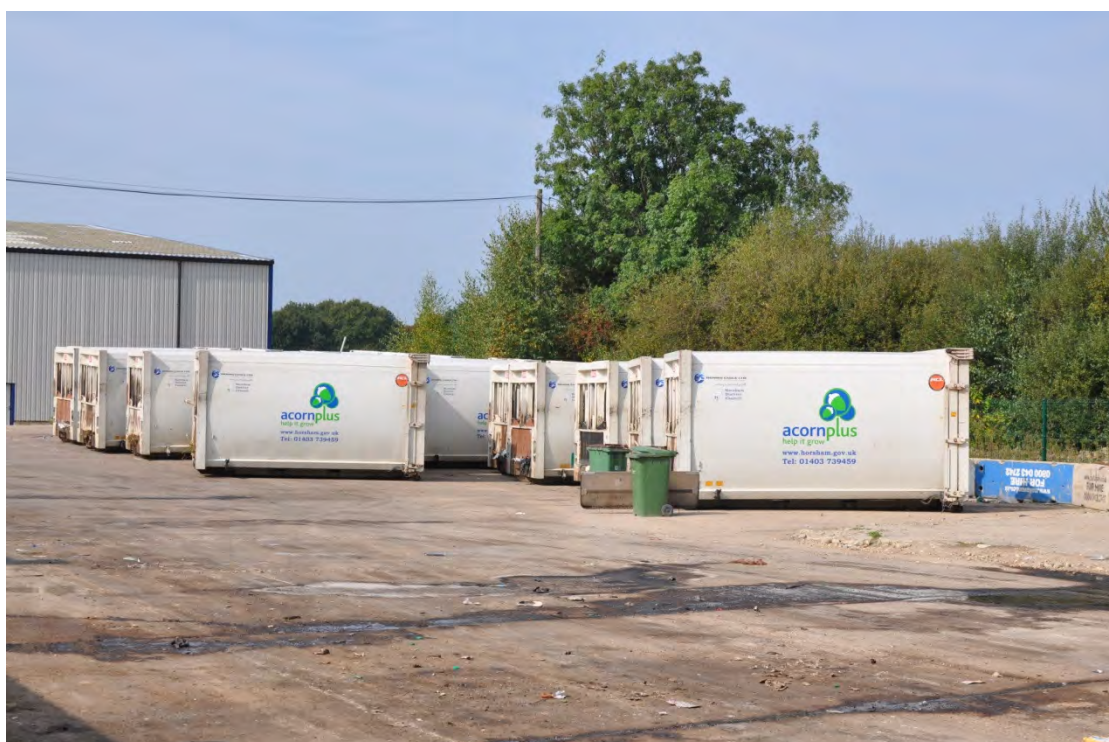
**Plate 10: Bin storage in the northern section**

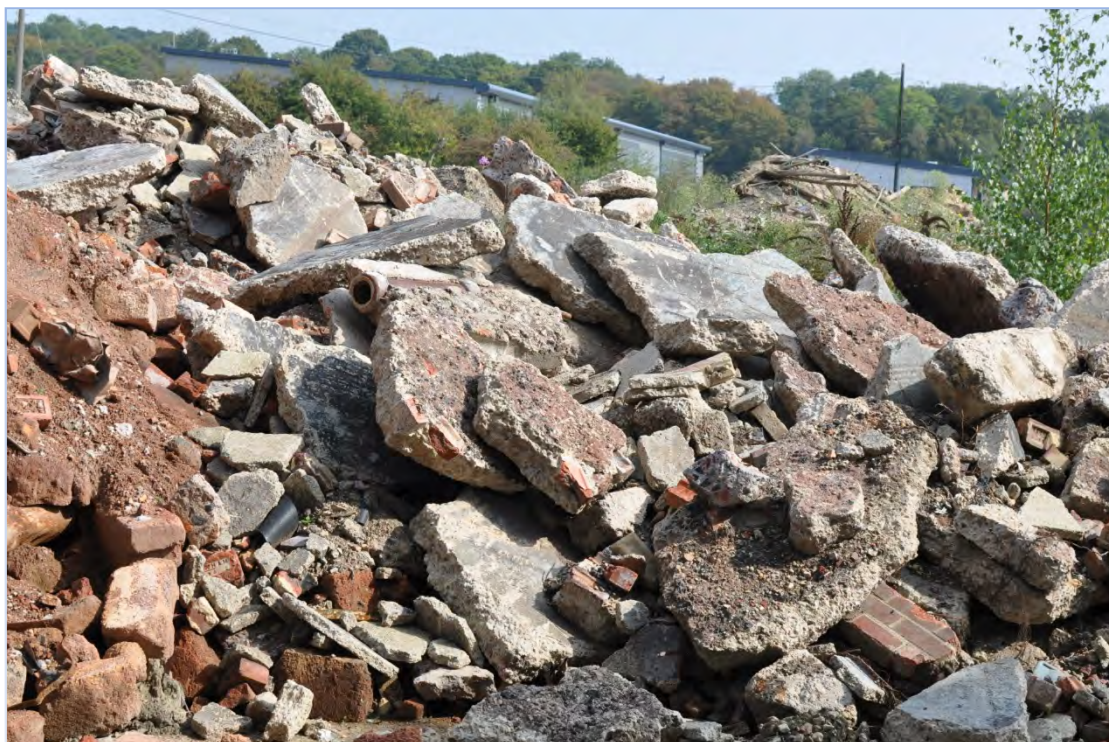
Several small stockpiles of soil and construction waste were noted around the site, predominantly along the southern boundary of the site near the former brickworks building. Other materials (bricks and other construction materials) are located in the south west corner of the site near the security building.

**Plate 13: Stockpiled construction and demolition waste**

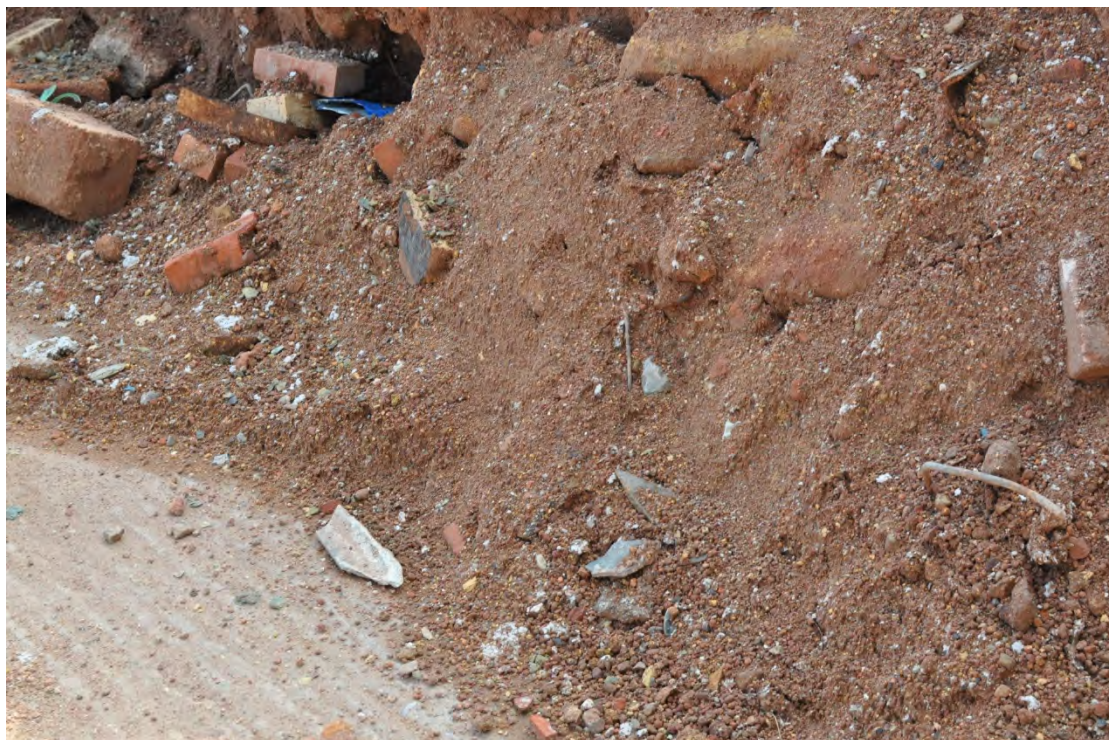
<b>Hardstanding / Landscaping</b>	Indoor and outdoor areas are covered with concrete and tarmac that is in very poor condition with cracks, fractures and holes (Plate 14). The indoor area showed evidence of a previous investigation with several trial pits having been dug and backfilled (Plate 15).
<b>Areas of Fill</b>	Given the industrial history of the area, the whole site is likely to be underlain by made ground.
<b>General Ground Slope</b>	The site slopes gently downward toward the south.
<b>Services</b>	Gas and electricity services are not disconnected. A water main runs across the site from the access road to the north of the production shed. It was disconnected due to significant leakages.

**Plate 14: Stockpiled waste and suspected ACM fragment**
