Appendix D

CCTV SURVEYS

Project Name: 2020_07_20 JACKSON CIVILS LIMITED
Project Number: PJ375561
Project Date: 20/07/2020
Project Standard: MSCC4 Sewers & Drainage GB (SRM4 Scoring)

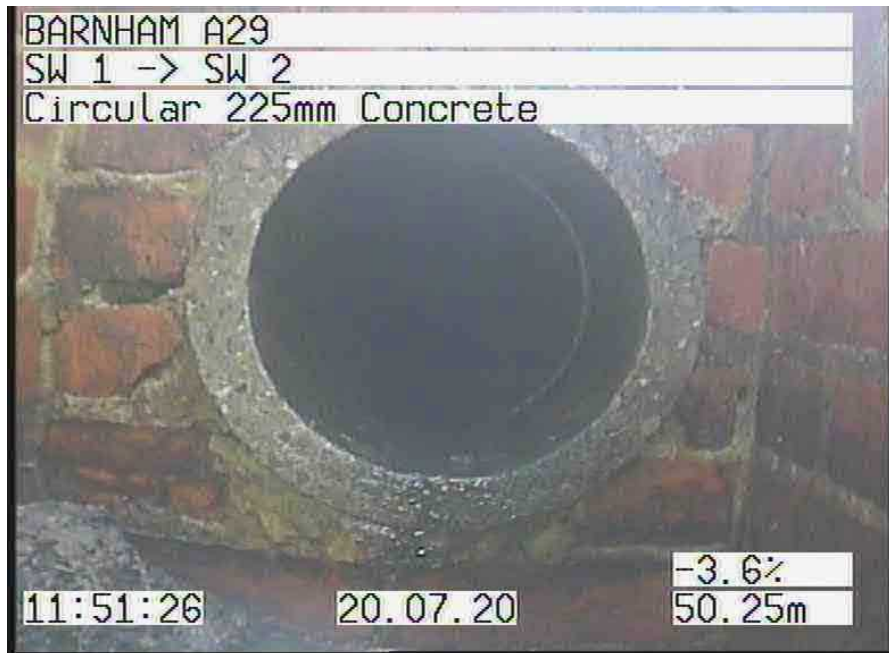
SW 1X_5e075df2-8536-40dc-8176-e38cc8cc59e1_20200720_115312_964.jpg, 00:04:08,
50.25 m
Finish node type, catchpit, reference number: SW 2

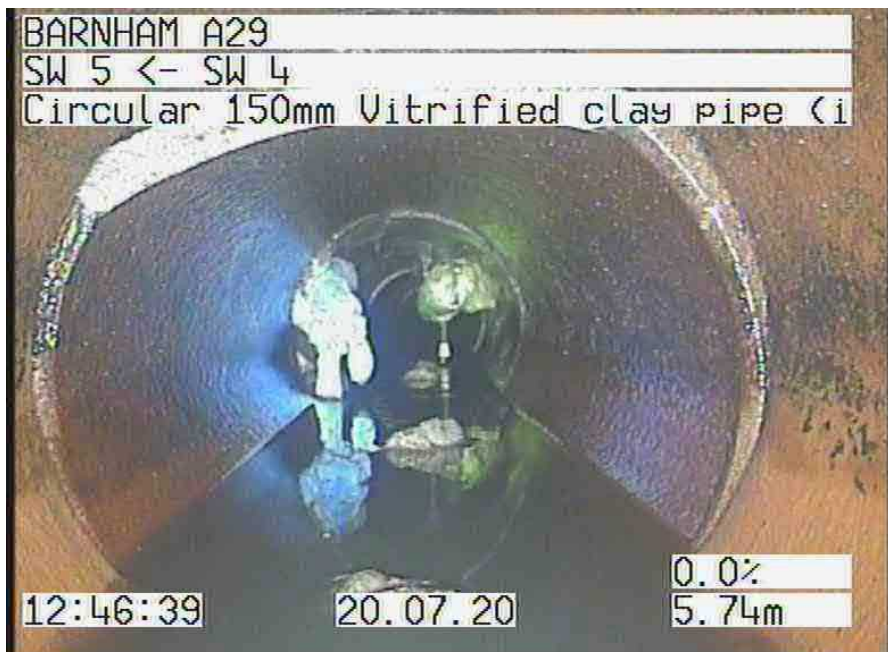
SW 5X_fa211a0f-85cc-4d20-b3ba-f0e25d73c061_20200720_124826_029.jpg, 00:00:44, 5.74 m

Hole in drain or sewer at a joint from 10 o'clock to 2 o'clock

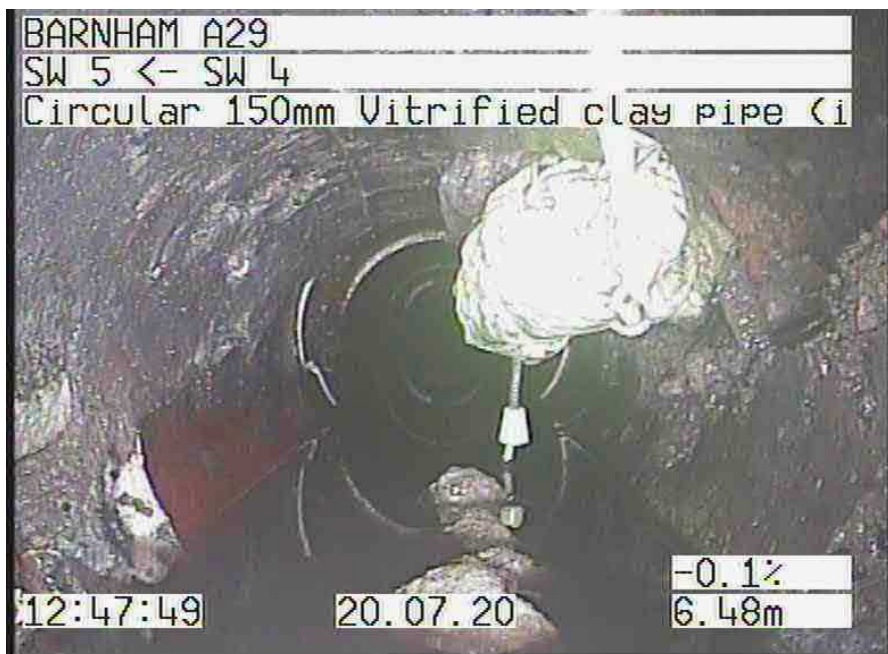
SW 5X_9002ac09-4809-4e85-9d52-90caf16e5504_20200720_124936_021.jpg, 00:01:17, 6.48 m

Survey abandoned, DUE TO HOLE

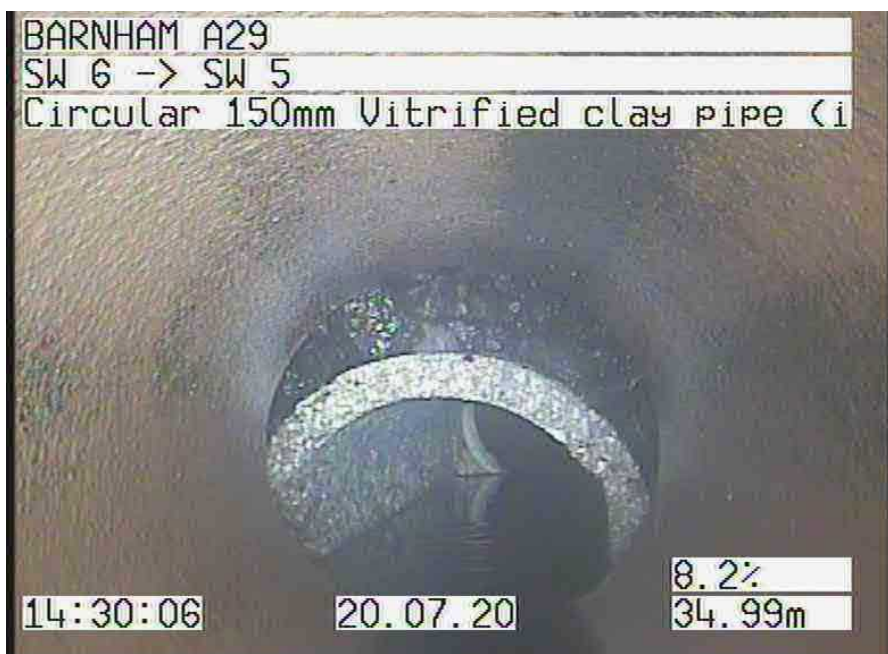
SW 6X_b29db18e-29ed-47a5-84b9-3fc2ed1f8a4b_20200720_143153_105.jpg, 00:06:09,
34.99 m

Joint displaced, large

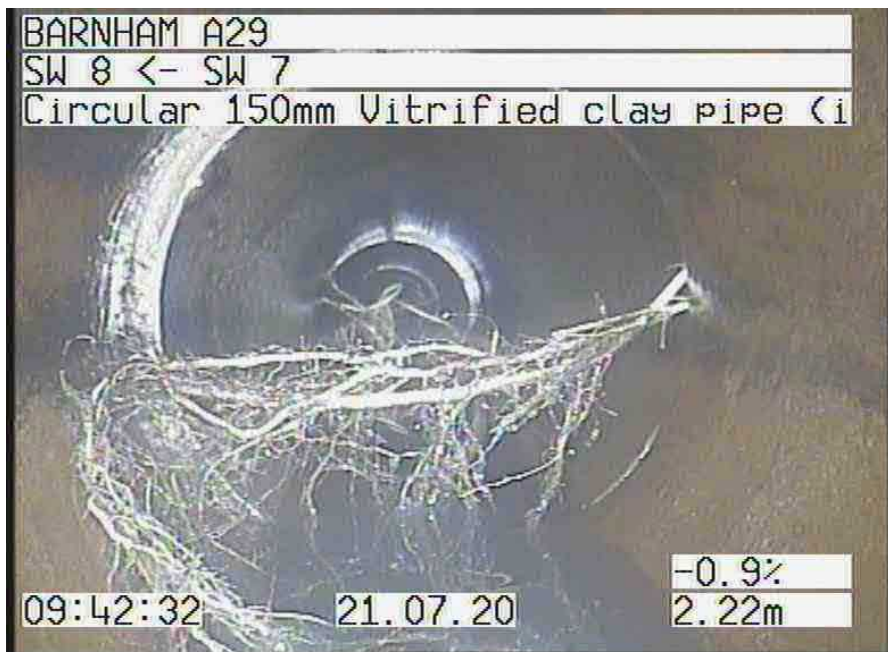
SW 8X_1b3da3de-c7a2-4ca9-87bb-f46f9c065640_20200721_094421_060.jpg, 00:00:39, 2.09 m
 Roots, tap at joint

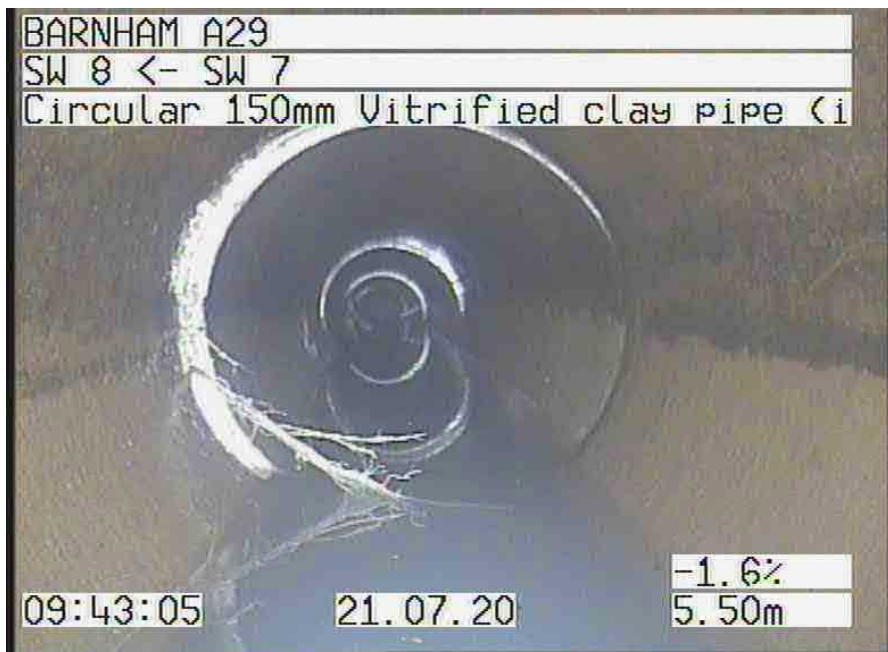
SW 8X_1be65c57-f970-4dd4-a9bd-98954347378e_20200721_094454_109.jpg, 00:01:08,
 5.44 m
 Roots, tap at joint

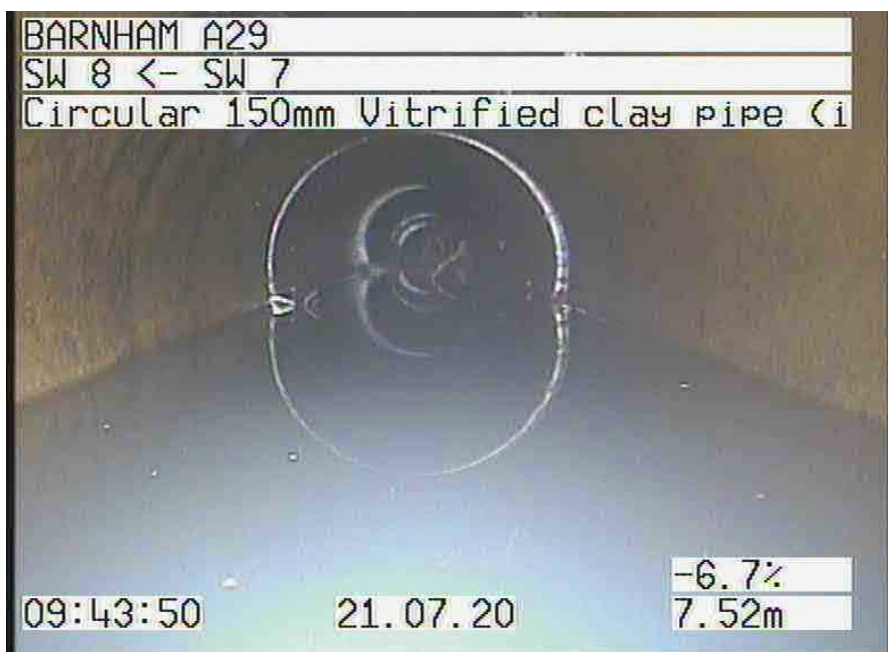
SW 8X_2aede51-6404-4cd3-bfcf-a823d2e5c3b5_20200721_094539_394.jpg, 00:01:24, 7.20
 m
 Water level, 30% of the vertical dimension

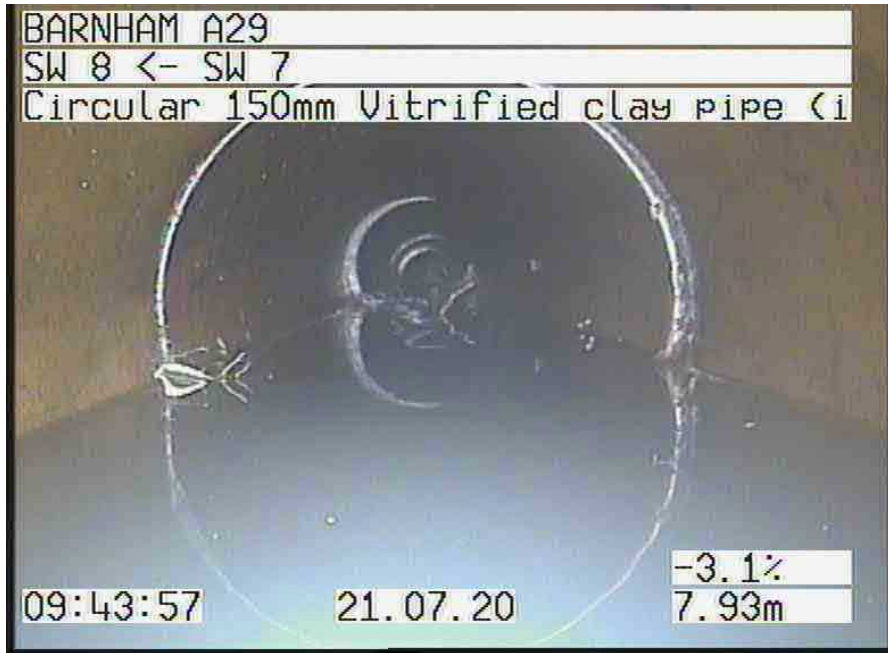
SW 8X_8c4988ac-d5d1-485b-bb90-dfc661fdb8d7_20200721_094546_267.jpg, 00:01:30, 7.52 m
 Connection other than junction at 12 o'clock, diameter: 150mm

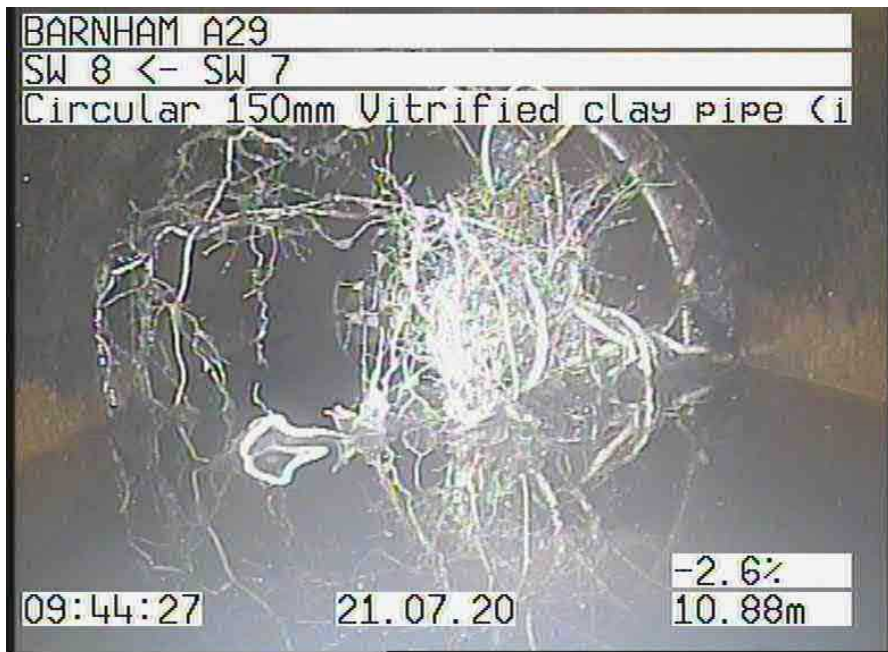
SW 8X_95cd1bcc-af66-4697-abb0-e04089c135fd_20200721_094616_416.jpg, 00:02:01, 10.88 m
 Roots, mass, 30% cross-sectional area loss

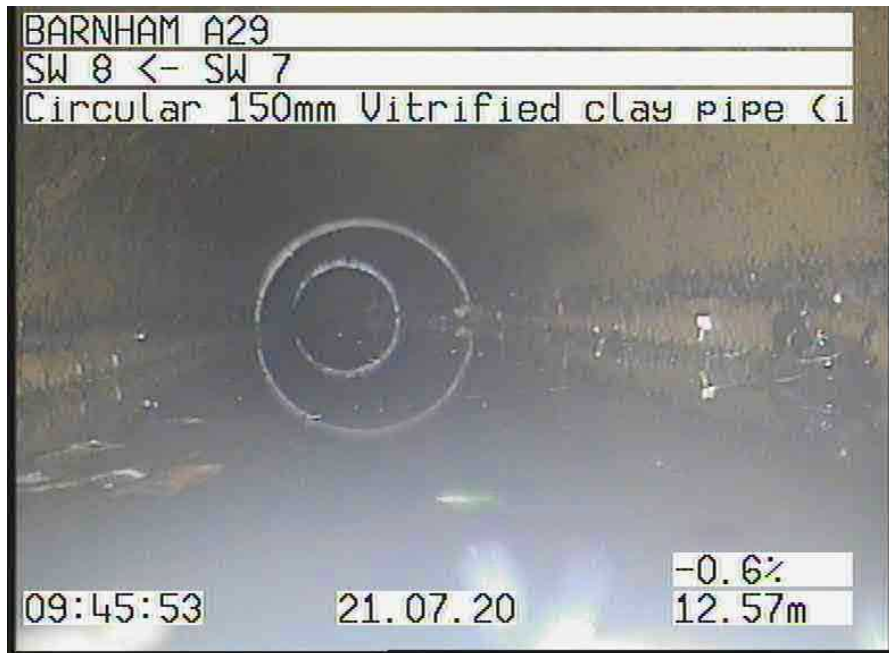
SW 8X_fb604b83-734b-4655-a3ef-4f075f8793a9_20200721_094742_587.jpg, 00:03:03,
12.57 m
Survey abandoned, DUE TO ROOT MASS

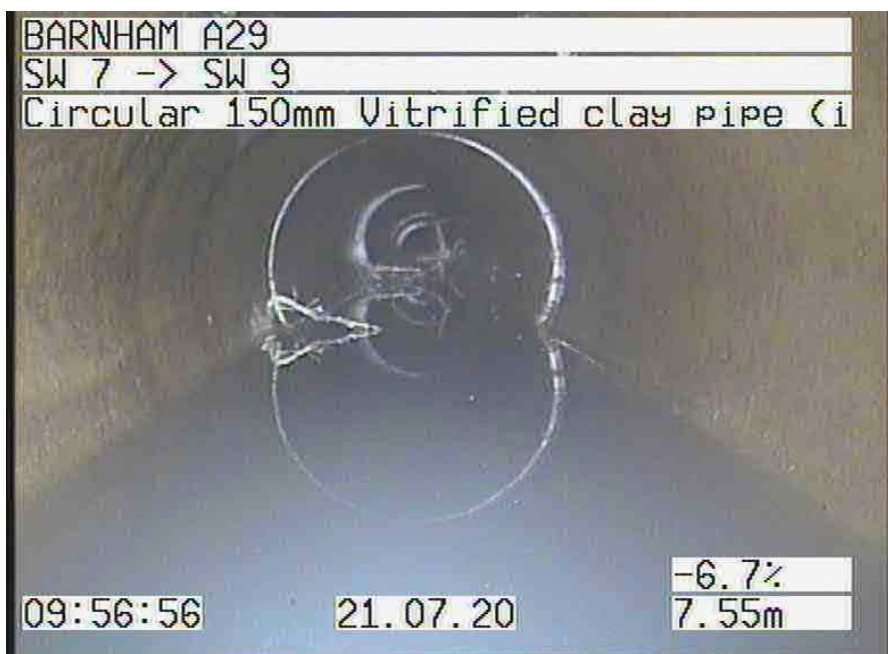
SW 7X_6ac5924f-c9a3-43e2-94a5-1aa1ccb459e5_20200721_095845_171.jpg, 00:01:17,
7.55 m

Connection other than junction at 12 o'clock, diameter: 150mm

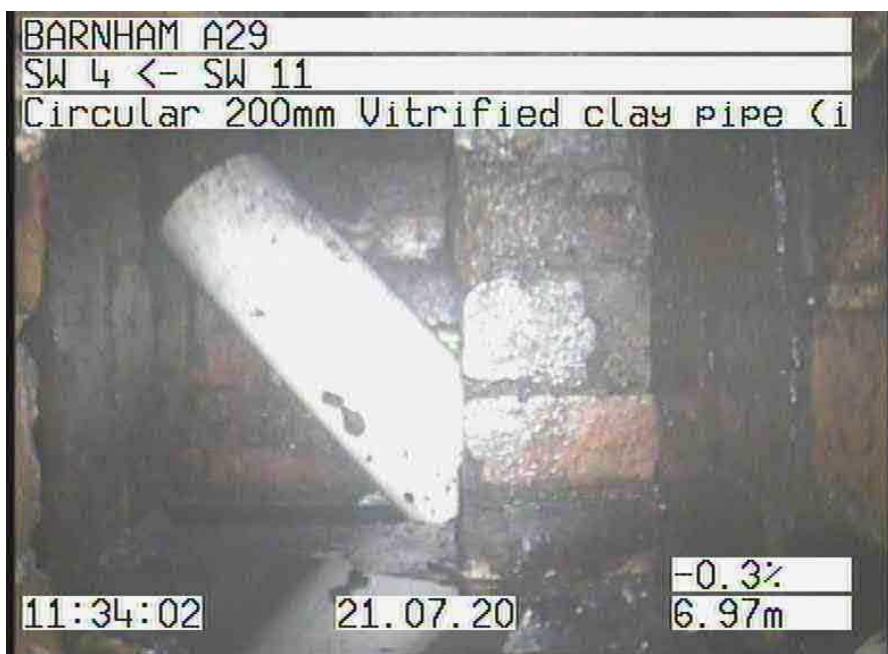
SW 4X_8fb27e7a-27fc-48b7-8ae2-847e5c5f8fe8_20200721_113551_460.jpg, 00:00:44, 6.97
 m

Finish node type, catchpit, reference number: SW 4

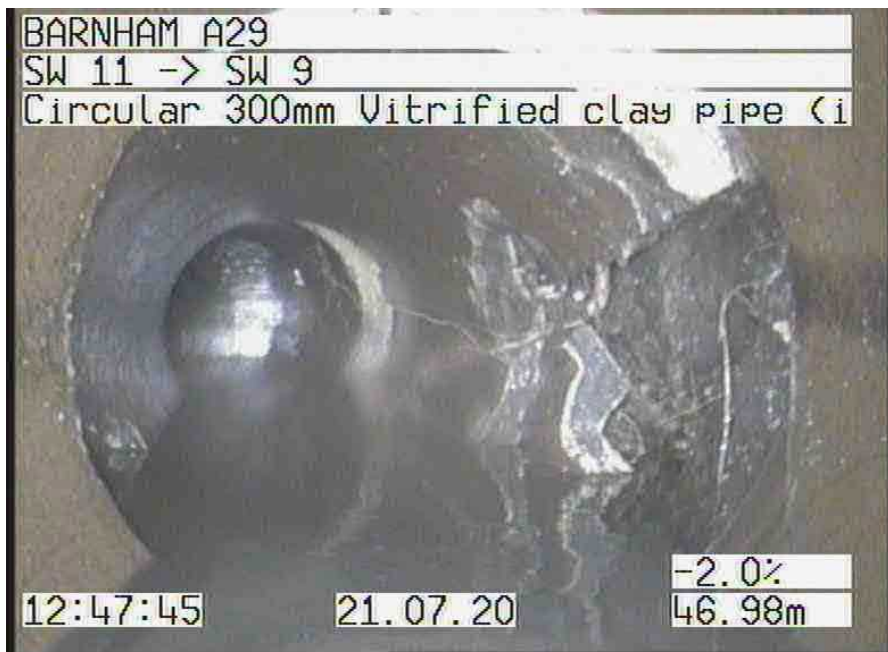
SW 11X_7bfeeee0-a072-484f-bdd1-59bc2a841a20_20200721_124934_680.jpg, 00:06:04,
 46.98 m

Hole in drain or sewer from 3 o'clock to 9 o'clock

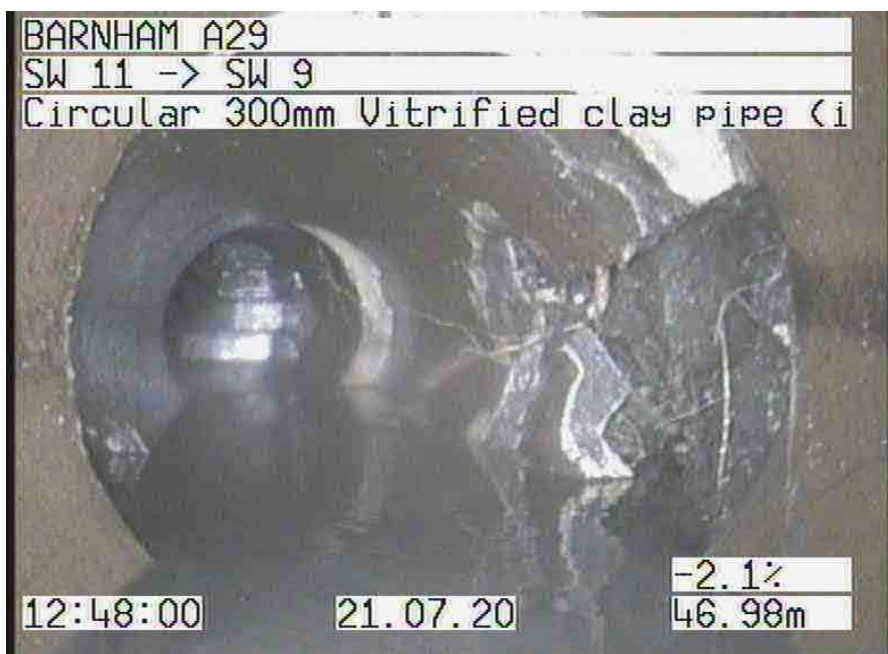
SW 11X_f8d8b242-2ab3-4230-a66d-9a0b5cc3b6e5_20200721_124949_845.jpg, 00:06:08,
 46.98 m

Survey abandoned, DUE TO HOLE IN PIPE

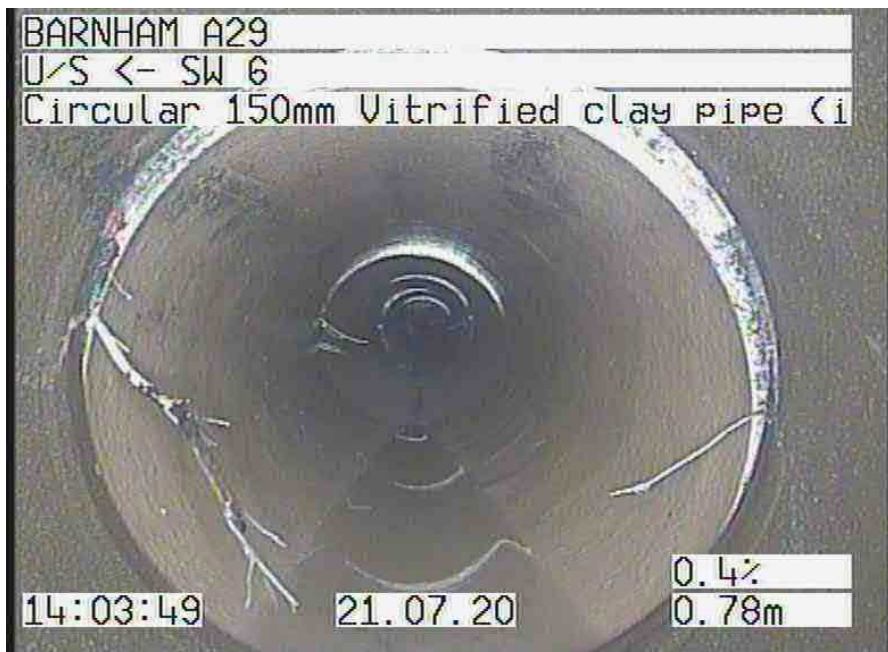
U_SX_b978a558-208b-4ba0-bd13-aea896c693e1_20200721_140539_285.jpg, 00:00:14, 0.78 m

Roots, fine at joint, start, MOST JOINTS

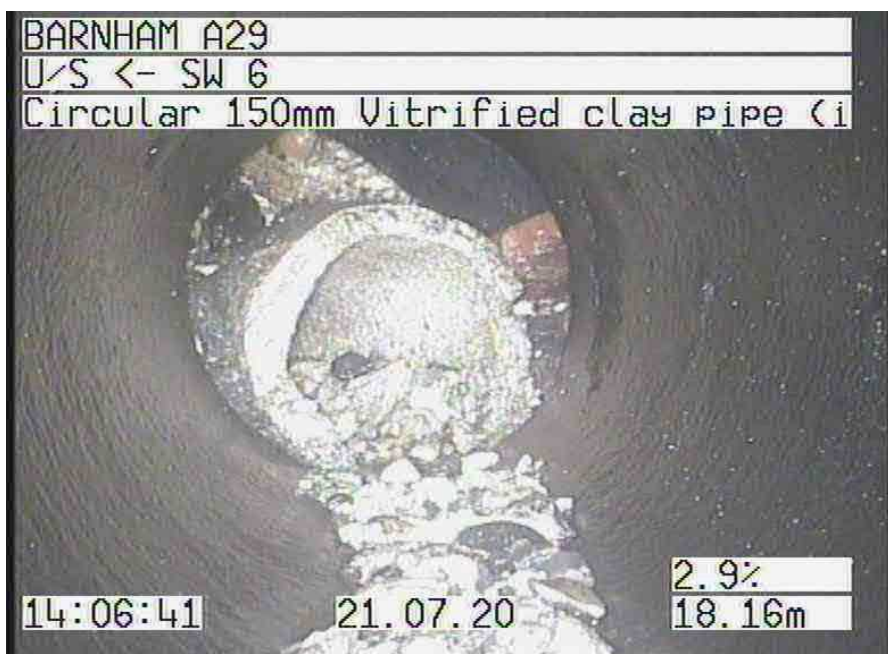
U_SX_225d8742-ac13-48b0-a8ba-e81a50b9e0d9_20200721_140830_680.jpg, 00:02:12, 18.16 m

Size changes, new size(s), 100mm high

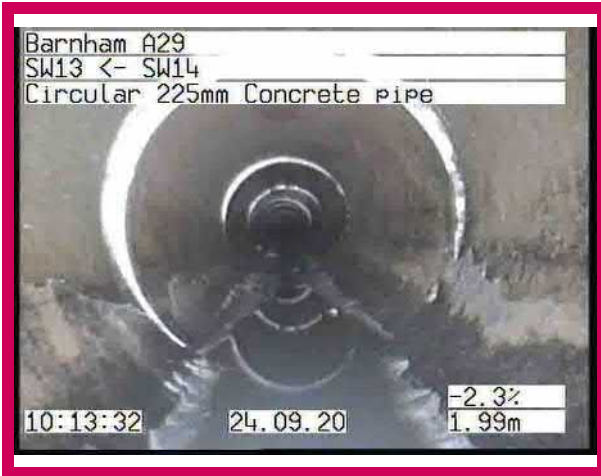
1, 00:00:26, 2.17 m
 Joint displaced, medium

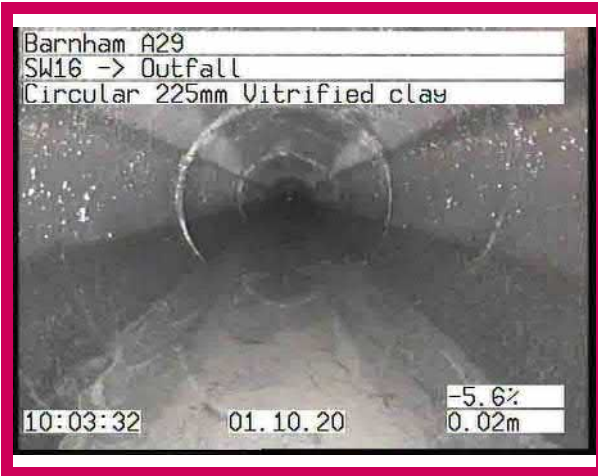
1, 00:00:22, 0.10 m
 Settled deposits, fine, 20% cross-sectional area loss, start

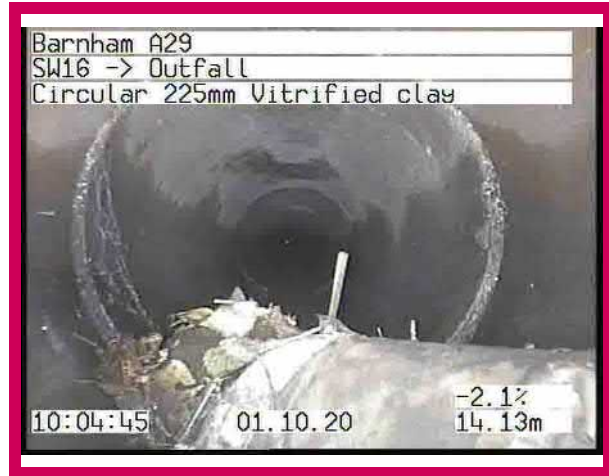
2, 00:01:36, 13.73 m
 Other obstacles from 4 o'clock to 8 o'clock, 25% cross-sectional area loss, debris

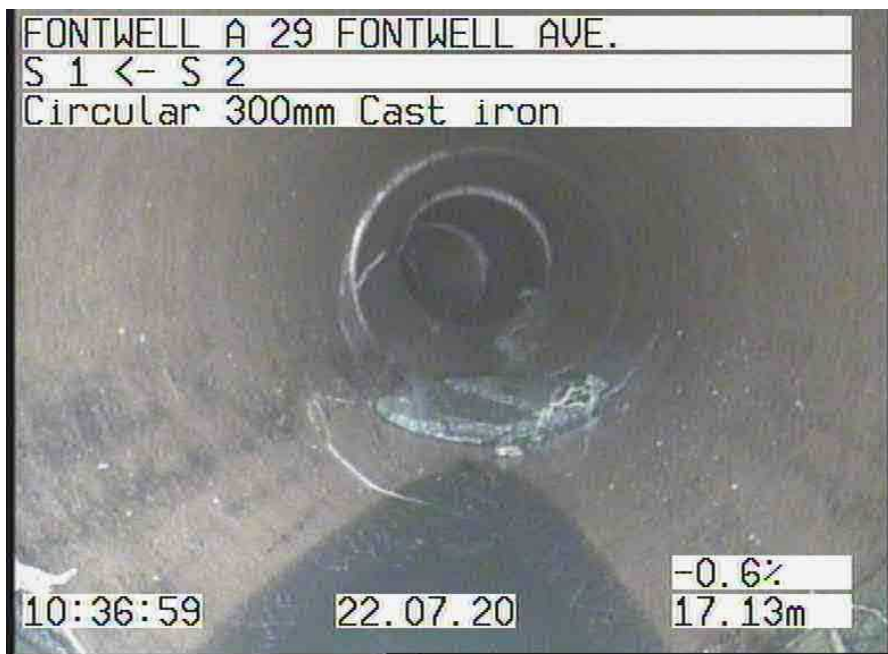
S 1X_5ea0d0dc-ae2d-4172-9971-a51fbc440884_20200722_103841_992.jpg, 00:01:13, 17.13
 m
 Roots, fine at joint

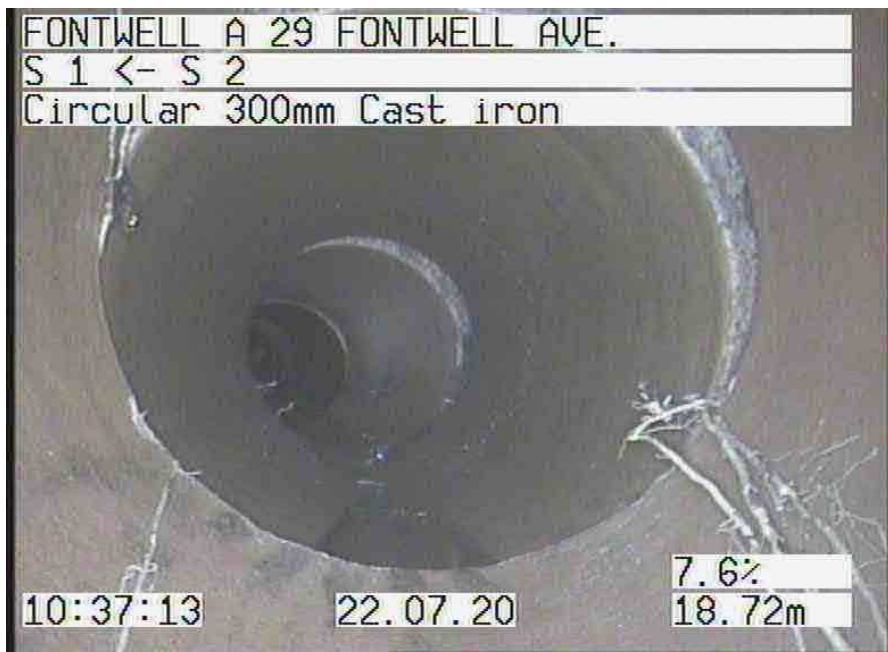
S 1X_1d6a4940-240e-46a7-848b-5f165be5c0d1_20200722_103904_219.jpg, 00:01:31, 18.72
 m
 Roots, tap at joint

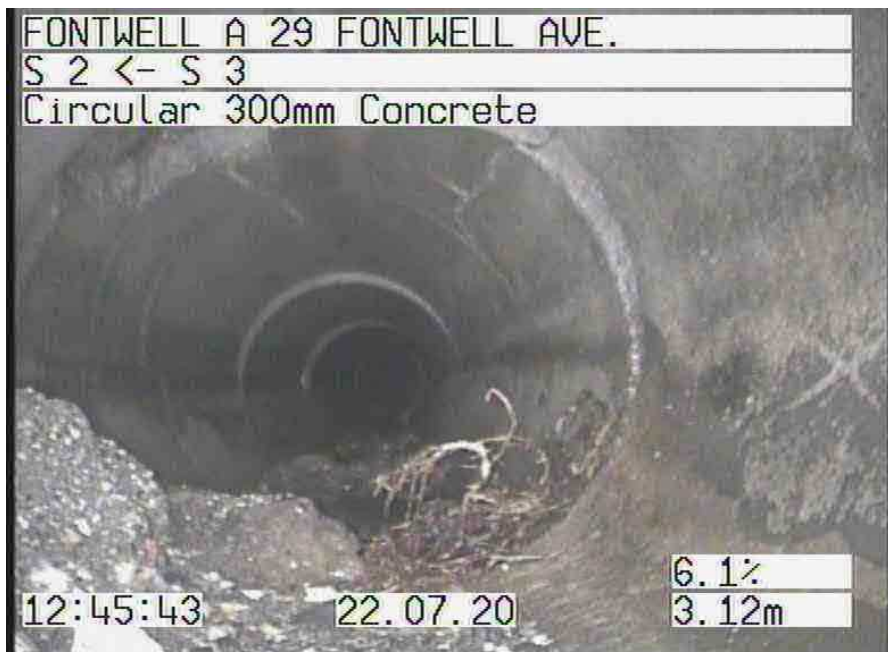
S 2X_4ef9c108-99cd-47cf-80b5-e90472ab2468_20200722_124734_730.jpg, 00:00:39, 3.12 m

Section	PLR	Grade	Description
2	S 2X	5	Hole in drain or sewer at a joint from 10 o'clock to 1 o'clock
3	S 3X	4	Multiple defects
4	S 4X	5	Hole in drain or sewer from 10 o'clock to 3 o'clock
5	S 5X	5	Hole in drain or sewer from 7 o'clock to 1 o'clock
6	S 6X	5	Hole in drain or sewer from 10 o'clock to 2 o'clock

Hole in drain or sewer at a joint from 10 o'clock to 1 o'clock

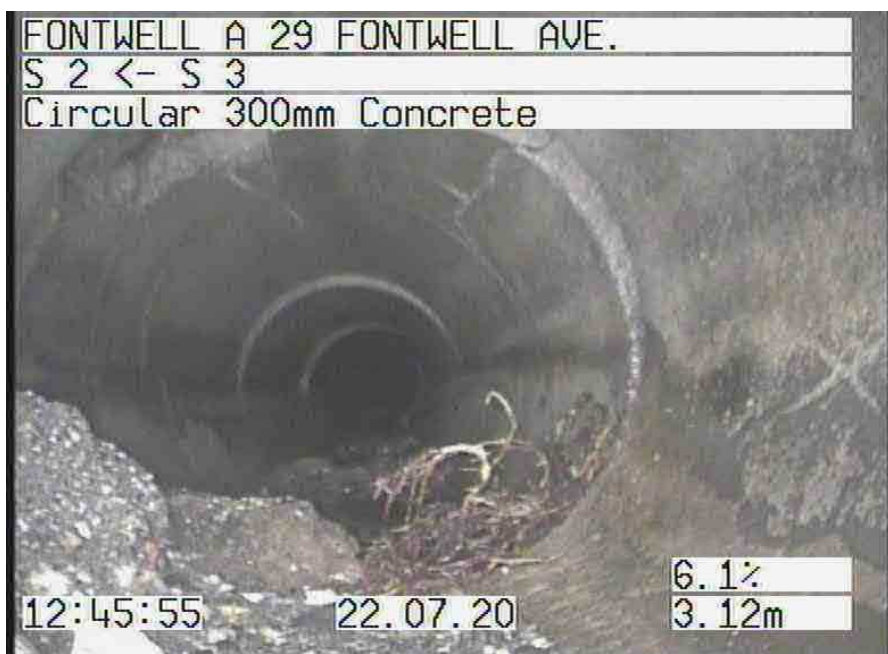
S 2X_08ebe699-ae42-4afd-ba5e-1620552b3292_20200722_124746_524.jpg, 00:00:43, 3.12 m

3.12	FC	Fracture, circumferential from 9 o'clock to 3 o'clock	3

Fracture, circumferential from 9 o'clock to 3 o'clock

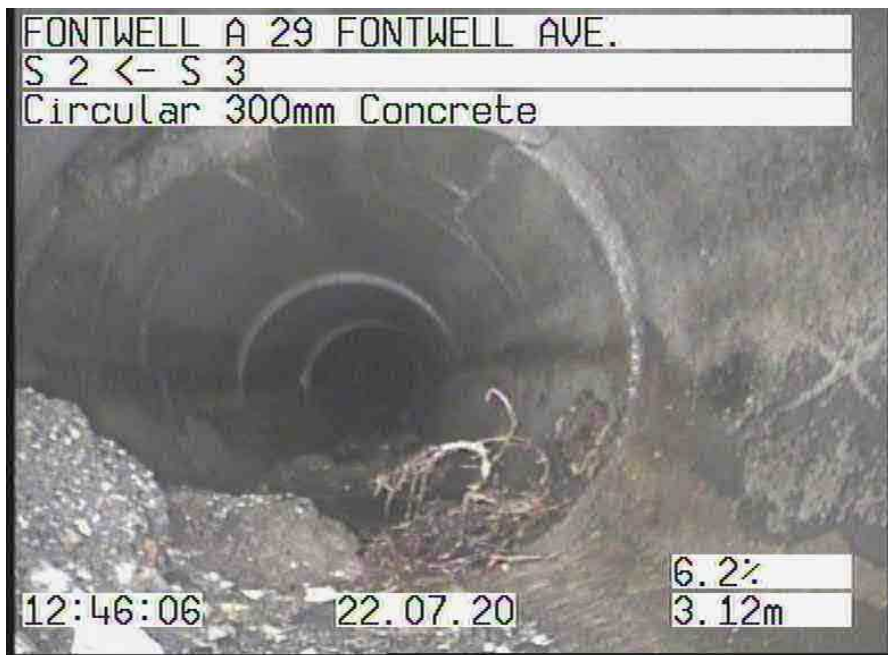
S 2X_8c6e3851-3c61-4e4d-b5a9-4a37fac715a1_20200722_124757_959.jpg, 00:00:47, 3.12 m

3.12m // 00:00:43.34 //
	3.12	FL	Fracture, longitudinal at 2 o'clock	3

Fracture, longitudinal at 2 o'clock

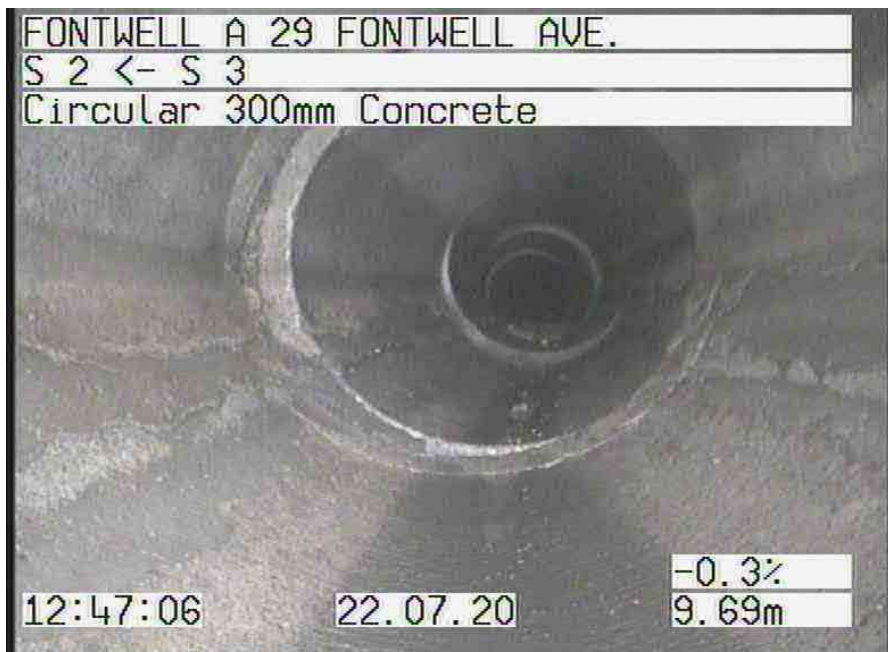
S 2X_05743cde-0a51-4426-b771-72a0ad369a01_20200722_124857_702.jpg, 00:01:27, 9.69
 m

Hole in drain or sewer at 12 o'clock

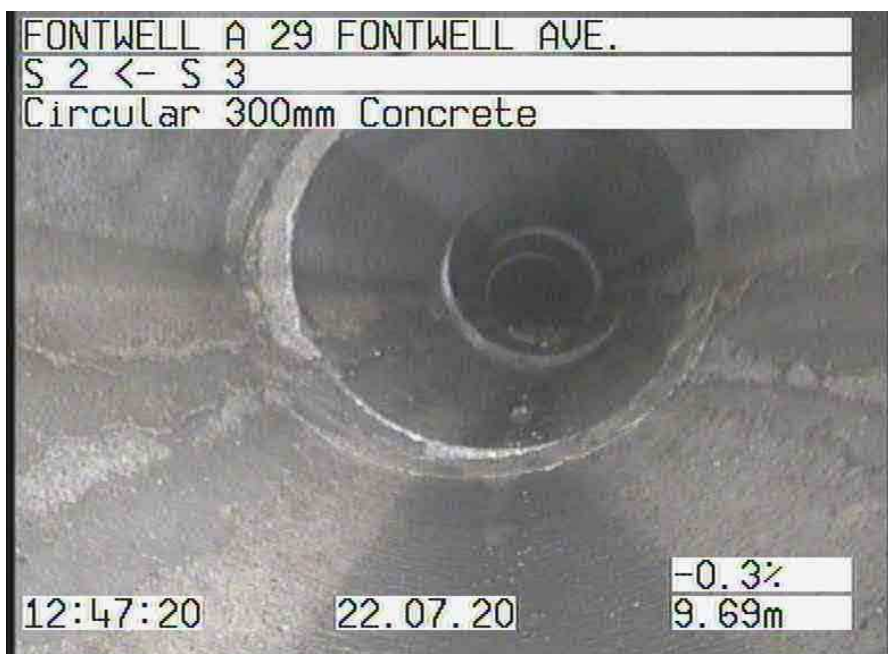
S 2X_e6d01b7c-f88c-4553-b80e-21952c5785a2_20200722_124911_516.jpg, 00:01:31, 9.69
 m

Fracture, circumferential from 12 o'clock to 12 o'clock

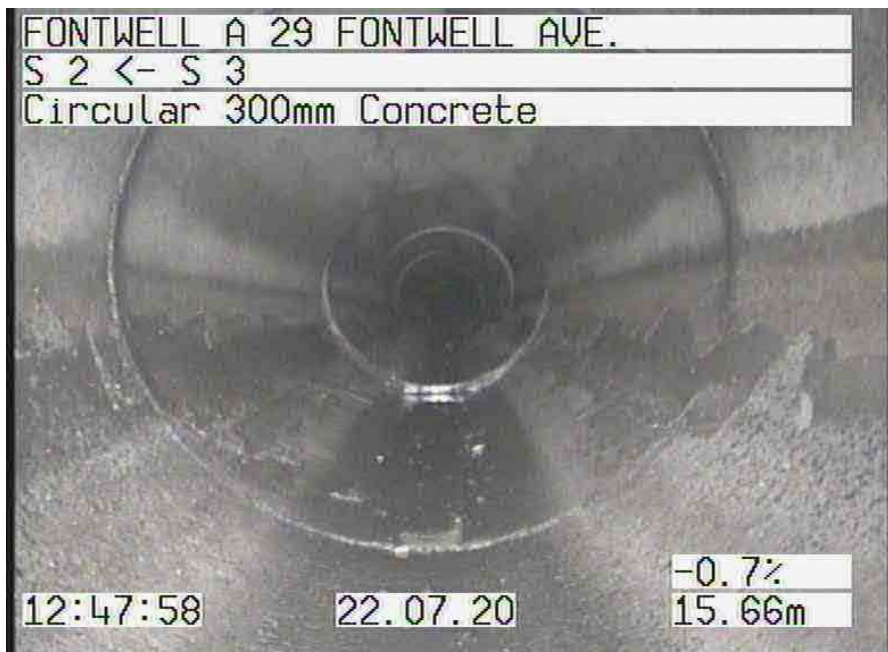
S 2X_63a01a65-f631-48db-947e-15d36b19dba8_20200722_124950_044.jpg, 00:02:04, 15.66 m

Fracture, longitudinal at 12 o'clock

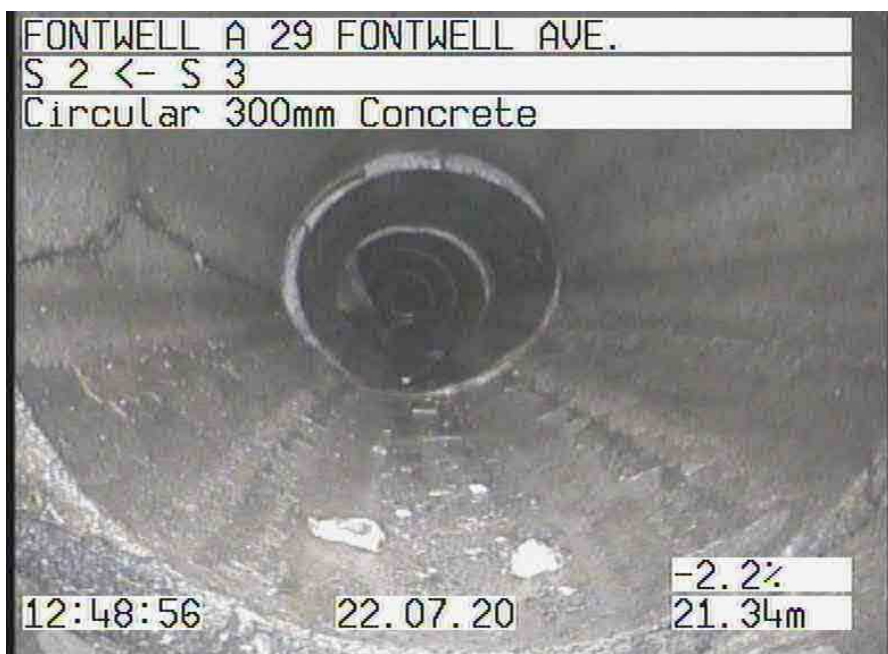
S 2X_b1e20b50-5e9f-4bf6-8dfd-f60614a5db96_20200722_125048_065.jpg, 00:02:37, 21.34 m

Fracture, longitudinal at 12 o'clock

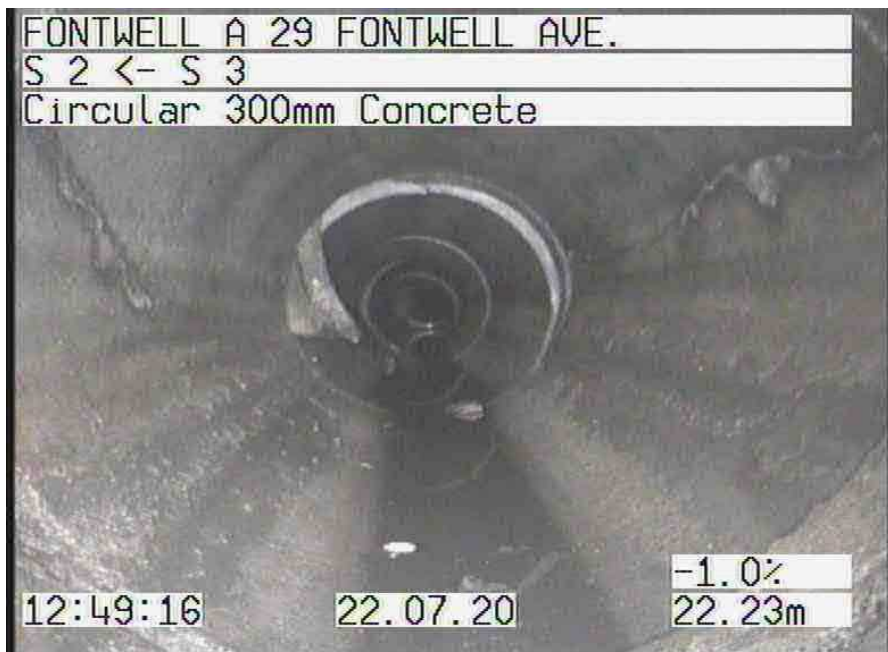
S 2X_2fab1903-e4c6-4d92-a59d-f7d854a79db2_20200722_125107_721.jpg, 00:02:47, 22.23
 m

Fracture, multiple from 9 o'clock to 3 o'clock

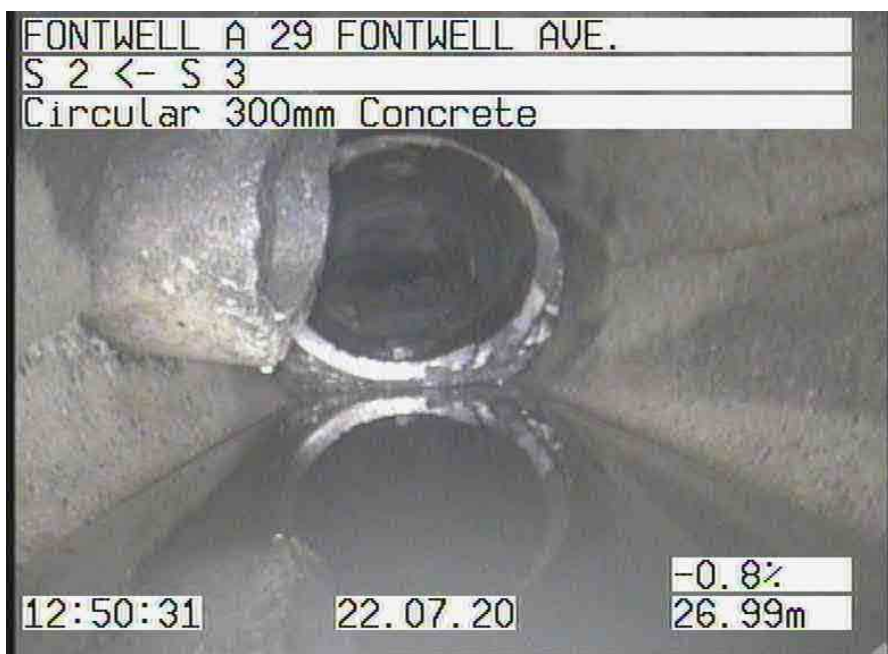
S 2X_3a3472bf-b4b7-46c5-981a-94c42e413e26_20200722_125223_288.jpg, 00:03:16, 26.99
 m

Scale: 1:214	Position [m]	Code	Observation	Grade
<p style="margin-left: 20px;">Depth: m</p>	26.99	CXI	Connection defective, connecting pipe is intruding at 10 o'clock, diameter: 150mm, intrusion: 20%	3
	26.99	SA	Survey abandoned: DUE TO INTRUDING PIPE

Survey abandoned, DUE TO INTRUDING PIPE

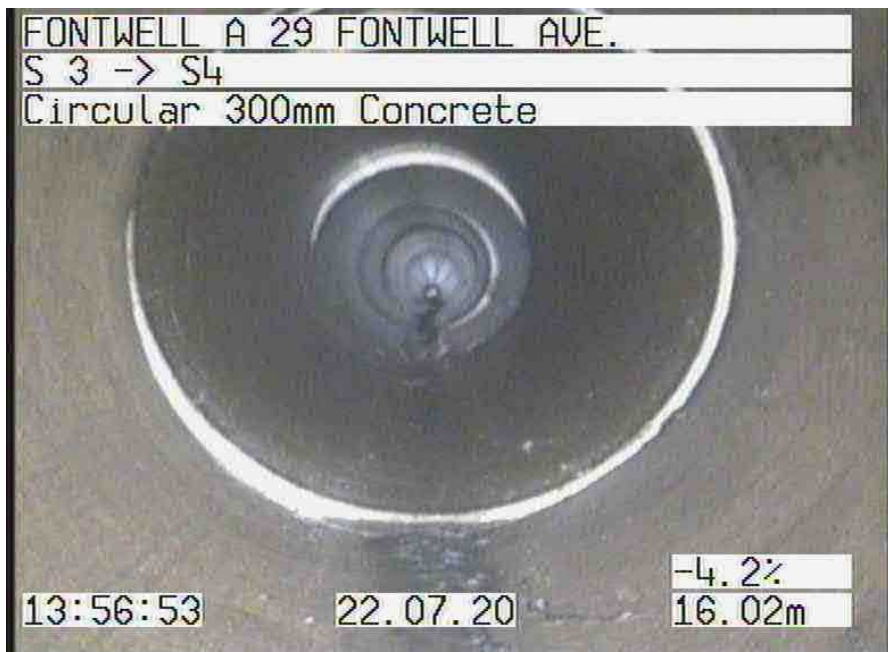
S 3X_aa978d16-91d5-4a28-b23f-0800ae9dce64_20200722_135830_494.jpg, 00:02:10, 16.02 m

Hole in drain or sewer at 11 o'clock

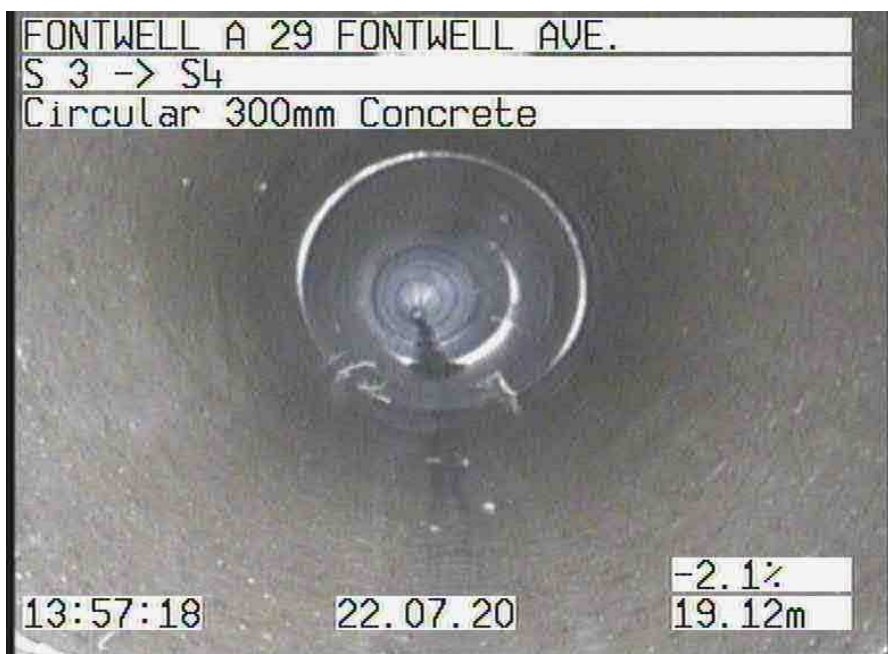
S 3X_ac290a74-d233-4a48-927b-aede5263fc22_20200722_135855_205.jpg, 00:02:31, 19.12 m

Hole in drain or sewer at 12 o'clock

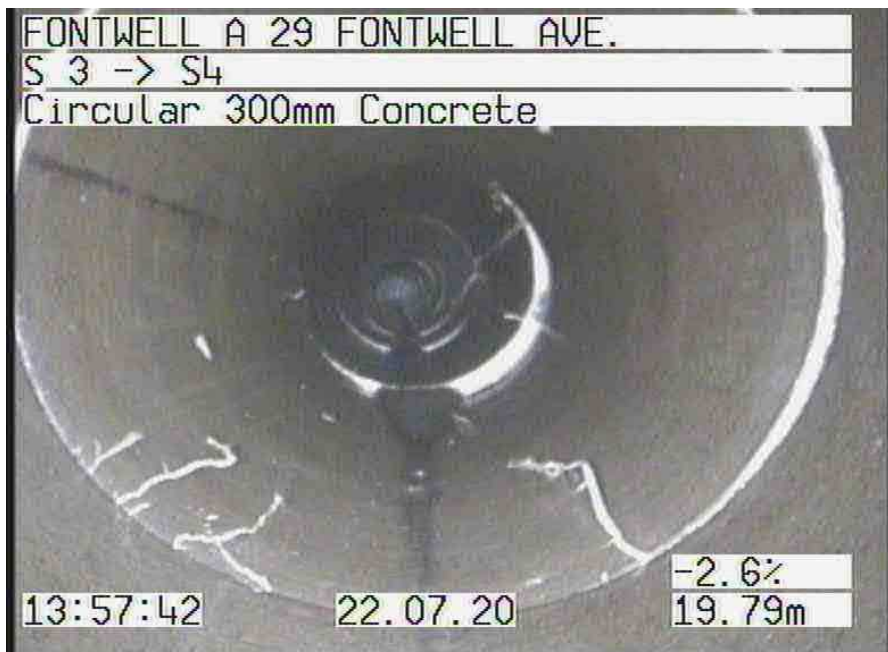
S 3X_33408f43-064d-4692-832e-9bc4f0e4d5ba_20200722_135919_237.jpg, 00:02:42, 19.79
 m

Roots, fine at joint, start, MOST JOINTS

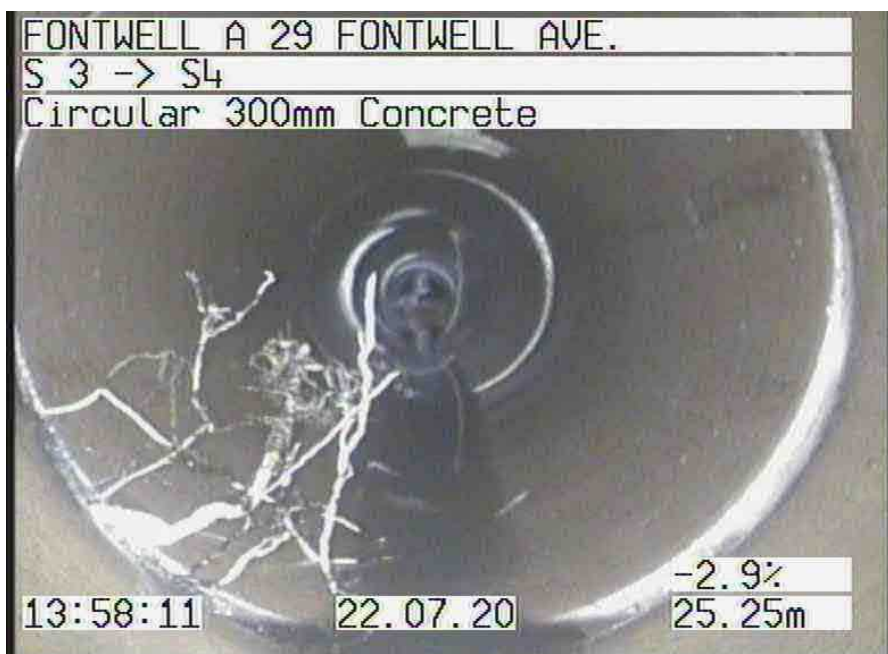
S 3X_53340216-b99e-4f5e-ae2e-f51e63c3ada8_20200722_135948_054.jpg, 00:03:10, 25.25
 m

Roots, tap at joint

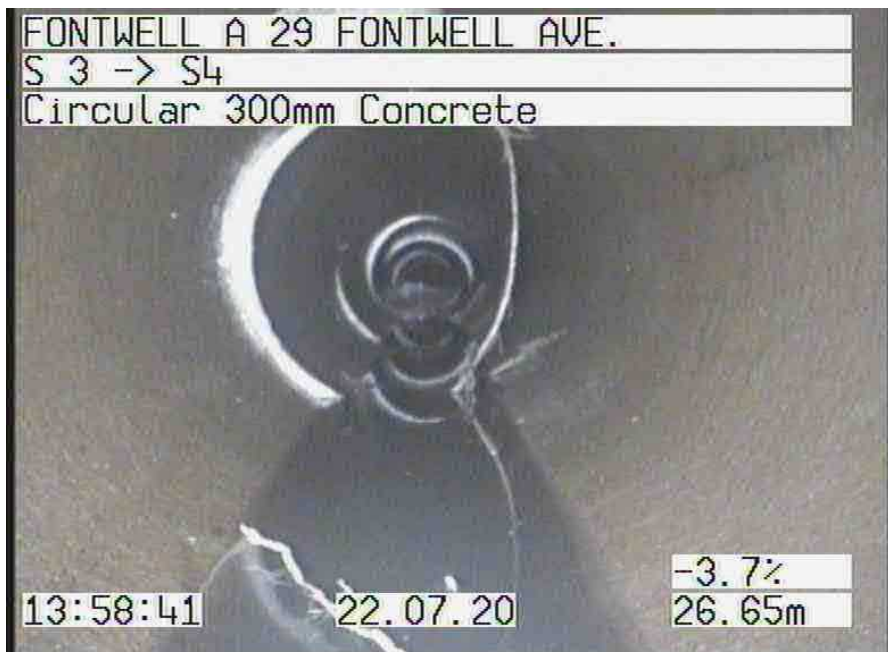
S 3X_c9aaf483-d7fb-402c-9b98-ad468d006810_20200722_140017_628.jpg, 00:03:25, 26.65 m

Hole in drain or sewer at 12 o'clock

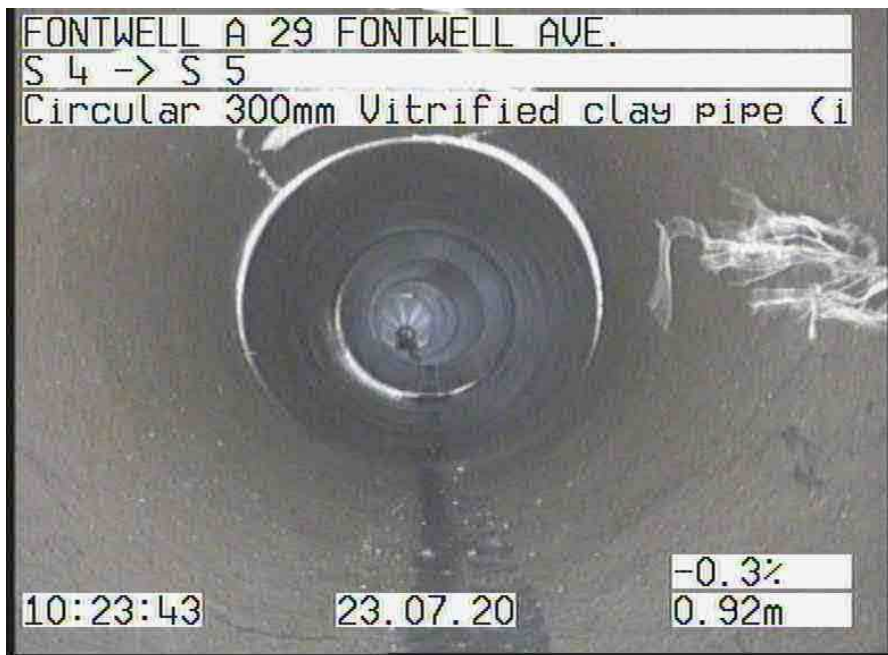
S 4X_3f8464b3-710c-4c99-9f9a-7b74153a84ca_20200723_102522_303.jpg, 00:00:18, 0.92 m

Hole in drain or sewer at 12 o'clock

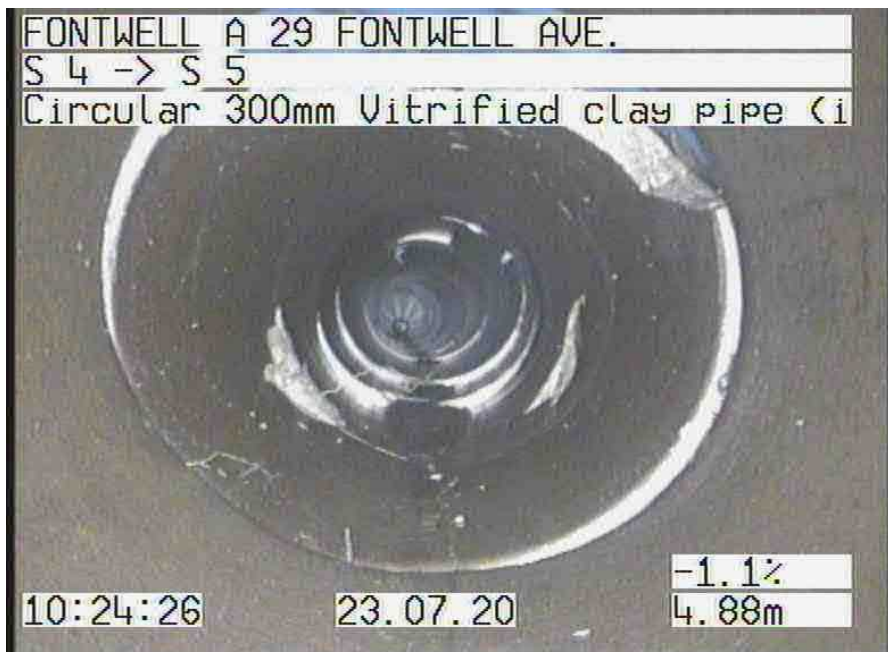
S 4X_98175ffa-e169-4917-a40b-1aa9542d5a26_20200723_102604_790.jpg, 00:00:44, 4.88 m

Hole in drain or sewer from 10 o'clock to 3 o'clock

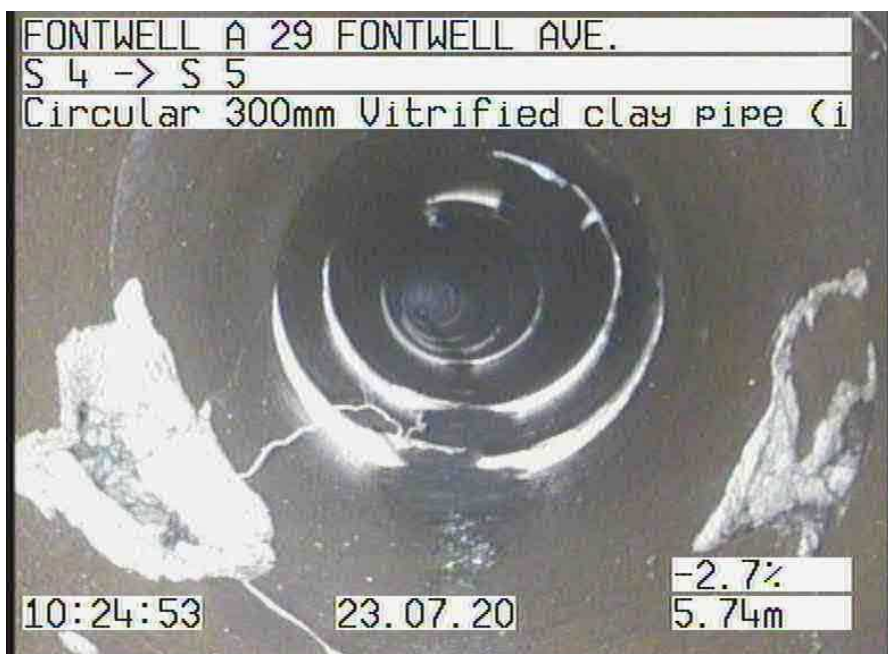
S 4X_b8b2736c-6b08-4d55-820e-55066b9e6e7b_20200723_102631_648.jpg, 00:00:59, 5.74 m

Hole in drain or sewer at 4 o'clock

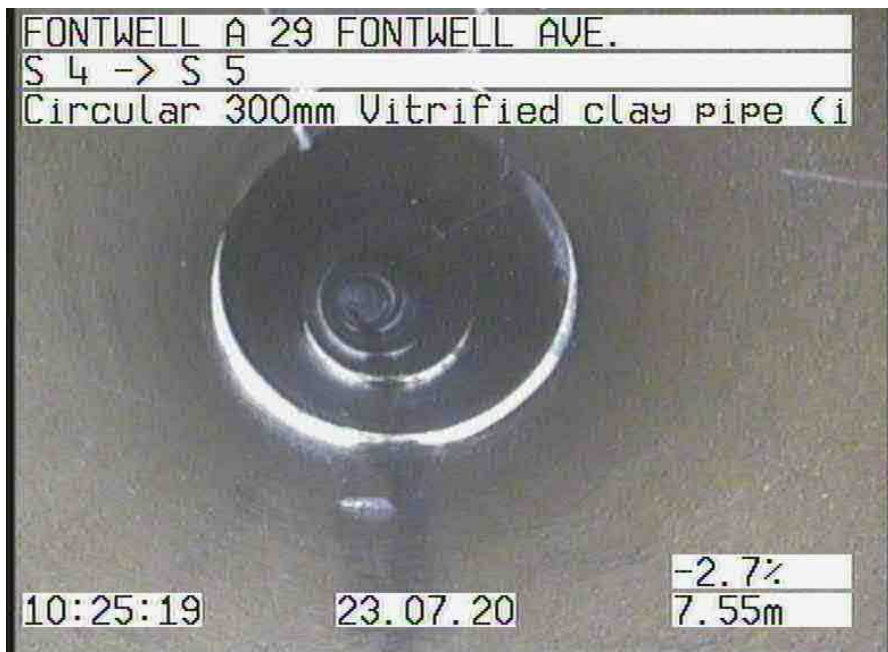
S 4X_1be84700-5cd3-446b-98b5-bc7b26c62438_20200723_102657_927.jpg, 00:01:19, 7.55
 m

Hole in drain or sewer at 12 o'clock
