Appendix D

CCTV SURVEYS

Project Name: 2020_07_20 JACKSON CIVILS LIMITED
Project Number: PJ375561
Project Date: 20/07/2020
Project Standard: MSCC4 Sewers & Drainage GB (SRM4 Scoring)

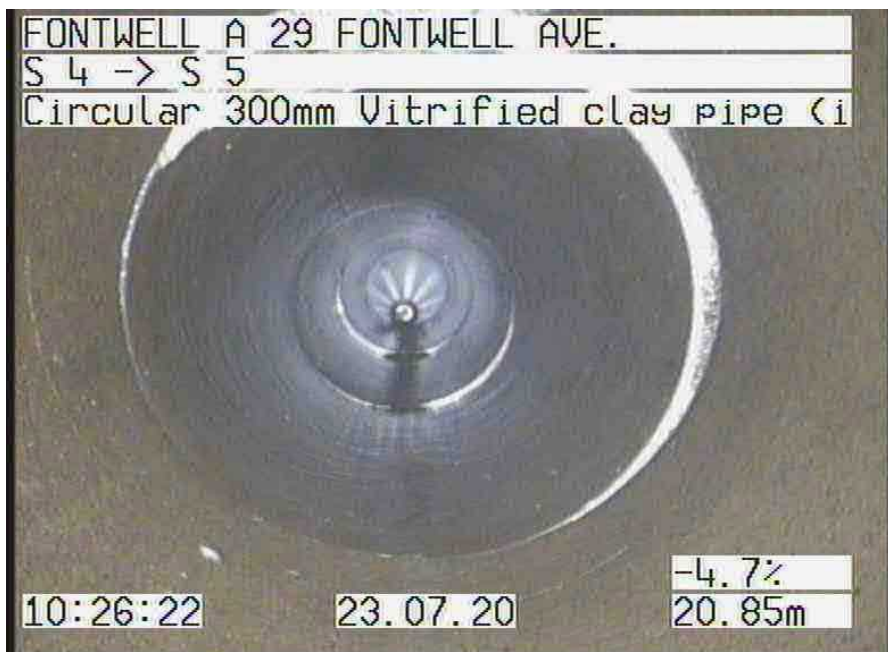
S 4X_ef5adade-e1f0-4cd7-b198-1a8e8e5f0cdd_20200723_102800_794.jpg, 00:02:16, 20.85
 m

Hole in drain or sewer from 11 o'clock to 12 o'clock

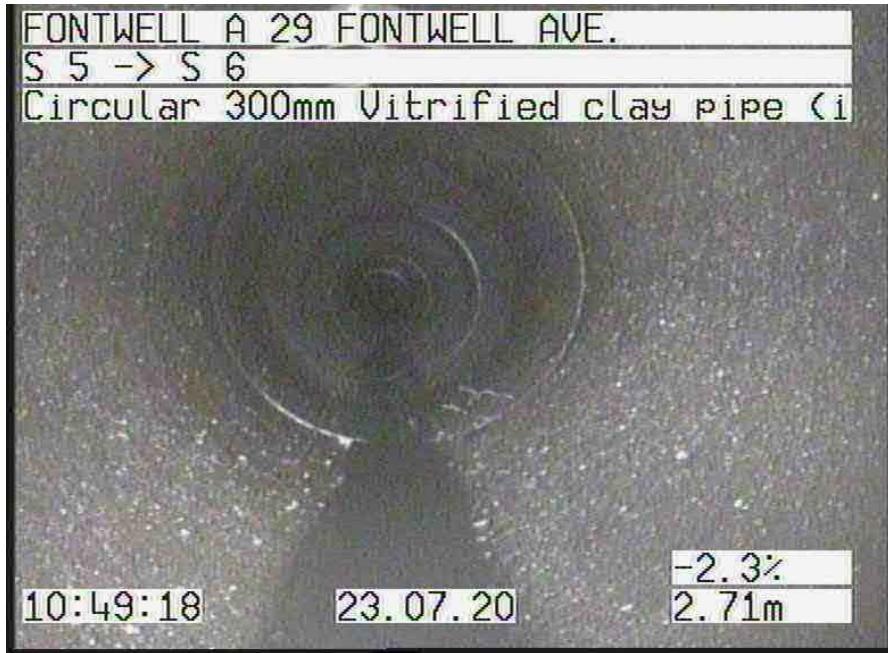
S 5X_a9b8138b-f5b7-4906-9384-e0eeeb86effb_20200723_105056_556.jpg, 00:00:23, 2.71 m

Hole in drain or sewer at 12 o'clock

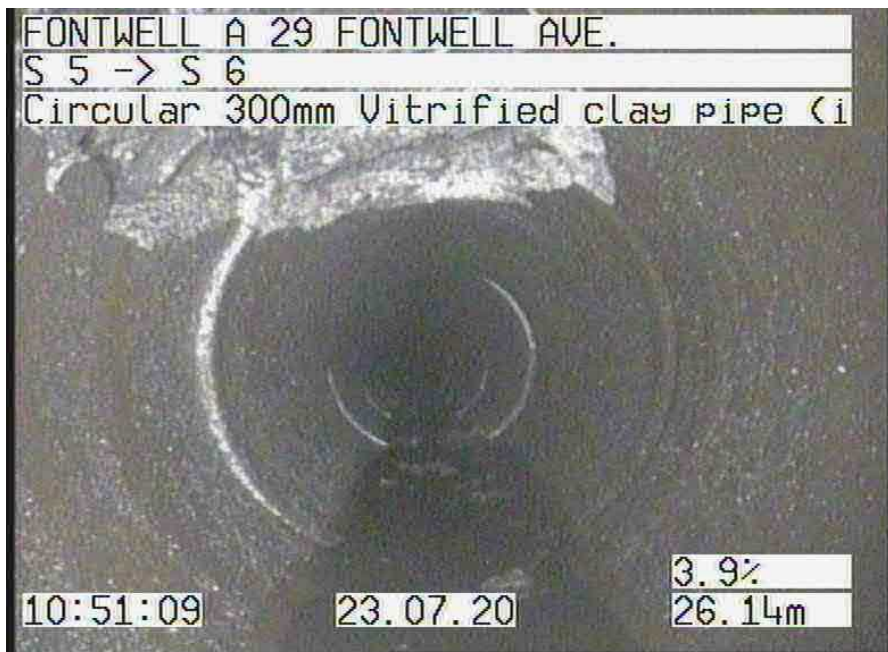
S 5X_25ebad10-72e5-4286-9079-02d7ede54310_20200723_105248_188.jpg, 00:01:59,
 26.14 m

Hole in drain or sewer from 10 o'clock to 12 o'clock

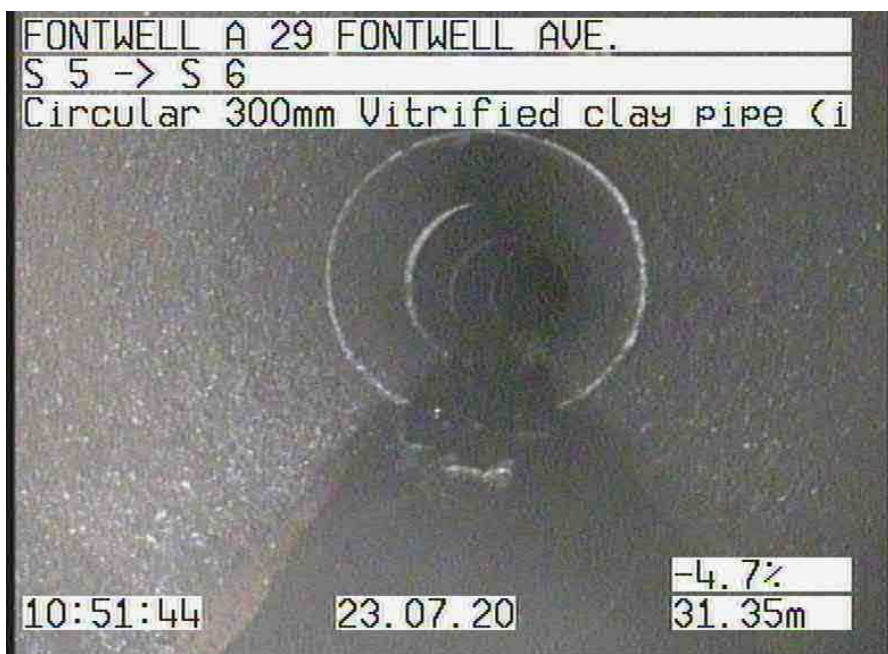
S 5X_b48b0b57-f860-4e15-8ca7-694b1fbabf70_20200723_105323_066.jpg, 00:02:29, 31.35
 m

Hole in drain or sewer at 12 o'clock

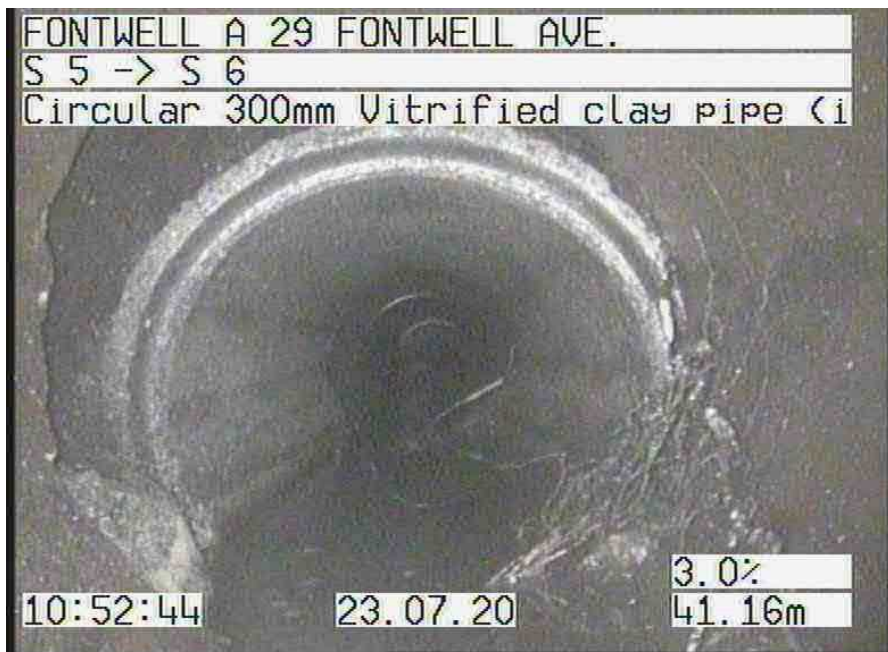
S 5X_88eb2311-d04c-4157-9865-fe6d3bfae336_20200723_105423_467.jpg, 00:03:18, 41.16 m

Hole in drain or sewer from 7 o'clock to 1 o'clock

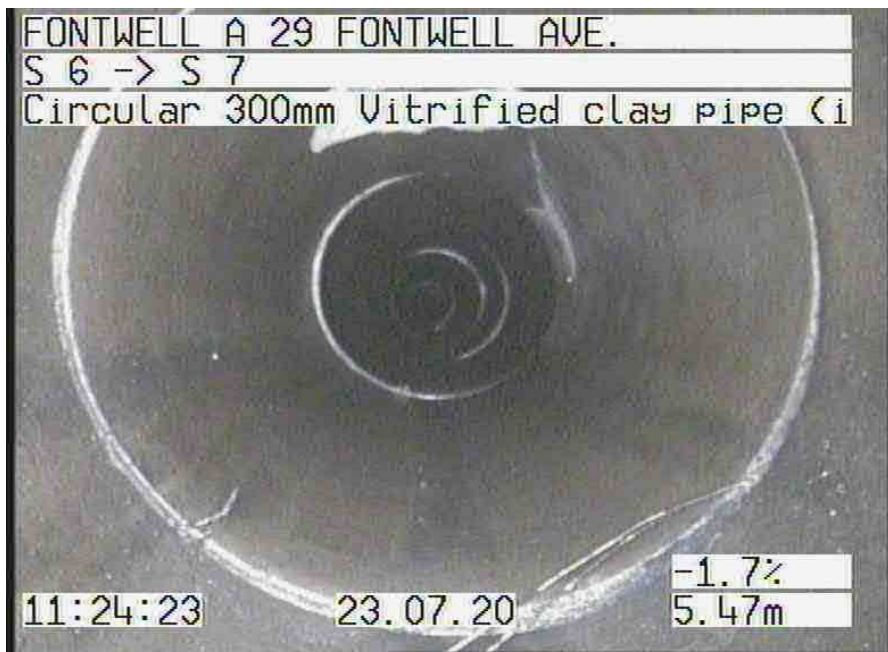
S 6X_cab79376-a58b-4a32-9e07-2ec8959dd169_20200723_112601_738.jpg, 00:00:49, 5.47
 m

Hole in drain or sewer at 12 o'clock

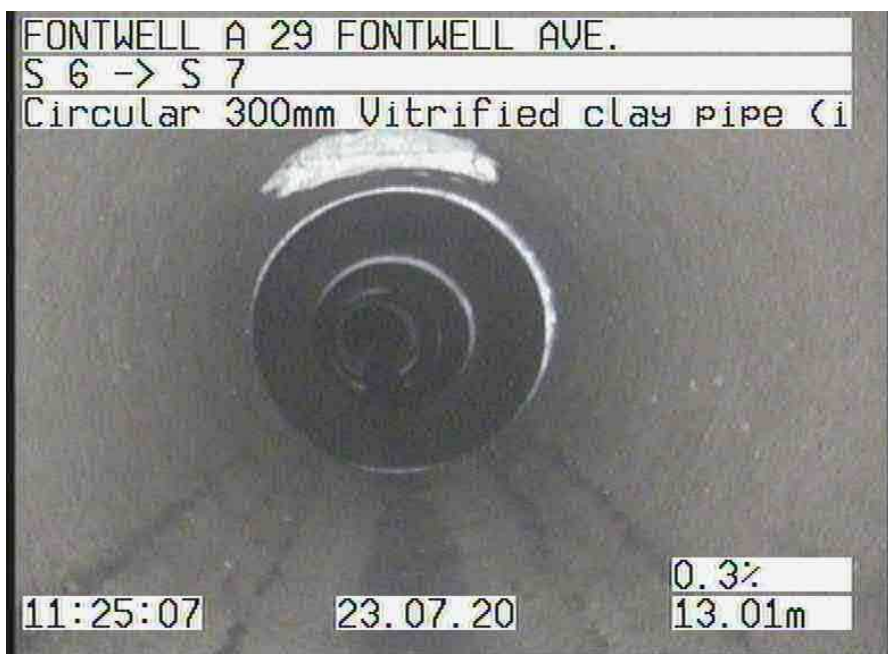
S 6X_23eca4da-d491-4334-92f0-2b839fe11615_20200723_112645_976.jpg, 00:01:31, 13.01
 m

Hole in drain or sewer at 12 o'clock

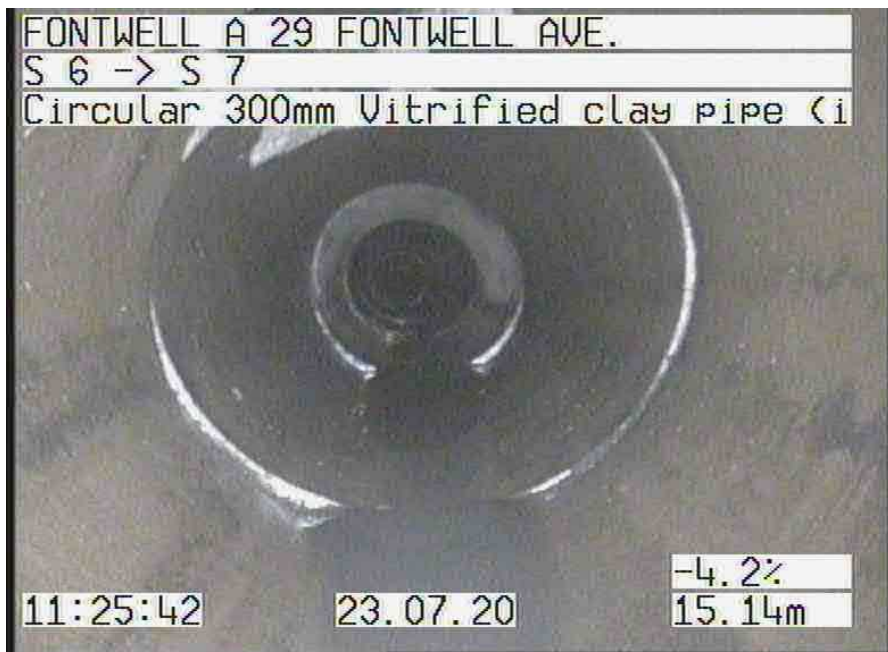
S 6X_20e5e42f-d214-462d-ae3a-a7277b04ff96_20200723_112721_561.jpg, 00:01:59, 15.14 m

Hole in drain or sewer at 11 o'clock

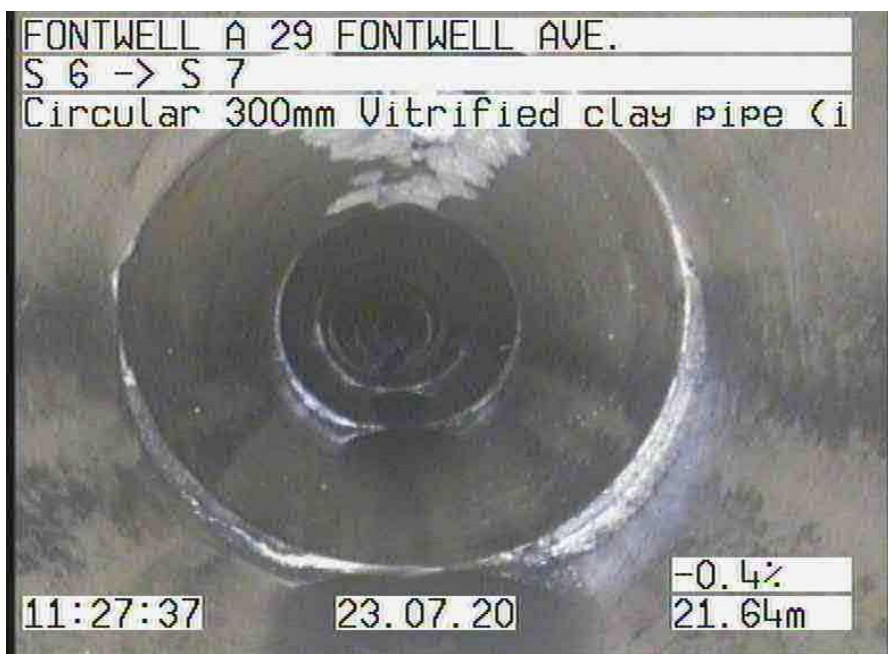
S 6X_1a10f9d8-f317-4d13-b953-18147d85f377_20200723_112916_441.jpg, 00:02:58, 21.64 m

35.05	H	Hole in drain or sewer from 10 o'clock to 2 o'clock: HAS BEEN REPAIRED	5	21.64m // 00:02:58.93 //
	40.66	CPF	Finish node type, catchpit, reference number: S 7

Hole in drain or sewer at 12 o'clock

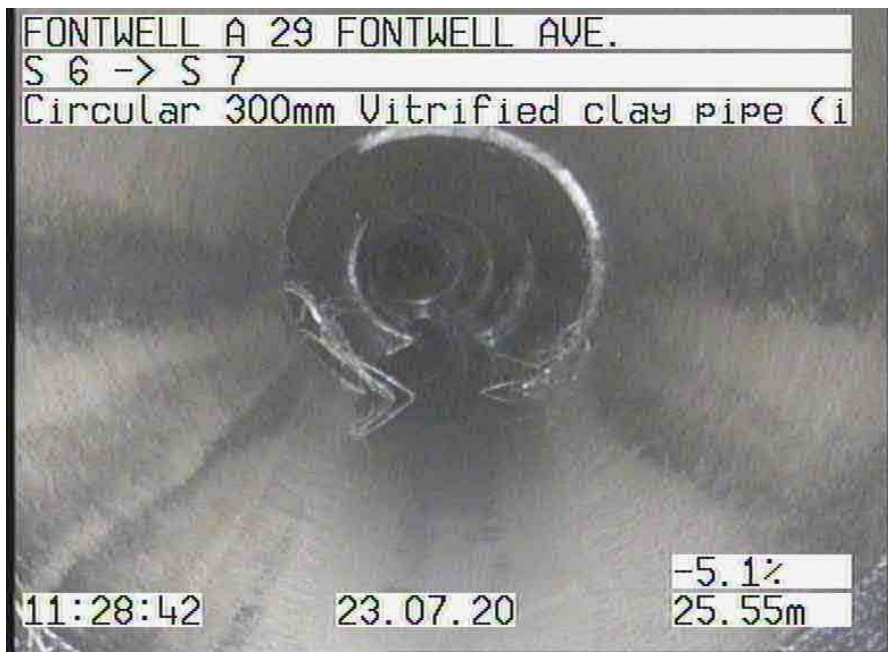
S 6X_8f772b69-20ca-403e-a337-5509ce129081_20200723_113020_892.jpg, 00:03:55, 25.55
 m
 Roots, tap

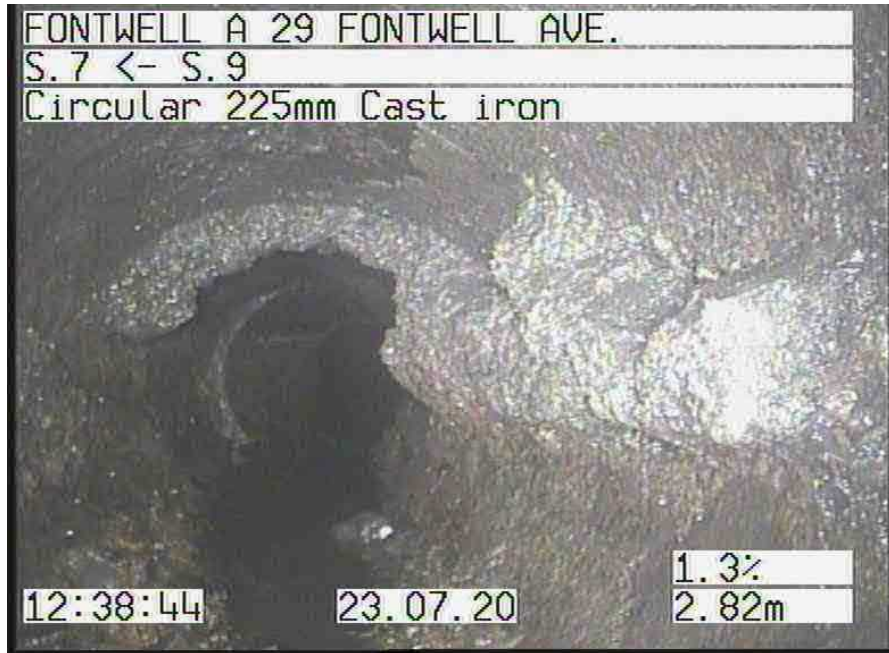
S.7X_cdd52aac-e82f-4337-acb2-3fc99a6120d2_20200723_124022_998.jpg, 00:00:25, 2.82
m

Attached deposits, encrustation from 2 o'clock to 3 o'clock, 20% cross-sectional area loss

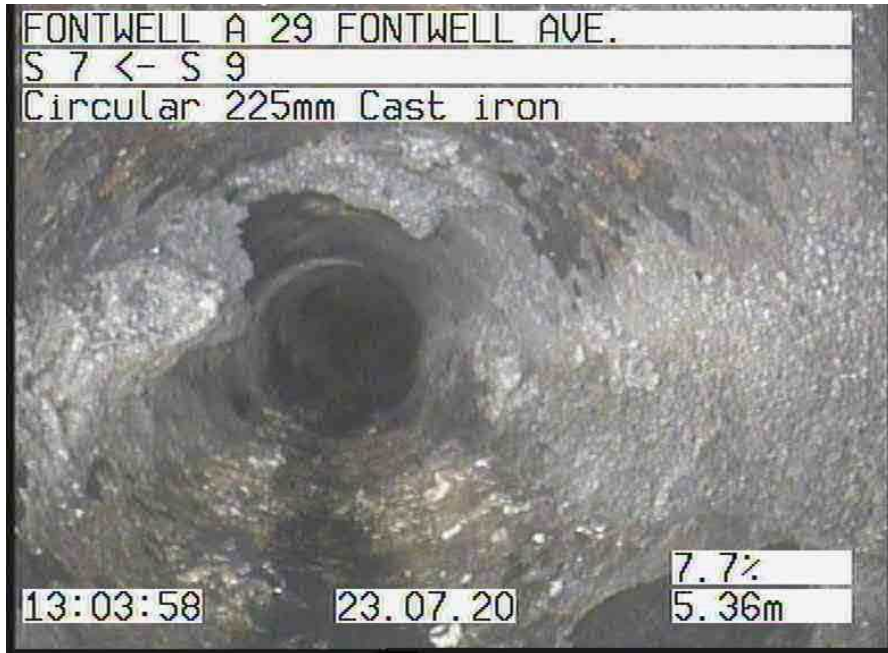
S 7X_35ac63c3-dec3-455f-8215-92d252d94c64_20200723_130537_508.jpg, 00:00:28, 5.36
 m
 Attached deposits, encrustation from 9 o'clock to 10 o'clock, 20% cross-sectional area loss

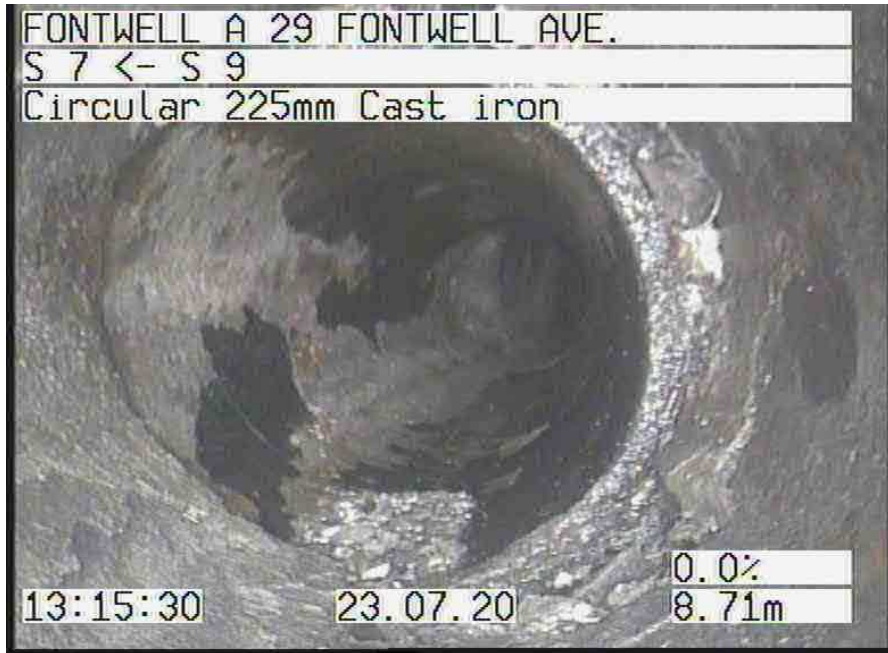
S 7X_1d069ccc-2753-4800-850e-0dc77471c39a_20200723_131709_472.jpg, 00:00:46, 8.71
 m

Joint displaced, large
