3.4 ARBORICULTURE REPORT AND TREE PROTECTION PLAN

A29 REALIGNMENT PHASE 1

Arboricultural Report

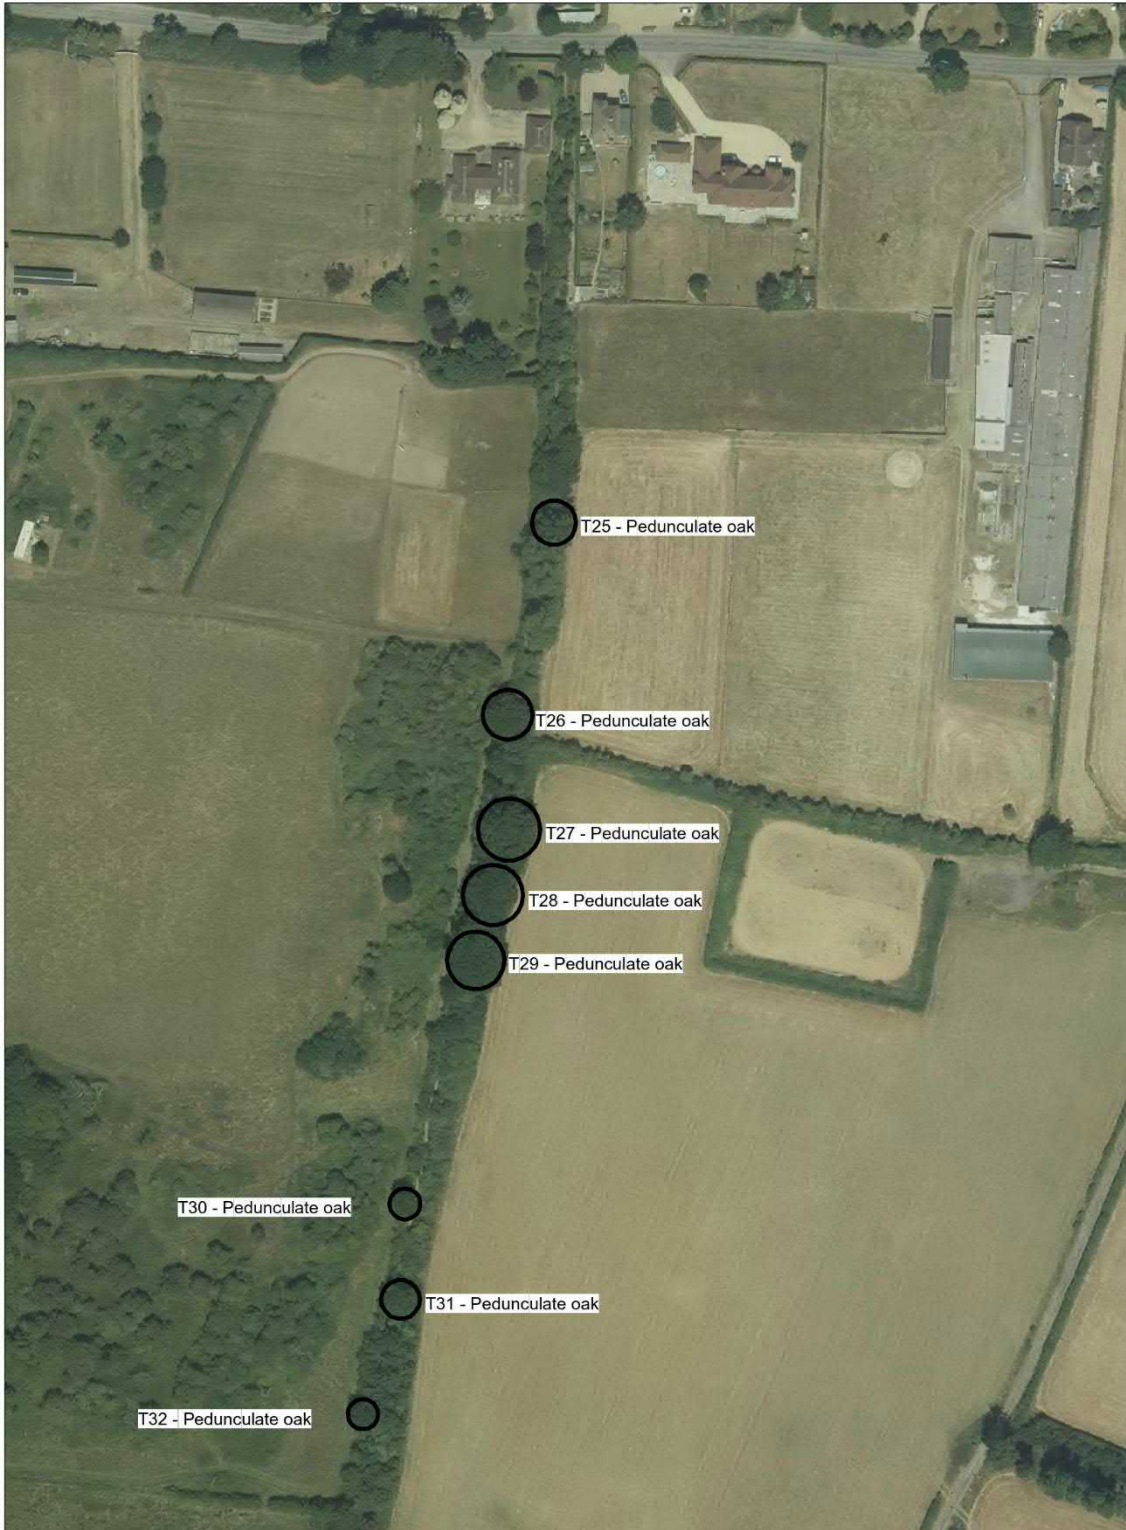
Figure F-3 - TPO/BN/1/20 - Map 3

Land N of Barnham Road, Eastergate, W.Sussex, PO20 3SJ
