APPENDIX 3.4 – ARBORICULTURE REPORT AND TREE PROTECT PLAN

A29 REALIGNMENT PHASE 1

Arboricultural Report

DATE: OCTOBER 2020

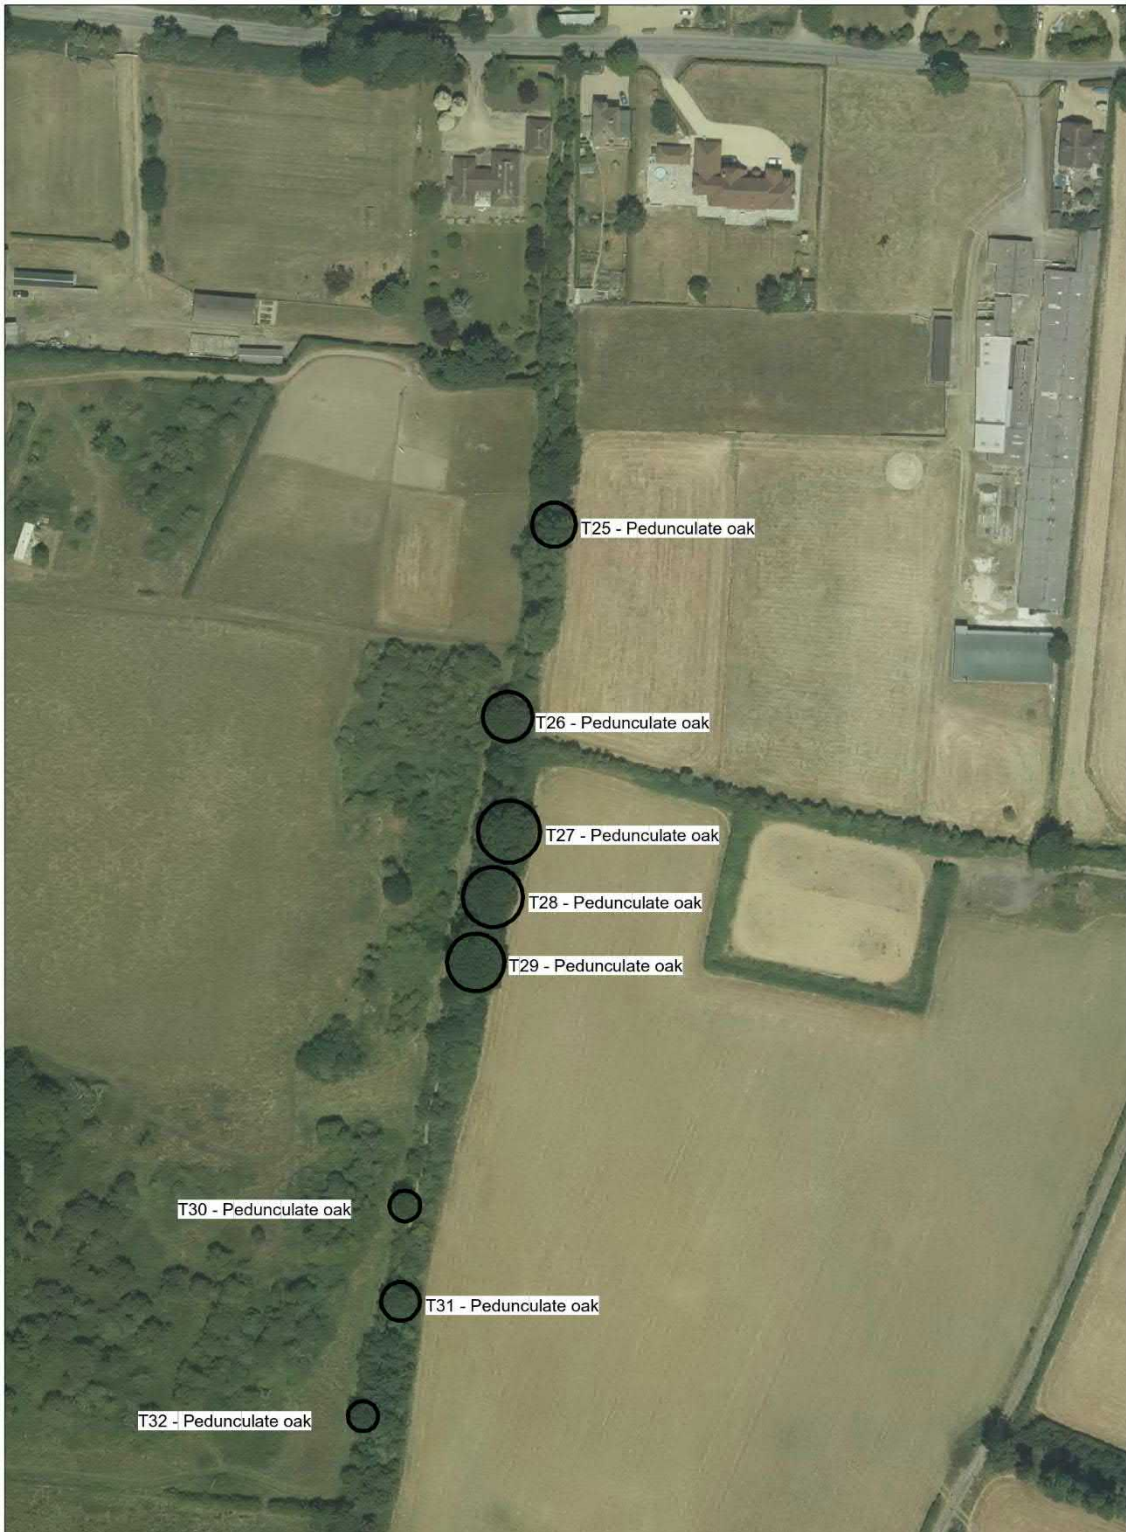
Figure F-3 - TPO/BN/1/20 - Map 3

Land N of Barnham Road, Eastergate, W.Sussex, PO20 3SJ
