FORD ENERGY RECOVERY FACILITY AND
WASTE SORTING AND TRANSFER FACILITY,
FORD CIRCULAR TECHNOLOGY PARK

ARBORICULTURAL
IMPACT STATEMENT

March 2021
CBA11322 v1H

Viridor Energy Ltd
Grundon Waste Management Ltd
Ford Energy from Waste Ltd

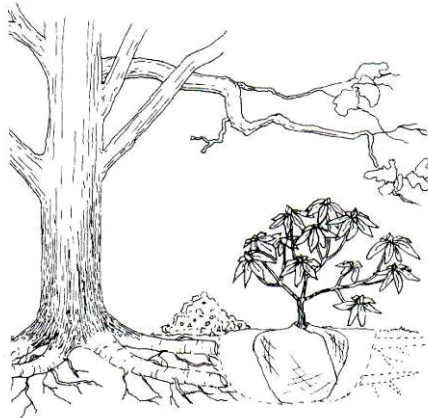
Figure 2:

Root severance as a result of planting within RPA

- All traffic, machine and pedestrian must be kept to an absolute minimum to complete the landscape installation works
- Bunds will be created close to or within root protection areas of trees, mostly on areas of existing built form. It is advised that the works to create the bund and/or remove the existing built form in particular for Group 1 is arboriculturally supervised to ensure that the initial ground works are completed in a fashion that is sympathetic to tree roots that may be exposed with roots >25mm are retained.
- Excavation of planting pits within the RPA can cause serious harm to the root system of retained trees. Planting pits within the RPA of retained trees will be excavated by hand to avoid roots greater than 25mm and masses of smaller roots.

- If any planting pits are required within the root protection areas of retained trees, these will be dug by hand and with care avoiding roots greater than 25mm diameter or masses of smaller roots.
